REPORT OF MARINE SURVEY

INSURANCE CONDITION & VALUE

"MINKIE - B"

1997 Lyman-Morse Custom Flybridge 46'

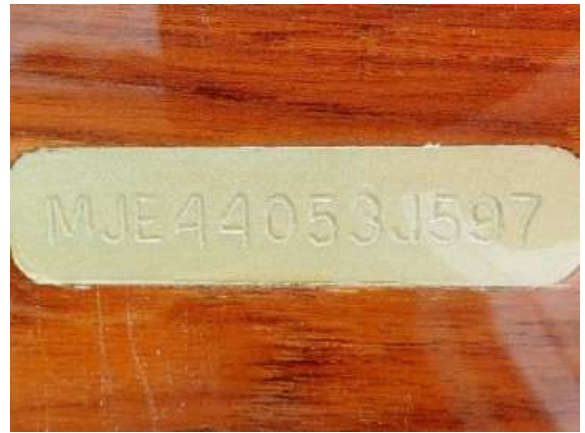
Hull ID number (HIN): MJE44053J597 - A true digital photograph of the hull ID number of the referenced vessel is shown here and was found located on the transom.

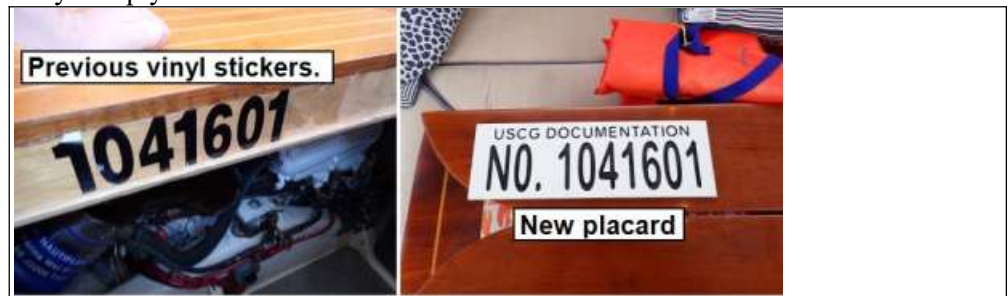
Official Documentation No: 1041601, Not permanently affixed per USCG regulations. The owner has had a new placard made which was not yet installed at the time of the survey on May 4, 2026. Peter Farrell, the service manager for the vessel, reported that the placard was scheduled to be affixed to either a stringer or bulkhead later in the week to fully comply with 46 CFR 67.121

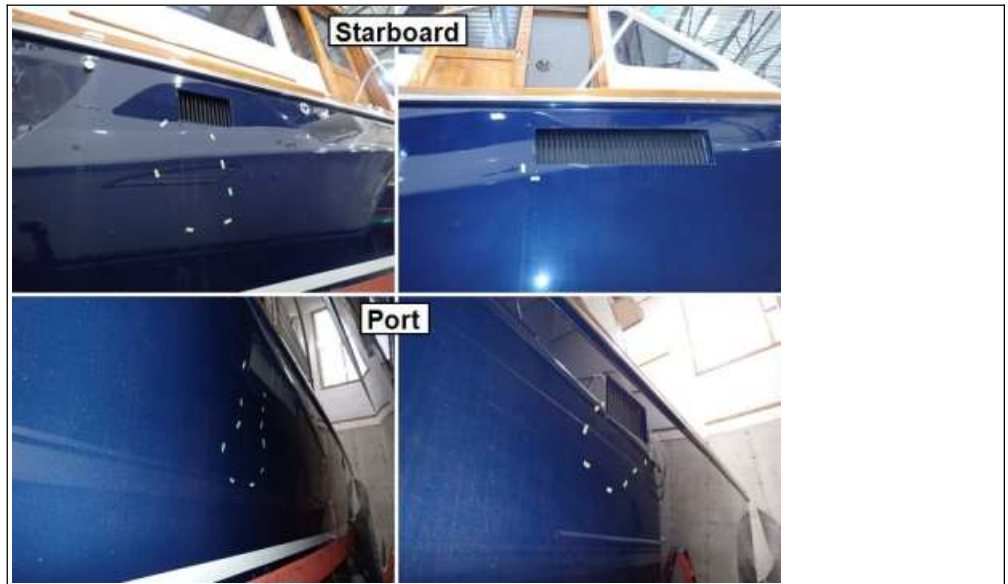
Moisture/Delamination: The majority of comparative moisture meter readings on the topsides were consistently low with the following exceptions with isolated moderate to high comparative moisture meter readings: below the four engine room vents along the topsides below the rail (two per side), and one isolated area on the port quarter. There was an isolated area with tones of delamination at the bottom aft corner of the after most engine room vent on the starboard side. The elevated comparative moisture meter readings found were isolated in nature and appear to be associated with the fasteners and drains for the engine room vents. Since the areas with elevated moisture meter readings were found the owner has had the yard reseal fasteners for the engine room vent boxes which were believed to have been a source of moisture intrusion. No further repairs are considered necessary at this time. (Photos taken on January 9, 2026)

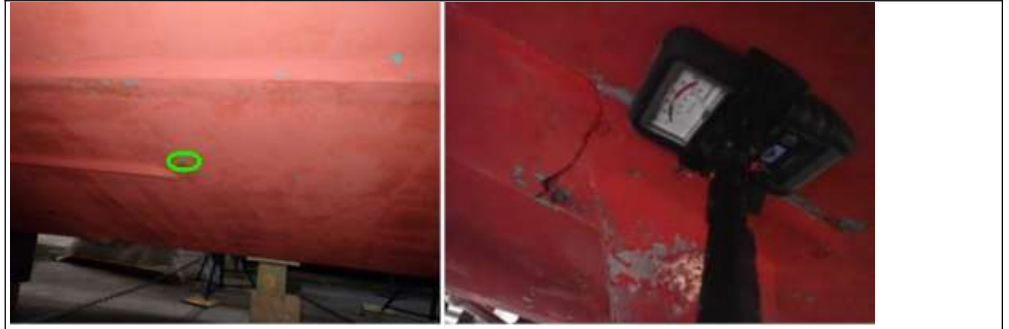
Moisture/Delamination: The majority of the comparative moisture meter readings on the hull bottom were low with moderate to high readings around the port propeller shaft strut base. There

was one small area with tones of delamination on the port side run at the end of one of the strakes. **PRIORITY THREE RECOMMENDATION:** It is advised to monitor the area with the noted delamination in the future and to make repairs if it begins to grow in size. If the port side propeller strut has not been rebbed in the last few seasons it is advised to do so a preventative maintenance in the near future due to the elevated comparative moisture meter readings around it's base. (Photos taken January 9, 2026)

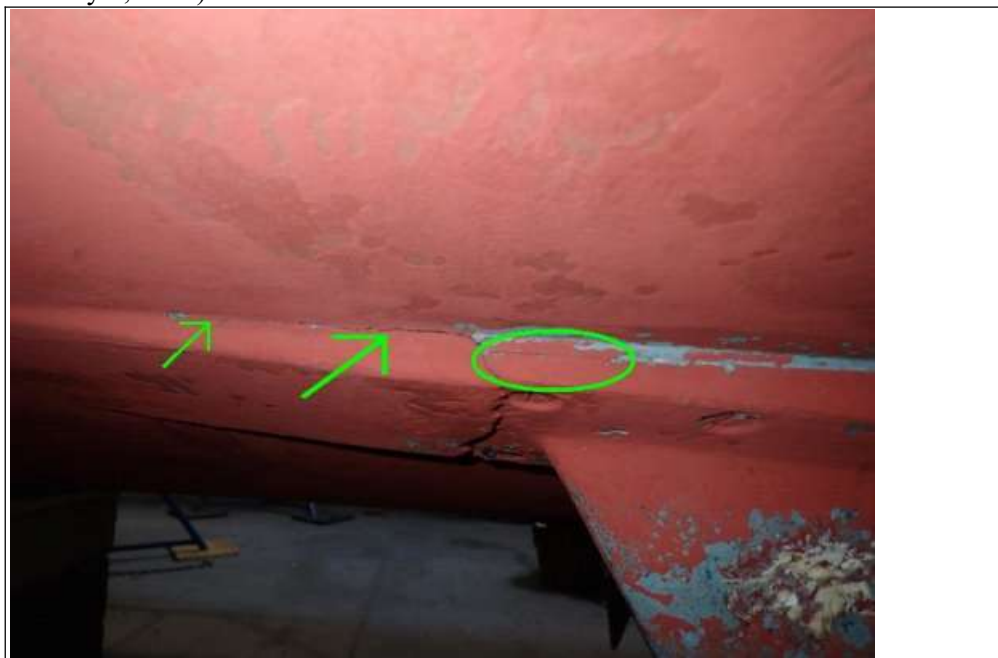
Strut(s): Two bronze alloy P-Struts were bolted to the hull bottom with bronze fasteners with stainless steel backing plates. The prop struts had fairings installed at their forward edges. The fairing forward of the port side strut was lifting from the hull and there was a small split in the sealant below the port prop strut base and the hull on its forward end. The starboard side strut was realigned and rebbed per service records in 2024. **PRIORITY TWO RECOMMENDATION:** It is advise to have

a the fairing forward of the port prop strut repair and re adhered. It is recommended to have a qualified marine propulsion technician check the torque of the fasteners on the port prop strut hardware and rebed and tighten if necessary. (Photo taken January 9, 2026)

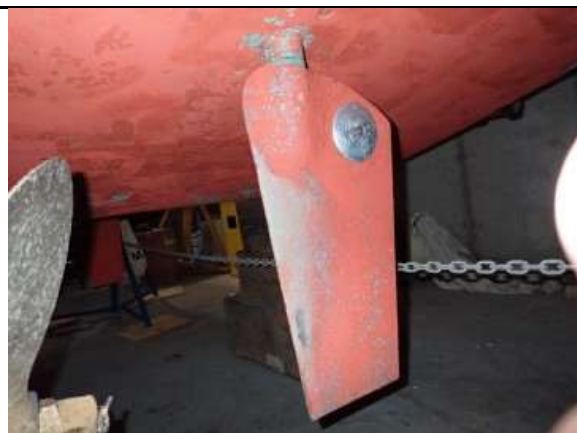
Rudder type/condition: Two cast bronze alloy spade type rudders. There was no damage sighted on the surface of the rudders. (Photo taken January 9, 2026)

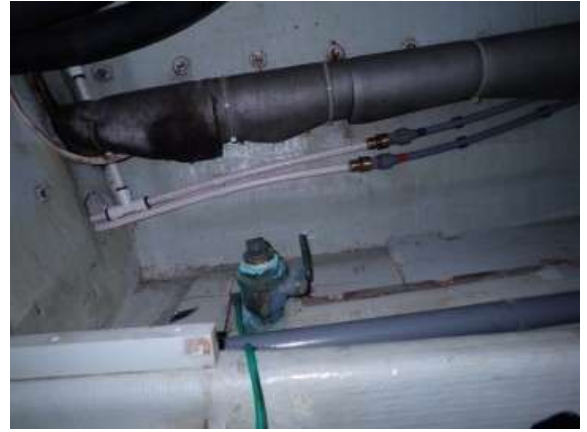
There was one seacock installed on the port side of the lazarette which had been discontinued from surface and had a threaded bronze plug appropriately installed.

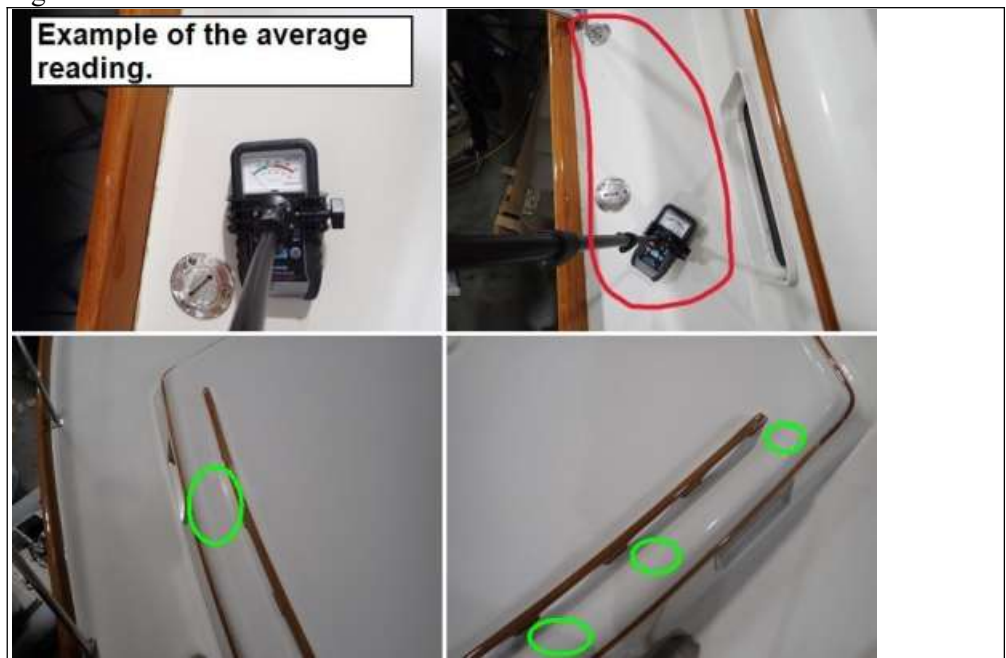
The majority of the decks and cabin trunk top had consistently low comparative moisture meter readings. There was an area with high comparative moisture meter readings on the starboard side deck between the toe rail and the cabin trunk. This area had deck fittings for the starboard water tank fill and waste tank pump out. The area with the high readings on the starboard side deck is approximated within the red outline in the following photo.

PRIORITY TWO RECOMMENDATION: It is advised to continue monitoring the areas noted outboard of the grab rails on the cabin trunk top. Rebedding the deck fittings and stanchion base in the area with elevated comparative moisture meter readings on the starboard side deck is advised to prevent a route for continued moisture intrusion, similarly, it is recommend to monitor this area for signs of delamination in the future.

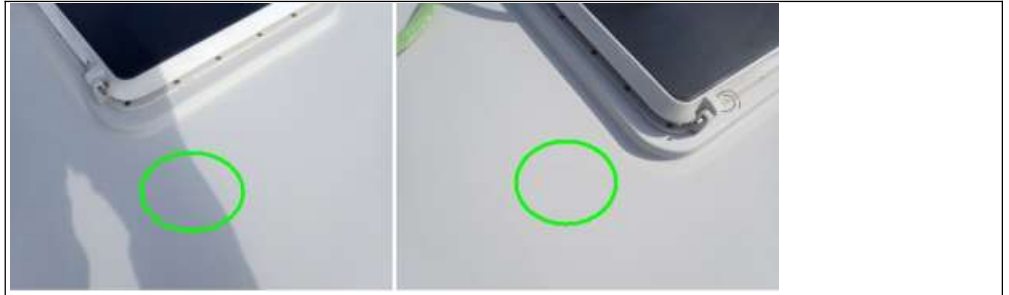
- Wash down:** A compartment below the foredeck on the port side had a wash down spigot and hose.
- Other notes:** There were two semi-circular cracks on the surface of the cabin trunk top on the port and starboard sides from older Dorade vents that had been removed.
PRIORITY THREE RECOMMENDATION: It is advised to repair the cracks on the cabin trunk top to prevent moisture intrusion and further deterioration of the surface.

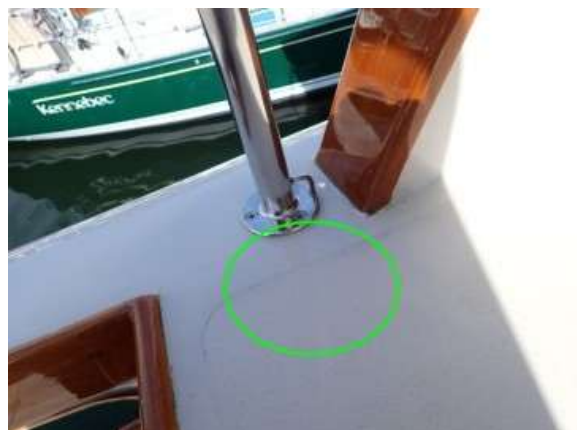
The majority of the flybridge sole had low comparative moisture meter readings with the exception of starboard aft corner near a stanchion base which had high comparative moisture meter readings, some localized tones of delamination, and a small superficial crack on the surface of the sole. The owner reported that this was a known condition which has been monitored and the nearby hardware rebedded.

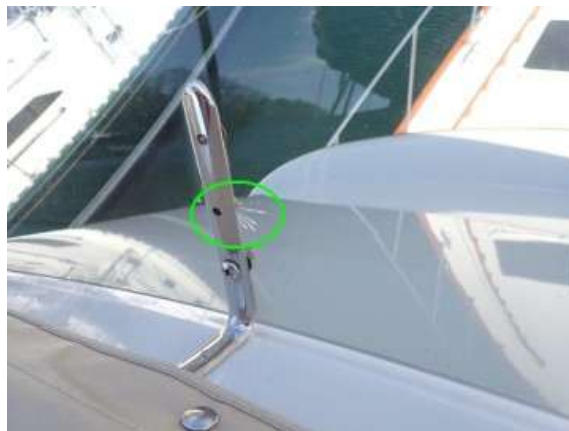
A tinted acrylic spray shield was securely installed with polished stainless steel trim and hardware. Only one small area with some crazing was noted on the port side near a fastener.
