# **Marine Consultants**

## **CONDITION AND VALUATION SURVEY**

**File No. P561123D**

| Vessel Name: | SEA JAY TOO | Survey Date | November 15, 2023 |

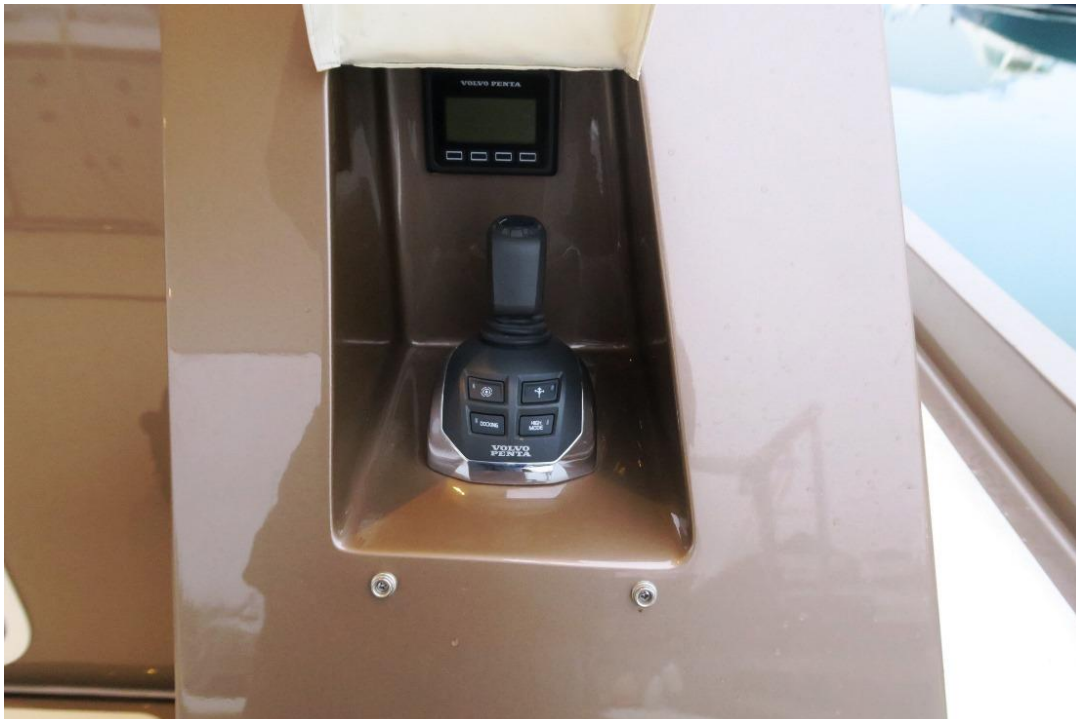
1. \* The starboard cockpit engine control station is inoperative.  
Recommendation: Service or replace for reliable operation.

**\* Not yet rectified.**

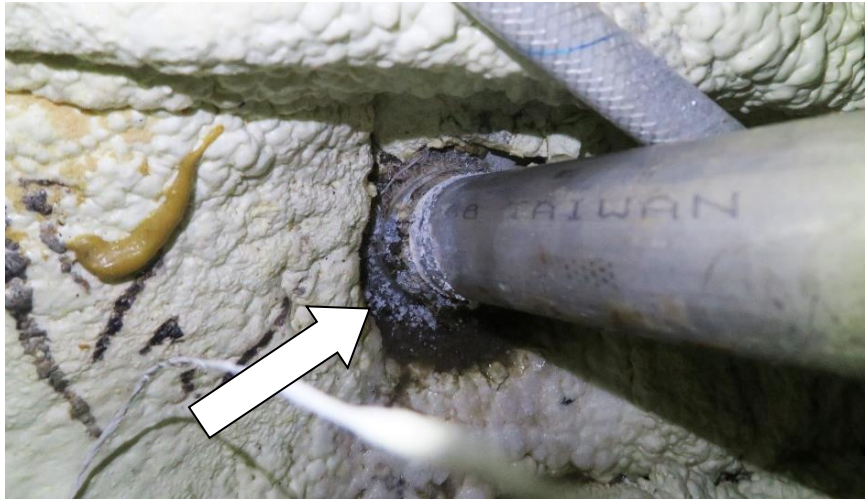
4. \* There is salt build up indicating weepage at the generator exhaust water separator water drain through hull or its fittings, just aft of the generator. See photo below.  
Recommendation: Disassemble for cleaning and inspection and repair/reseal as required.

**The plumbing has been disassembled, inspected and resealed.**

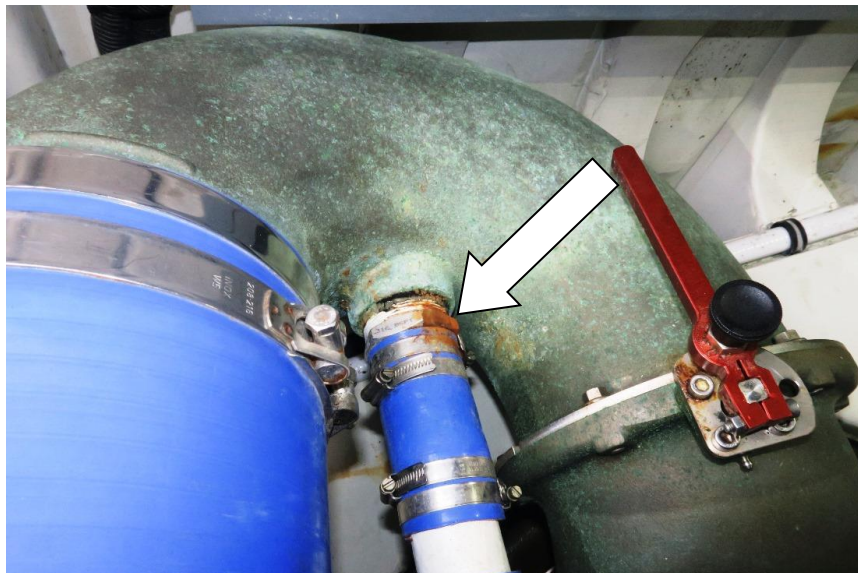
5. There are stains indicating past or present water leakage at the port engine exhaust system idle bypass hose connections.  
Recommendation: Monitor for leaks and service as needed.

**The staining has been addressed.**

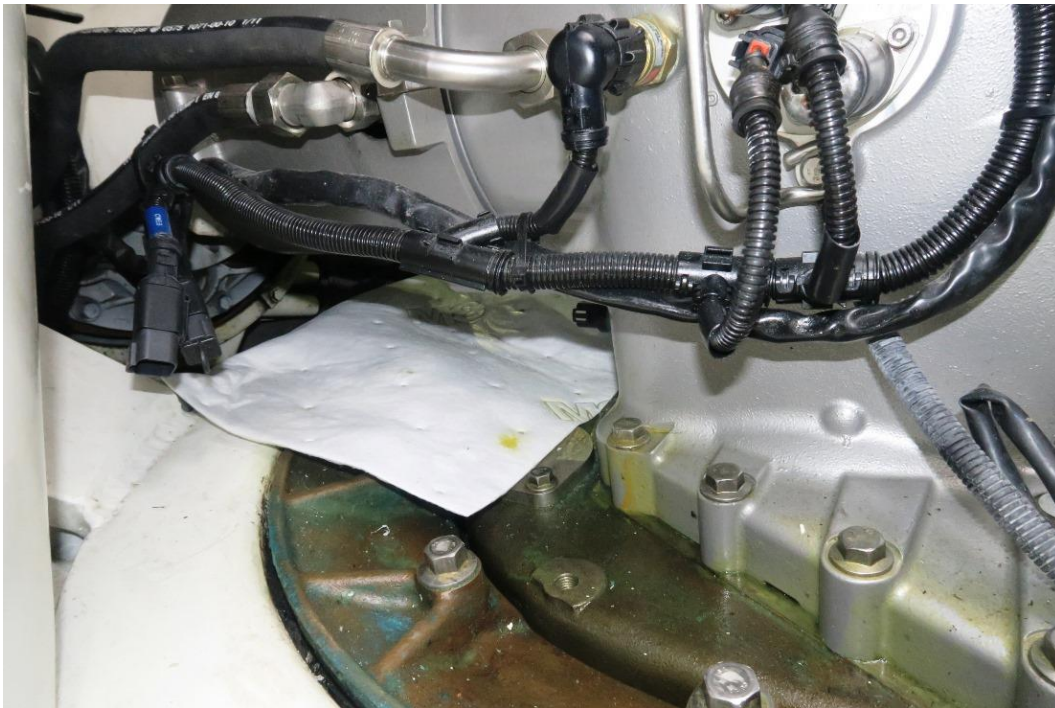
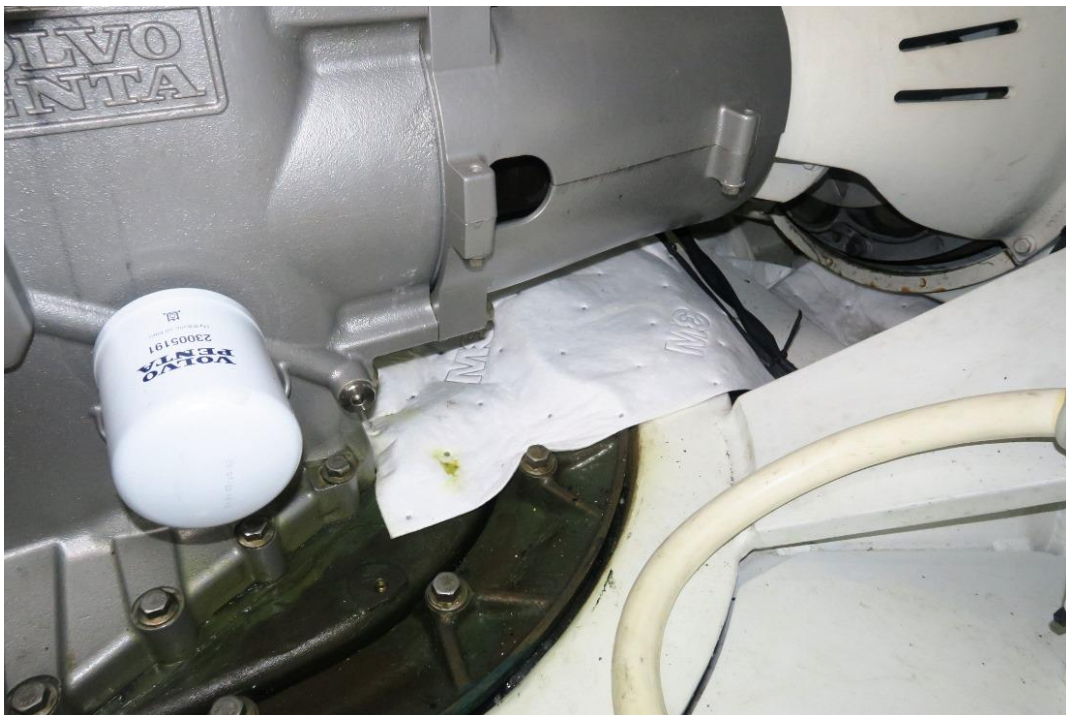
6. The starboard side pod is overfilled with oil, and oil seeping was evident on both port and starboard sides. Recommendation: Remove excess oil, monitor oil seeping and consult with Volvo specialist to resolve.

**The excess oil has been removed, and the residual oil cleaned up. Continue to monitor.**

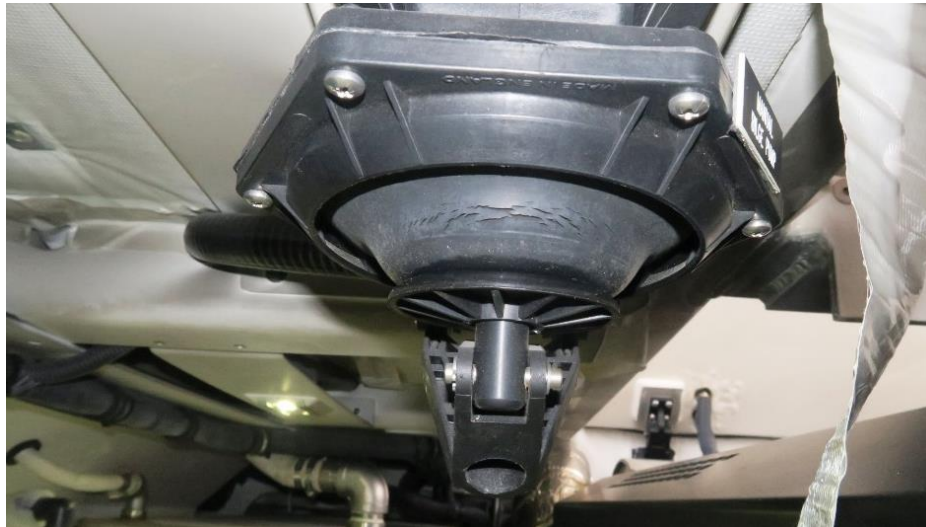
**The sonar unit was proven operational.**
13. The manual bilge pump diaphragm is cracked.  
Recommendation: Replace the diaphragm.

**The diaphragm has been replaced.**

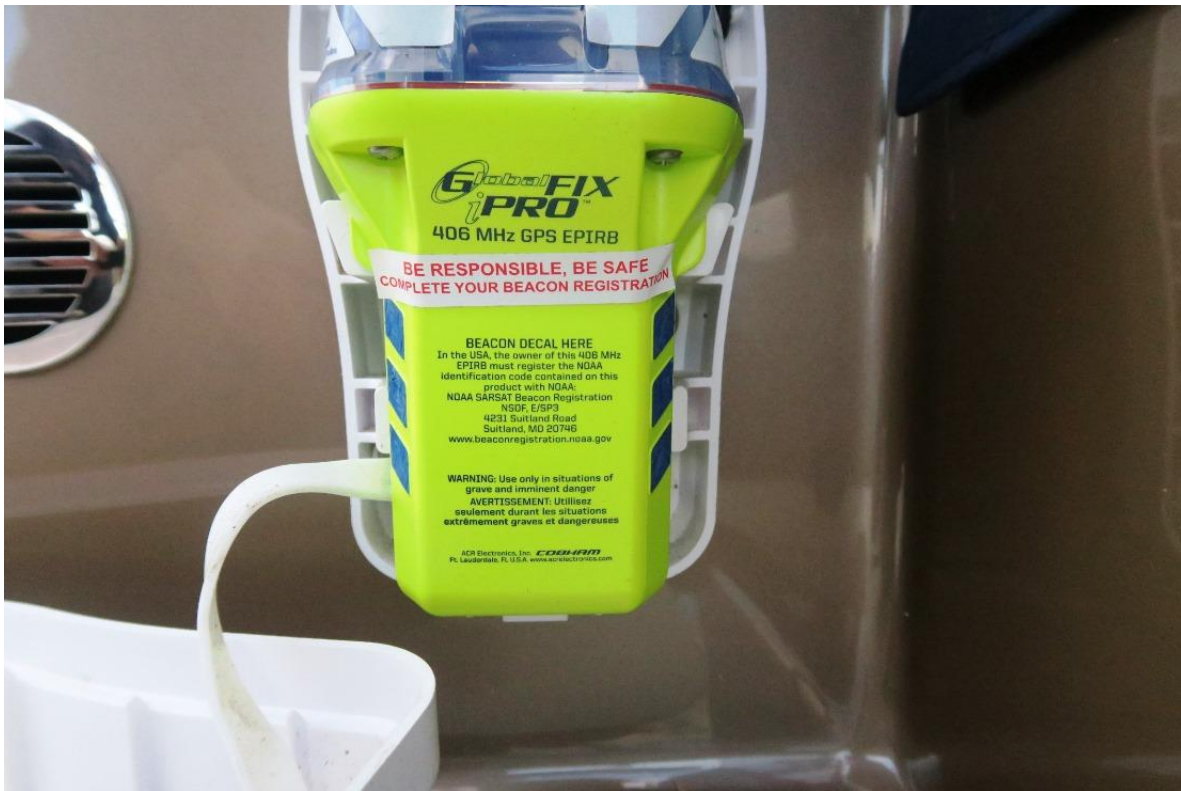
17. The EPIRB has a label: COMPETE YOUR BEACON REGISTRATION.  
Recommendation: Service and register the EPIRB in a new owner's name.

**The EPIRB has not yet been serviced or re-registered.**

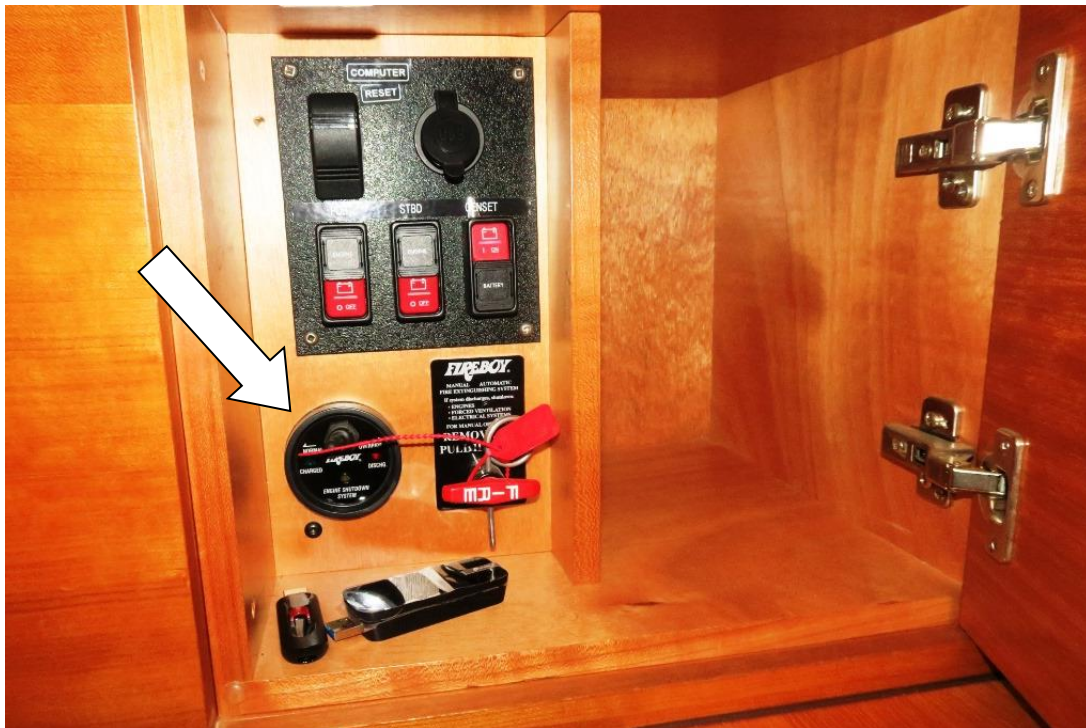
- c. The Fireboy switch is located in a locker below the helm, where it isn't readily visible.  
Recommendation: Consider re-mounting this switch on the helm for visibility and ease of access.

**The switch has not been relocated.**

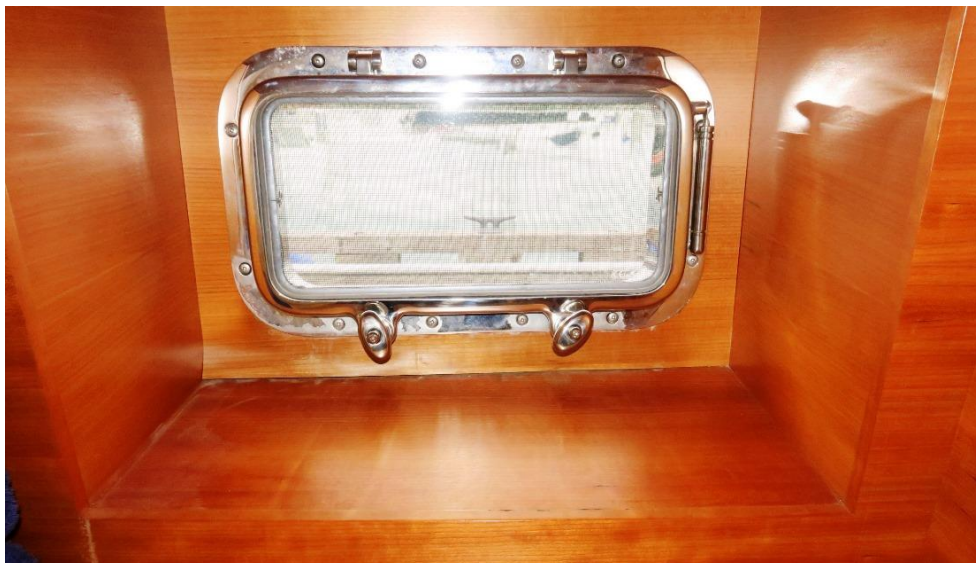
21. There are water stains below the port hull side opening port in the guest stateroom head. See photo below. Recommendation: Clean the portlight gasket and tightly secure. Monitor for leaking, and reseal portlight to hull if found leaking. Repair woodwork if desired.

**The staining/leaking has not been addressed.**

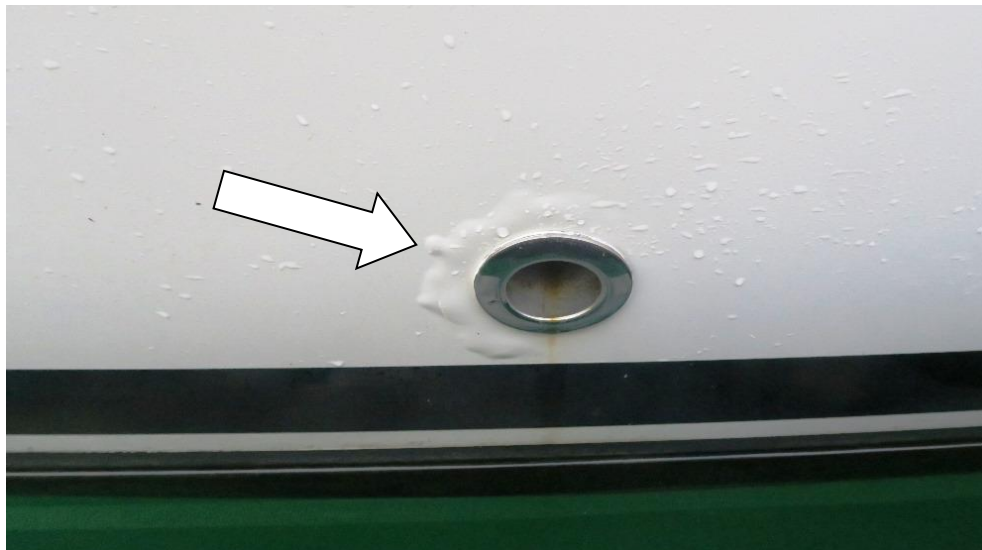
23. This vessel has been repainted. Currently, there are a few areas of failing/bubbled coatings, listed but not limited to below.

- a. On the port hull side adjacent to the generator exhaust gas outlet through hull.

**The paintwork has not been addressed.**

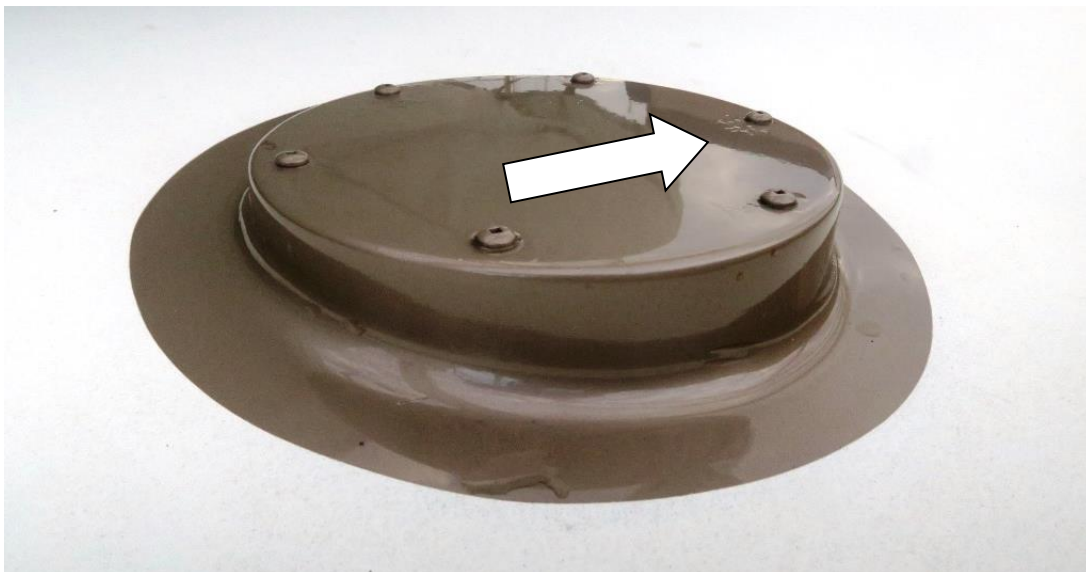
- b. At a plate just forward of the davit base.

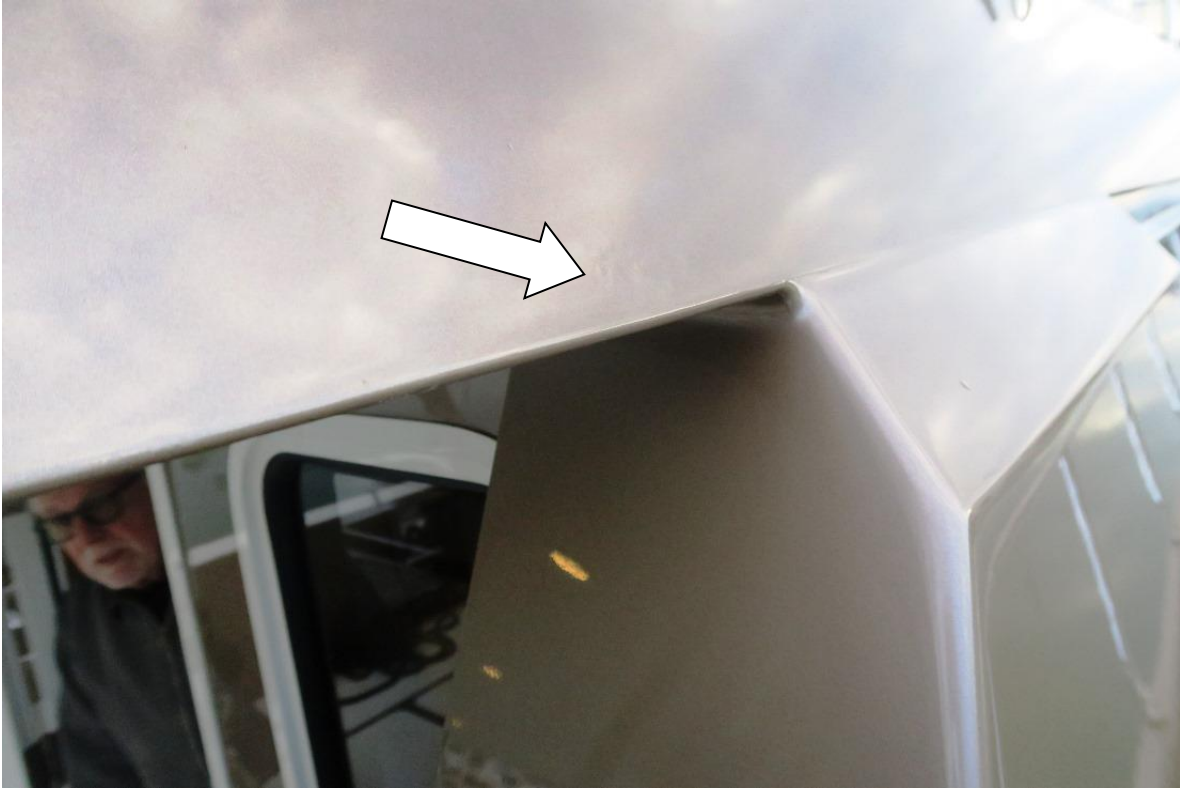
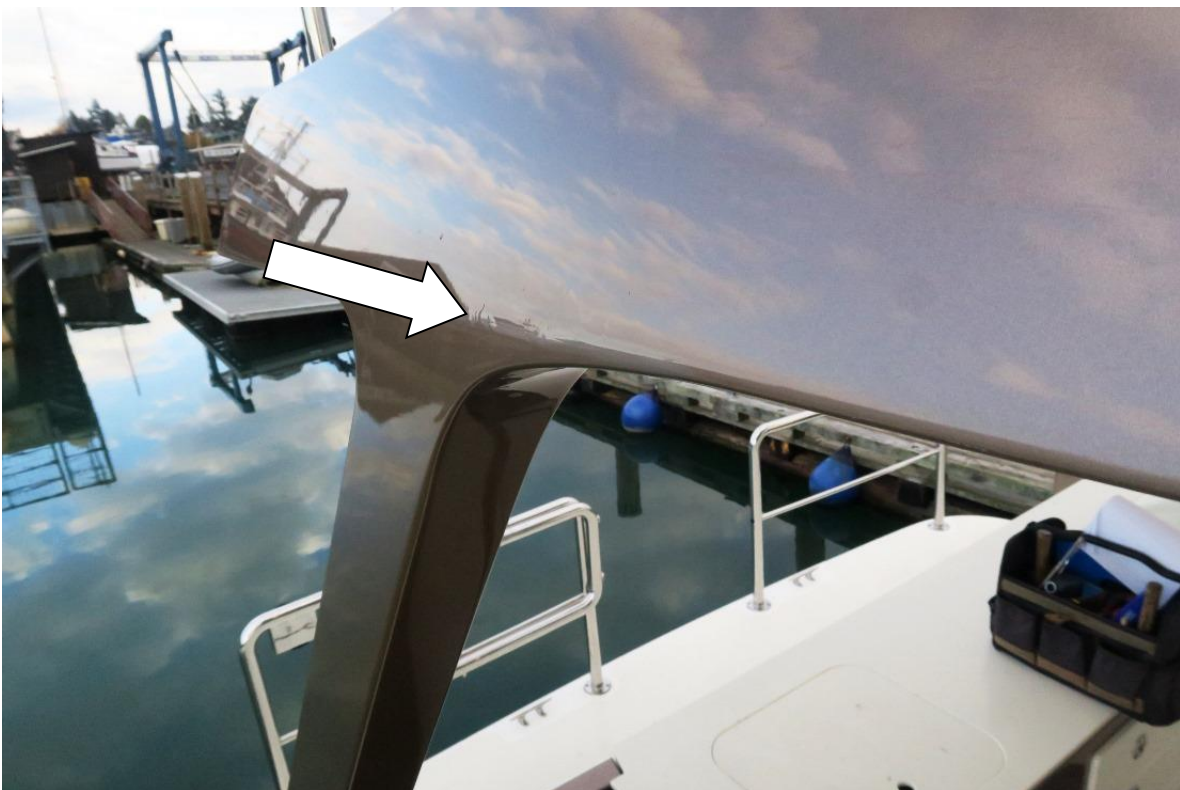
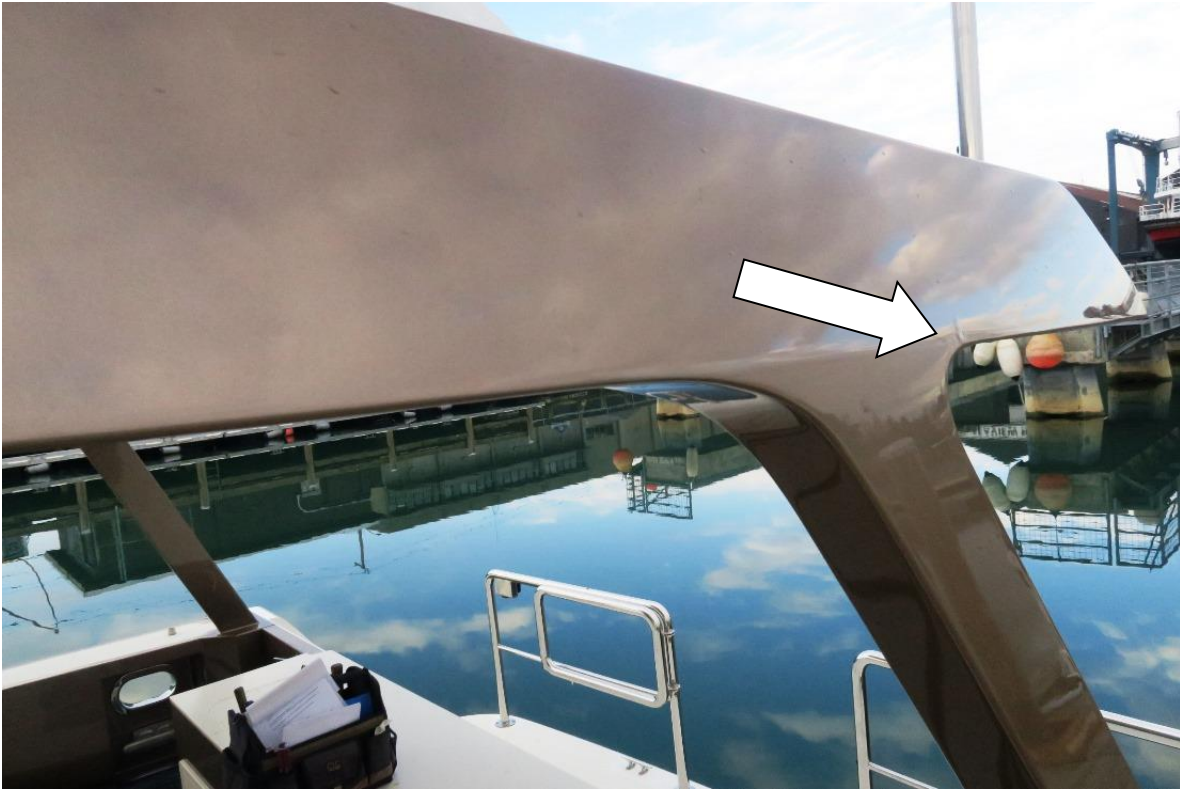
- c. At port and starboard side edges of the aft deck hardtop.

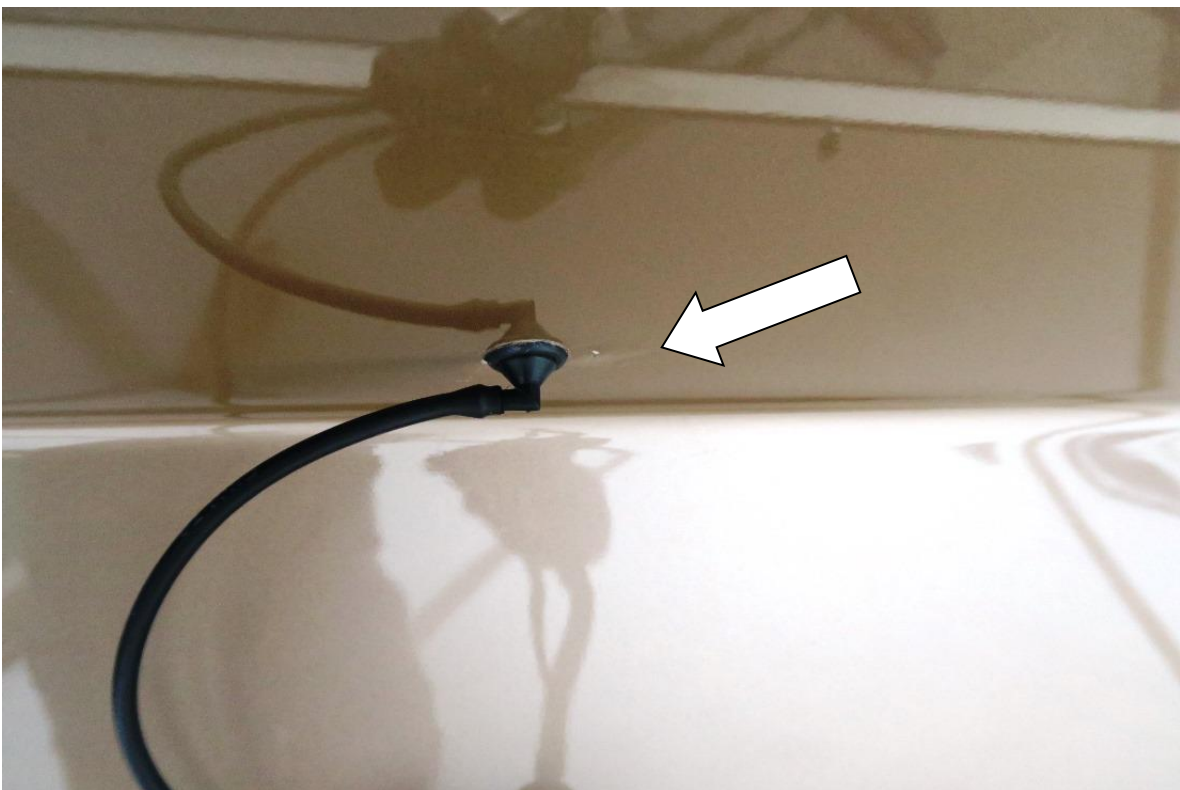
- d. By a windshield washer hose connection on the forward face of the cabin:

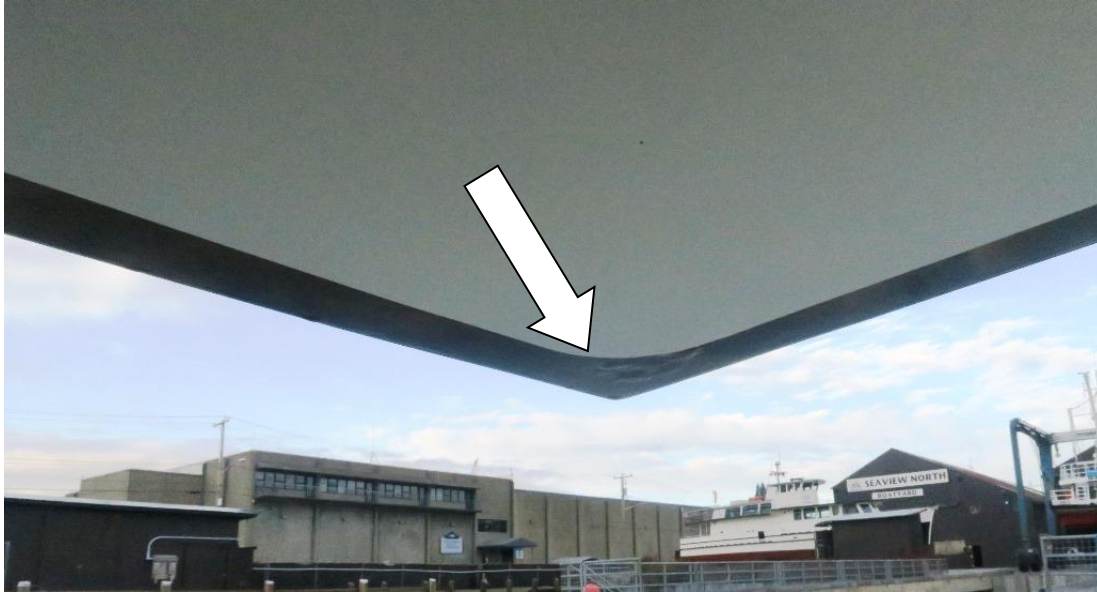
- e. The lower corners of the boat deck overhang:
