## *Pre-Purchase Marine Survey*

*42 Buddy Davis CC 2018*

Acting at the request of Charles Stout, the attending surveyor did attend onboard the Buddy Davis 42 on October 7th, 2026, when a "Pre-Purchase Marine Survey" was conducted at the HMY Yacht Sales Stuart, Florida to evaluate the vessel to obtain a fair market value. The ship's papers were verified for this report. The Hull Identification Number (HIN) KQA42122A818 Was verified from the transom. A limited test run was performed. An out-of-water inspection of underwater machinery and the exterior of the hull's wetted surface area was performed. The survey was to ascertain the physical condition and value of the vessel for interested buyers. Moisture readings taken and referenced throughout the body of the report were taken with the Tramex Skipper Moisture Meter. A fluke VOM Meter was used to check the VDC & VAC power. This survey report represents the vessel's condition on the time, date, and place of the vessel during the day of the survey.

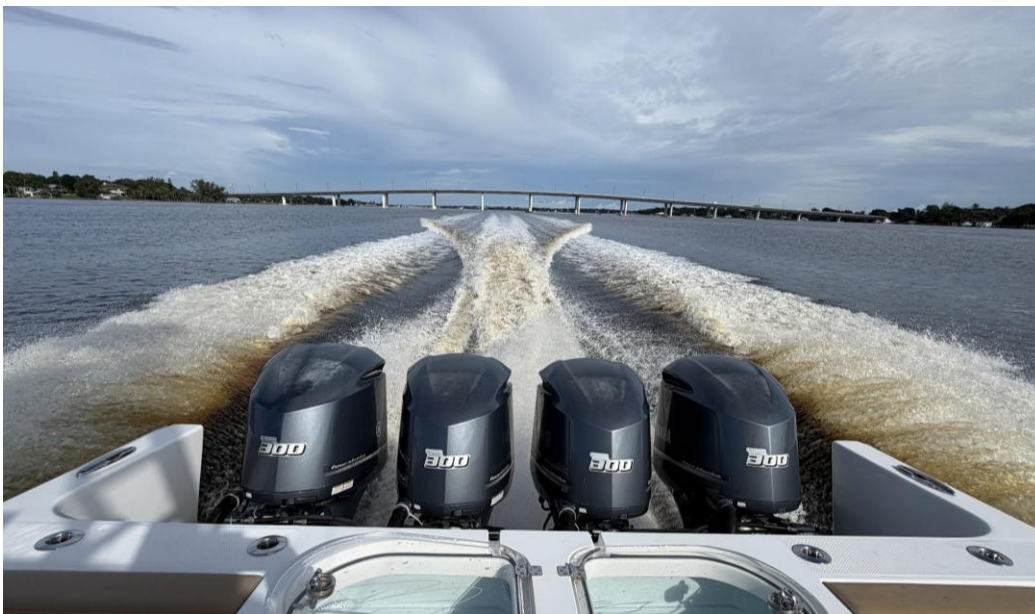
**Sea-Trail information:** Engines started up quickly, the gears shifted smoothly. The vessel cruised at 4200 Rpm pushing 32.9 Knots and WOT Rpm was measured at 5600-5700 Rpm at 44.1 Knots. Vessel was tested in a left & Right turn. Engines operated well with no conditions to report for the sea trail. The vessel gas gauge was at ¼ Full (and diesel was ¾ full). The GPS, Radar, Auto pilot was tested. There were (3) people on board. All transducer functions worked well when tested.

Vessel at WOT

44Knots @5700-5800RPM

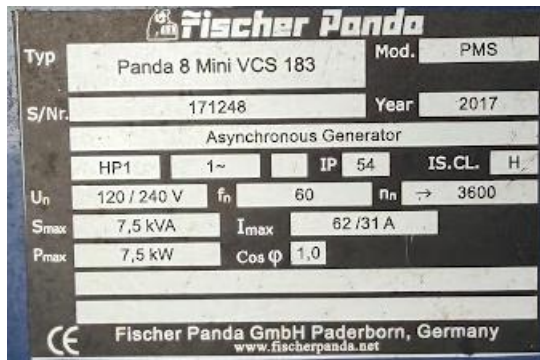
**Remarks:** Gen-sets did not run more than 30 seconds.

**Note:** [Genset has a control card fault.](#)

Left:  
Generator  
Tag

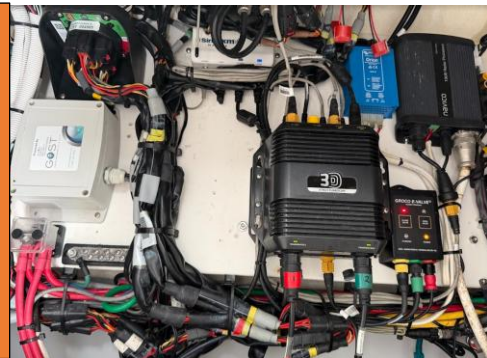
R: Under  
helm  
electronics

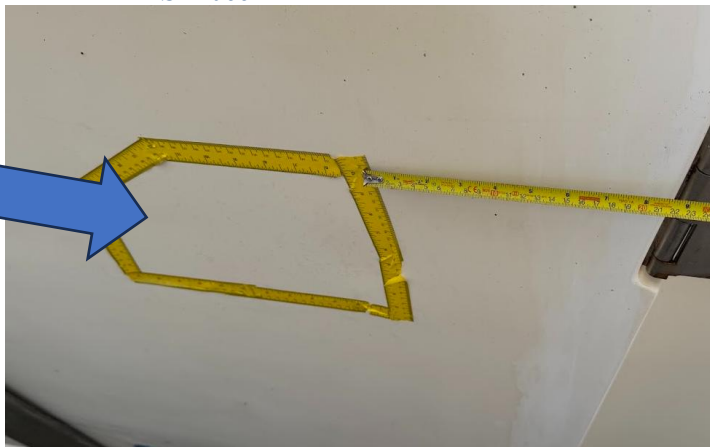
**Wetted surface & Freeboard:** The hull sides and bottom were percussion tested; there was no evidence of delaminating or softness noted on the hull. No evidence osmotic blisters were present during the inspection. An electronic moisture meter was used on fiberglass surfaces from the water line to the rub-rail. No relative moisture, was detected on the hull with the moisture meter. Moisture meter used is a Tramex Skipper 5. **Note:** there is a small 8" X 10" Area on the port aft hull adjacent to the transom that has questionable soundings that sounds like a void. See pictures. Further troubleshoot with a qualified marine technician.

Port Hull- Questionable sounding

3. Support Port center battery. Battery strap is loose. Slide all the positive connections over the post.
4. There is a small 12"x 9" area that has questionable sounding. This is located on the wet surface Port side HULL, approximately 12" inches from the transom. This area is 9 inches in front of the trim tab and 12 inches from the outboard chin. See picture.
5. The head compartment bilge rule 1100 Gph not working. Repair as needed.
6. The Fischer panda gen-set will need to be troubleshoot. It did not run correctly.

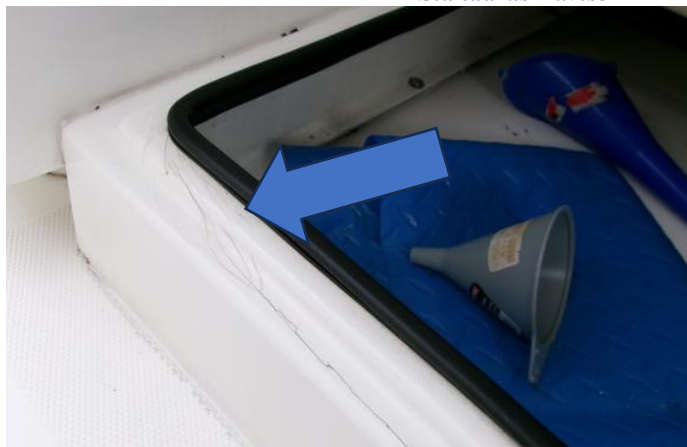
Stress Cracks on the hull

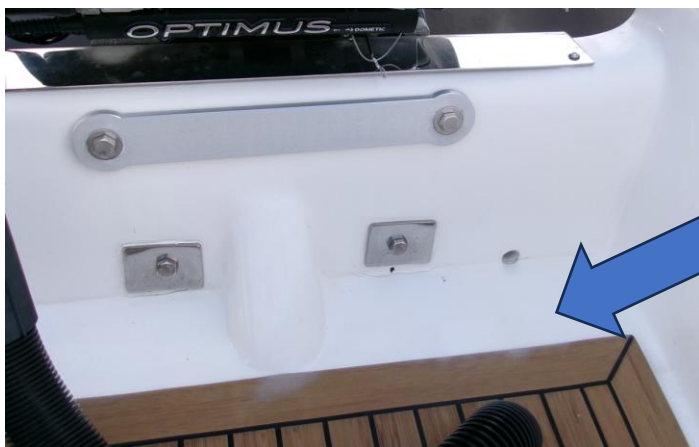
**Transom:** Percussion tested well. Checked with moisture meter and found very low relative moisture in the inboard/outboard of the transom. The moisture meter used is a Skipper Tramex 5. Percussion testing produced solid soundings throughout this entire area. **Note:** \*The port transom had a stress crack. No moisture was detected. **Bilges:** Clean in most areas.

Stress Crack on the port Transom-No moisture

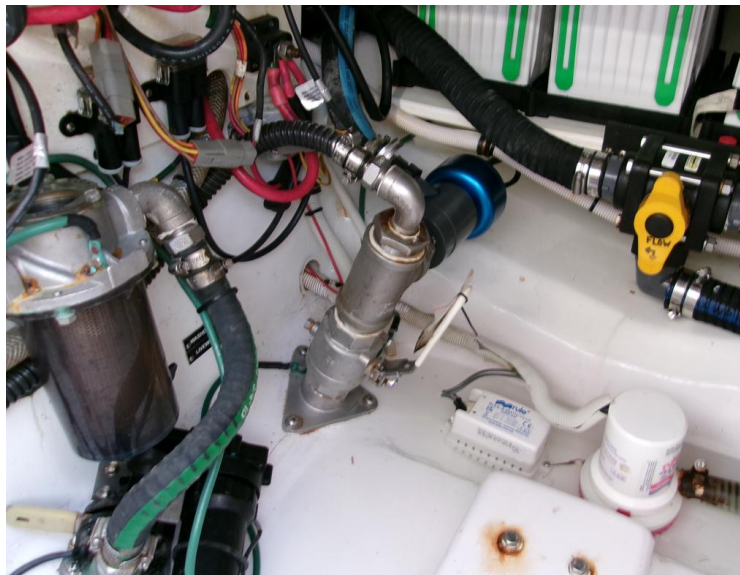
Clean presentable bilge

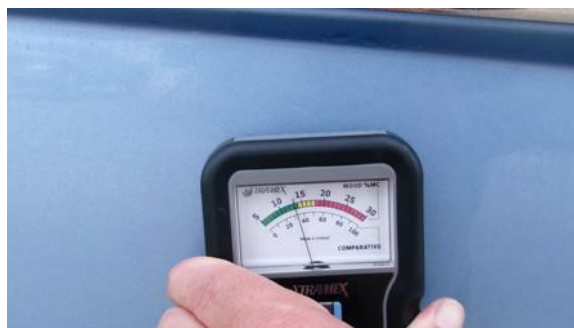
**Acceptable Moisture Readings on the hull**

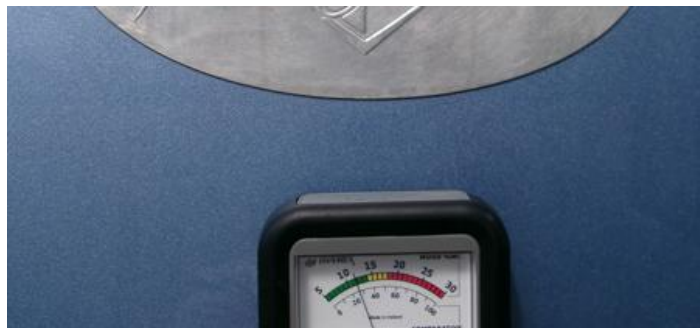
**Acceptable Moisture Readings on the hull**

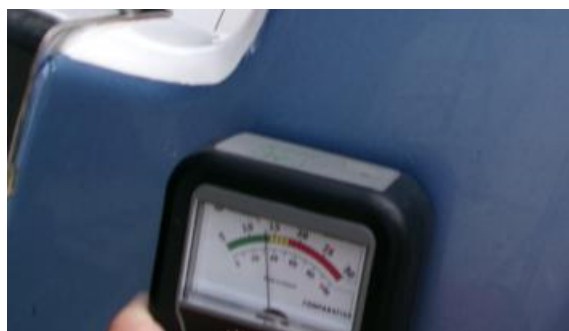
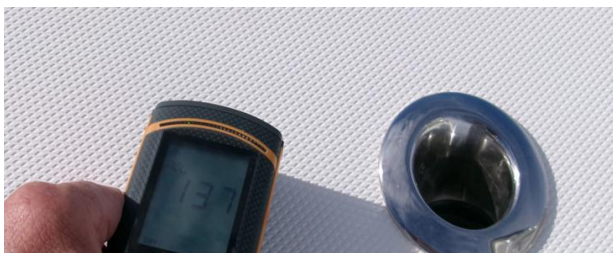
**\*\*\*\*\*Acceptable Moisture Readings on Hull & Deck \*\*\*\*\***
