Bunker A. Hill

Marine Surveyors

VESSEL SURVEYED			
VESSEL NAME:	Aandeel	HAILING PORT:	Zephyr Cove, Nevada
VESSEL MFG. BY:	Goetz Custom Boats	MFG. AT:	Bristol, R.I.
OFFICIAL NUMBER:	1044825	HULL NUMBER:	DGG0001F696
LENGTH:	77'	MODEL:	Custom ultralight cruising sloop
YEAR BUILT:	1996	YEAR MODEL:	1996
SURVEY REQUESTED BY:	Mr. Jim Voorhees	DATE OF SURVEY:	January 10/11, 2024
OWNERS NAME:	Aandeel LLC	DATE OF REPORT:	January 14/15, 2024

RECOMMENDATIONS: AANDEEL

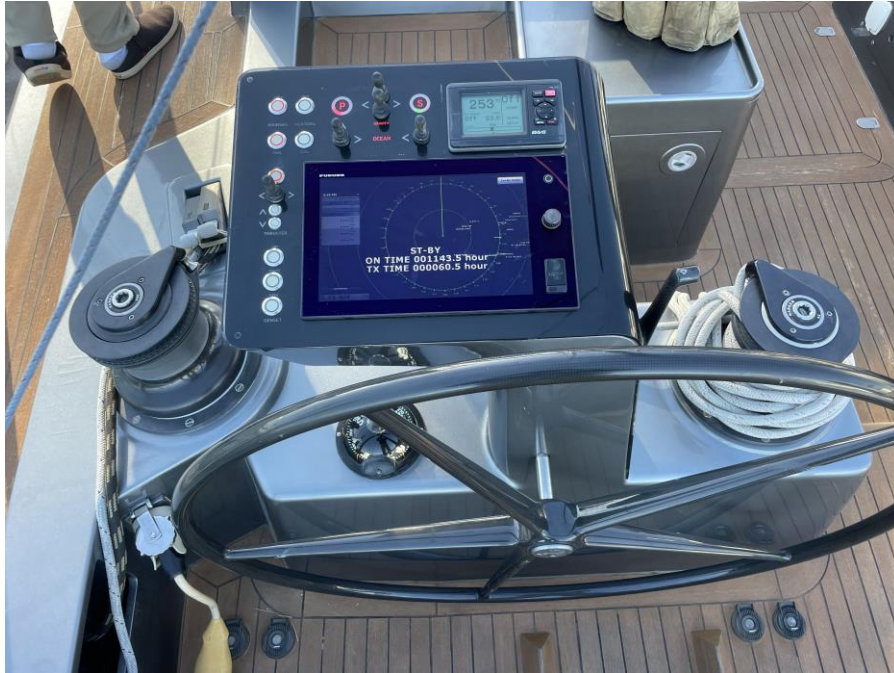
- Z. The engine room insulation is beginning to come loose in random areas.
- AA. The wiring below the compass for the port helm is disconnected.
- BB. The steering lines show mild fraying in areas, consideration should be given to renewal.

Above shows the port helm

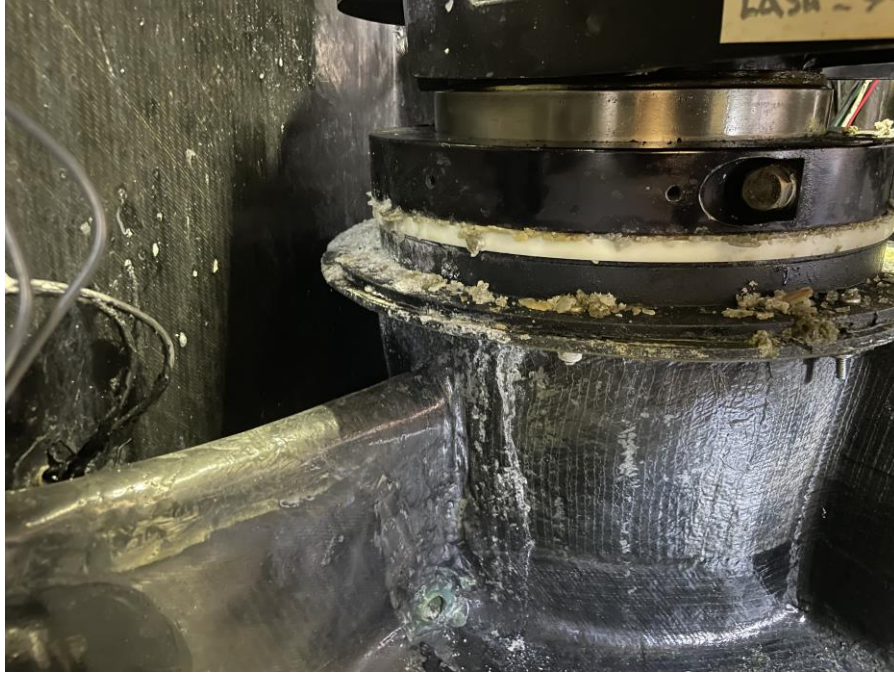
30. There is blooming and evidence of leaking at the rudder seal, drop rudder to further inspect and service as needed.
31. There is weeping at the hydraulic ram for the adjustable backstay to port in the lazarette, clean/monitor and service as needed.

Above shows the leaking at the rudder bearing

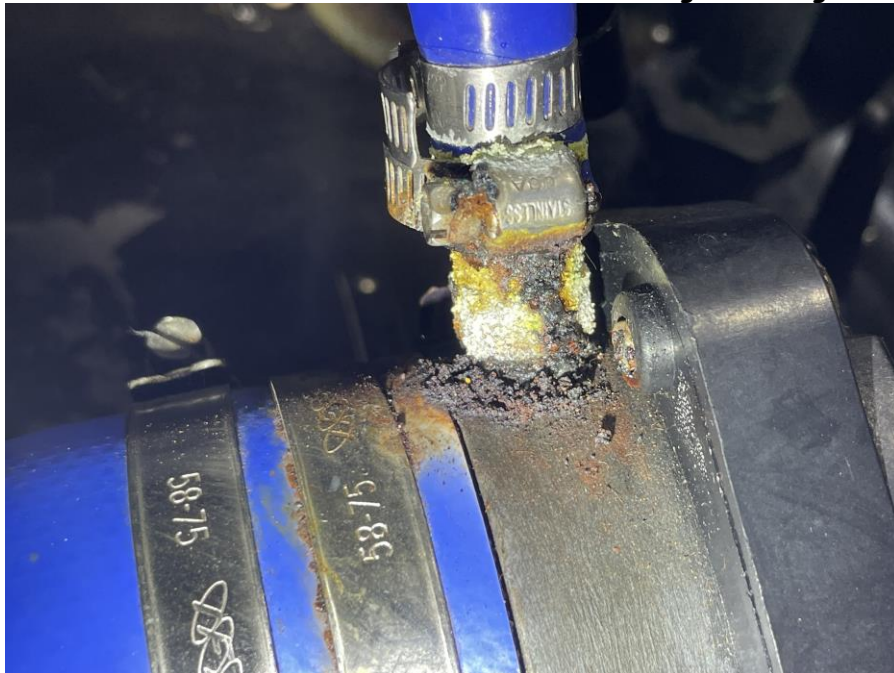
22. There is rust/blooming and evidence of possible weeping at the cooling feed fitting in the shaft seal, descale to further inspect and service as needed.

Below shows the corrosion at the shaft log cooling hose

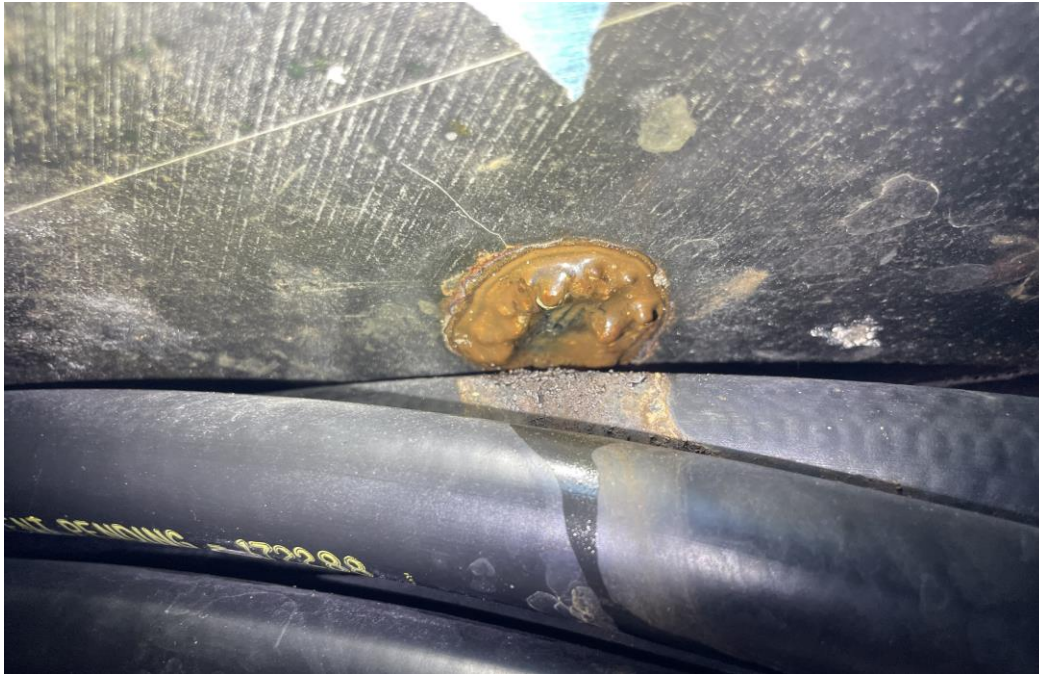
25. The cockpit sole is soft and flexible under foot. Two penetrations centerline aft in the engine room overhead that show evidence of water weeping and when sounding this area, there is a noticeable tonal difference. It is clear there is water intrusion into deck core, destructive discovery required to determine full

26. extent. Repairs not immediate action items, however this should be completed in the next few years.
27. Clean the bilge area around the bilge pump forward in the lazarette, the float switch hangs up when operated.

Above shows the weeping from the overhead centerline aft in the engine room

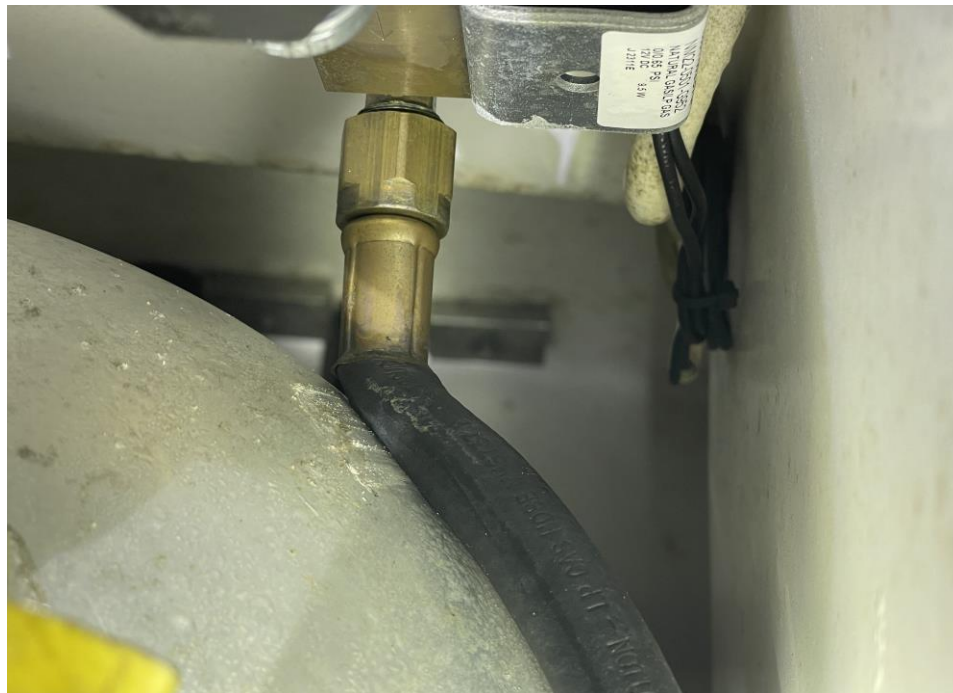
40. Properly secure the Rule 2000 bilge pump in the forward bilge, currently adrift.
41. Service the motor for the Lewmar bow thruster.
42. Properly secure the propane bottle in the port side propane locker. Additionally, the bottle is pressed up against one of the propane lines causing it to kink, correct.

Below shows the kinked propane hose
