Pre-Purchase Survey Inspection

Vessel Name

“M”

JMT Charters, LLC.

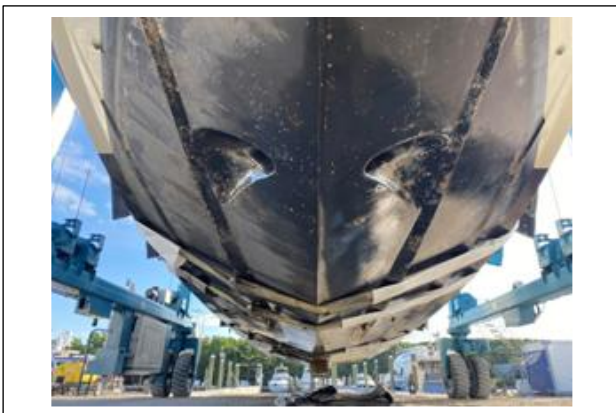
HAUL OUT

Condition of underwater areas: The vessel was taken for trial run after the inspection of the underwater areas at time of haul out. The antifouling coatings were found worn and marine growth was noted on the jet impellers.
