Chris Sitarz Inc. Diesel Engine Repair 16 Marshall St. Lisbon Me. 04250 chrissitarz@yahoo.com

S/V Sunflower

2004 Oceanis 523

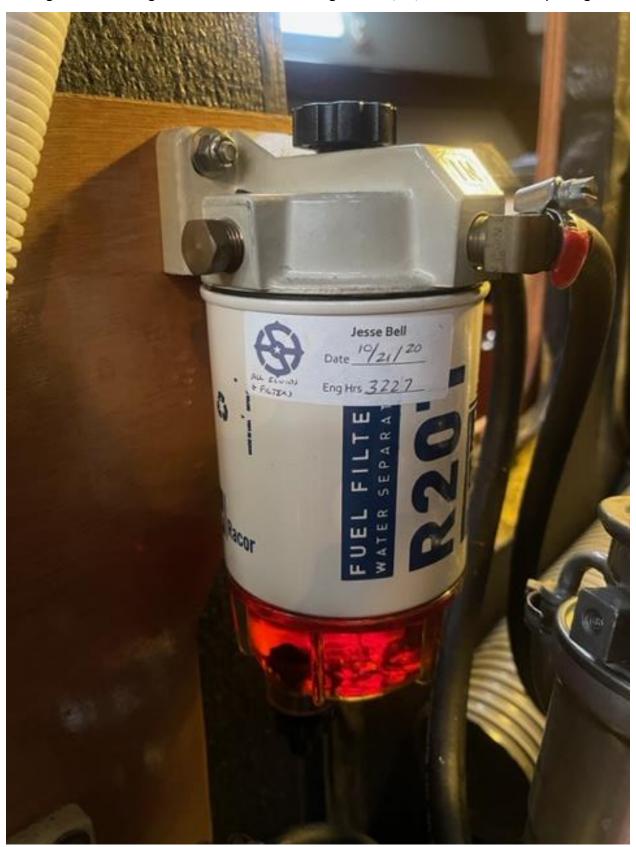
Findings: The main engine fuel filter was last changed on 10/21/20. Recommend replacing it.

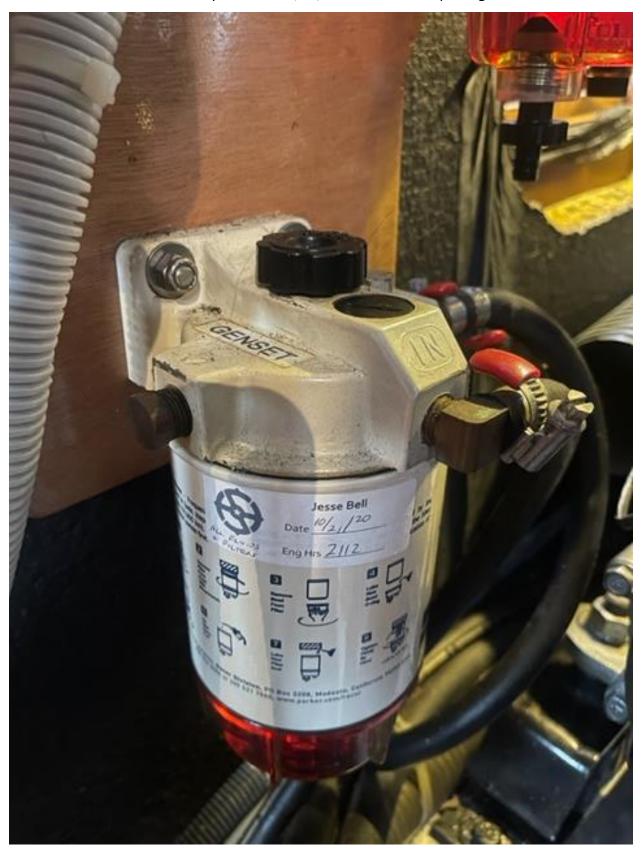
Generator fuel filter was last replaced on 10/21/20 recommend replacing it.

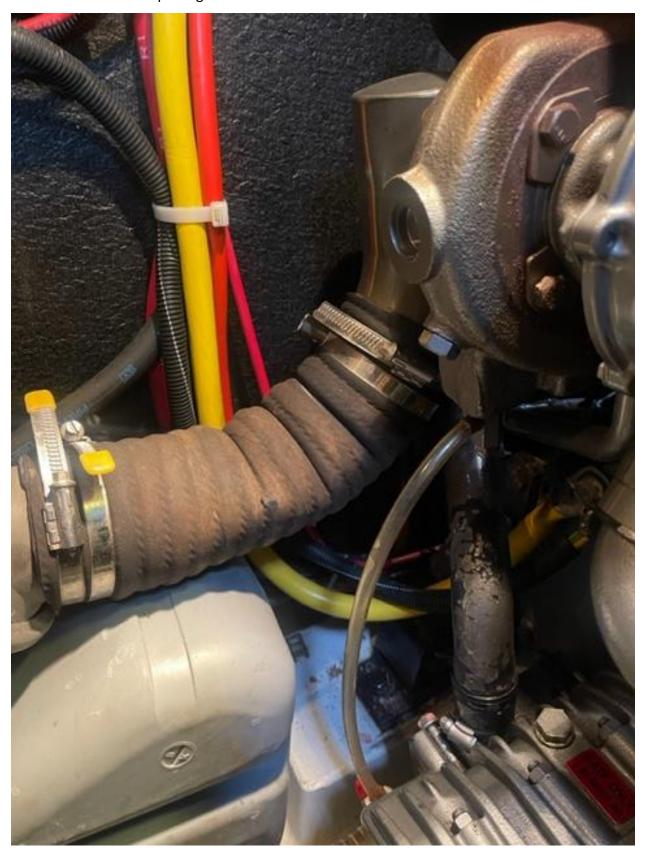
Issues: Recommend replacing the exhaust outlet hose due to kinks and cracks in the hose.

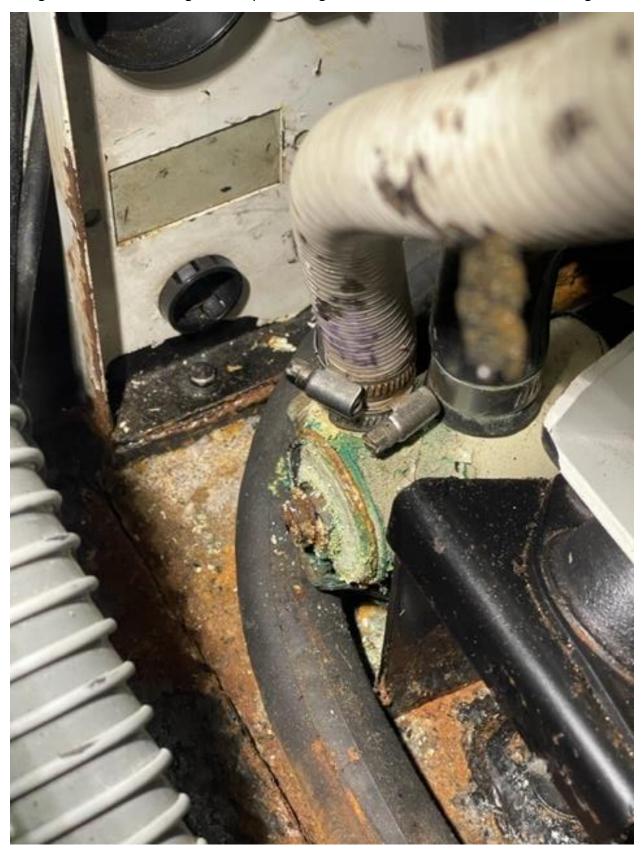
The generator heat exchanger end cap shows signs of corrosion. Recommended resealing it.
