REPORT OF MARINE SURVEY

PASSING WIND

1992 CARPENTER 62

October 3, 2022

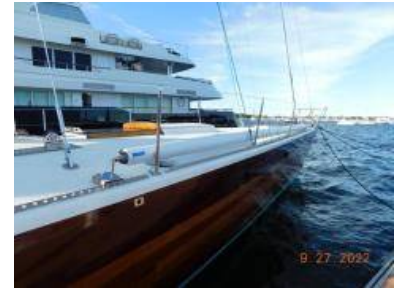
Construction material: The hull sides are one inch thick mahogany planking on mahogany frames.

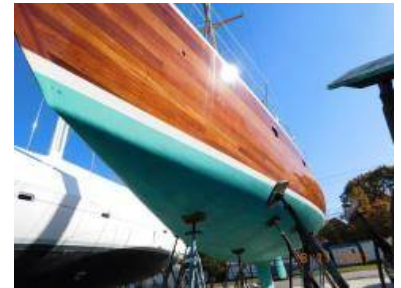
Hull cosmetics: Excellent condition-Well protected and no severe external scratches chips or abrasions sighted. The hull was recently stripped to bare wood. West system special clear epoxy was applied. The exterior was finished using Awl Grip clear coat.

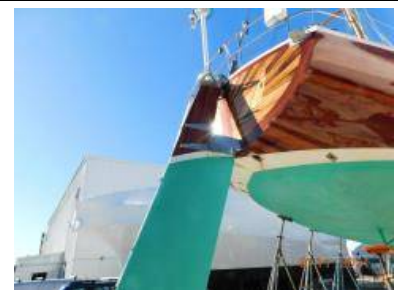
Transom type: Reverse transom.

Stress cracks: None sighted.

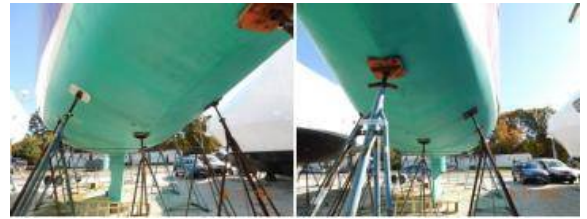
Construction material: One inch mahogany planks applied to mahogany frames.

Bottom paint: Anti-fouling bottom paint in good condition.

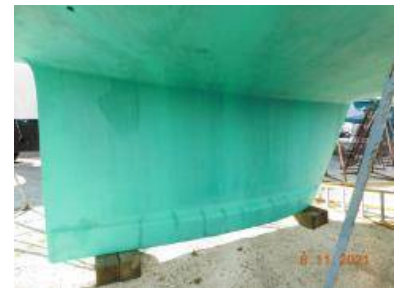
Keel type: Deep fin - lead bulb type.

Keel condition: Keel is well secured and well faired into hull. No cracks or separation sighted at hull to keel joint.

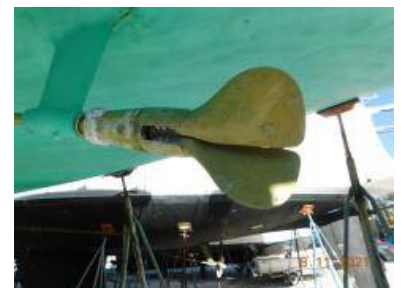
Prop(s) description: Prop has two blades and is made of bronze alloy, Prop is folding/feathering type. Prop is in excellent condition. No chipped bent or damaged prop blades.

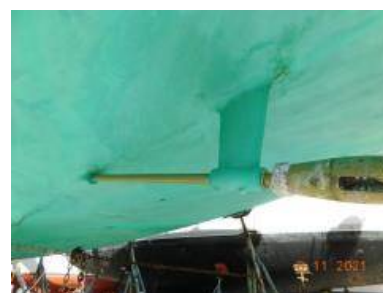
Shaft size / material: Shaft size is 1-1/2" and made of Stainless steel. No pitting, cracks or corrosion sighted. Shaft appears straight with no visible bends. The image shows what looks like a bronze shaft. The shaft is protected with a product that resists mussels and other marine growth.

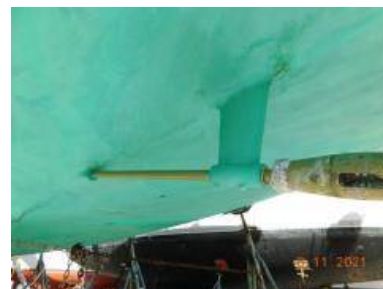
Strut(s): Single bronze P-Strut per shaft. Strut appears to be in line.

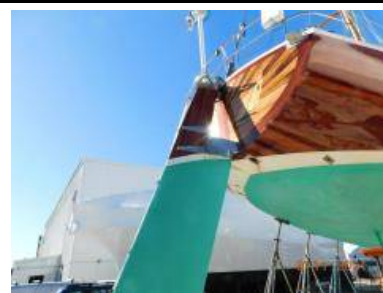
Rudder type: Wooden rudder transom hung. Well secured. No abnormal horizontal or fore/aft movement in rudder. No cracks or bending or damage sighted in rudder.

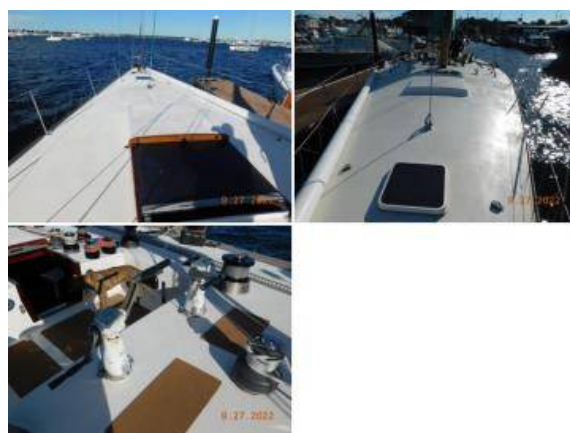
Deck Surface: Flush deck, cold molded, with fiberglass cloth covering. Light Grey Applied Awlgrip non skid. Good condition. Deck is solid under foot, no soft spots discovered and no visible cracks or chips sighted.

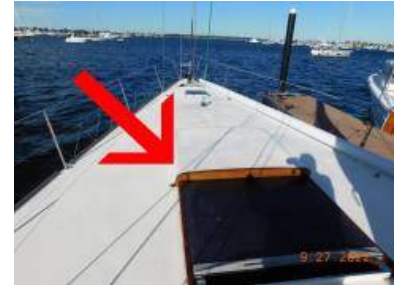
Deck hatches: Yes, well secured, seals in good condition, support arms in place. Some hatches have crazed glass but are serviceable.

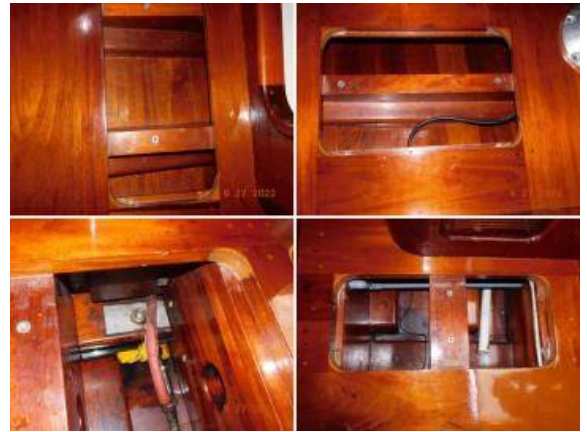
Hull to deck joint: Overlap (Shoe box type), Deck joint was covered with FRP (Fiber reinforced plastic), no cracks sighted where it could be sighted.

Bilge(s): Clean and dry.

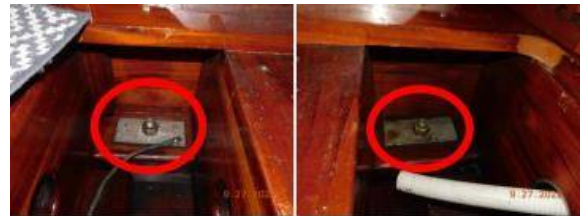
Keel bolts: Visually sound, no corrosion sighted, no loose bolts. Hammer test does not appear to indicate internal keel bolt corrosion.

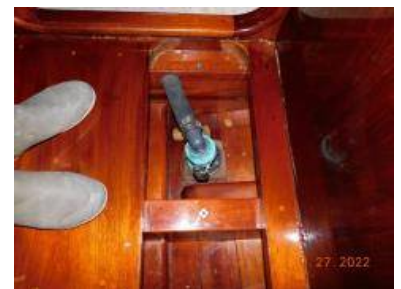
Sea valves: Bronze seacock ball valves installed, Sea valves sighted are used for: Air Conditioner raw water intake, Deck wash down inlet, Engine raw water intake, Head raw water flush intake. Waste discharge
Tapered wooden plugs tied to sea valves were found.

Sea valve condition: Some Valves works stiff-difficult to open/close. **RECOMMENDATION:** Recommend valve be serviced or replaced.

Some Valves works stiff-difficult to open/close. RECOMMENDATION: Recommend valve be serviced or replaced.

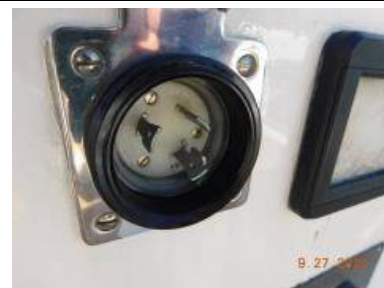
A.C. Voltage system: 30 Amp - 120 Volt system. Shore Power: provided by Marincor 30 Amp capacity. The cover is missing repair or replace.

The cover is missing repair or replace.

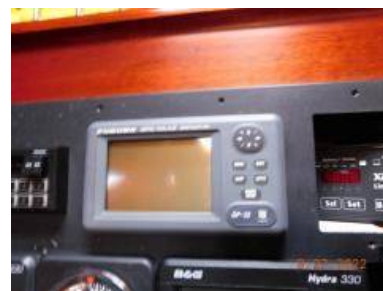
NOT all instruments powered up. Repair or replace.

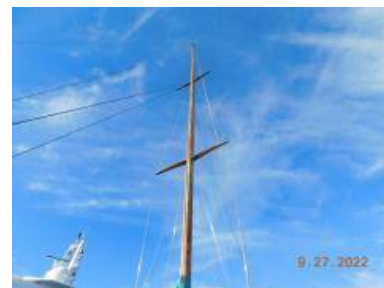
Main mast(s): Wooden, Sitka spruce. Good condition. No cracks or rotted areas sighted. Wood is varnished for protection from elements.

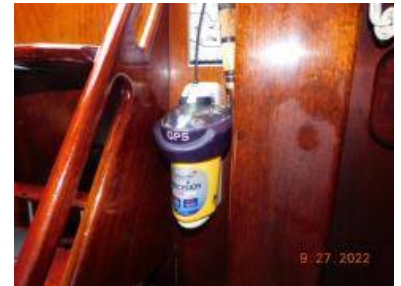
First aid kit: Yes and appears well equipped.
Carbon monoxide detectors: Carbon monoxide fume detector was not sighted but have been required since 2001 by both ABYC and NFPA. ----- Install Carbon Monoxide detectors in any enclosed accommodation spaces per ABYC A-24.5 and NFPA 302 recommendations.
Search light: Hand held 12 volt-not tested.
EPIRB: ACR Satellite 406, Class 2, manually deployable-

Carbon monoxide fume detector was not sighted but have been required since 2001 by both ABYC and NFPA. ----- Install Carbon Monoxide detectors in any enclosed accommodation spaces per ABYC A-24.5 and NFPA 302 recommendations.
