**REPORT OF MARINE SURVEY**

**Condition & Value  
of the vessel**

**PASSING WIND**

**1994 CARPENTER CUSTOM YACHTS 62**

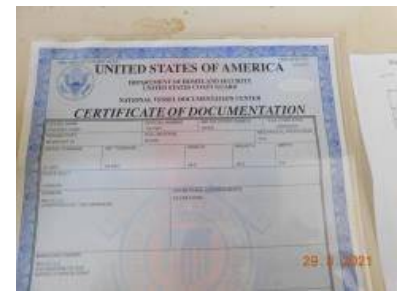
**Official Documentation No:** 1307867 The vessel documentation was sighted aboard and documented information listed below. Not permanently affixed per USCG regulations. **RECOMMENDATION:** The official documentation no must be permanently affixed in block type Arabic numerals not less than 3 inches on a clearly visible interior structural part of the boat. Recommend compliance with existing regulations.

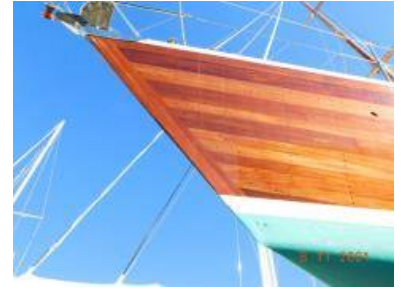
**Stem:** Solid, no cracks on external inspection.  
11/08/2021 image was added.

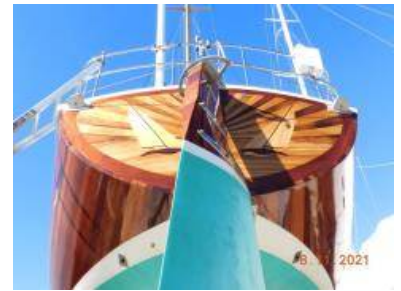
**Transom type:** Reverse transom.  
11/08/2021 image added.

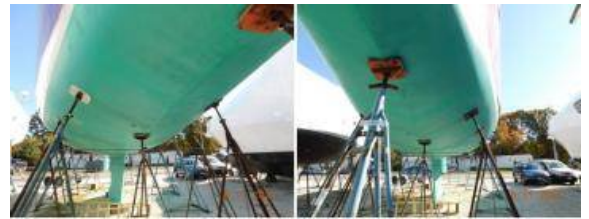
**Construction material:** Vessel was not pulled for bottom inspection. No bottom inspection performed.----- Owner is advised to fully inspect bottom and all underwater machinery at next haul out.  
11/08/2021  
The vessel bottom was inspected.  
Transom was percussion tested with no apparent signs of deteriorated planks.  
Images added.

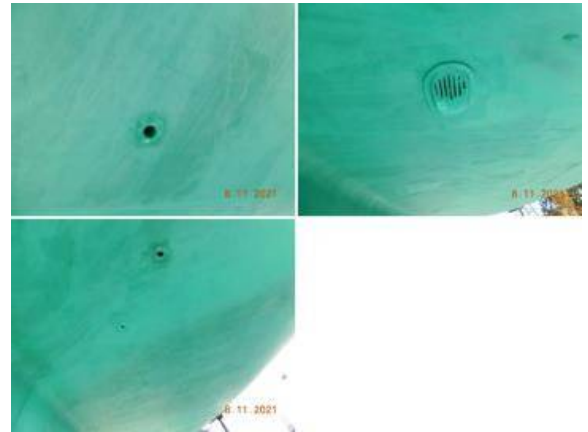
**Strainers/Scoops/Screens:** 11/08/2021  
All strainers/screens are well secured to hull bottom. Clear of debris & mussels. Images added.

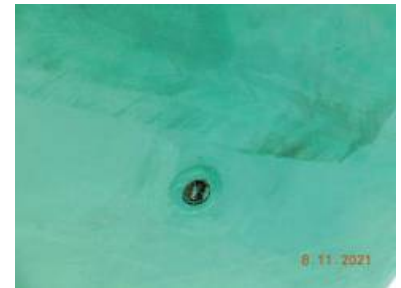
**Transducers:** 11/08/2021  
Transducers for speed and depth are adequately sealed and bonded to the hull. Image added.

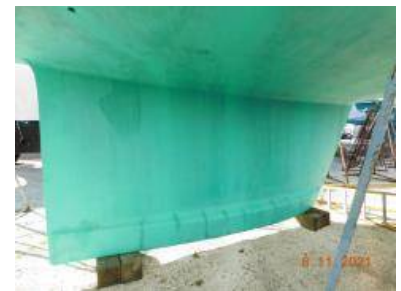
**Keel type:** 11/08/2021  
Deep fin - lead bulb type. Image added.

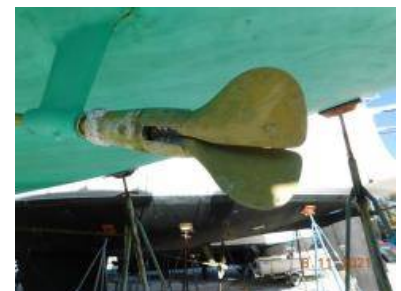
**Prop(s) description:** 11/08/2021  
Prop has two blades and is made of bronze alloy, Prop is folding/feathering type. Prop is in excellent condition. No chipped bent or damaged prop blades.

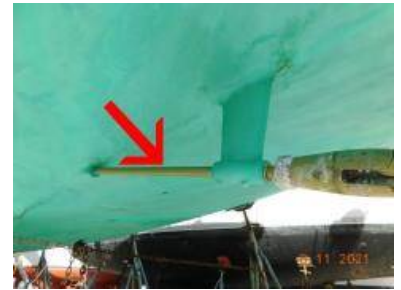
**Shaft size / material:** 11/08/2021  
Shaft size is 1-1/2" and made of Stainless steel. No pitting, cracks or corrosion sighted. Shaft appears straight with no visible bends. In the image the shaft appears to be bronze. It is stainless steel and has a coating to prevent barnacles from attaching  
Image added.

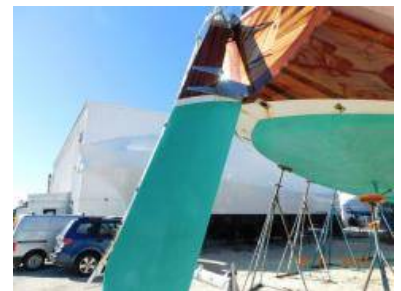
**Rudder type:** 11/08/2021  
Wooden rudder. Well secured. No abnormal horizontal or fore/aft movement in rudder. No cracks or bending or damage sighted in rudder.  
Image added 11/08/2021.

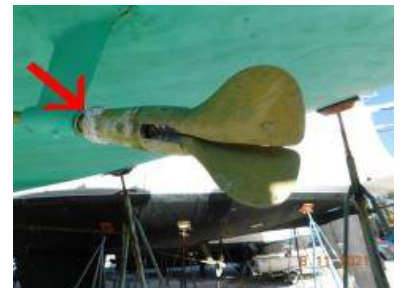
**Shaft:** 11/08/2021  
Collar anode on shaft.  
Image added.

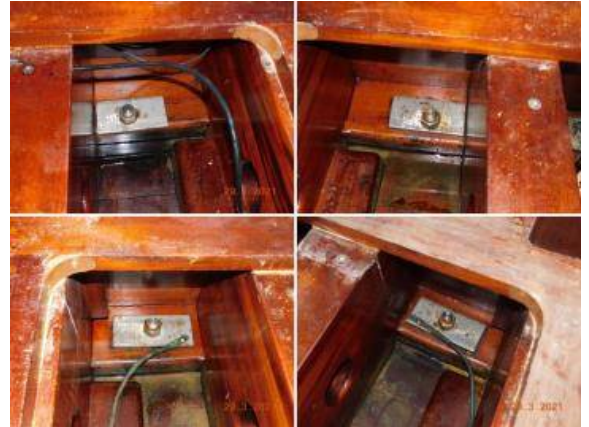
**Keel bolts:** Visually sound, no corrosion sighted, no loose bolts. Hammer test does not appear to indicate internal keel bolt corrosion.

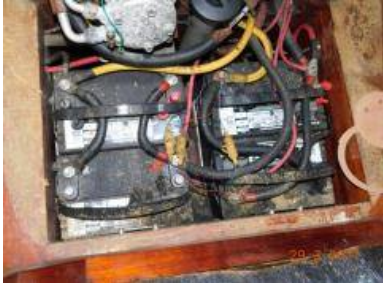
Positive terminals not covered as required.  
**RECOMMENDATION:** Code of Federal Regulations - CFR33.183.420 mandates that positive terminals be protected against accidental shorting by the use of insulation barriers or sleeves or with battery case cover. Recommend compliance with Code of Federal Regulations.

**Positive terminals not covered as required. RECOMMENDATION:** Code of Federal Regulations - CFR33.183.420 mandates that positive terminals be protected against accidental shorting by the use of insulation barriers or sleeves or with battery case cover. Recommend compliance with Code of Federal Regulations.

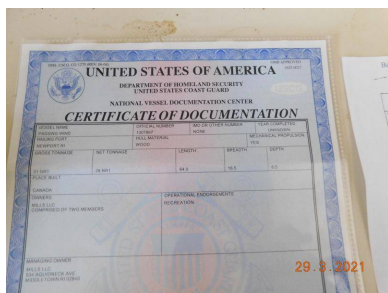
1307867 The vessel documentation was sighted aboard and documented information listed below. Not permanently affixed per USCG regulations. **RECOMMENDATION:** The official documentation no must be permanently affixed in block type Arabic numerals not less than 3 inches on a clearly visible interior structural part of the boat. Recommend compliance with existing regulations.
