Maine Design Company, LLC
Capt. Tom Lokocz Adams, SAMS® AMS®
Marine Design, Engineering and Surveys Since 1999

Condition & Value Survey

April 8, 2019

Jean Marie

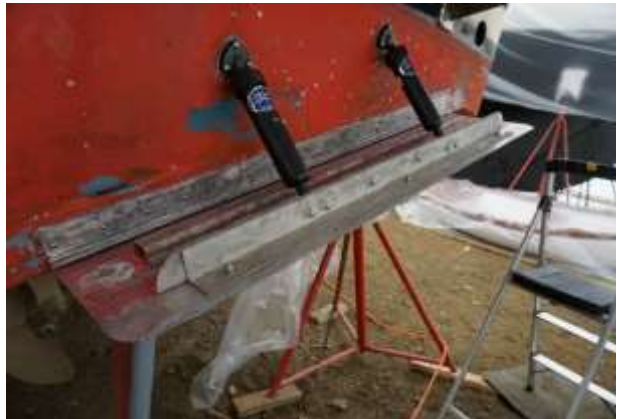
| Trim Tabs: | Rams appear new [Figure 10.4] |

Figure 10.4 New trim tab & reinforcement assembly

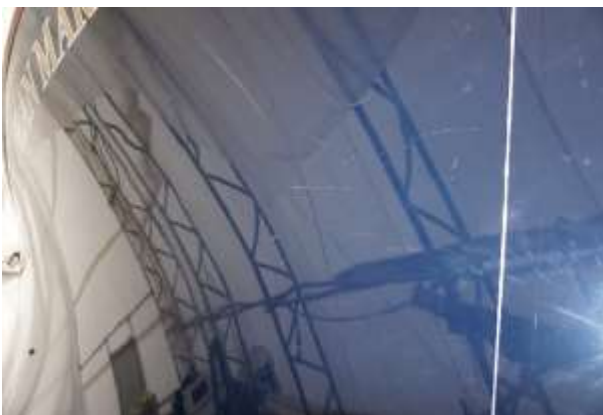
The topside paint has a good appearance, upon very close inspection a few minor cosmetic scratches were noted [Figure 10.5]. A paint flaw was observed on the port bow $\pm 4'$ below and slightly aft of the vessels name, this flaw is $\pm 2'$ in area and noticed upon close inspection (difficult to photograph due to reflections).

Figure 10.5 View of port topsides

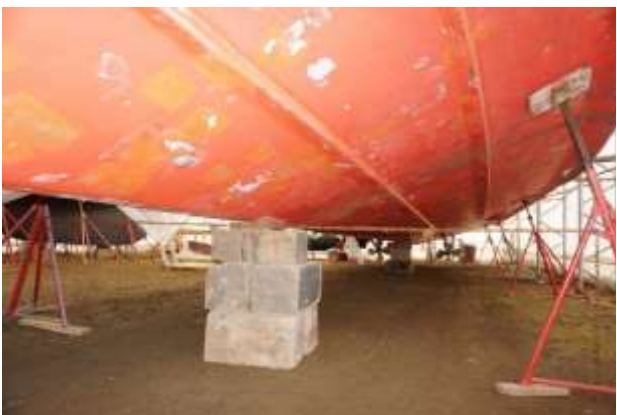
| Condition of Bottom: | Serviceable condition; flaws noted (see section 7.1), areas of flaking bottom paint noted [Figure 10.6] |

Figure 10.6 Bottom view looking aft

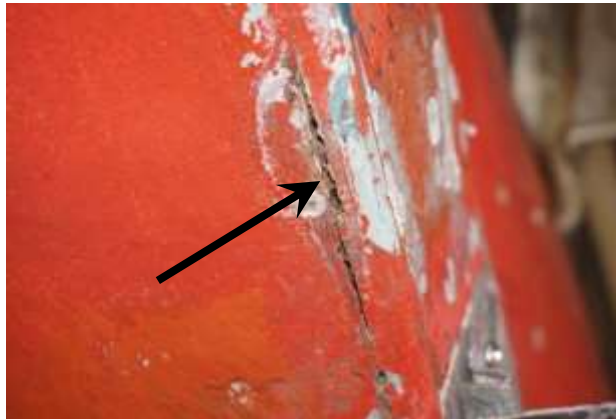
A few very small flaws in the epoxy/fiberglass coatings were observed below the waterline, these areas should be addressed to prevent water intrusion [Figure 10.16 & Figure 10.17]. The lifting rail and hull seam interface is compromised in several locations, cracks were noted creating voids between the lifting rail and the hull [Figure 10.14 & Figure 10.15].

Figure 10.14 Flaw at lifting-rail hull interface

- 3 Seal scarp joint imperfections in keel plank located in aft engine room bilge
- 3 Repair cracks at lifting rails & hull interface to prevent water intrusion
- 3 Repair cracks on locker, window and deck hatch openings & other radiused areas
- 3 Replace missing & corroded fastenings on hauling strap guards at chine
- 3 Remove corrosion from aluminum sliding wheelhouse windows & paint
- 3 Repair leaks in forward wheelhouse windows
- 3 Replace broken spring in starboard forward cockpit locker & repair knob of starboard center outboard cockpit locker

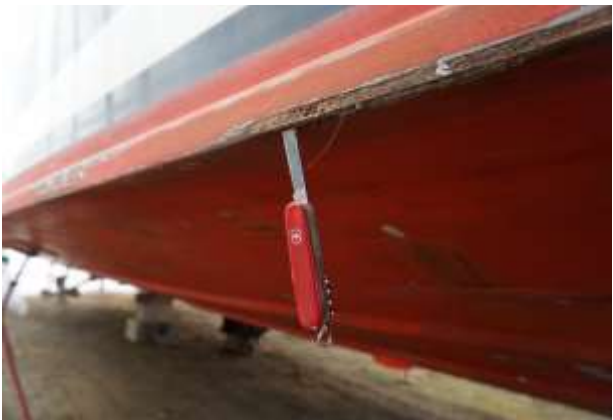
Figure 10.15 Crack in lifting rail/hull interface

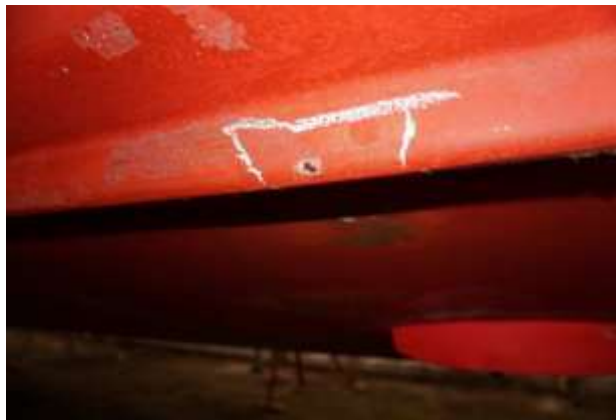
Figure 10.16 Flaw in epoxy/fiberglass on stab. bottom

- 1 Install USCG required documentation numbers to hull as required by law, if not currently present
- 2 Determine extent of void/lifting fiberglass on starboard bottom & repair accordingly if the condition warrants
- 2 Repair loose & unattached swim platform framing
- 3 Repair flaws in epoxy/glass below the waterline to prevent water intrusion

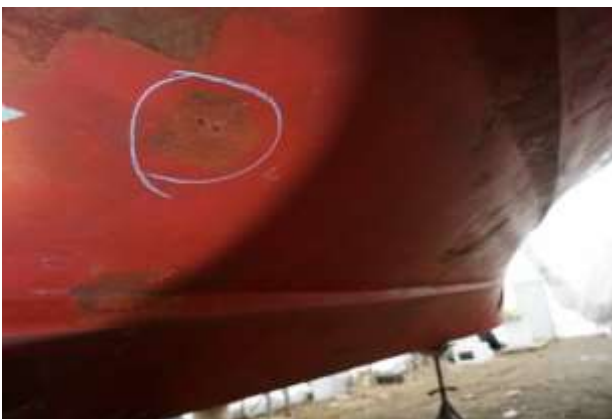
Figure 10.17 Circle marks flaws in epoxy/fiberglass on stb. bottom

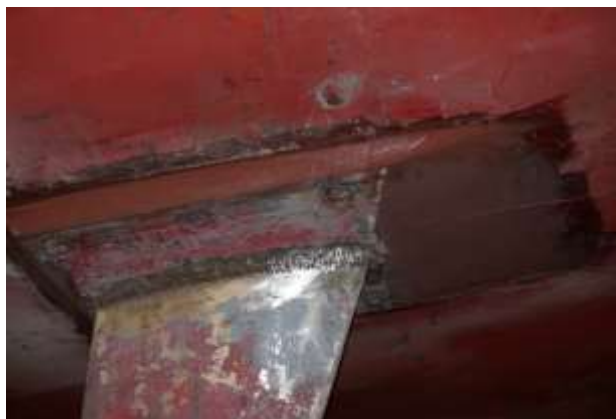
- All cutlass bearings appear new and work has been recently been done to the shafts, struts, rudders and their assemblies, the repairs all appear to be properly executed. Fairing compound has been applied to the starboard strut and hull interface that still requires sanding and finishing [Figure 10.18].

Figure 10.18 Fairing compound at hull & starboard strut interface

- 1 Replace blue hump hoses on main engine exhaust
- 1 Properly attach thruster blades & zincs to bow & stern thrusters
- 1 Complete repairs to starboard strut/fairing compound as scheduled
- 1 Install exposed 240V wire connection in junction box as recommended by ABYC section E-11
- 2 Determine if 3-row water splitters currently leak, repair if necessary
- 2 Determine if thermostatic unit on port engine intercooler is leaking & repair if necessary
- 2 Secure battery box lids to prevent vertical movement of batteries as recommended by ABYC section E-10
- 2 Attach auto pilot feedback sensor to port rudder quadrant
- 3 Remove loose paint & surface corrosion on base of radar antenna & paint

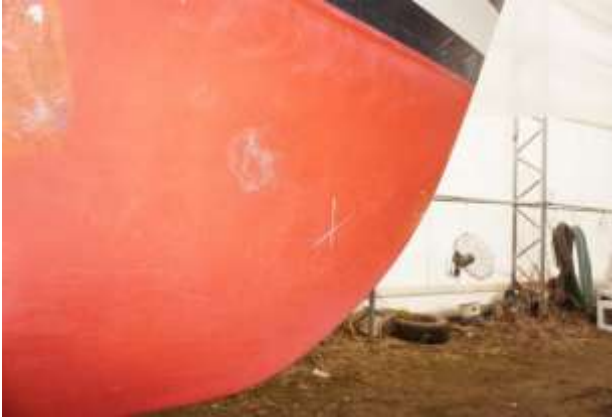
An ±5”x5” area on the starboard bottom, forward of the bow thruster, brought reports from the percussion hammer indicating a possible void within the laminates, or separation of the fiberglass cloth covering the hull. Moisture readings in this area resulted in highly elevated moisture levels [Figure 10.19 & Figure 10.20]. This area should be explored in detail and repaired accordingly.

Figure 10.19 X marks area of small void/lifting fiberglass

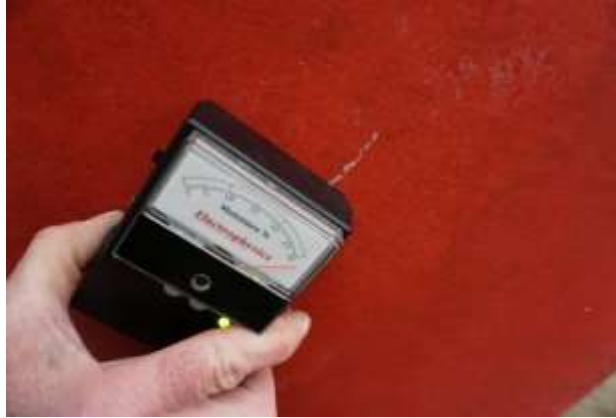
Figure 10.20 Elevated moisture on X mark on stb. bow

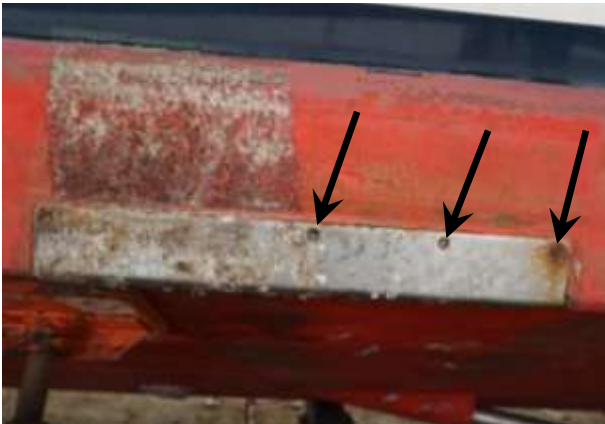
Many of the stainless-steel lifting strap guard fasteners are missing or corroded [Figure 10.21].

Figure 10.21 Missing & corroded fasteners on s.s. strap guards

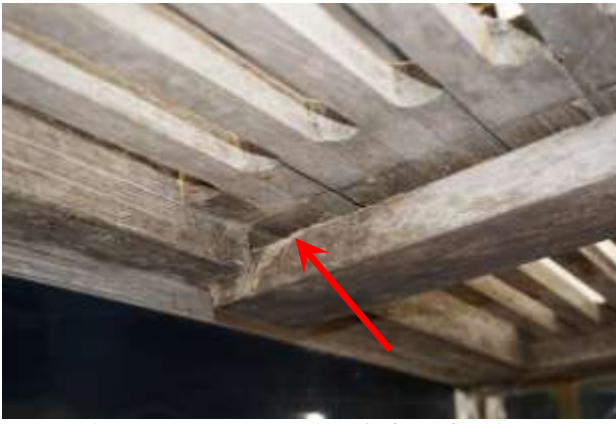
Some of the underside swim platform framing is loose or unattached and needs repair [Figure 10.22].

Figure 10.22 Loose swim platform framing

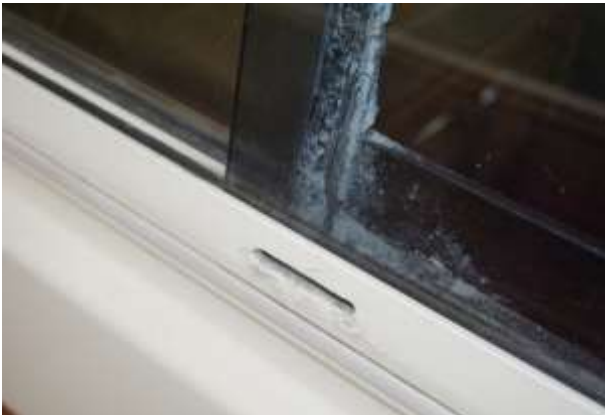
The port and starboard aluminum framed sliding wheelhouse window frames are corroded in areas and around their scupper drains [Figure 10.23]. The forward wheelhouse windows show evidence of leaks around the outboard lower corners.

Figure 10.23 Corrosion on wheelhouse sliding windows

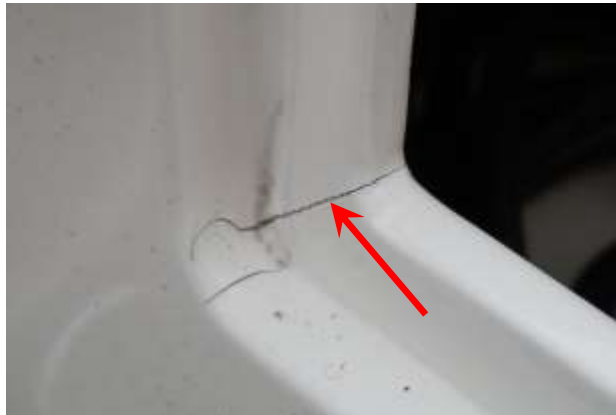
Numerous cracks were observed on the deck and cockpit structure joints, primarily around lockers, deck hatches and window openings [Figure 10.24 - Figure 10.26]. The cracks were noted at radiuses or miter joints of locker and hatch openings and contours in the cockpit deck, these areas should be monitored and sealed in the future to prevent water intrusion. No elevated moisture readings were recorded around these compromised areas.

Figure 10.24 Crack in corner of cockpit storage locker

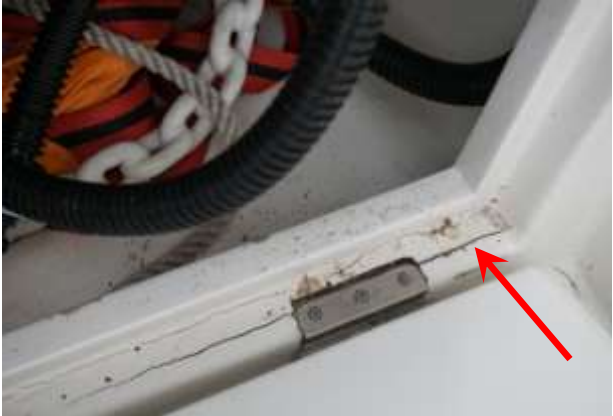
Figure 10.25 Crack/split in cockpit storage locker

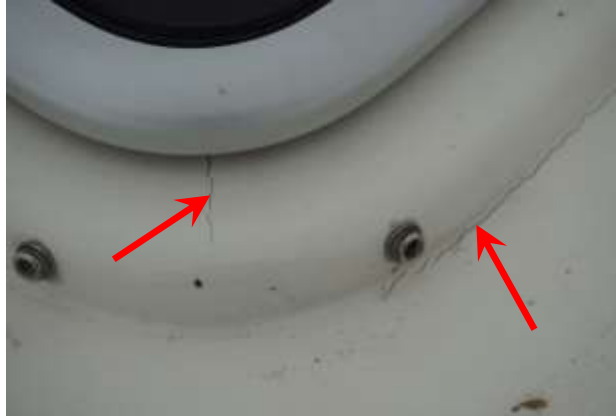
Figure 10.26 Cracks around deck hatch on top of wheelhouse

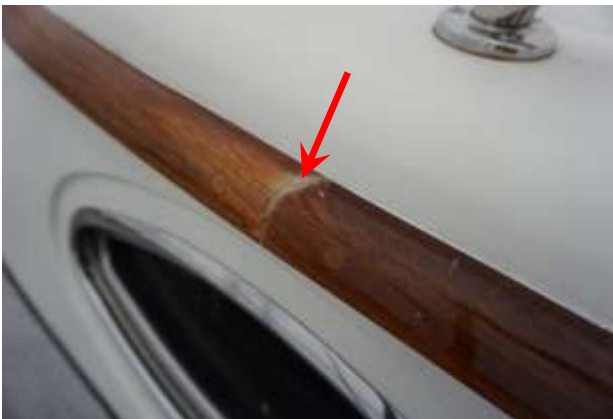
There are some flaws in the varnish on areas on the toe-rails and other areas of brightwork [Figure 10.27] but overall the brightwork has a good appearance.

Figure 10.27 Imperfection in varnish

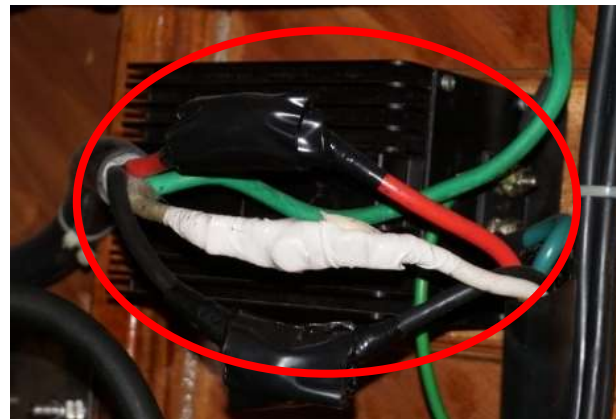
- There is a 240-volt wire connection near the Cablemaster on the interior of the transom. The connection is covered with tape and not in a junction box as recommended by ABYC section E-11 [Figure 10.28].
- The batteries are installed in fiberglass lined boxes attached to the hull. Before getting underway the lid straps should be secured to prevent vertical movement of the batteries.
- Two bonding wires are unattached, one near the port rudder quadrant; the other is located in the engine room, slightly to port of the centerline, near the forward bulkhead.
- The covering on the microphone wire near the plug has deteriorated on the Garmin VHF.

Figure 10.28 240-volt wire connections not in junction box

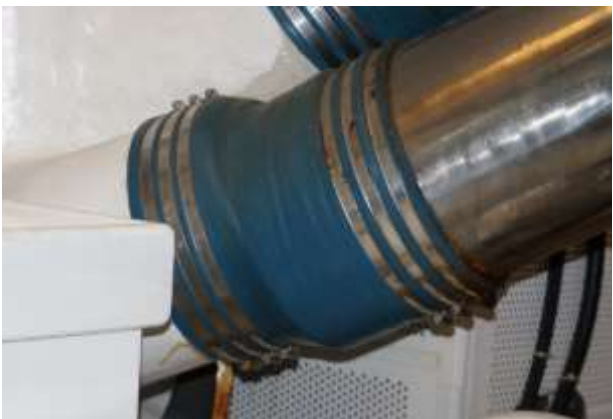
| Exhaust System: | Wet exhaust; hump hose connectors need service/replacement (see section 7.2) |

Figure 10.29 Stress on port hump hose

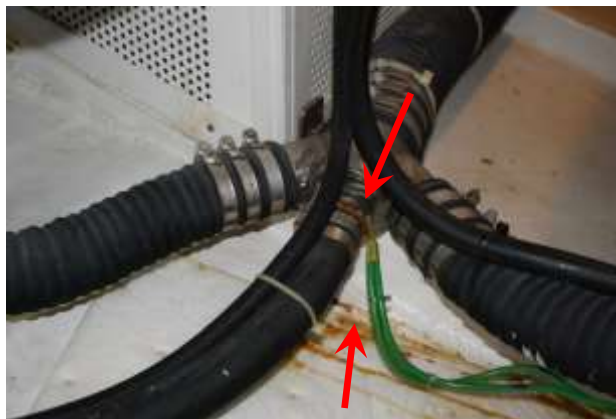
Figure 10.30 Stains indicate evidence of past/present leak on 3-way raw water diverter

- 3 Remove any surface corrosion on port engine below intercooler thermostatic unit and paint
- 3 Monitor small oil leak on port inboard valve cover & tighten or repair if necessary
- 3 Determine if there are any current water or coolant leaks on 16kw generator and repair if necessary
- 3 Remove surface corrosion from 16kw unit and paint
- 3 Attach loose bonding wires to their proper locations
- 3 Repair Garmin VHF microphone wire covering

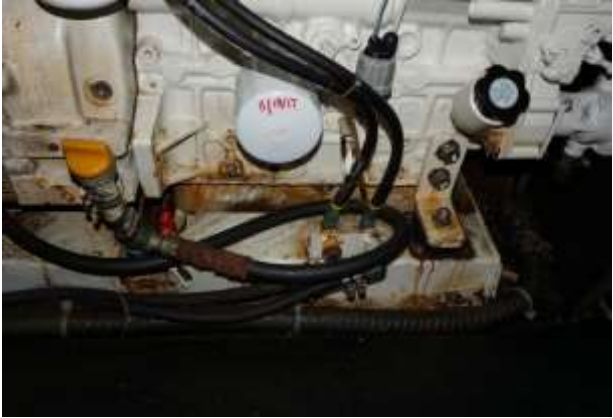
- Surface corrosion was noted on the 16kw unit, no water or sources of coolant leaks were observed, all belts and hoses appear serviceable, no oil leaks were noted [Figure 10.31].
- The paint on the 5kw unit is in good condition, no oil, water or coolant leaks were noted, all belts and hoses appear serviceable

Figure 10.31 Corrosion on 16kw gen set

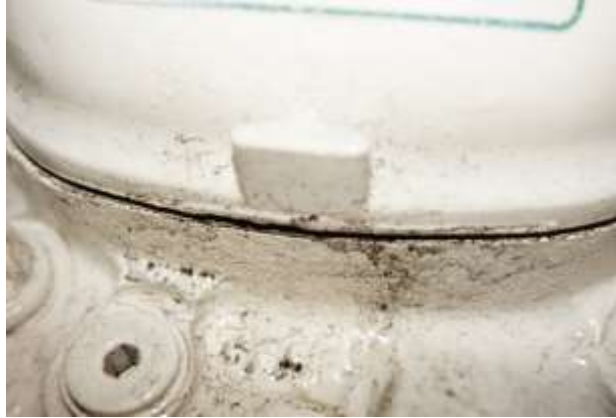
- No evidence of any oil, coolant, water leaks or corrosion were noted on the main engines with exception of a valve cover leak on the port engine (inboard), it is not of any immediate mechanical concern but should be monitored [Figure 10.32].
- All the blue hump hose connectors on the main engine exhaust show signs of deterioration and are nearing the end of their service life. One port side hose is quite stressed due to poor alignment of the connected pipes, a crack in this hose was noted [Figure 10.29].
- The port and starboard raw water discharge 3-way splitters show evidence of leaking [Figure 10.30].
- The thermostatic control valve on the port engine intercooler appears to have been recently replaced, there is evidence of a past or perhaps a present leak that has caused surface corrosion on some engine components below the thermostatic unit [Figure 10.33].

Figure 10.32 Small oil leak around port engine valve cover

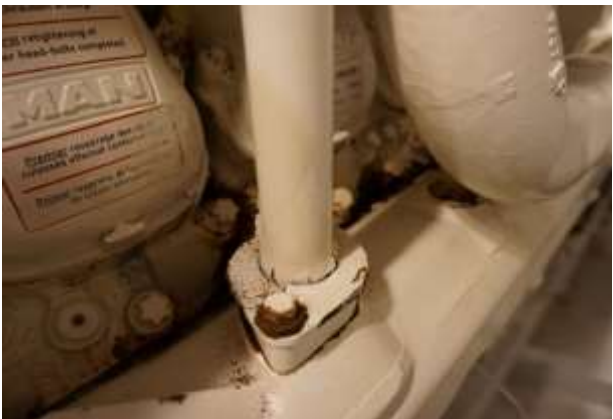
Figure 10.33 Surface corrosion beneath port engine intercooler thermostat
