REPORT OF MARINE SURVEY

CONDITION AND VALUE
of the vessel
"REDEMPTION"
2001 Tartan 4100

CONDUCTED BY:
Allen Kesner
on
September 1st 2021

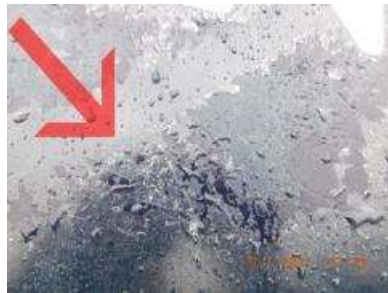
Transom cosmetics:

The paint on the transom shows signs of deterioration. Recommendation; repaint the transom to improve the appearance of the vessel.

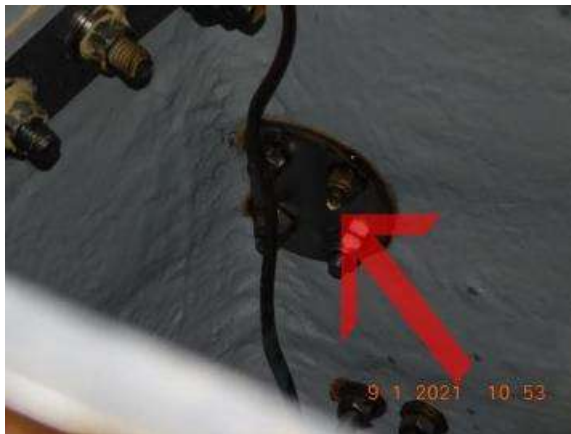
Davit system:

Dinghy swing davits system mounted on the transom. Bolts mounting the davit arms to the vessel showed signs of water leaking into the lazaret . Recommendation; remove the davits, clean old sealant from the mounting area, reinstall davit arms using quality marine sealant.

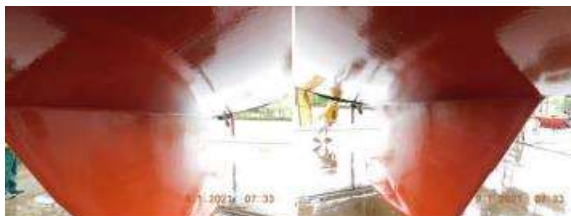
Keel is well secured and well faired into hull. No cracks or separation sighted at hull to keel joint.

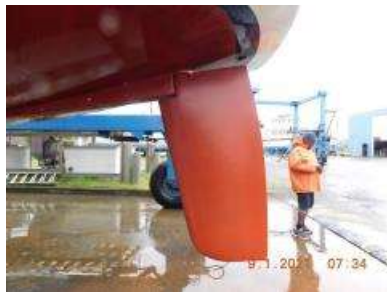
Rudder type/condition:

Moisture/Delamination: Fiberglass. Spade. Rudder showed no signs of delamination based on testing with percussion hammer.

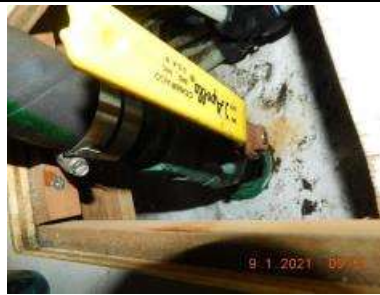
Sea valves:

Bronze seacock ball valves installed for the galley sink drain. Valve was difficult to operate. Recommendation; Exercise all ball valves frequently to ensure proper operation.

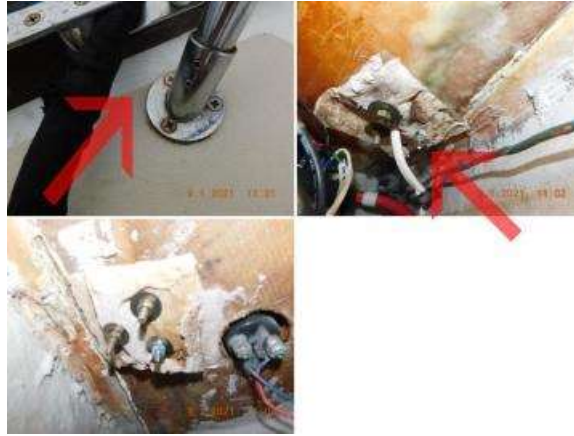
Bow pulpit/rail:

Stainless steel bow railing. Some stress cracking of the deck around base of port rear foot pad on the bow railing. Recommendation; have the deck repaired by a marine FRP technician and manufacture new backing pads that better form to the underside shape of the deck and replace the backing pads currently used to attach the bow railing to the deck.

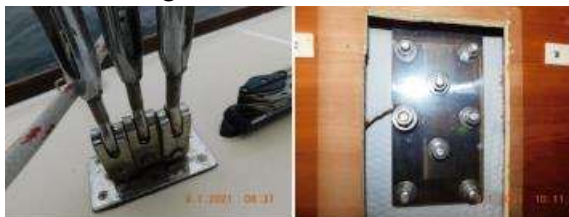
Chain plates appear well secured to deck, and bulkheads for portions that were visible.

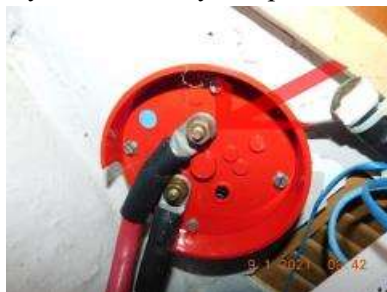
DC wiring spark prevention:

Rotary battery switch for the inverter supply does not have protection on the terminals. ABYC E 11.5.2.8 states; continuously energized parts, such as positive battery terminals and both ends of all wires connected thereto, shall be physically protected to prevent accidental short circuits. Protection shall cover all energized surfaces. Recommendation; cover battery terminals on the back side of the rotary switch.

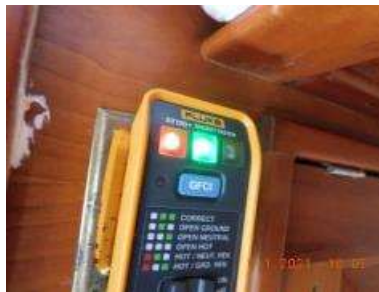
Other A.C.:

Outlet in Vee berth when tested showed a Hot and Neutral reversed condition. Recommendation; remove the receptacle and ensure that is wired correctly , repair as necessary and reinstall.

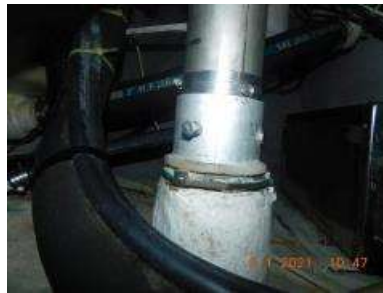
Type: Whitlock.
Mounting(s): Secure.
Rudder stock(s): Visually sound.
Packing glands:

Appears well sealed- No leaks sighted.

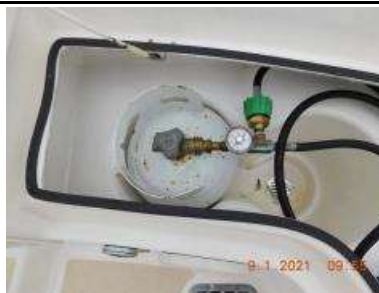
No & location of tanks:

Secured: One tank inside transom dedicated LPG locker with proper ventilation overboard. Tank is properly secured to prevent upset or displacement that could place a strain on fuel distribution or appliance fittings per ABYC A-1 recommendations.
Tank type & OPD: Steel, Tank is properly fitted with the Overflow Protection Device (OPD)
Regulator(s): Yes-Appropriate LPG regulator.
Pressure gauge(s): Pressure gauge is installed and holds pressure when main gas valve is turned off indicating no leaks in the system. NOTE: *Always retest for leaks when removing or*
