**PATTON MARINE SURVEYORS
AND CONSULTANTS, INC.**

February 20, 2026
File No.: 13935-26
Page 1 of 4

**RE: "LIV MAS", 2017,
85' Ocean Alexander Motor Yacht**

RECOMMENDATIONS

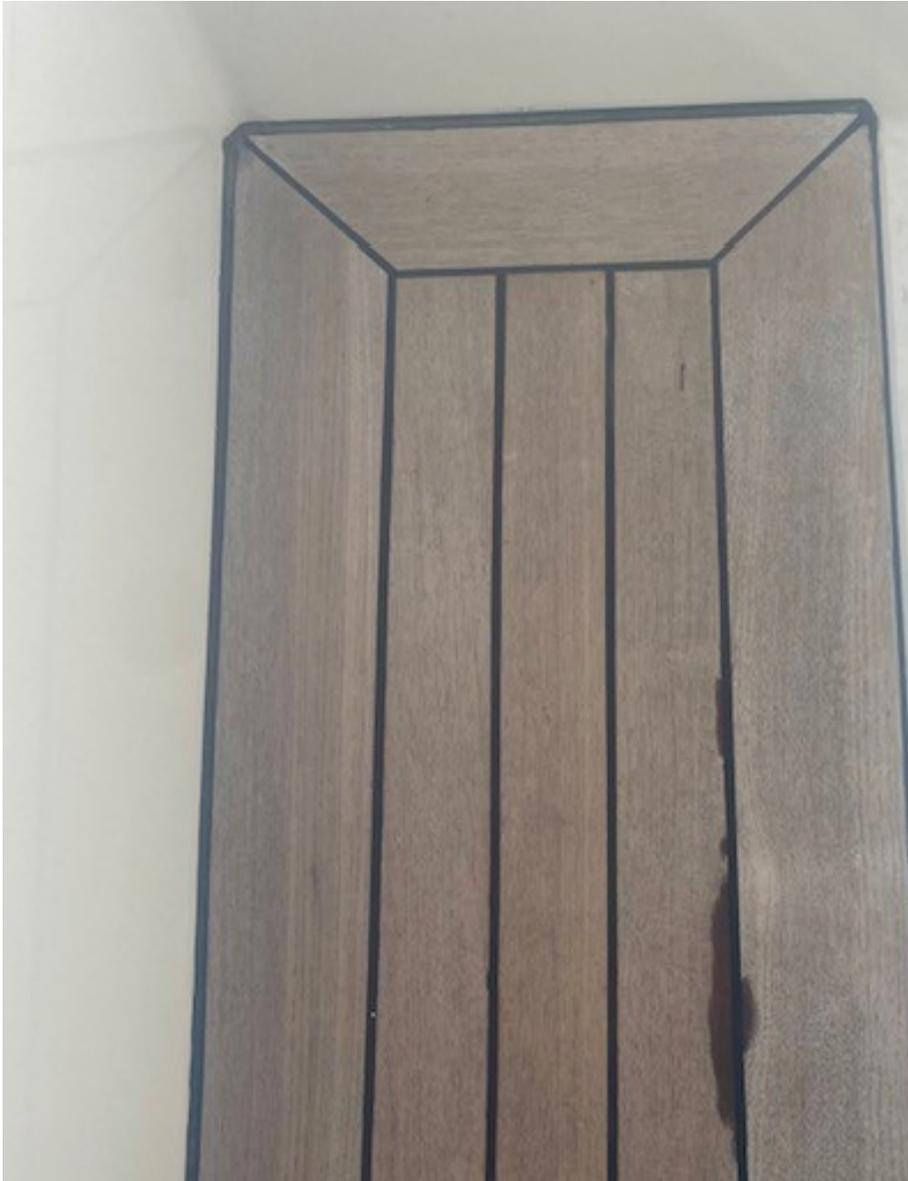
1. There is an wet open seam on the starboard forward main deck, recommending reefing and re-caulking.

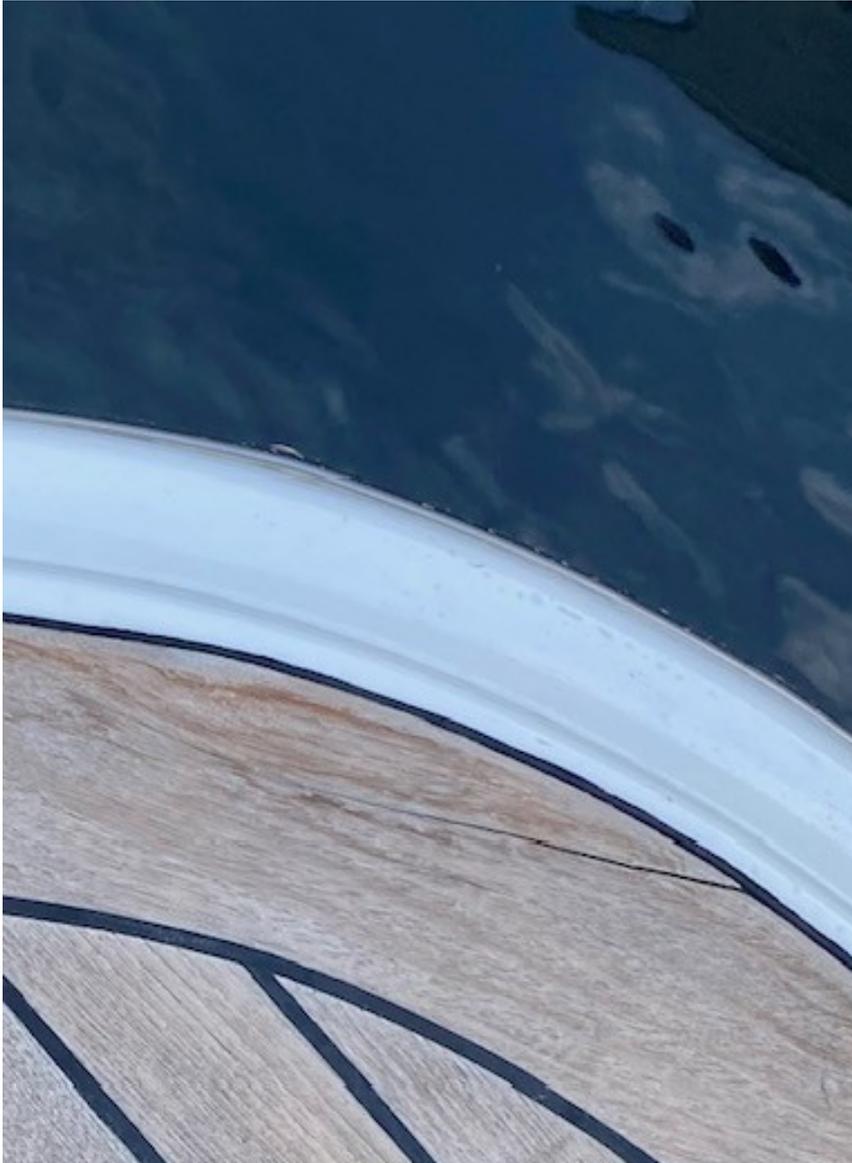
2. There is a checked outer corner margin on the port swim platform repair or replace.
