**PATTON MARINE SURVEYORS
And CONSULTANTS, INC.**

February 20, 2026

File No.: 13935-26

RE: "LIV MAS", 2017, 85' Ocean Alexander Motor Yacht

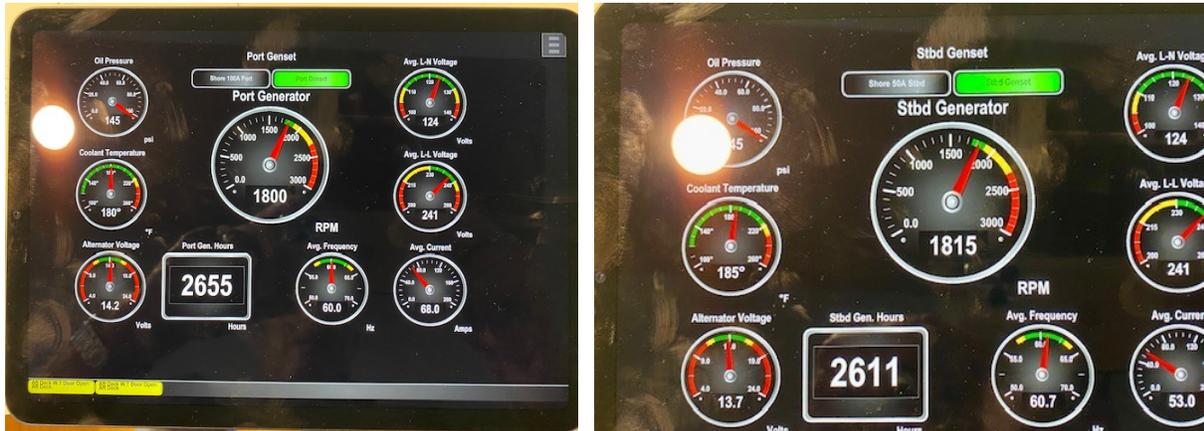
- Factory sound shields are installed.
- Both generators were full load tested. No problems noted.

PORT GENERATOR AND STARBOARD WITH FULL AC & GALLEY LOAD
