VESSEL: EQUINOX
HULL #: UNS65504I809
FILE #: 24767
DATE: July 26, 2024

REPORT OF SURVEY

The above captioned vessel was surveyed on July 26, 2024, at the request of _____ for the purpose of pre-purchase hull condition and marine risk.

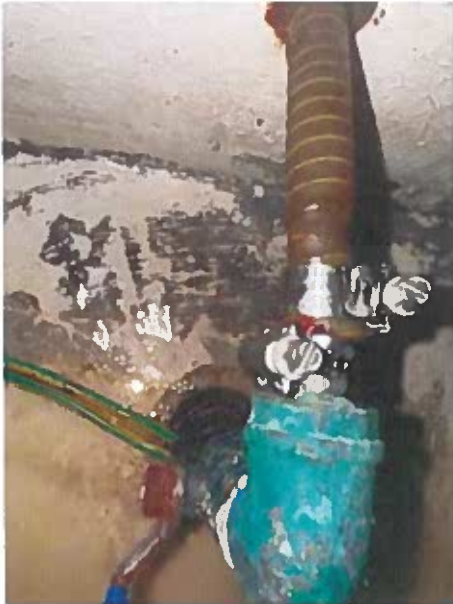
15. Identify and label raw water intake seacocks.
16. * The hose to the starboard raw water intake seacock has split. Renew hose.

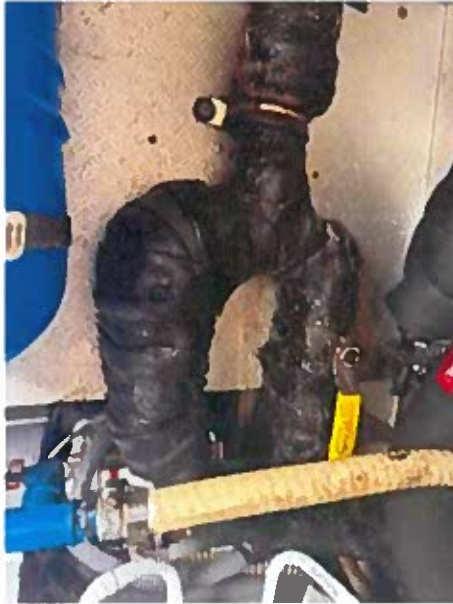
21. Air conditioning chilled water loop insulation has deteriorated. Renew.

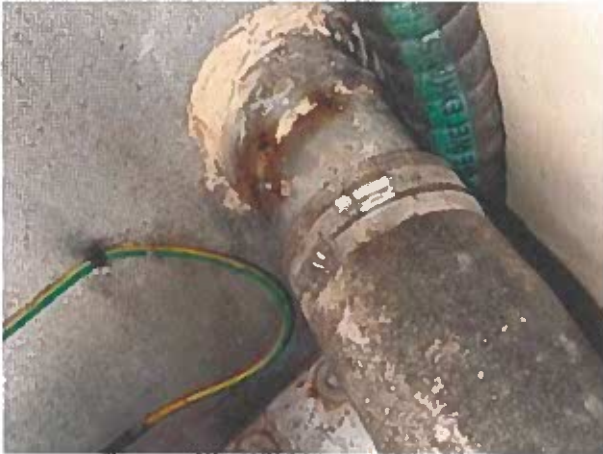
25. Porosity and signs of water leakage were noted at the port engine / generator raw water overboard discharge through hull fitting port side. Renew the overboard discharge fitting at the next scheduled dry dock service.

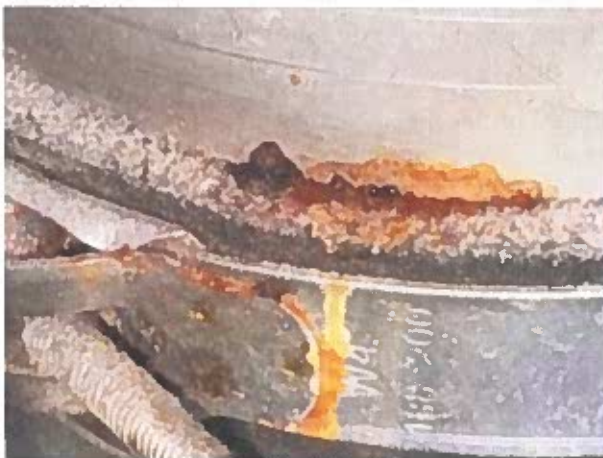
26. Corrosion and porosity were noted in the port engine exhaust riser. Repair or renew as deemed necessary.
