# VESSEL PRE-PURCHASE SURVEY REPORT

M/Y "BRANDI WINE" Hargrave 114'

Fort Lauderdale, FL, USA – October 6th, 2026

This is to certify that I personally attended the model year 2009, 114-foot fiberglass hull, motor yacht built by Kha Shing Enterprises Co. (HIN – HCY14125G809).

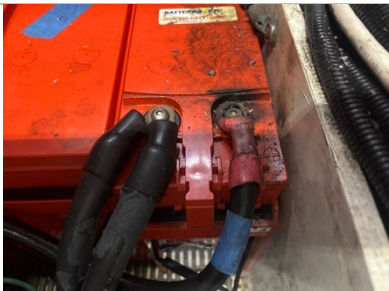
| 5 | The positive terminal on the starboard outboard battery was severely deformed, with black smoke residue around the stud. Excessive oil was also observed on top of the battery. | Clean the oil from the battery and replace the battery cable without delay. Inspect the terminal stud and replace the battery as needed. | |

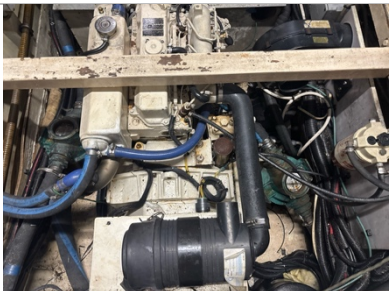
| 6 | Neither of the two main generator sea strainers were secured in place. | Securely mount the strainers to prevent excessive stress on the connected hoses, which could lead to hose failure and flooding. | |

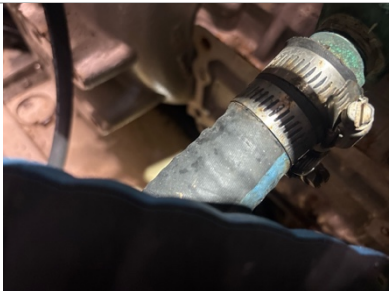
| 7 | The night generator raw water intake hose was broken and deteriorated. | Replace with marine-grade hose rated for the application. | |

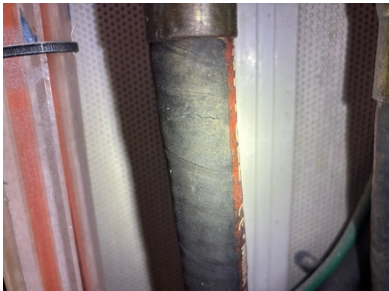
| 9 | Both port engine fuel hoses were deteriorated and cracked. | <p>Replace without delay with marine-rated fuel hose meeting ABYC requirements to prevent fuel leakage into the engine room.</p> | |

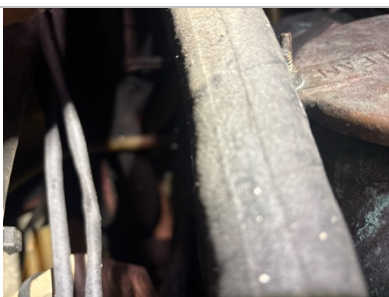
| 10 | The starboard engine fuel hose was cracked and swollen. | <p>Replace without delay with marine-rated fuel hose meeting ABYC requirements to prevent fuel leakage into the engine room.</p> | |

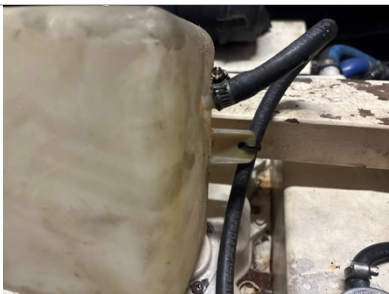
| 12 | The night generator coolant overflow/expansion tank was not properly mounted, and its flange was broken. | <p>Replace the tank and mount it properly to prevent coolant from discharging into the bilge and, via the bilge pump, overboard.</p> | |

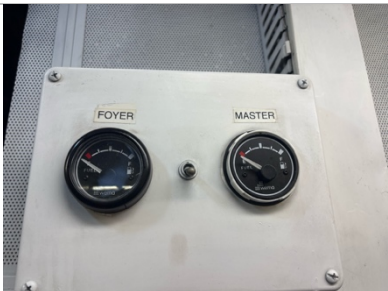
| 16 | The master fuel tank gauge cover was missing. | Install an appropriate cover. | |

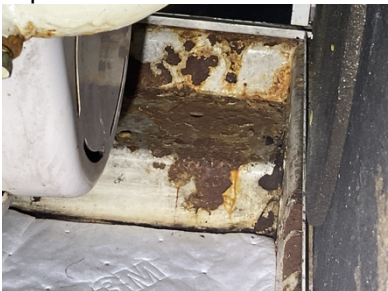
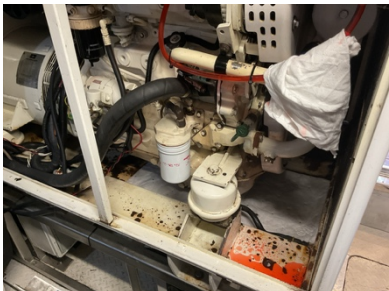
| 18 | Coolant leakage and multiple areas of corrosion were observed on the lower frame of the port generator. | Inspect the cooling lines for leaks and loose connections and repair as needed. Remove the corrosion, prime and paint the affected areas, and apply corrosion inhibitor to any exposed metal. | |

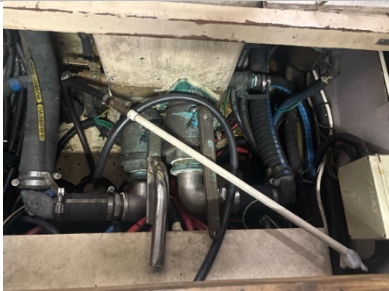
| 19 | The main engine through-hull valves were inoperable. | Service or replace the through-hull valves. | |

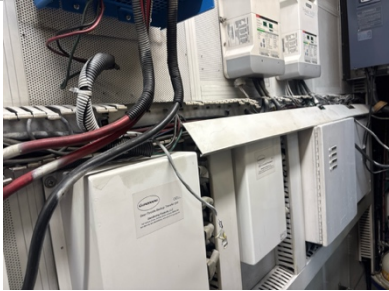
| 20 | Loose wires were observed hanging near the battery chargers on the forward engine room bulkhead. | Trace the loose wires and reconnect or remove them as necessary. | |

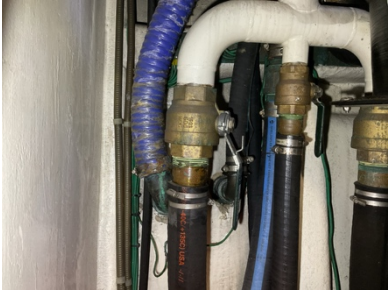
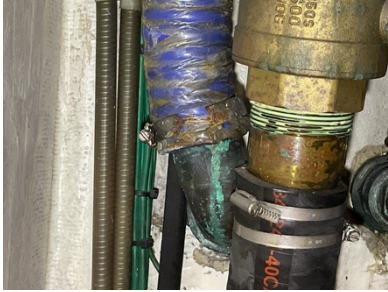
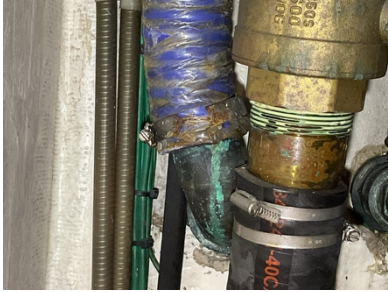
| 21 | On the center generator exhaust system, a hose clamp on the outboard discharge line was broken and the connection was not double-clamped. | <p>Replace the broken clamp and install double clamps at all exhaust hose connections in accordance with ABYC standards. Replace hose fittings as needed.</p> | |

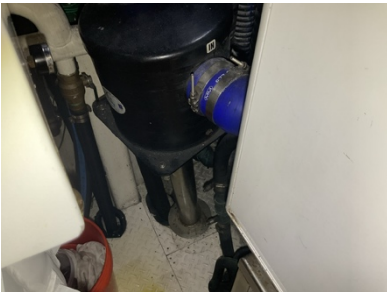
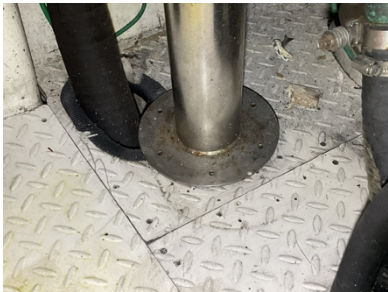
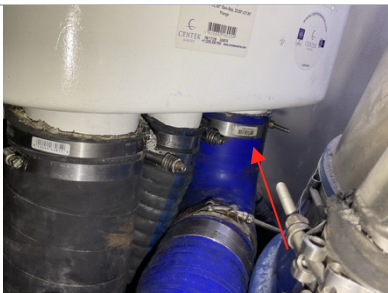
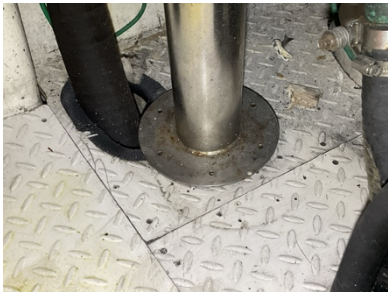
| 22 | The port generator exhaust lines were missing double clamps, and the stand supporting the mixing box was not secured to the deck. | <p>Install the missing clamps in accordance with ABYC standards and secure the mixing box stand to the deck/structure to prevent loosening or damage from vibration in service.</p> | |

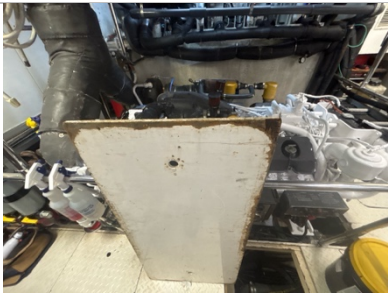
| 23 | The underside of the deck plates was worn. | <p>Monitor and recoat the deck plates to preserve the integrity of the wood.</p> | |

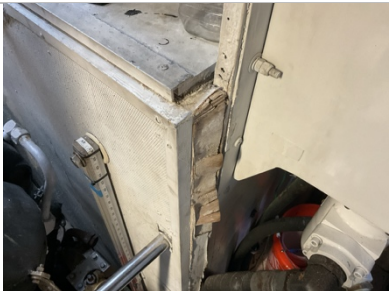
| 25 | Delamination was observed in the wood framing around the starboard tank. | Replace the affected wood framing to prevent failure. As this framing supports the watermaker, consider an alternative material less susceptible to damage from leaks. | |

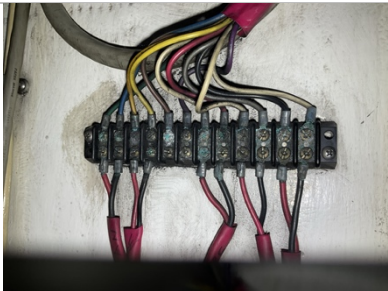
| 30 | Excessive corrosion was observed on the positive and negative connections on bar next to the A/C circulating pump in the port side engine room. | Clean all connections and replace broken or corroded terminals. | |

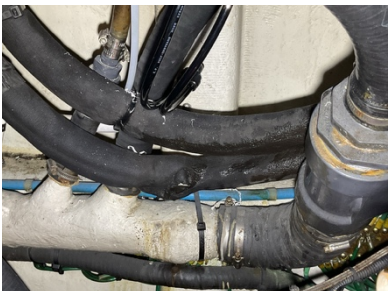
| 31 | The chiller line hose in the port aft engine room, behind the generator, showed deterioration, with wet areas dripping into the bilge. | Remove the deteriorated insulation and install proper insulation around the chiller hose. | |

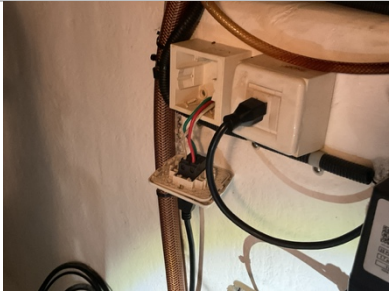
| 33 | A loose power outlet was observed in the bilge compartment of the VIP stateroom. | Repair or replace components as needed to secure the outlet. | |

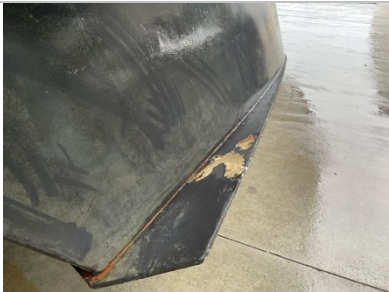
| 35 | Bottom paint was peeling on the starboard fin. | Touch up the bottom paint as needed. | |

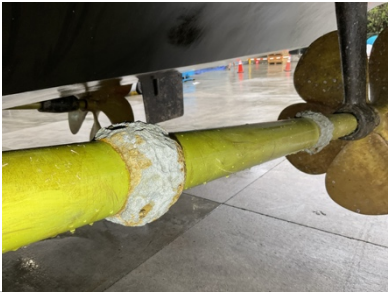
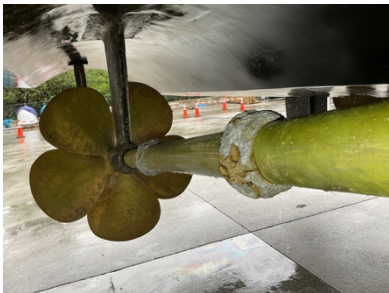
| 36 | The shaft zinc anodes had approximately 30% of their service life remaining. | Replace the port and starboard shaft anodes to prevent their complete loss and subsequent corrosion of the running gear hardware. | |

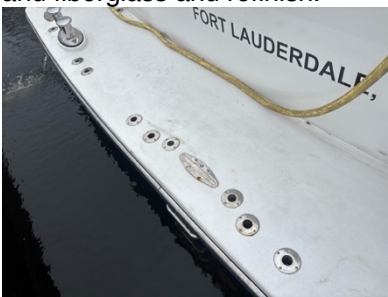
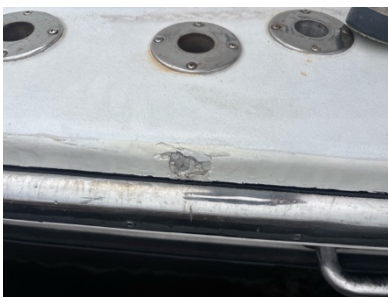
| 39 | Gelcoat and fiberglass damage was observed along the centerline of the transom swim step. | Repair the damaged gelcoat and fiberglass and refinish. | |

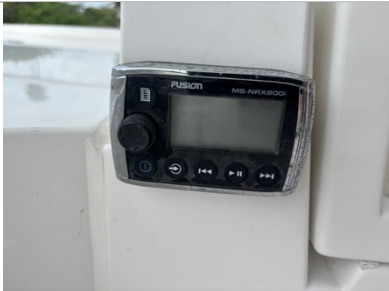
| 43 | The Fusion audio receiver on the flybridge was inoperable. | As the vessel's audio system is operated via an app through the Crestron receiver, remove or replace the Fusion receiver as desired. | |

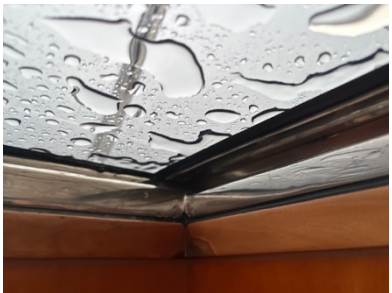
| 45 | An active water leak was observed at a window seal of the hatch between the flybridge and the helm station, with evidence of previous water intrusion and damage to the woodwork surrounding the companionway hatch. | Repair the leaking hatch and the surrounding interior woodwork. | |

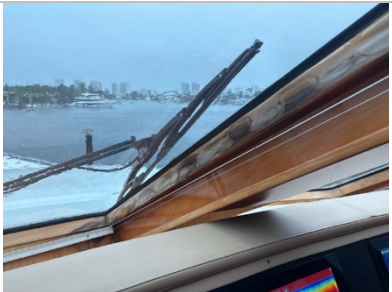
| 46 | Evidence of previous water intrusion or sun damage was observed on the helm station windshield frames. | Leak test each windshield, repair any areas of water ingress, and refinish the windshield frames. | |

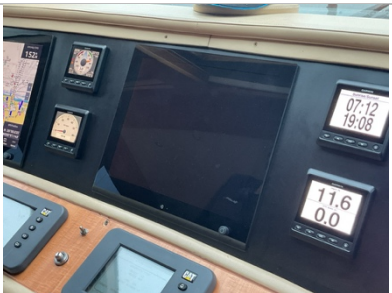
| 47 | The TimeZero system was reported by the captain to be inoperable at the time of survey. | Perform full troubleshooting and repair or replace components as needed. | |

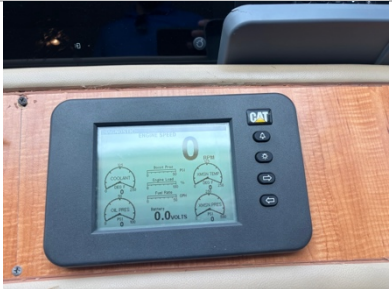
| 48 | None of the CAT monitoring screens were operational; the original screens had been removed and loaner units were provided for the sea trial. Starboard engine data did not display on the CAT screens. | Have a qualified CAT technician further investigate, diagnose, and repair. | |

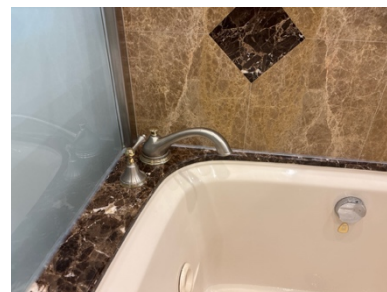
- 49 The master bathtub faucet was inoperable, and operation of the whirlpool (jacuzzi) tub could not be verified.

Investigate further, including the freshwater distribution manifold, and repair or replace components as necessary to restore water flow. Fill the tub and verify operation of the jets.

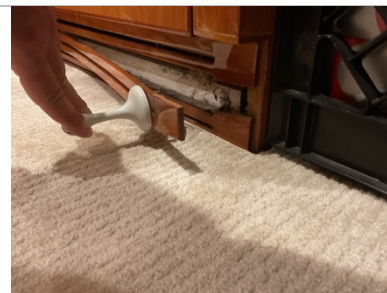
- 50 The head door stopper attached to the cabinet was broken and loose.

Reattach the stopper securely to restore the magnetic door catch and prevent the door from closing unintentionally.

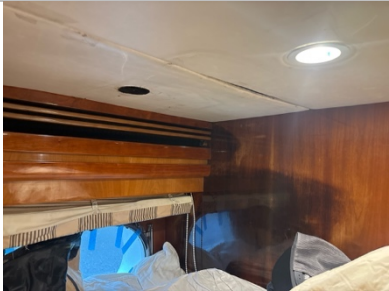
| 55 | An overhead light fixture was missing in the aft crew quarters, with evidence of previous water intrusion. | Replace the light fixture, ensuring the wiring complies with ABYC standards. | |

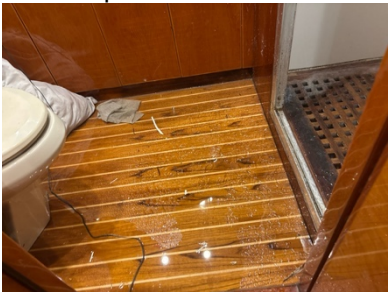
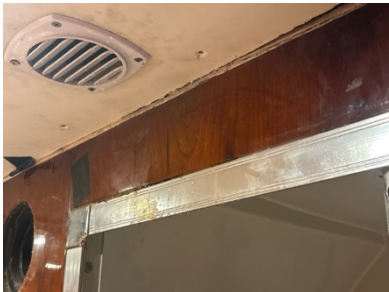
| 56 | Excessive water and an active leak were observed during a rainstorm at the overhead of the port bulkhead in the aft crew head. | Trace and stop the source of water intrusion, and clean the areas exposed to water. | |

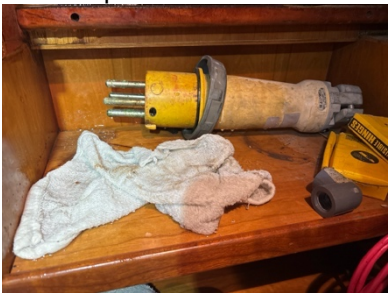
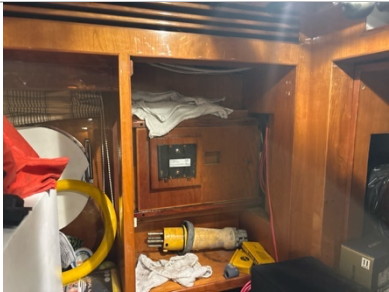
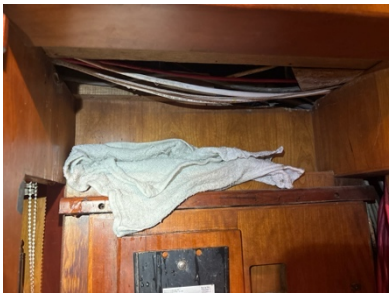
| 57 | Excessive standing water and an active drip were observed on the starboard side of the control room/aft crew quarters. | Trace and stop the source of water intrusion, and clean the areas exposed to water. | |
