Sea Trial Report

Chris Sitarz Inc.

M/V Minkie B

1997 Lyman Morse Custom 46 Flybridge

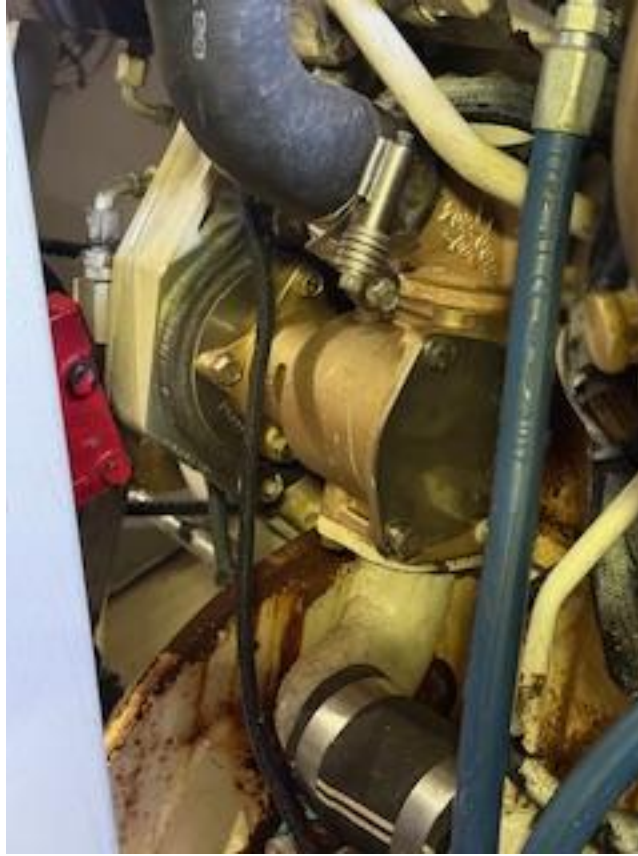
The starboard engine sea water pump appears to have been recently replaced.

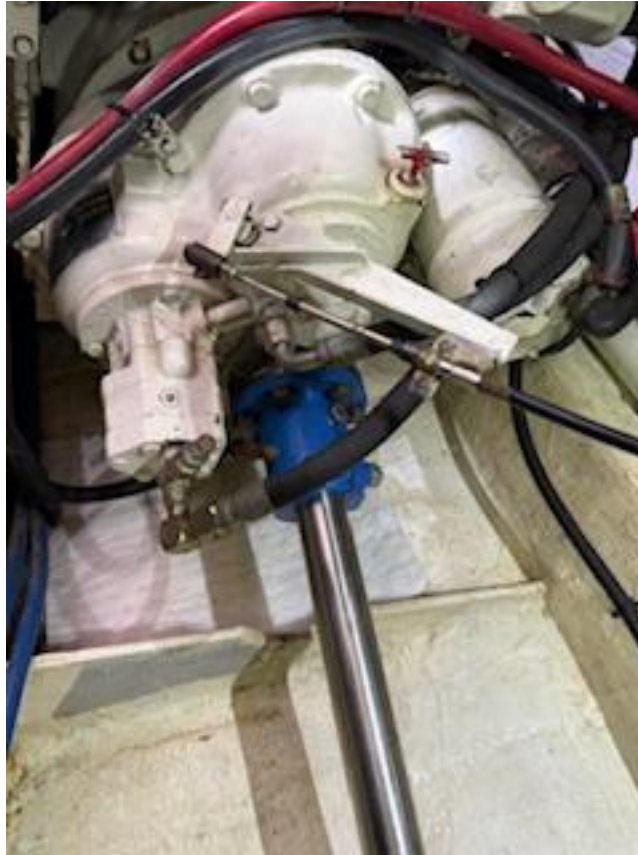
The starboard prop shaft coupling appears to have been recently replaced.

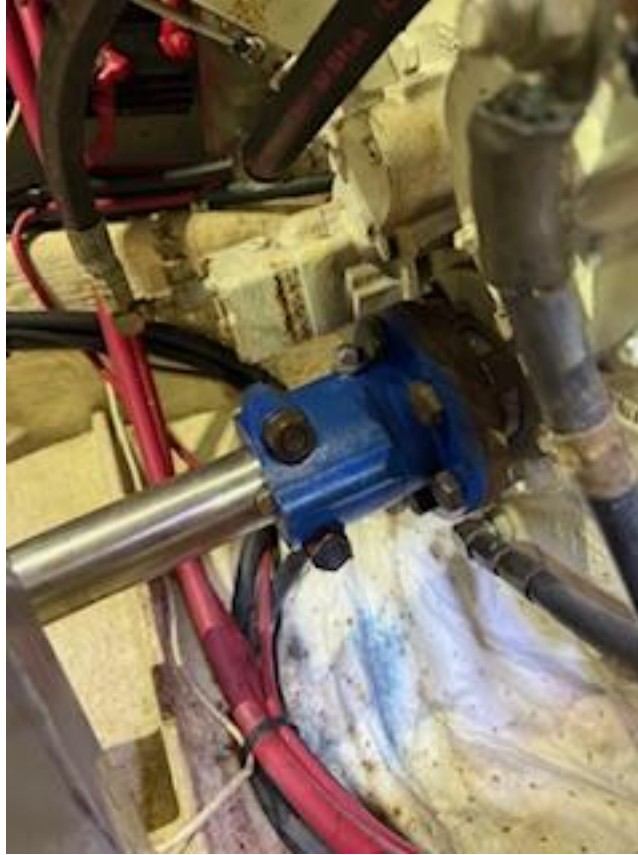
The port prop shaft appears to have been recently replaced.

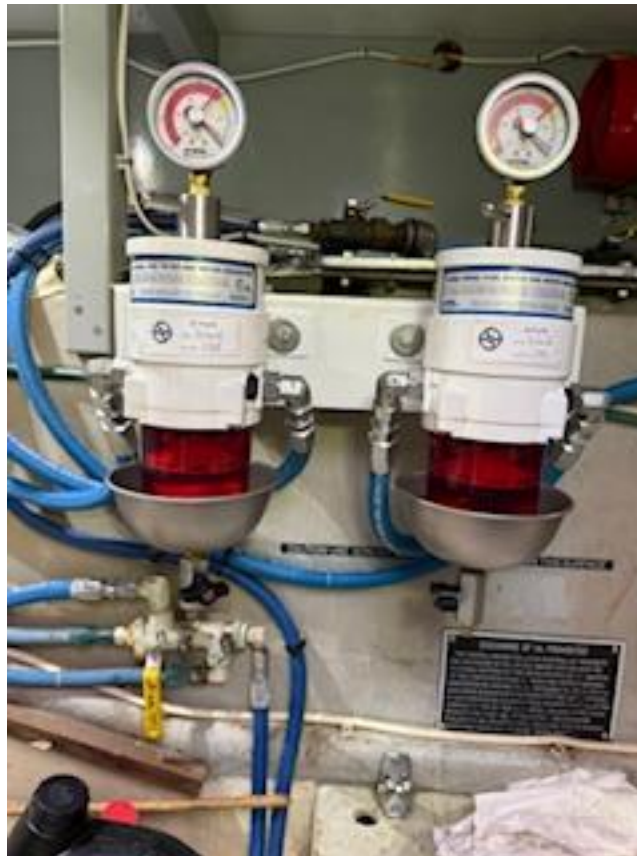
Both main engines are equipped with a single Racor fuel/water separator Model 500MA.

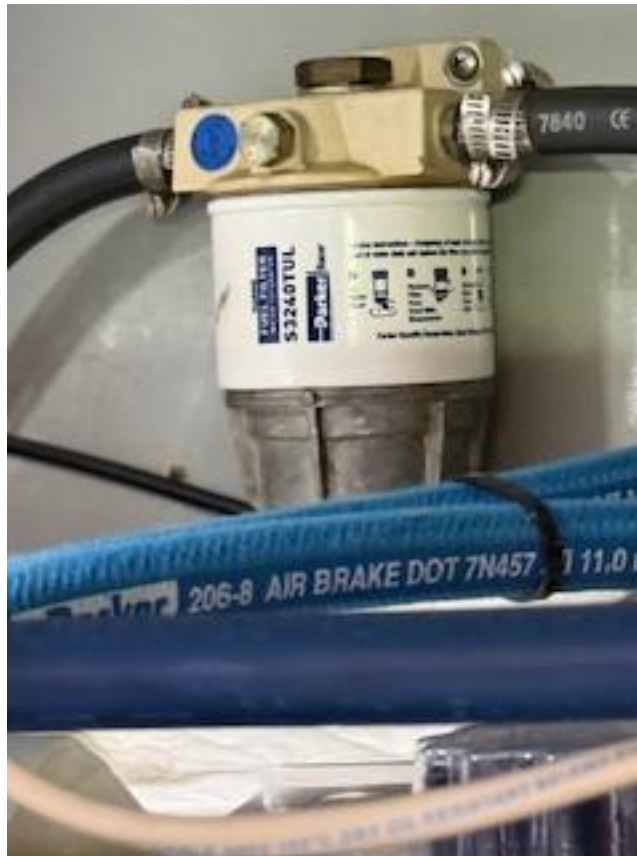
The generator is equipped with a single Parker/Racor fuel water separator. Part number S3240TUL.

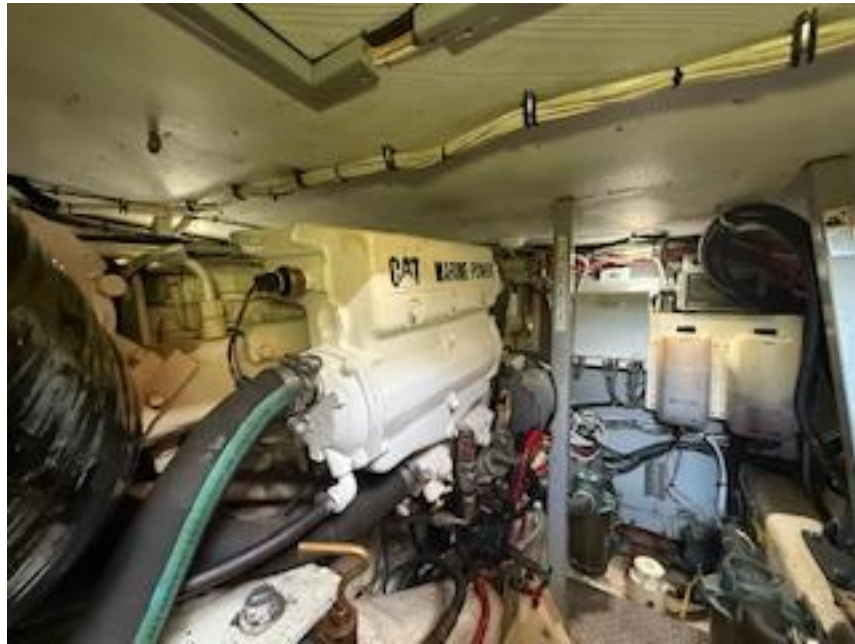
The port engine heat exchanger appears to have been removed and serviced recently.

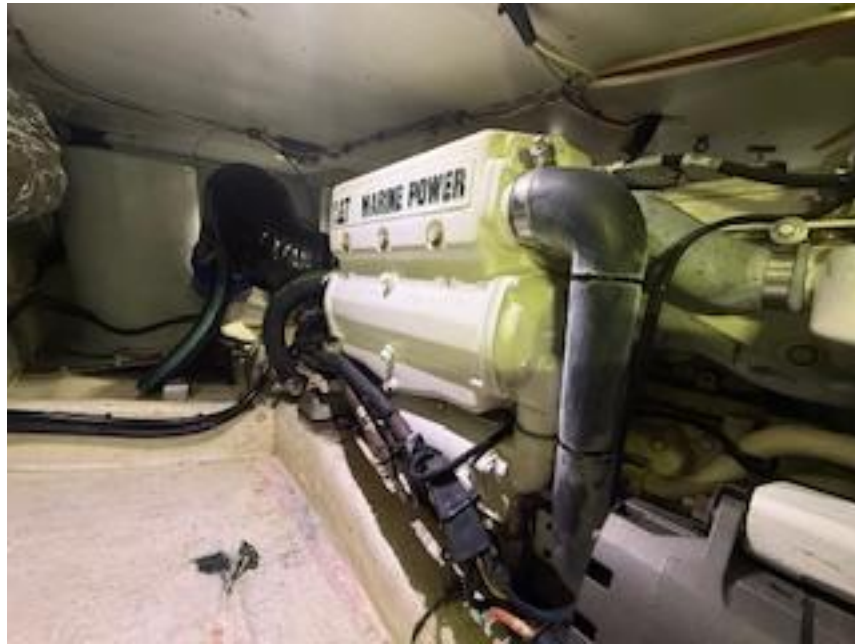
The starboard engine heat exchanger appears to have been removed and serviced recently.

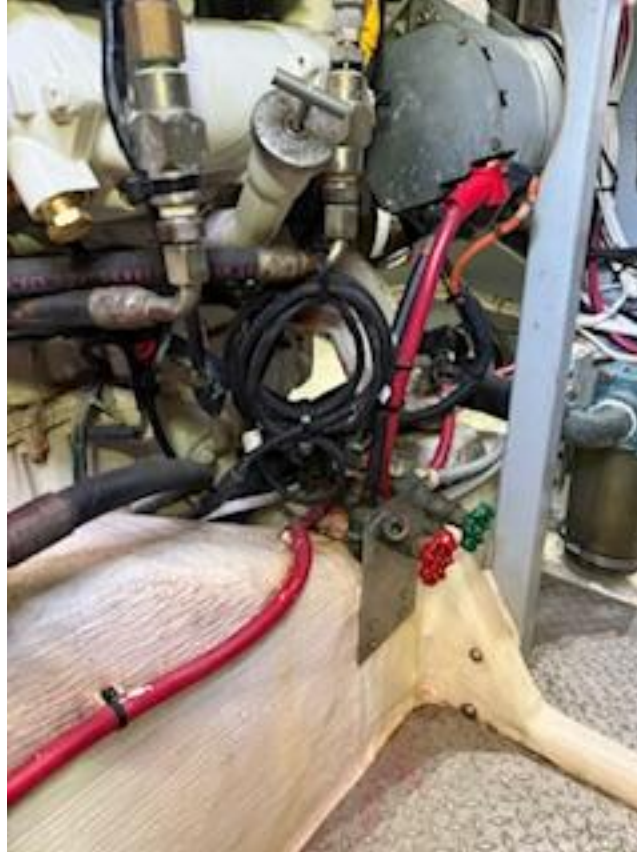
The port engine wiring behind the alternator should be properly secured to prevent chaffing.

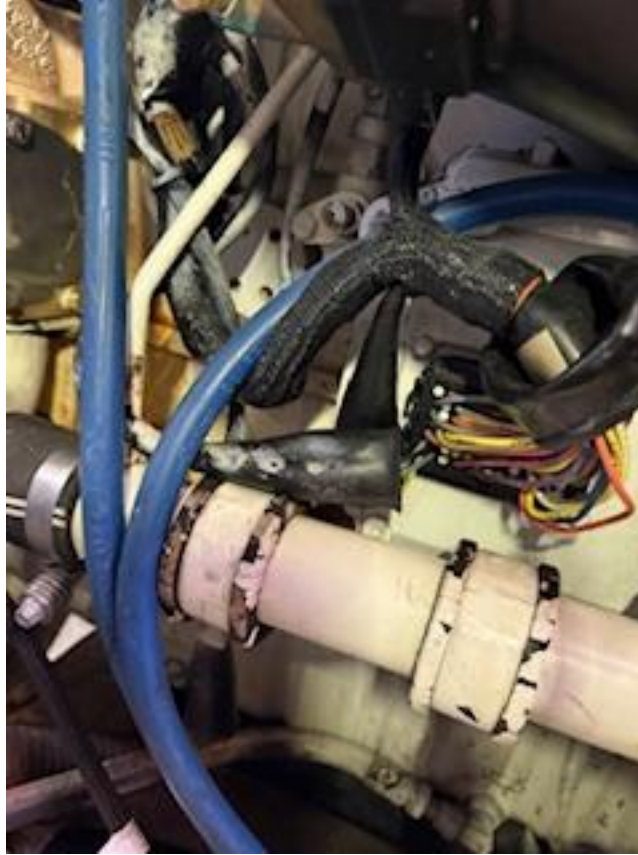
Starboard engine fuel lines are chaffing on the main engine harness. The harness and the hose should be rerouted and properly secured to prevent chaffing.

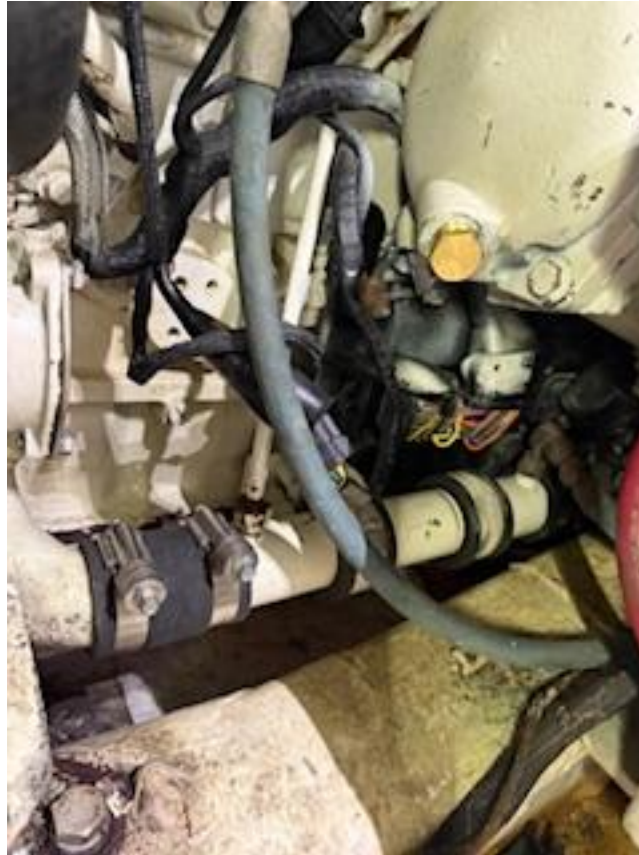
The port engine outboard side fuel hose is also chaffing on an electrical harness.
The hose and the harness should be properly secured to prevent chaffing.

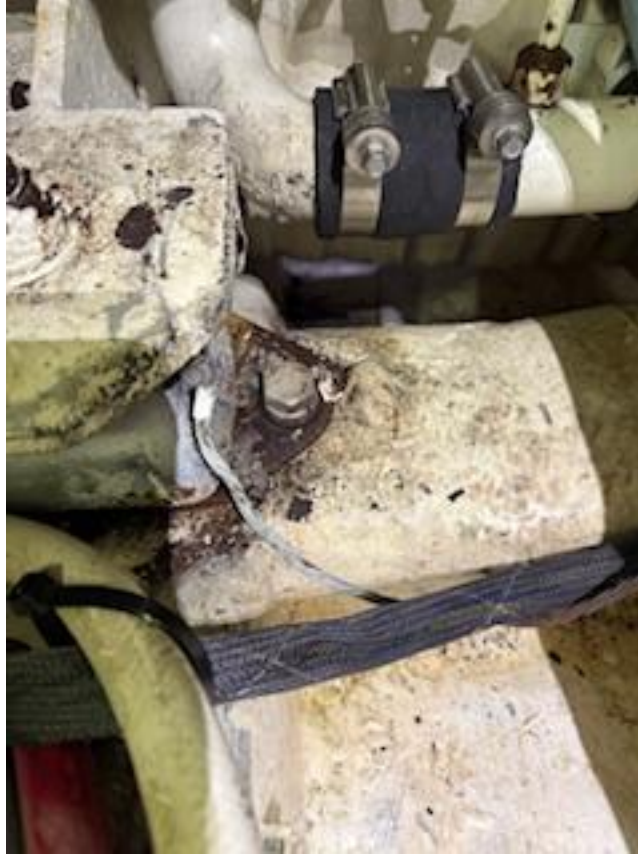
The port engine left front has a broken grounding wire by the left front engine mount.

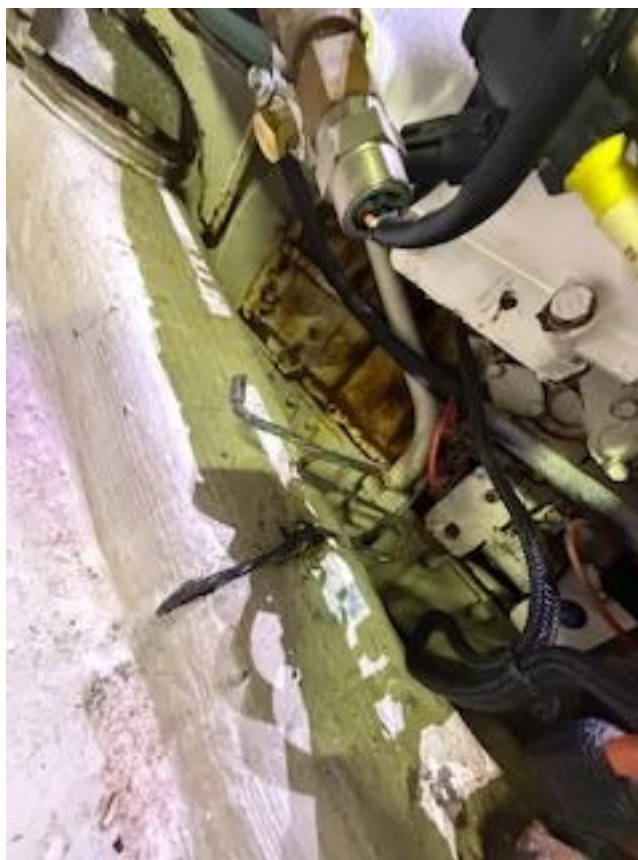
The starboard engine also has a broken grounding wire by the right front mount.

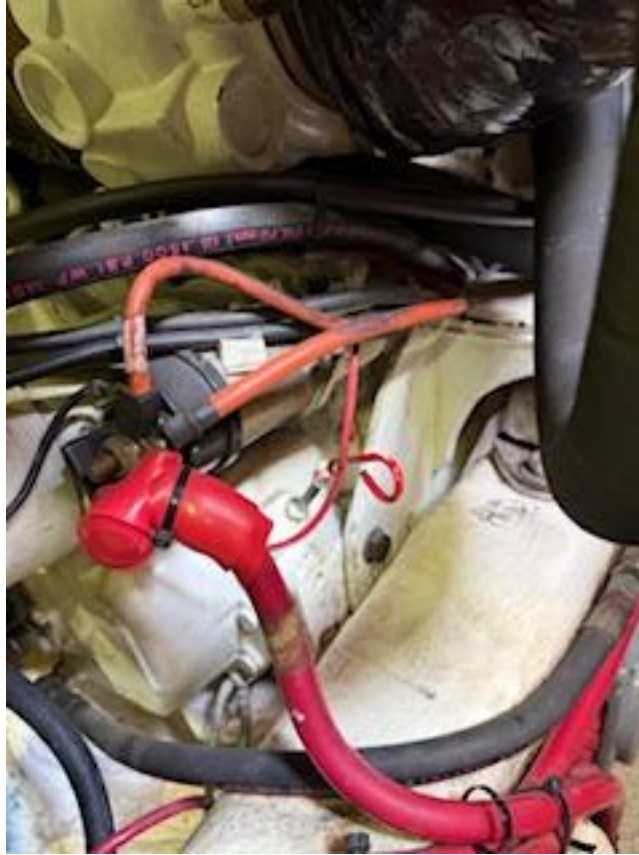
Port engine starter wiring is chaffing on the right rear engine mount.

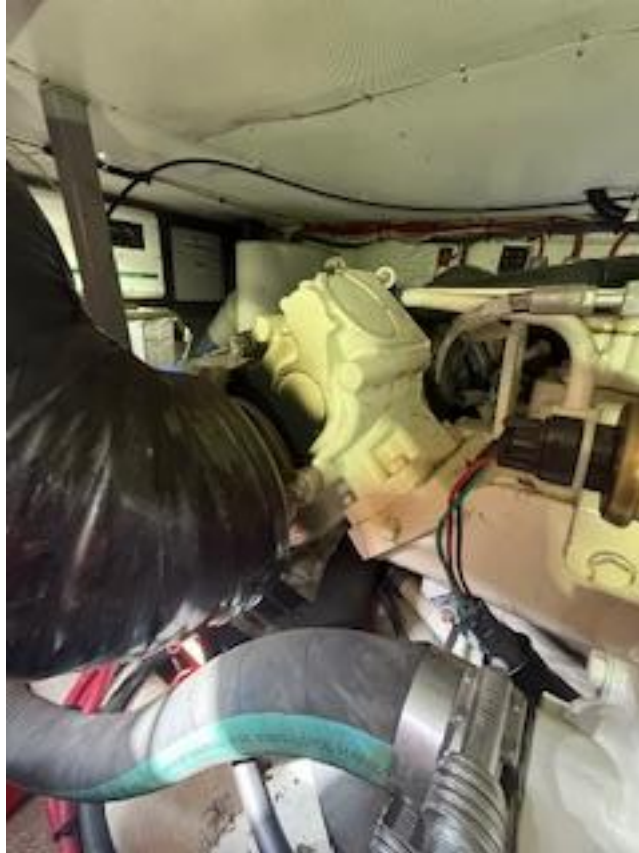
The port engine has an exhaust leak at the turbo outlet flange.

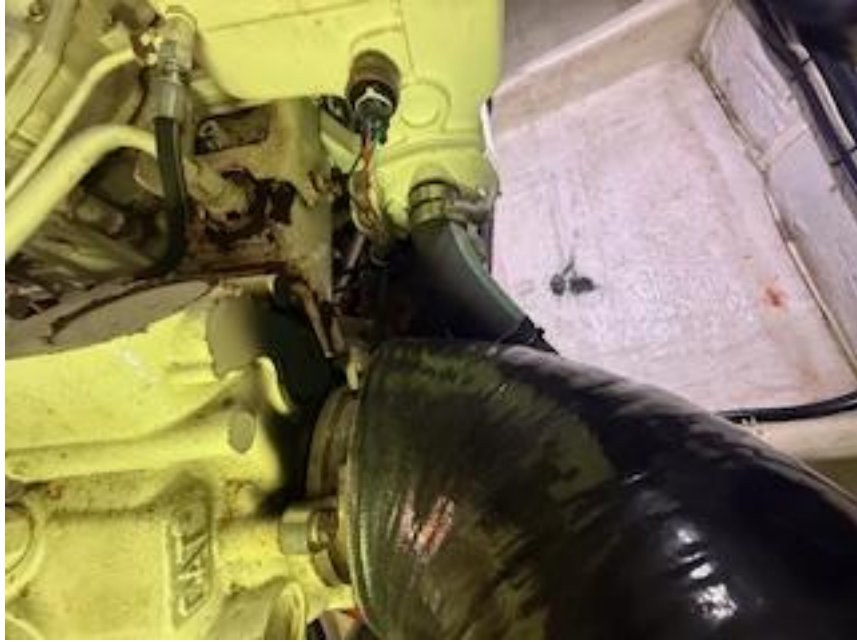
The starboard engine also has an exhaust leak at the turbo outlet flange.

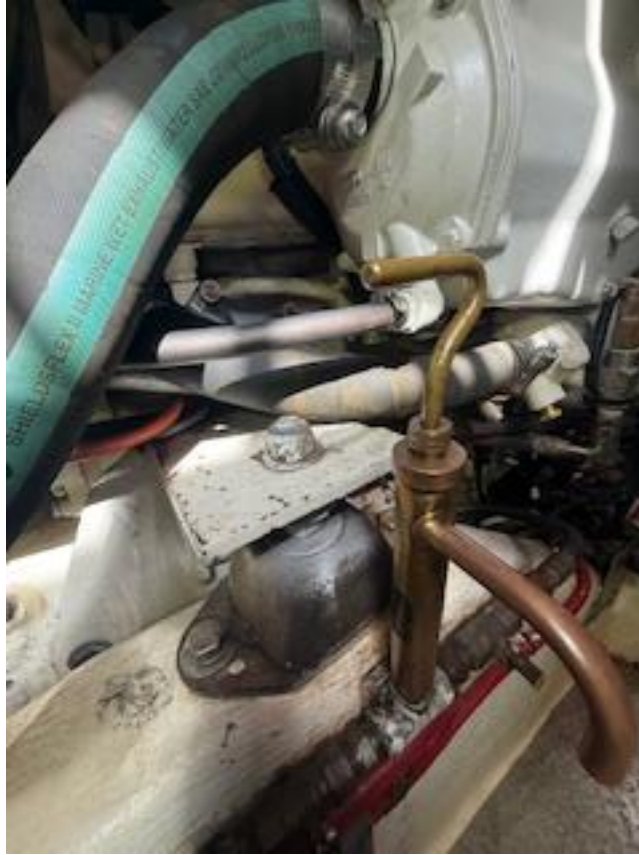
The port engine has a sea water hose chaffing on the right rear engine mount.

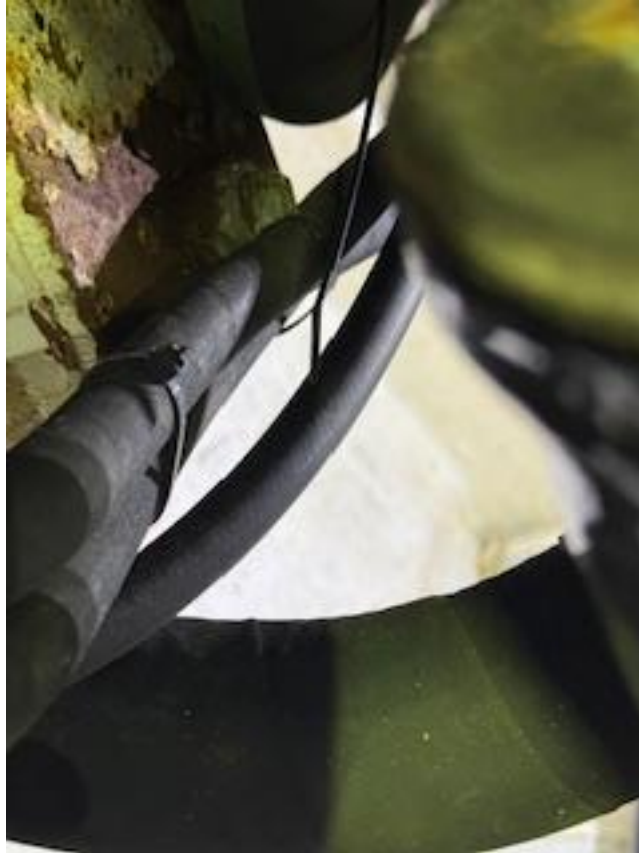
The starboard transmission cooler hoses are chaffing on the right rea engine mount.

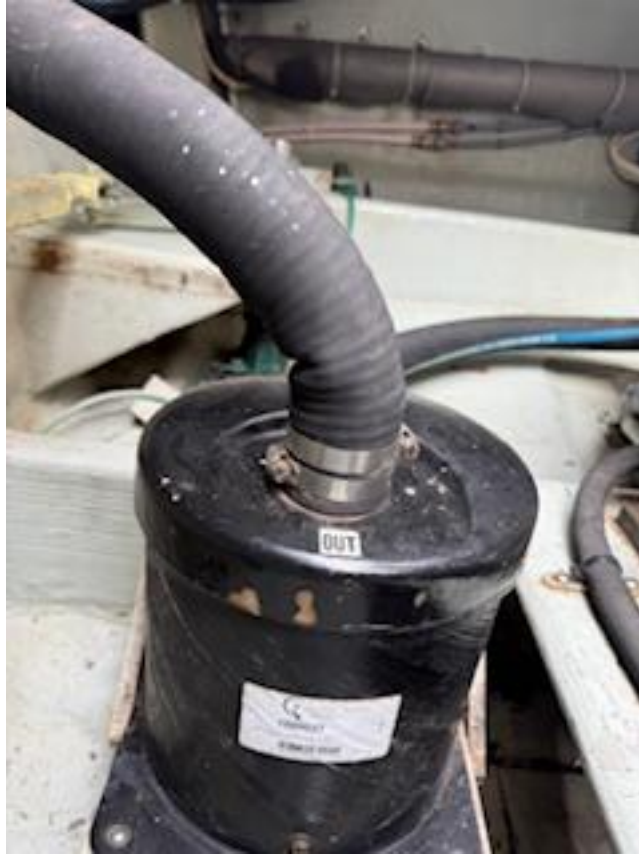
The generator muffler outlet hose is partly kinked.

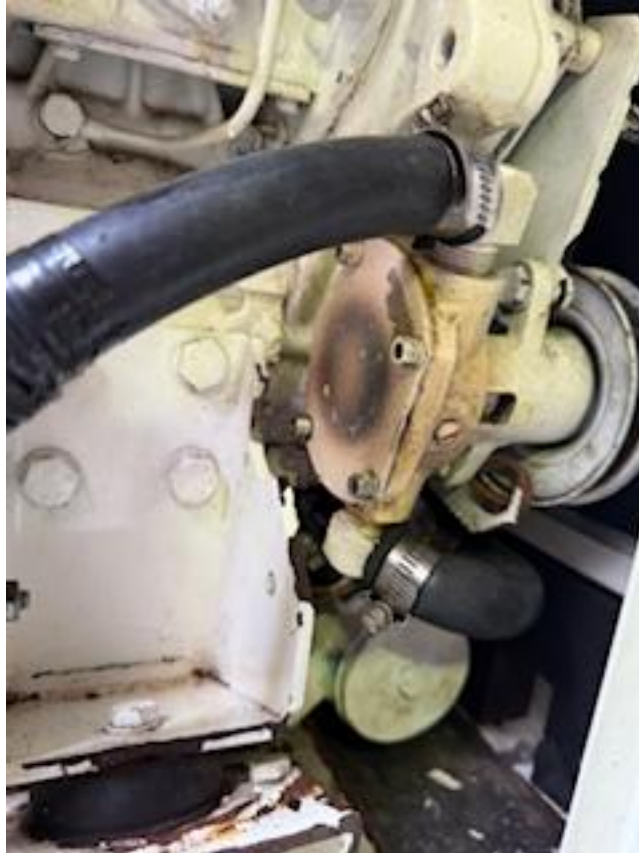
The generator sea water pump was overheated at some point. There was no overheating issue at the time of the sea trial.

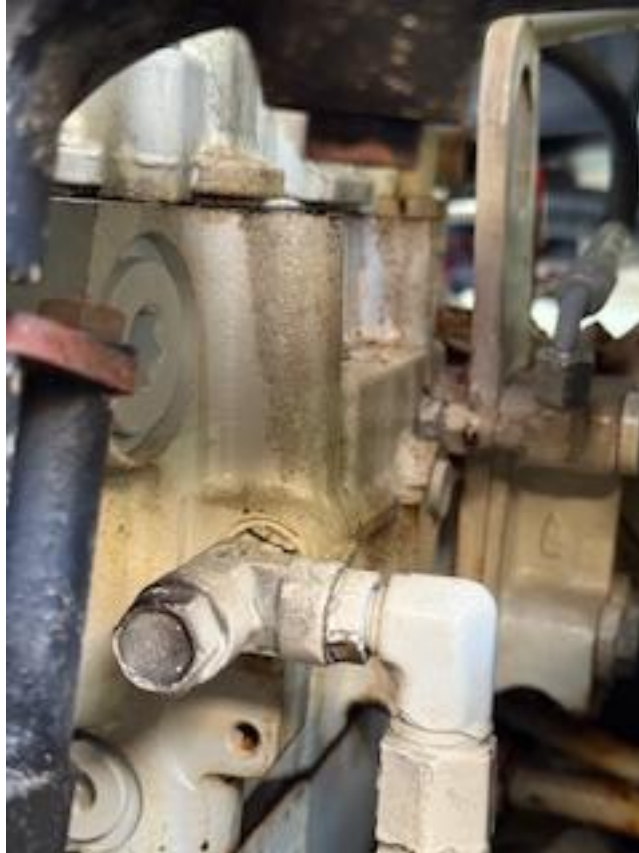
There is a small oil leak coming from the starboard engines' lower valve cover gasket.

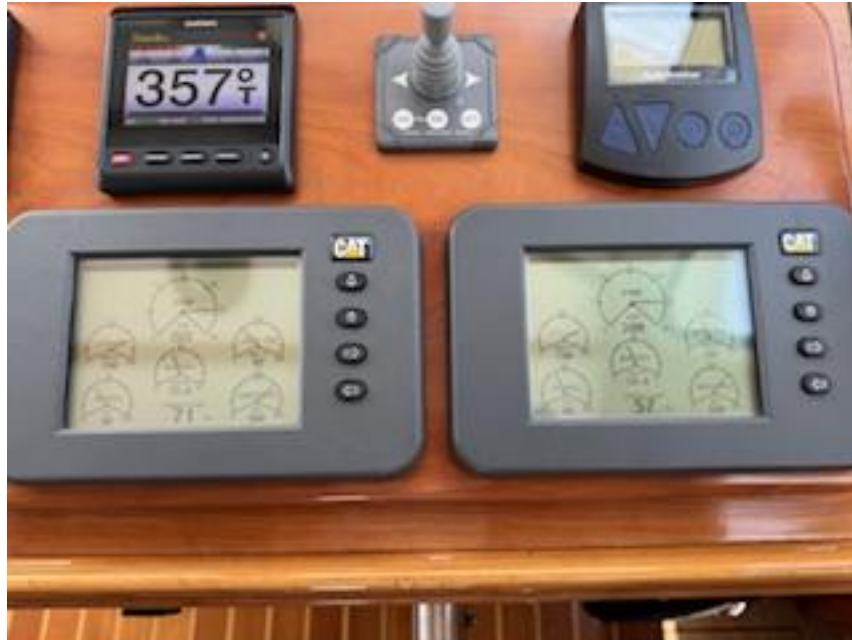
While out on sea trial I found that the starboard engine runs at about 14% less engine load than the port engine. This issue could be related to the props being mismatched. This difference stays through out the throttle range under load from idle to wide open throttle. At full load the port engine is running 98% engine load and the starboard engine is running at 84% engine load.
