**PATTON MARINE SURVEYORS
AND CONSULTANTS, INC.**
P.O. Box 331884
Miami, FL 33233-1884, USA

March 2, 2025
File No.:13756-25
Page 1 of 50

RE: "IONIAN PRINCESS" 2005 150' Christiansen Hull No. 018

**A Patton Marine Survey
on the Yacht "IONIAN PRINCESS"**

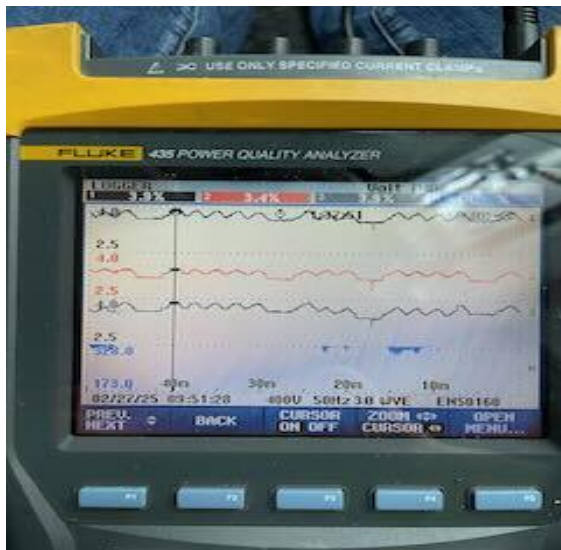
Graph below shows the THD at good at 3.9%.

The majority of harmonic distortion is caused by onboard non-linear loads including frequency drives. The THD was captured at 3.9 %, which is below the acceptable level of 8%, and in addition 3rd, 5th and 7th individual harmonics was all below the acceptable level of 3%. It is this surveyor's opinion that no action is required at this time.

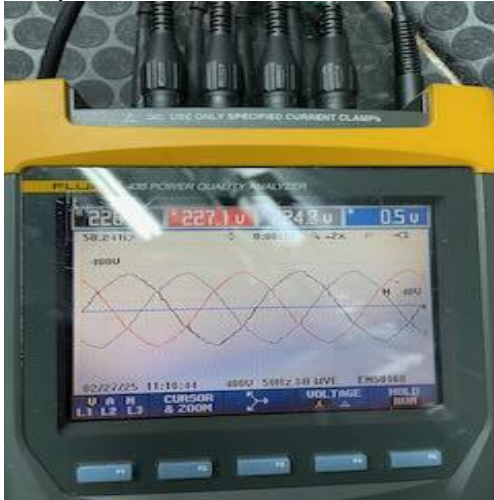
Graph below shows the clean voltage wave form.

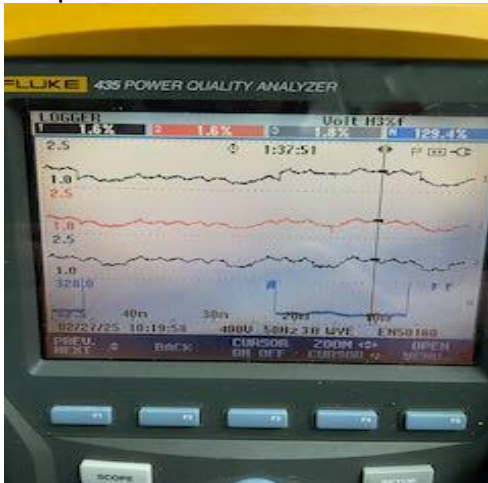
Graph below shows the 3rd harmonic (150Hz) at 1.6%

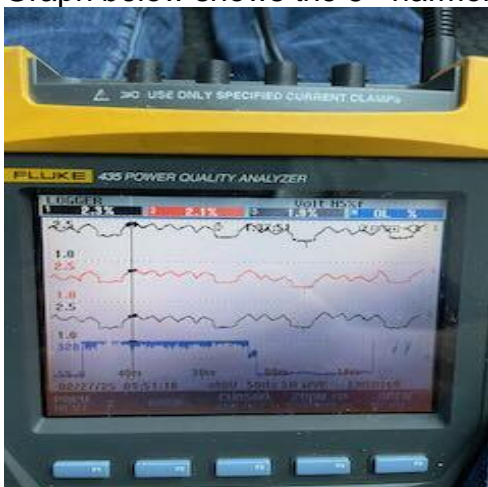
Graph below shows the 5th harmonic (250Hz) at 2.3%

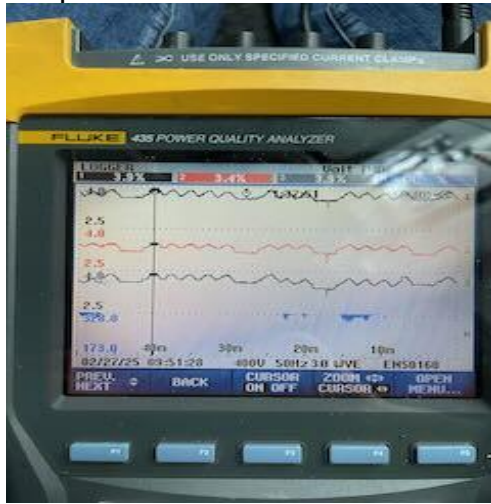
Graph below shows the 7th harmonic (350Hz) at 1.3%

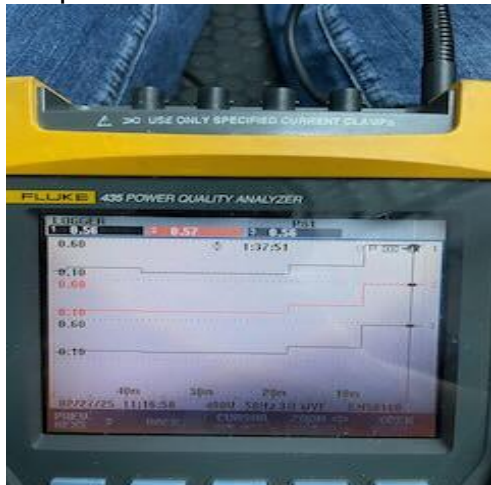
Graph below shows PST at 0.56

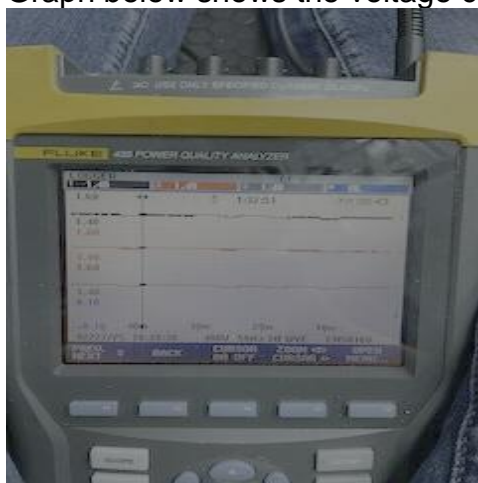
Graph below shows the voltage crest factor at 1.48
