**PATTON MARINE SURVEYORS  
and CONSULTANTS, INC.**  
P.O. Box 331884  
Miami, FL 33233-1884, USA

**December 14, 2024**  
**File No.: 13717-24**  
**Page 1 of 57**

**RE: "SAPPHIRE", 2009,  
50.44 Meter TRINITY Motor Yacht**

Date of Inspection: December 9,10,11,12,13, 2024  
Scope of Inspections: Pre-purchase

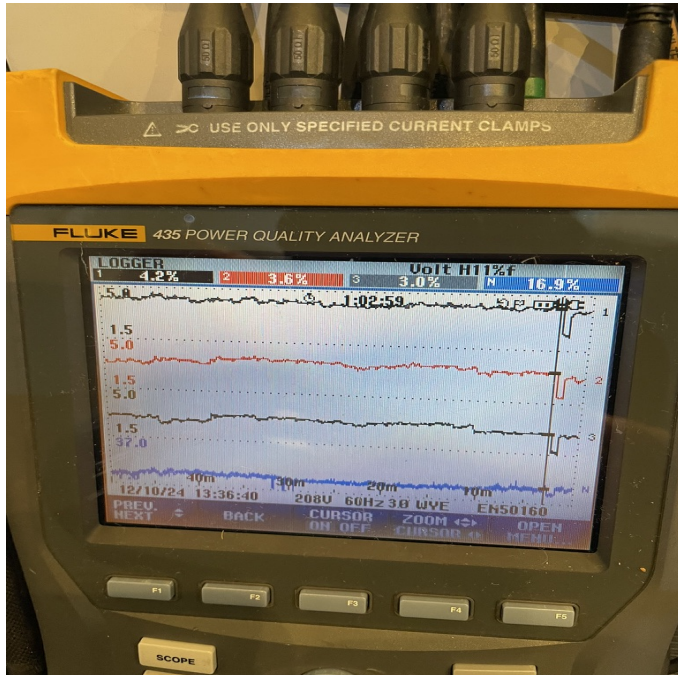
Graph below shows the 11<sup>th</sup> harmonic (660Hz) over 3% to 4.2%

The majority of harmonic distortion is caused by onboard non-linear loads including frequency drives, the THD was captured at 8.1%, which just above the classifications acceptable level of 8%, and in addition the 5th and 11<sup>th</sup> individual harmonics above the acceptable level of 3%.

It is suggested the majority of the vessels harmonic distortion is coming from the Air conditioning compressors frequency drives and the engine room fan frequency drives.
