**PATTON MARINE SURVEYORS
and CONSULTANTS, INC.**
P.O. Box 331884
Miami, FL 33233-1884, USA

December 14, 2024
File No.: 13717-24
Page 1 of 58

**RE: "SAPPHIRE", 2009,
50.44 Meter TRINITY Motor Yacht**

Date of Inspection: December 9,10,11,12,13, 2024
Scope of Inspections: Pre-purchase

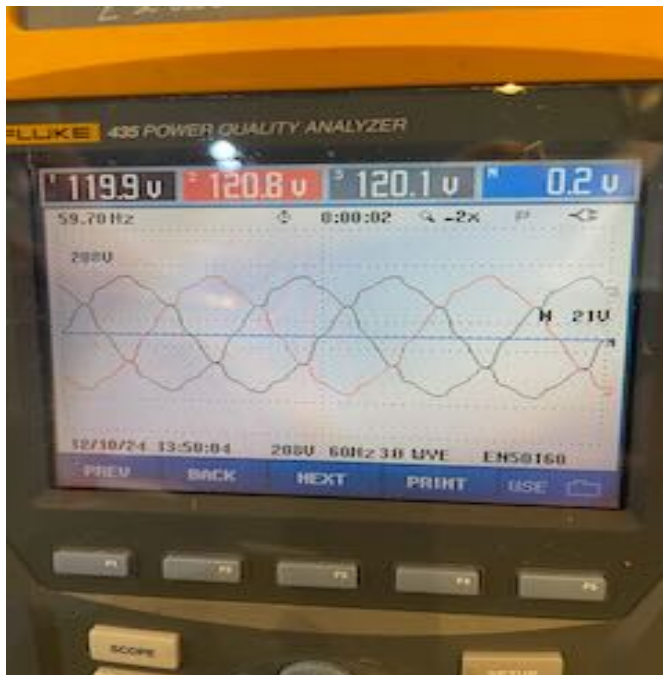
Graph below shows the complex voltage waveform.

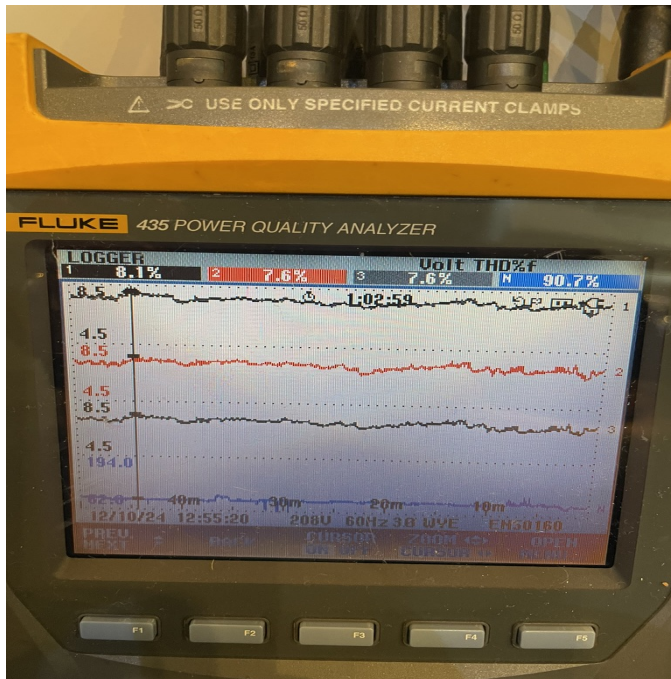
Graph below shows the THD at 8.1%

The majority of harmonic distortion is caused by onboard non-linear loads including frequency drives, the THD was captured at 8.1%, which just above the classifications acceptable level of 8%, and in addition the 5th and 11th individual harmonics above the acceptable level of 3%.

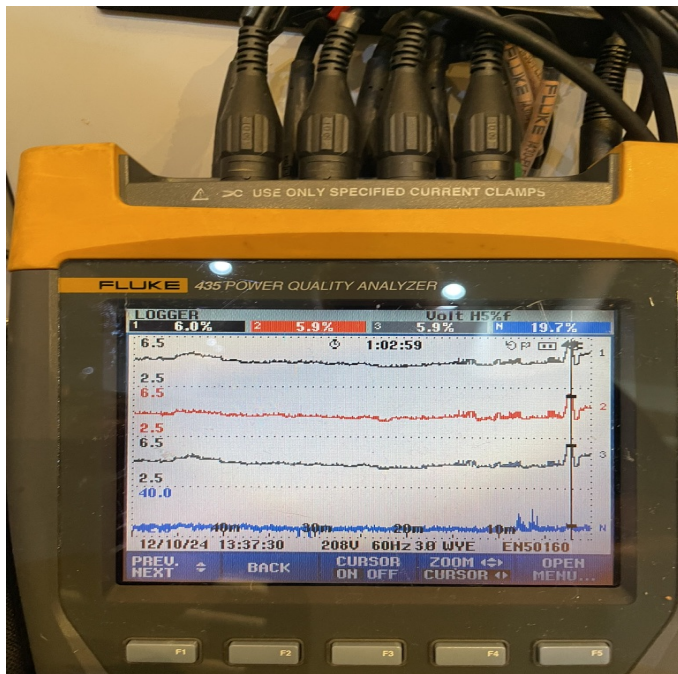
Graph below shows the 5th harmonic (300Hz) over 3.0 % to 6.0%

It is suggested the majority of the vessels harmonic distortion is coming from the Air conditioning compressors frequency drives and the engine room fan frequency drives.

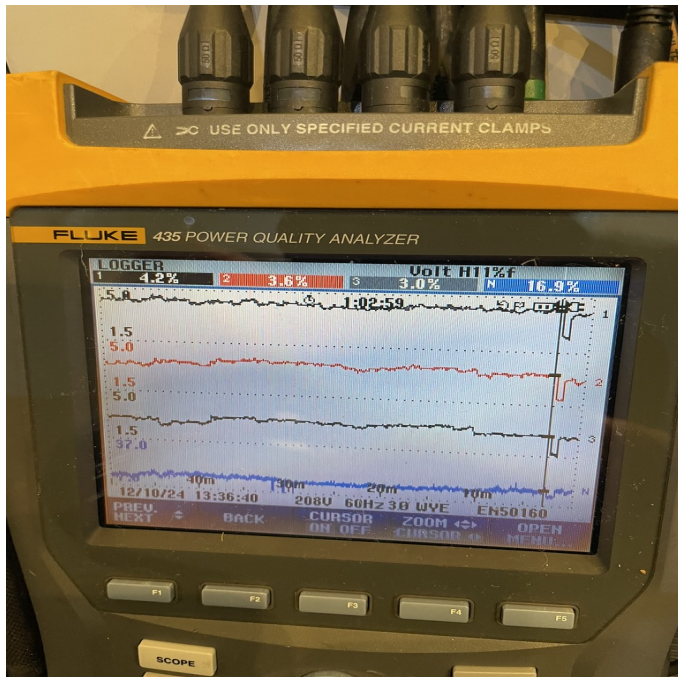
Graph below shows the 11th harmonic (660Hz) over 3% to 4.2%

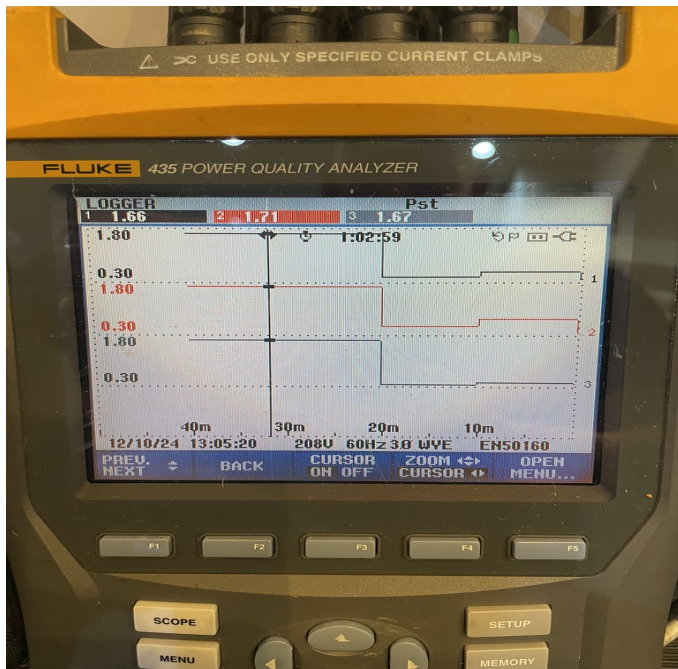
Graph below shows the PST (Perspective Short Term) up at 1.50
