**PATTON MARINE INC.**  
**SURVEYORS And CONSULTANTS**  
P.O. Box 331884  
Miami, FL 33233-1884, USA

**May 30, 2026**  
**File No.: 13984-26**  
**Page 1 of 36**

**RE: "ELYSIAN", 2004,  
130' Westport Motor Yacht**

**RECOMMENDATIONS**

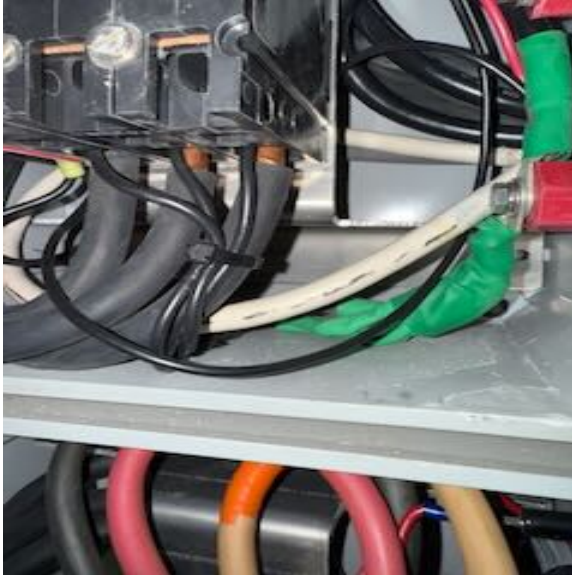
6. The shore power 480 volt supply protection breakers three phase output connections are connected directly to the galvanic isolators earth connection stud within the breaker enclosure. It is unclear if this arrangement is a home made type of surge arrestor. Further review this arrangement and provide electrical drawings supporting this connection. Anticipate removal of these connections.

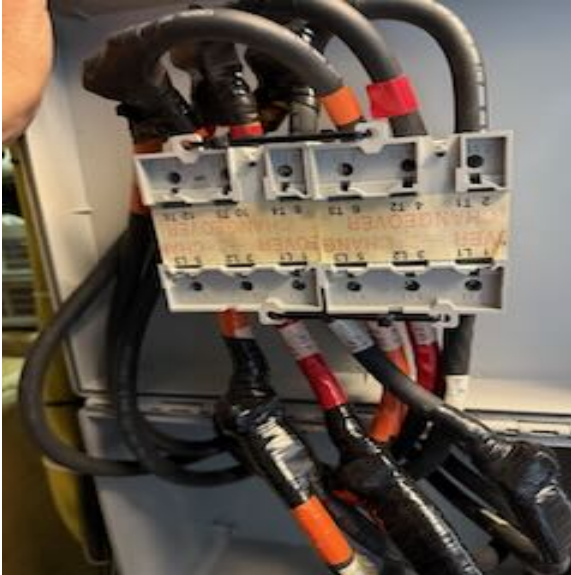
11. The shore power input selector switch is located starboard aft machinery space; the switch connections are connected using nuts and bolts then wrapped with electrical tape which is not rated for the expected current. Re-connect these connections to approved marine grade connectors.

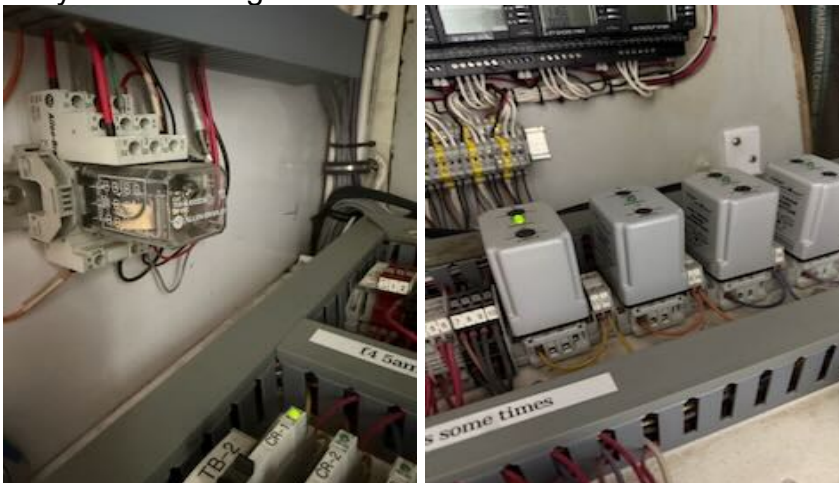
7. An unidentified Allen Bradley relay and Tmax timer relays mounted in the inboard section of the main switchboard is not fitted with a relay retaining clips. Identify this relay and install a relay retaining clips to all relays to aid in preventing the relay from working lose.

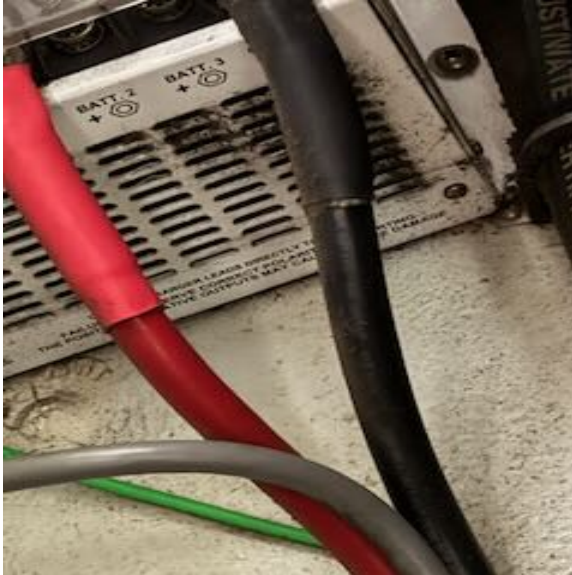
8. The lower inboard section of the main switchboard house the battery chargers, the section door houses cooling fans that are not filtered, contaminants are being drawn into the battery chargers. Service all battery chargers, clean this panel section and ad filter to the cooling fans.

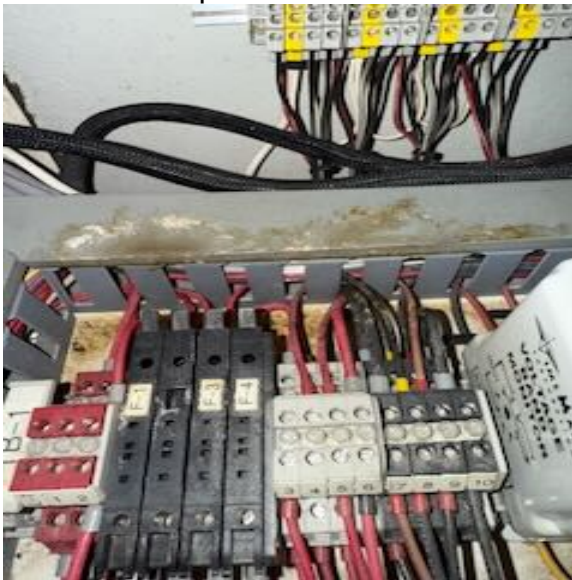
9. ★Air conditioning chilled water is leaking on to electrical components in the main switchboard inboard section. Trace and remove this leak, replace any damaged electrical components.

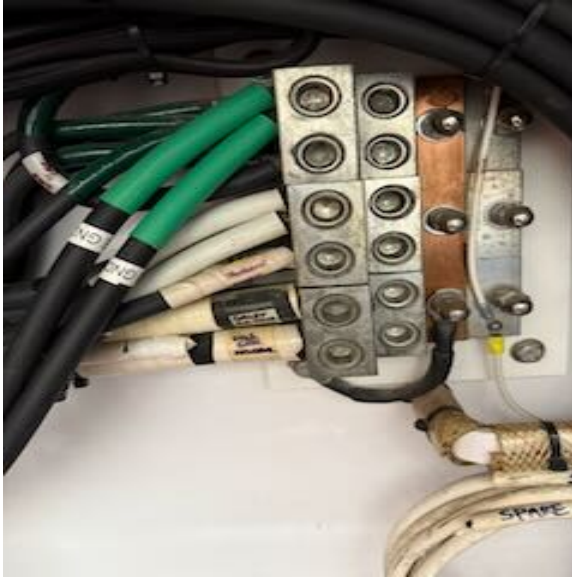
12. The main switchboard is not able to be fitted with ground fault monitoring, as the neutral and ground busses are connected together, the system is designed as a TN-S grounded system means the neutral and grounds are separated with only a single neutral to ground link, this link is using for ground fault monitoring. Re-configure the connection method to a TN-S grounded system by separating the neutral and ground busses.

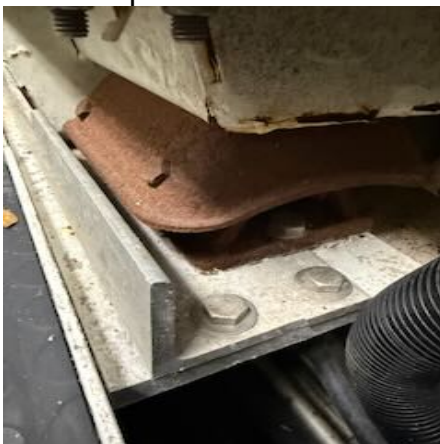
1. The generators vibration mounts are contaminated. Anticipate generator vibration mount replacements.

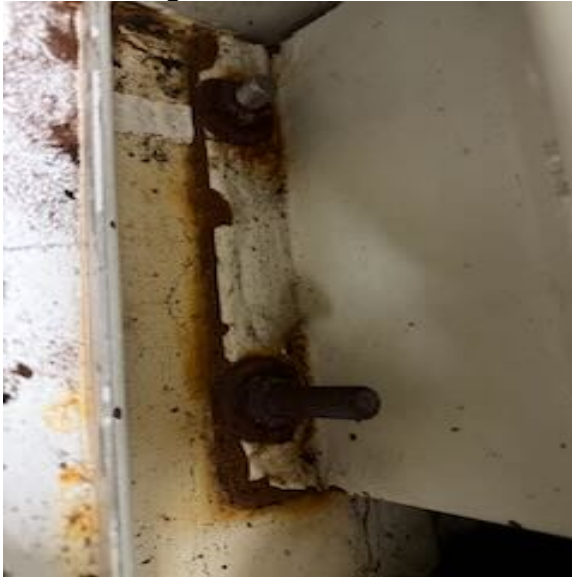
2. The port generators electrical end securing hardware is contaminated. Replace this securing hardware.

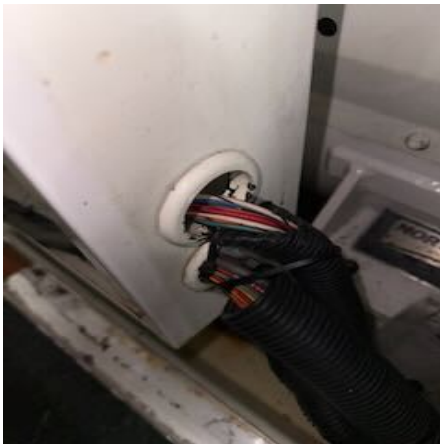
3. The generators sea water supply hoses are single hose clamped. Install back-up hose clamps.
4. The generators sender and control conductors are sleeved with black split flexible conduit; this conduit was found to be flame supporting. Re-place this flexible conduit with self-extinguishing type.
5. The generators starter and slave solenoid energized connection are exposed. Provide connection protection covers as used on the main engines.
6. Both generators drip trays contain oily water. Trace source of water and oil and seal.
7. Control and sender conductors are pulled from the port generators local connection. Panel within the sound shield. Re-secure these conductors.

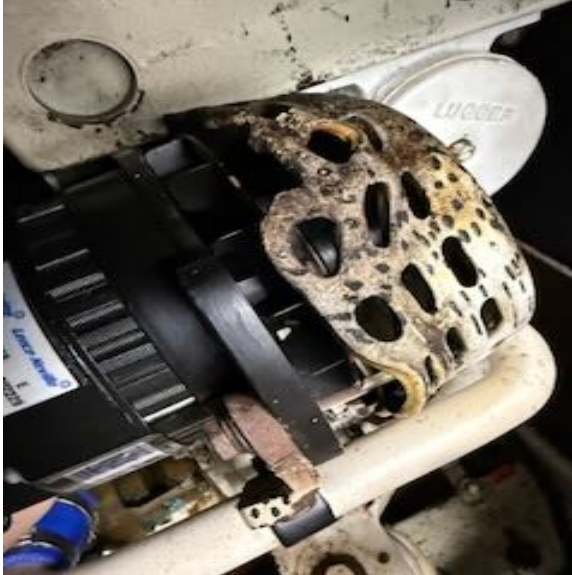
8. The port generators charge alternators protection cover is damaged by a previous charge alternator fire. Replace this protection cover.

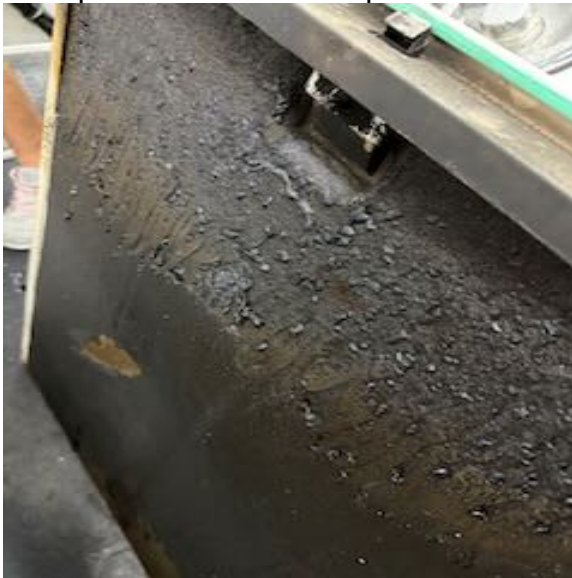
9. The port and starboard generators sound shields are both in poor condition, in addition the port generators sound shield insulation has been damaged by a previous charge alternator fire. Re-condition both generators sound shields, anticipate sound shield replacement.

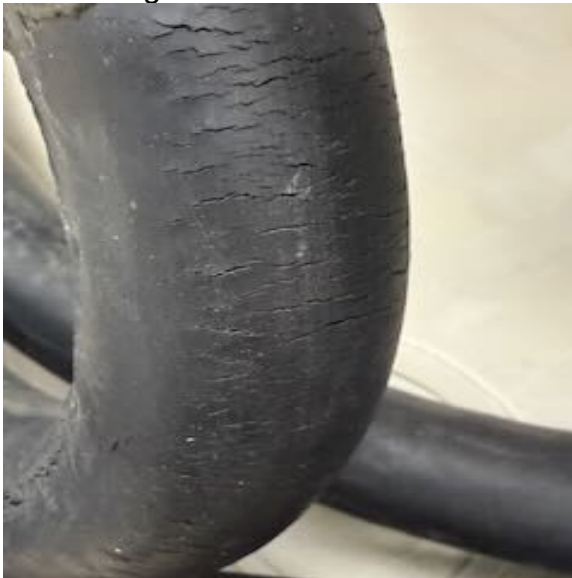
10. The port generators output protection breaker is mounted above the sound shield, the bend radius for the L-1 power cable is too tight, the heat generated by this has caused the cables outer jacket to crack. Replace this cable and install conforming to cable bend radius minimums.

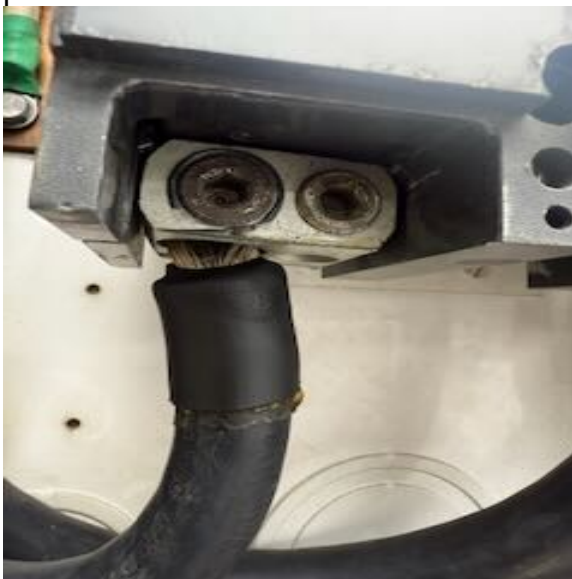
11. The generators output protection breakers cable connections are not connected using pins of ferules, and in addition the connections are exposed. Re-connect these cables using pins, ferules or similar and provide suitable connection protection covers.

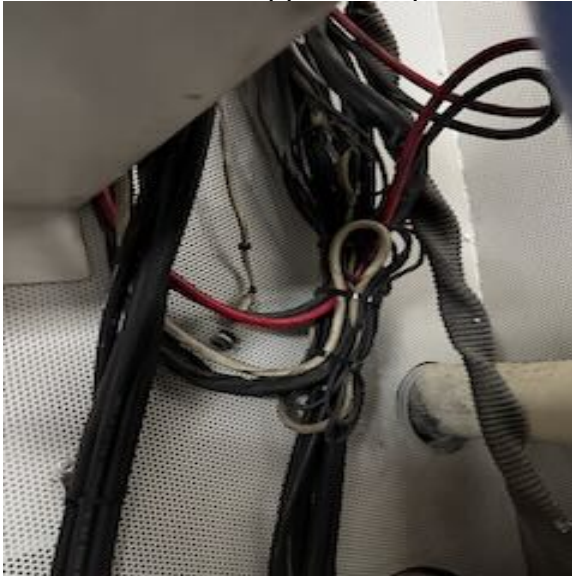
1. Cables associated with the Besenzoni Passerelle hydraulic power pack located port aft engine room are not secured or protected and are secure to hydraulic lines. Re-wire this hydraulic power packs cabling in its entirety and provide additional cable support and protection.

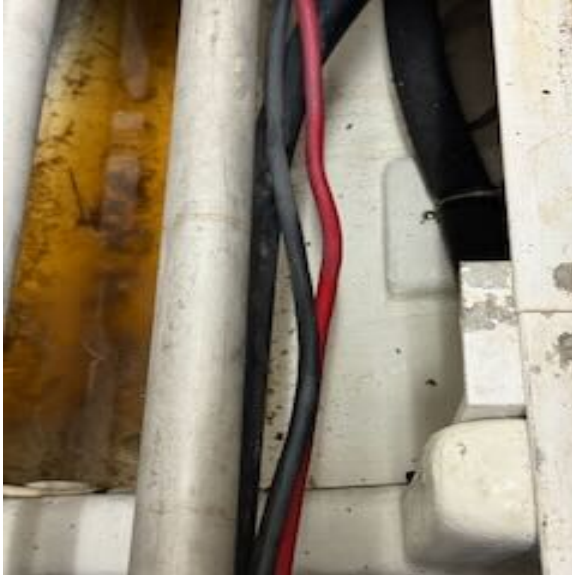
2. VDC cables are run under the port side engine room deck plates without support and protection. Provide cable support and protection.

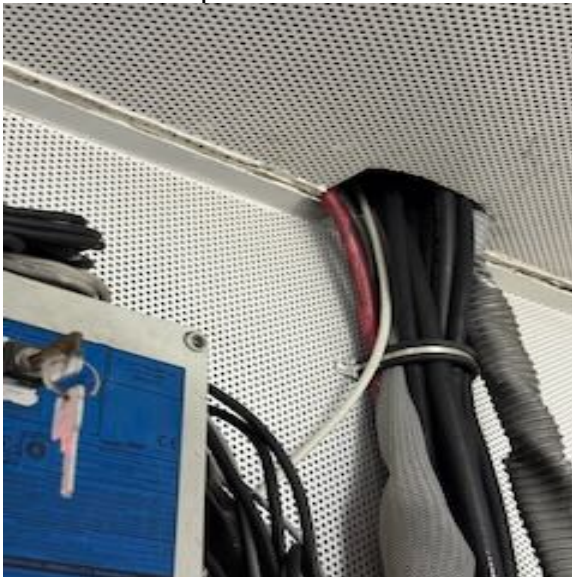
3. Cables have been run through the engine room perforated overhead sheeting without chafe protection. Install cable chafe protection.

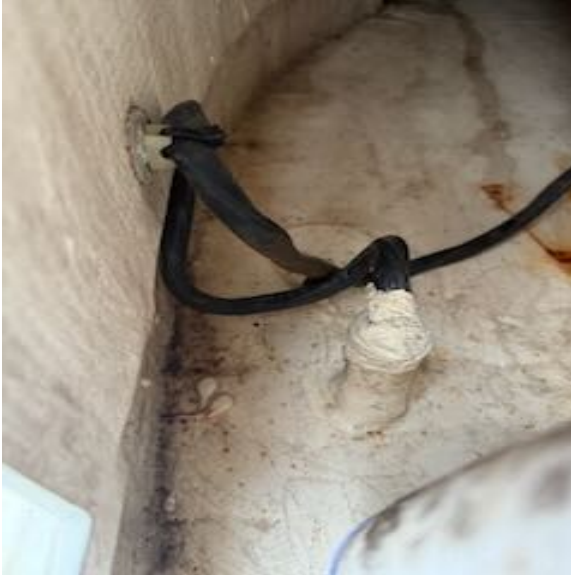
4. The supply cable to the hot tub is not conforming to cable bend radius minimums. Relieve this cables bend radius.

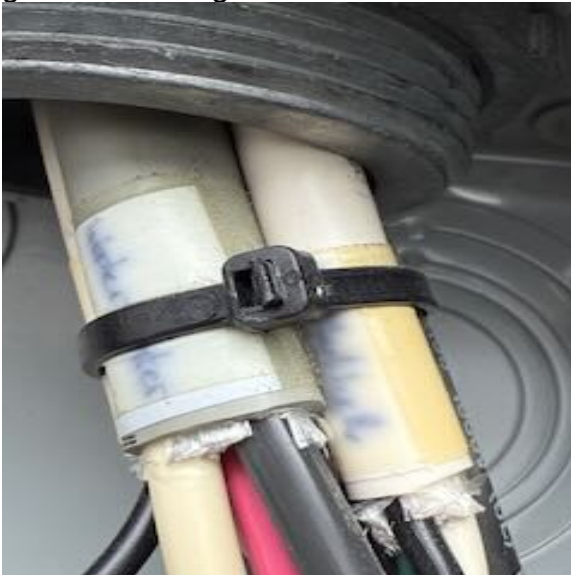
5. The machinery space and galley distribution panels consumer cables are run through cable glands; the glands are not fitted with chafe rings. Install cable gland chafe rings.

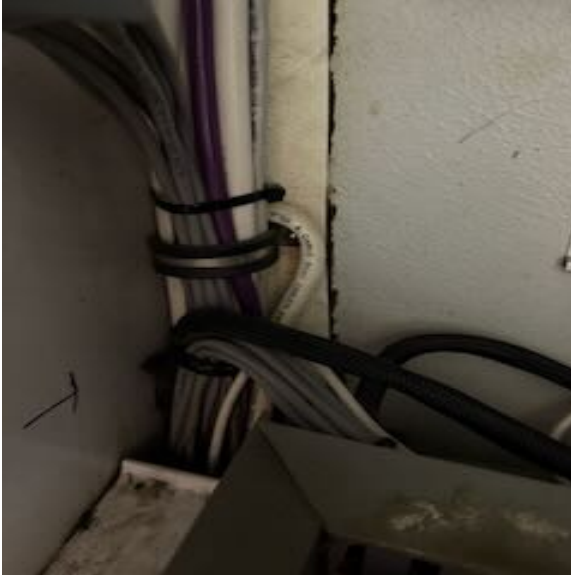
7. An unidentified boat cable is located in the inboard section of the main switchboard the cables bend radius is too tight. Relieve these cables bend radius.

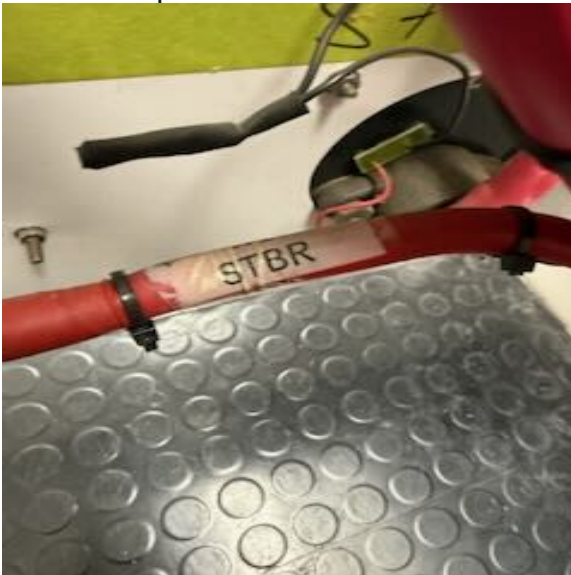
8. Cable to the newly installed main switchboard capstan protection breaker has been line splice the nut and bolt and electrical tape. Replace this cable.

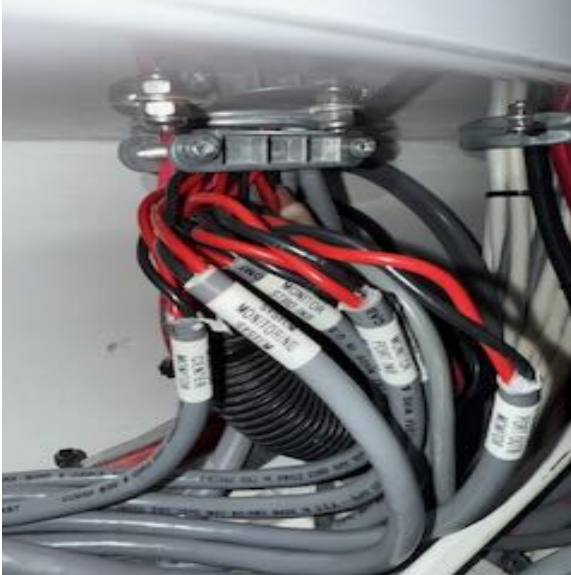
11. The cable run from under the wheelhouse console into the interior is not sealed. Seal this cable gland.
12. Multiple cables are stripped back too far exposing the current carrying conductors at the wheelhouse console 12 /24 VDC main connection enclosure. Re-connect these conductors ensuring the exposed conductors are within the enclosure.

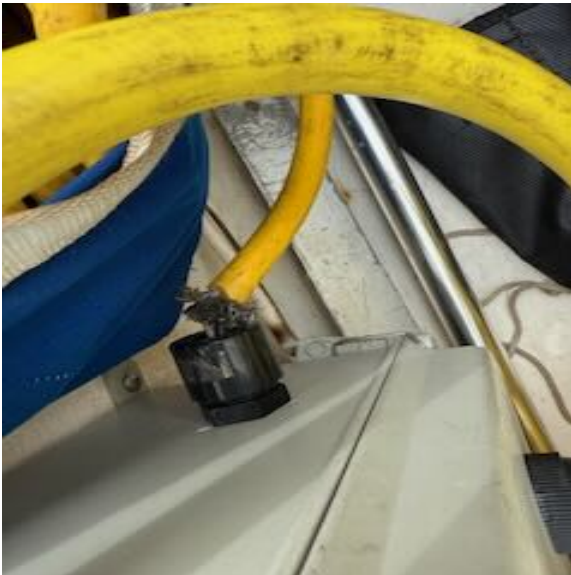
13. The windlass control cables are pulling from the connection enclosure. Re-secure these cables.

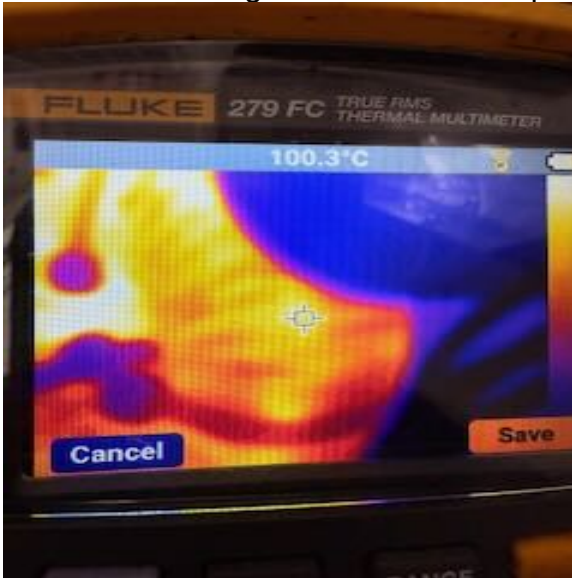
9. ★ The aft deck low voltage transformers running temperature was captured at 100.3 °C / 212°F, these transformers are used throughout the vessel and appear to be from the original installation. Replace all of these type transformers.

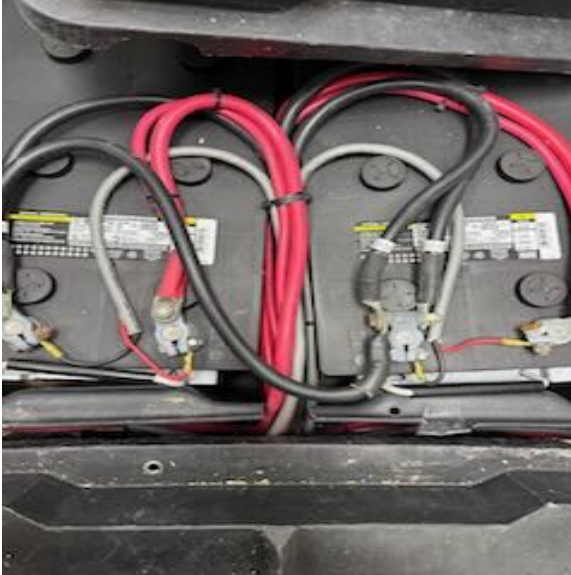
7. The generator starting banks are 12 VDC, the banks are permanently connected in parallel with the house 12 VDC bank using a bank connection cable, this is not an acceptable practice. Isolate the generator starting banks from the house bank.
8. ★Unidentified 10 awg cables are connected to each of the generators starting banks and are not over current protected. Identify these circuits and provide over current protection as close to the battery connection posts as practical.

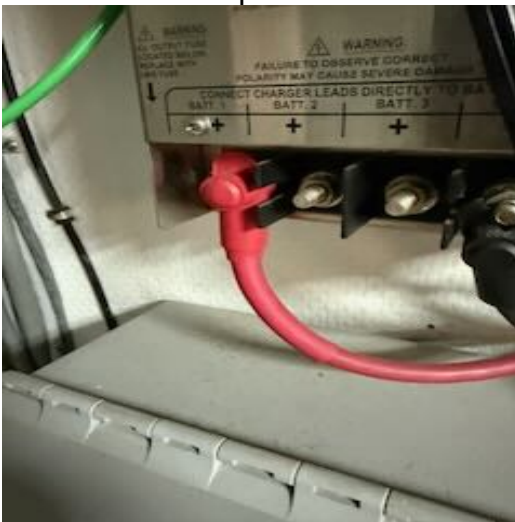
9. The GMDSS battery chargers permanently energized connections are exposed. Provide suitable protection cover.

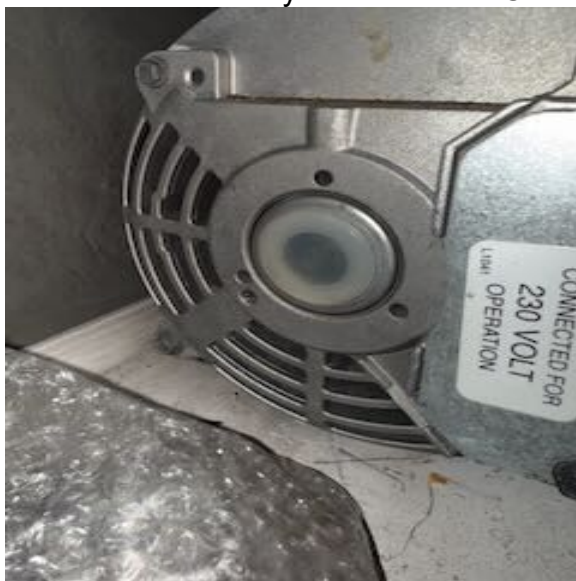
2. ★The air conditioning chilled water pump motor and the sea water pump #2 are open wound type not suitable for machinery space use. Replace these pump motors with a Totally Enclosed fan Cooled (TEFC) type.

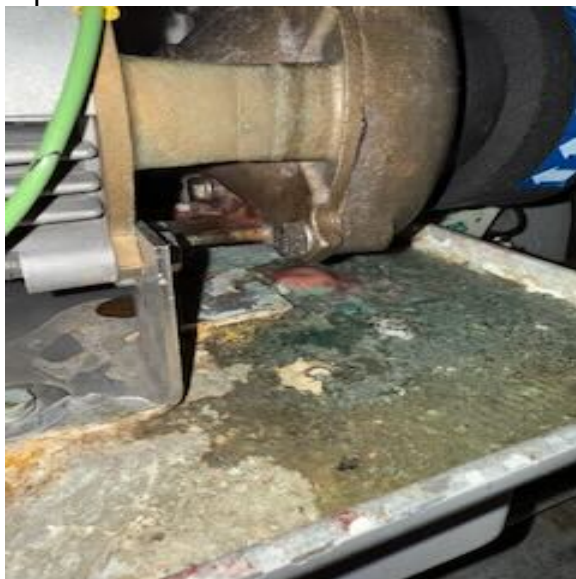
3. The air conditioning chilled water pump is leaking. Service this pump, anticipate replacement.

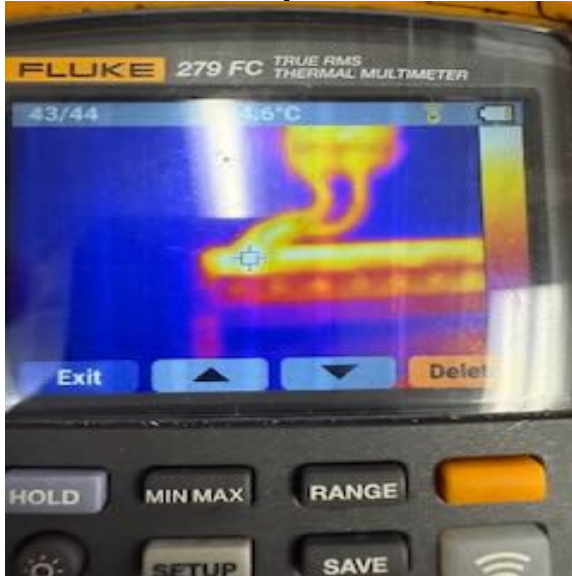
5. The air conditioning chilled water pump associated 20 amp protection breakers running temperature was captured at 44.6°C / 112.°F. Further review this condition, verify the connections are clean and tight and that the cable and breaker are correctly sized for the loads expected.

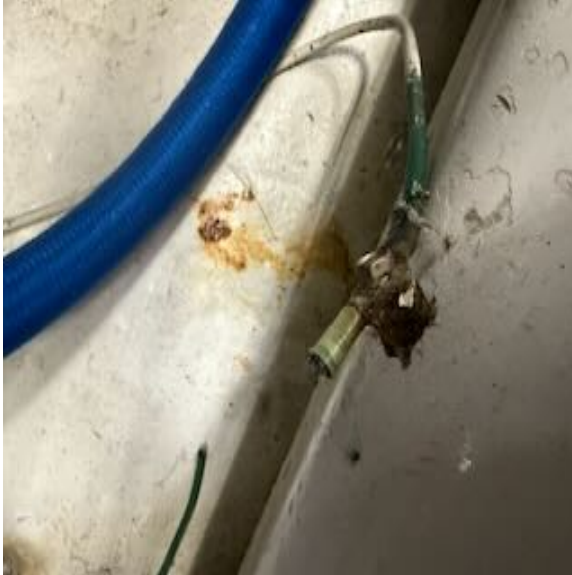
5. An unidentified ground / bonding conductor is disconnected and free swinging under the starboard main engine. Identify this conductor is re-connect.

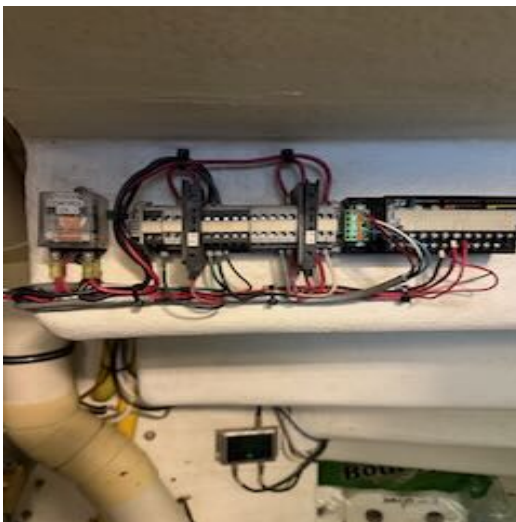
1. The engine and generators fuel filters are not fitted with catch bowls. Install fuel spill catch bowls.
2. The starboard main engine exhaust associated control relay and terminal block connection located just inboard of the shore power Glendenning cable reel are exposed. Re-connect these electrical components within a marine approved connection box.

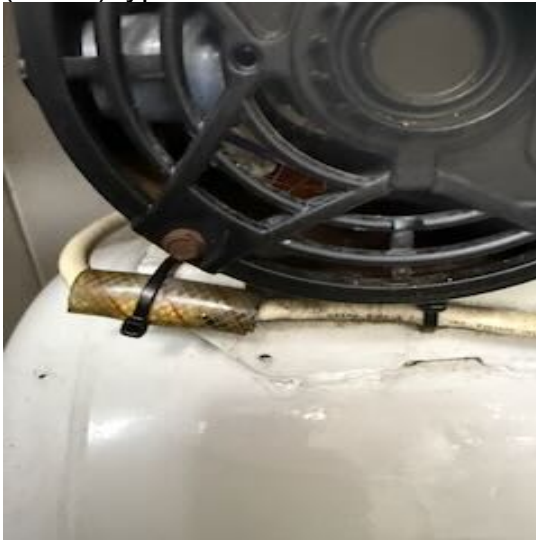
3. The Electrosea associated 120-24 volt power supply located starboard aft machinery space has the permanently energized connections exposed. Provide a suitable connection protection cover.
4. ★The aft machinery space and boat deck 120 volt receptacles are not ground fault protected. Ensure all receptacles located in machinery spaces, laundries, galleys, heads, weather decks and any areas subject to water intrusion are ground fault protected.
6. ★The engine room air compressor motor is open wound type not suitable for machinery space use. Replace this motor with a Totally Enclosed fan Cooled (TEFC) type.

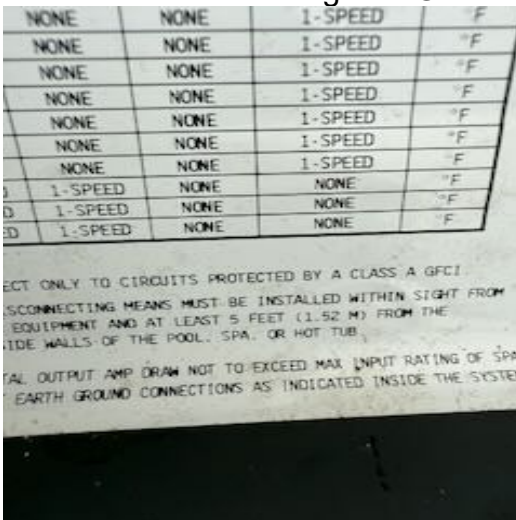
5. ★The Balboa hot tub is not ground fault protected as required and as noted on the unit connection diagram. Ground fault this hot tub.
