**PATTON MARINE SURVEYORS  
And CONSULTANTS, INC.**

**January 26, 2026**  
**File No.: 13920-26**  
**Page 1 of 34**

**RE: "ESCAPE of LONDON", 1997,  
36.46 Meter TRIDENT Motor Yacht**

**RECOMMENDATIONS**

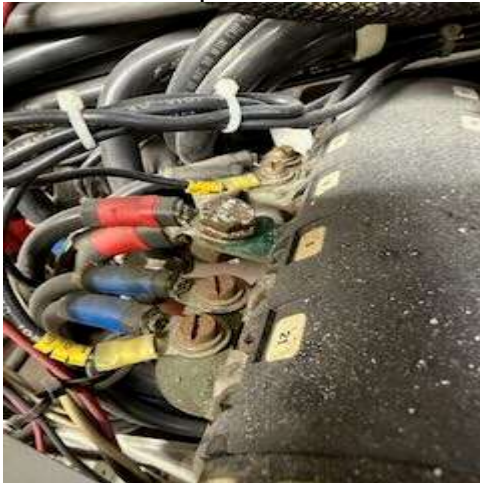
1. All main switchboard terminations and connections should be checked for torque, support, and chafe protection. Recommend this procedure be performed annually within the main switchboard and all distribution boards to eliminate excessive heat caused by loose connections.
2. ★Evidence of water intrusion was observed in the main switchboard, reportedly originating from the above overhead perforated sheeting. Water damage is visible on the load center selector switch connections, resulting in corrosion at these points. Additionally, water stains are present on the interior surfaces of the switchboard doors. Trace source of water intrusion and replace all water damaged electrical components.

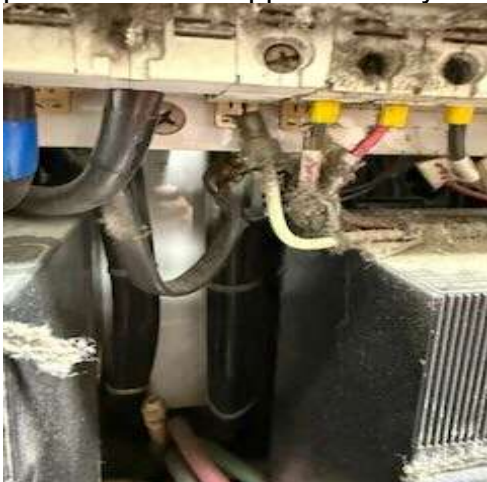
3. ★The main switchboard internal condition is considered poor, heavy dust accumulation can be readily seen, metallic particles in collected dust can become conductive and carry unwanted currents. and the internal wiring lacks chafe protection and support. Rectify these conditions.

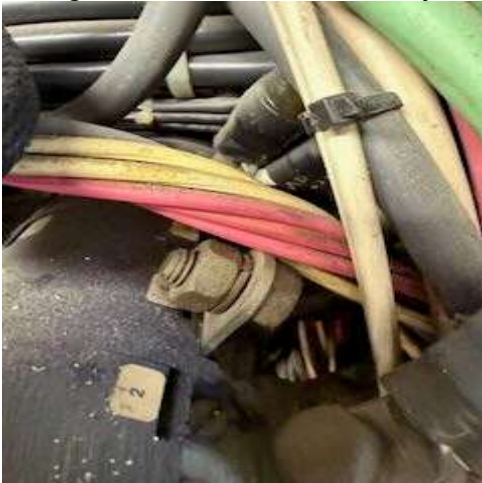
4. ★Most of the main switchboard Merlin Gerin multi 9 series consumer breakers are not properly secured to their respective DIN rails due to failed securing clips, which is a frequent issue with breakers of this age. Replace all breakers securing clips, anticipate breaker replacements.
5. ★The main switchboard internal condition is considered poor, the internal wiring lacks chafe protection and support, conductors are resting on permanently energized connections. Rectify these conditions.

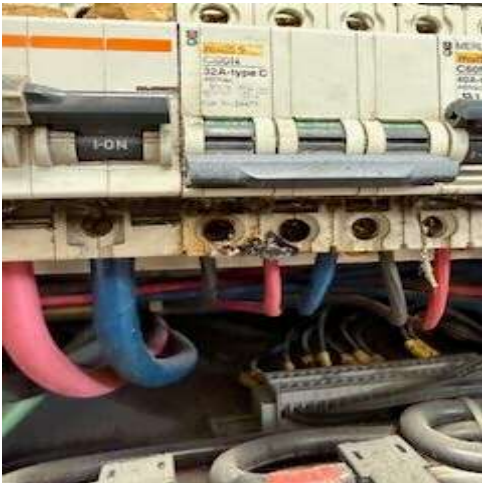
6. ★The 32 amp three phase protection breaker for the starboard aft warping capstan has overheated. Further review cause of the overheating, ensure the breaker and associated conductors are correctly sized for the loads expected.

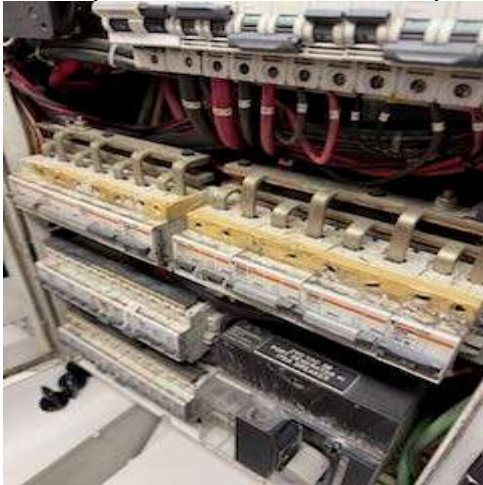
7. ★ Permanently energized buss bars and connections within the main switchboard are exposed. Provide suitable protection covers.

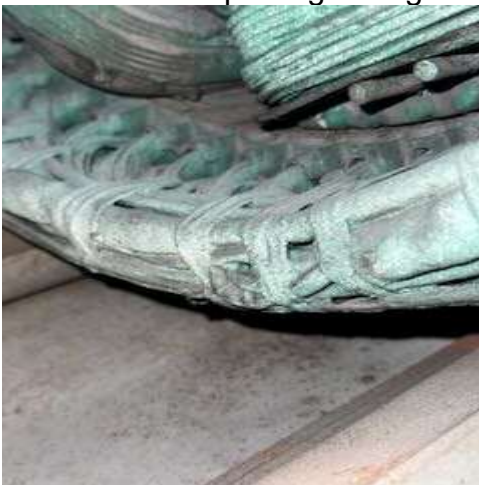
1. The generators sea water supply hoses are single hose clamped. Install back-up hose clamps.
2. ★No neutral conductor is provided by the generators for 120-volt consumers. The vessel's ground must not be used as a neutral, as the neutral is intended to carry current back to the source and complete the circuit. Using the ground as a neutral allows the ground conductor to carry current, creating a significant shock hazard. Conduct a thorough review of this arrangement and make any necessary corrections.
3. Both generators have exceeded 12,000 operating hours. Inspection of the electrical system reveals that the rotating rectifier diodes are contaminated and the stator plates show significant corrosion. Additionally, both the front and rear bearings require replacement. Based on the cost-benefit analysis, this surveyor recommends replacing both generator electrical ends.

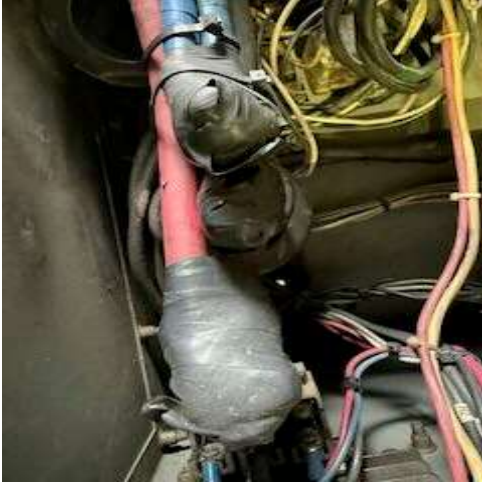
- Both generator electrical ends were reviewed, the phase connections are connected using nuts and bolts then wrapped with electrical tape which is not rated for the expected currents. Re-connect both generators phase connections to purpose made connection blocks.

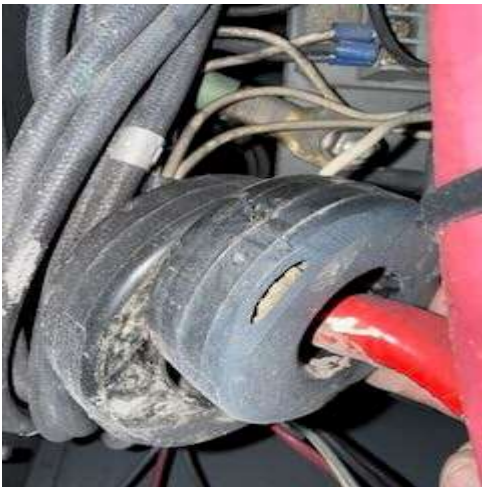
- The current transformers in both generator electrical ends are unsecured and wearing on the end casings; one in the port generator has worn through to the windings, creating a hazardous condition. Replace damaged current transformers and ensure all are secured.

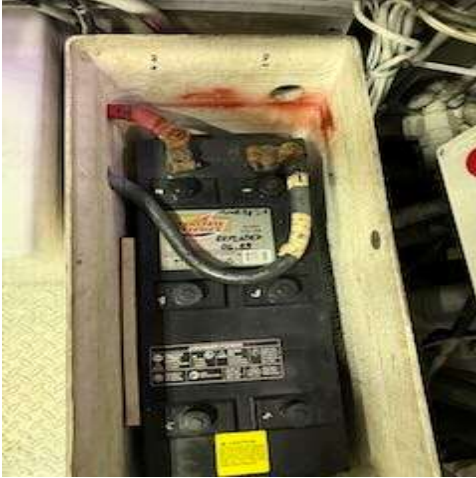
4. The starting battery banks permanently energized connection posts are exposed; no protection boots have been provided. Install battery post protection covers.
5. ★The starboard starting bank outer most battery is of a different manufacture to the rest of the bank, this battery appears to have been gassing, electrolyte can be readily seen on top of the battery. Further review this condition and rectify.

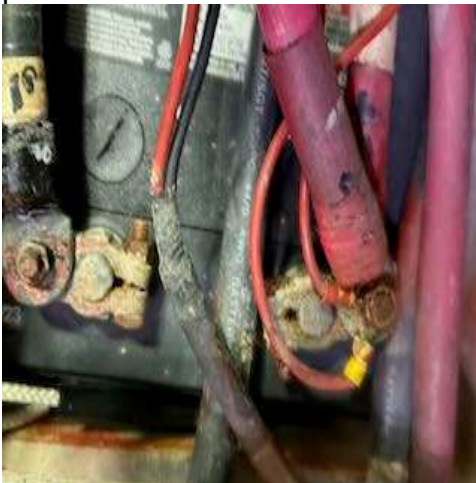
6. Multiple starting bank battery posts are contaminated. Chemically clean all battery post connections.

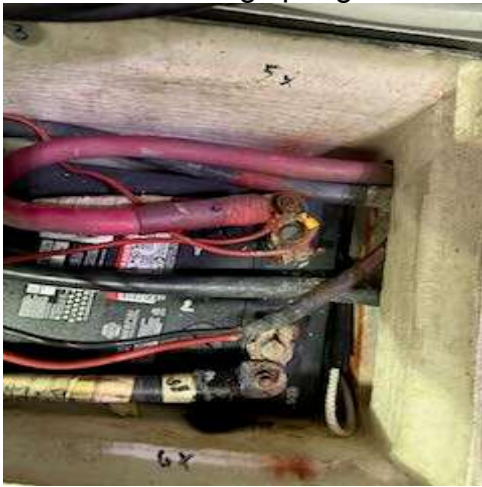
7. Multiple starting bank battery posts are not secured using lock or spring washers to aid in preventing the connections from working loose. Ensure all battery posts are secured using spring or lock washers.

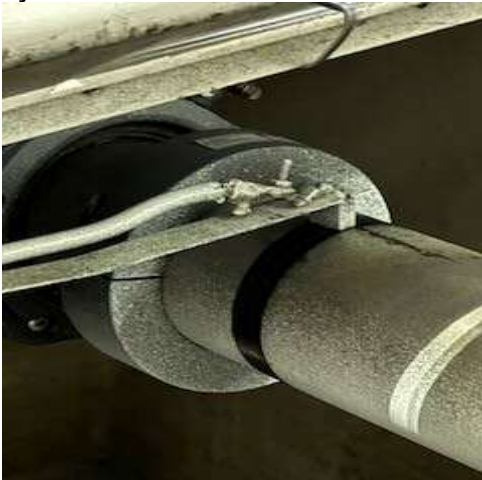
2. The vessels cable trays are not grounded. Ground all cable trays including lone sections.
3. The control room motor control center (MCC) cabinet doors are not grounded. Ground these doors.
4. No ground conductor was sighted for both of the gear boxes. Ground both gear boxes.
5. Both propeller shafts are fitted with homemade type grounding brush gear, resistance from the port shaft to ground was captured at 2.9  $\Omega$  Ohms and the starboard at 3.1 $\Omega$  Ohms. Clean both brushes to ensure resistance of less than 1.0  $\Omega$  Ohms, suggestion is made to replace with a purpose made propeller grounding system.

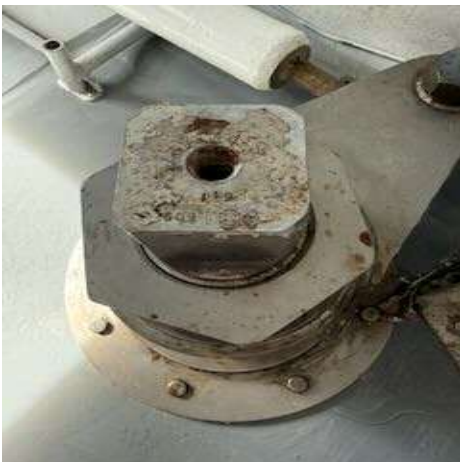
6. The port and starboard rudder housings are grounded; the rudder stocks are not. Ground both rudder stocks, suggestion is to use the stock lifting eye female threaded shaft.

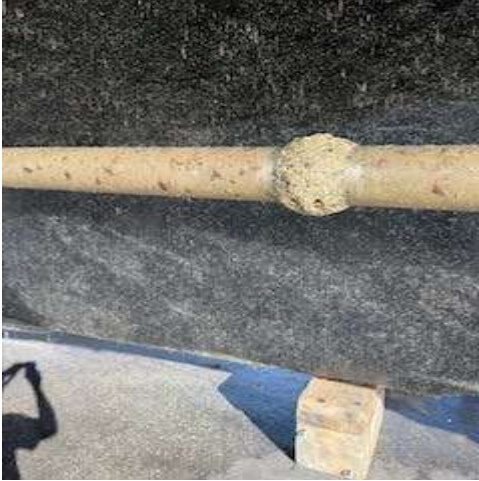
7. The hull mounted ground dyna plates ad lightning plate are contaminated. Wire brush these plates.
8. The majority of the hull mounted sacrificial zinc are passivated which occurs when the anode becomes coated with a barrier of oxide or corrosion that prevents it from working. Wire brush all zincs.

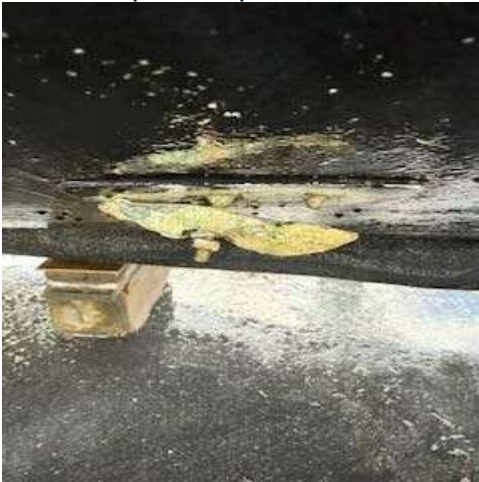
9. Multiple underwater zincs are either missing or have reached the end of there usable life; it was noted that many were replaced during haul out but many were not. Complete replacement of hull mounted sacrificial zincs.

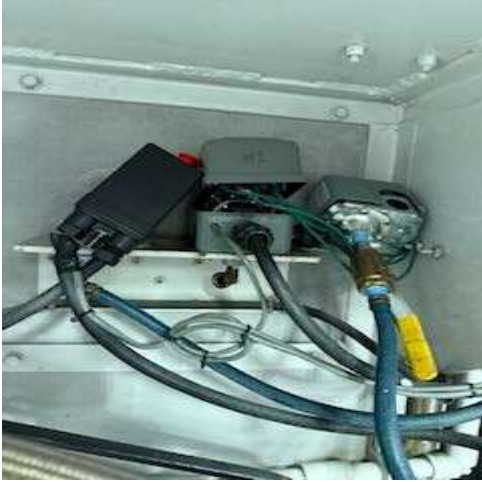
2. The generator fuel filters are not fitted with catch bowls. Provide fuel catch bowls.
3. ★The engine room air compressors electrical housings are not secured and are exposing energized connections. Rectify these conditions.

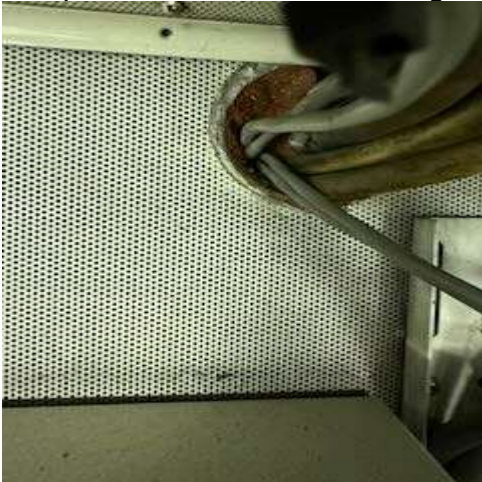
4. No compressor drive belt covers have been fitted to the engine room air compressors. Install drive belt covers.
5. The cable gland port forward engine room running into the control room has been compromised. Seal this cable gland.

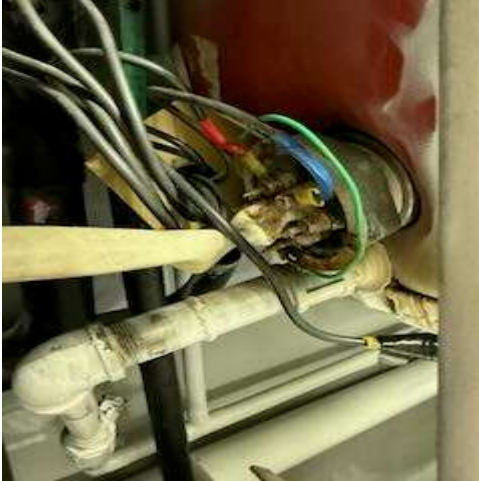
6. ★The port engine room water heater element connection cover is adrift exposing energized connections. Rectify this condition.

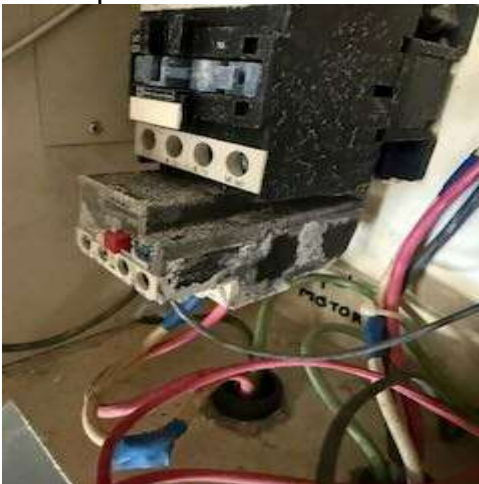
8. ★The port aft capstan contactor enclosure mounted overload relay is covered in salt deposits. Further review this condition and rectify.

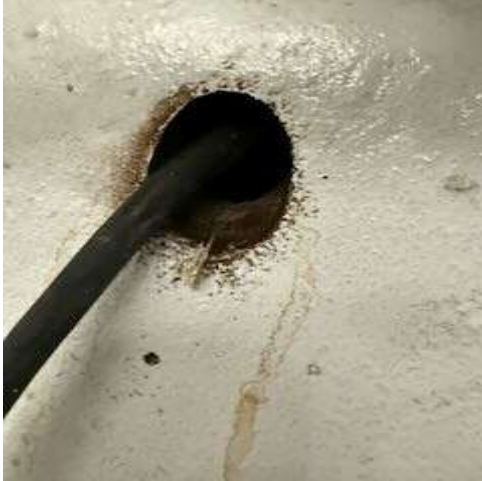
9. Evidence of water leaking can be readily seen at the port and starboard capstan foot switch cable deck penetrations. Rectify these conditions.

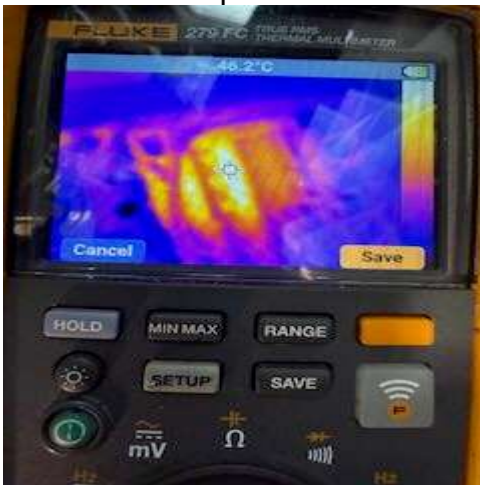
10. The air conditioning sea water pumps three phase breakers running temperature was captured at 46.2°C. Further review this condition and ensure the connections are clean and tight and that the breaker and associated conductors are correctly sized for the expected load.

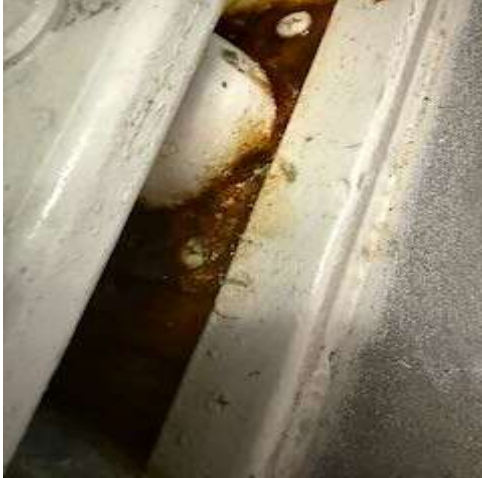
11. The air conditioning chilled water pumps vibration mounts are corroding. Further review this condition, anticipate vibration mount replacement.

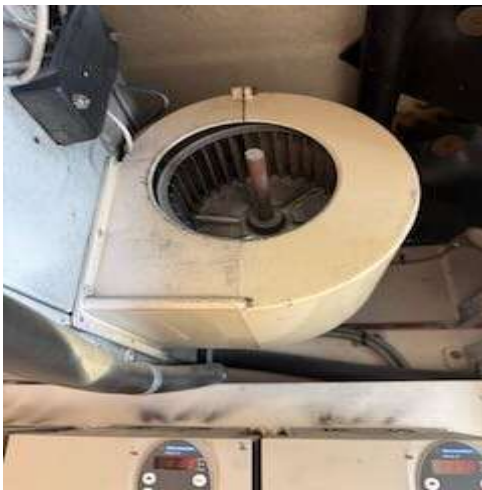
12. The fan above the chiller plant is exposed, no finger guard has been fitted. Rectify this condition.

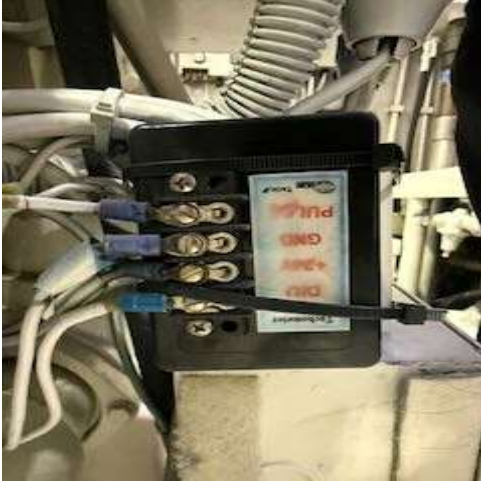
13. Port and starboard main engine mounted Tachometer modules connections are exposed. Provide suitable protection covers.

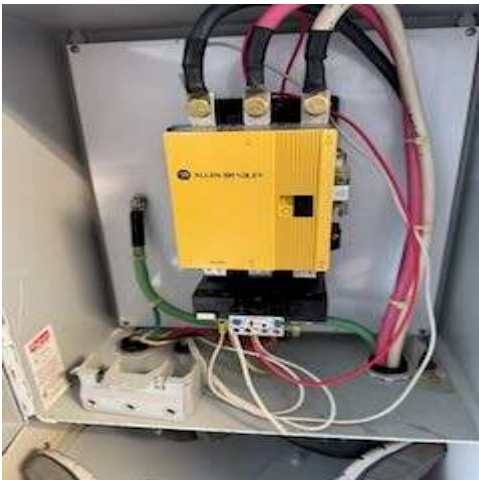
15. An unidentified Allen Bradley contactor is mounted in the lazarette. Identify this contactor.

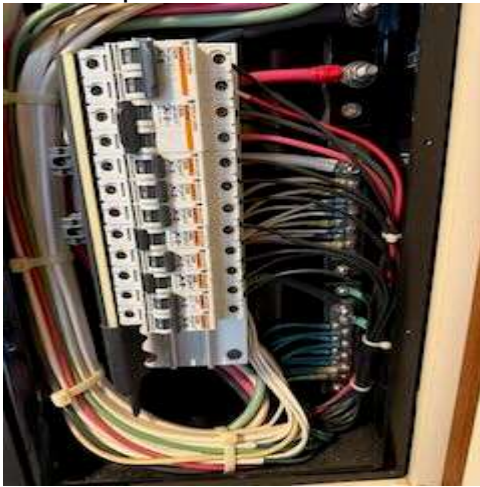
16. ★The vessels distribution panels were opened for review; it was noted that in all the 120/240 distributions the phase connection posts are exposed. Provide suitable protection covers.

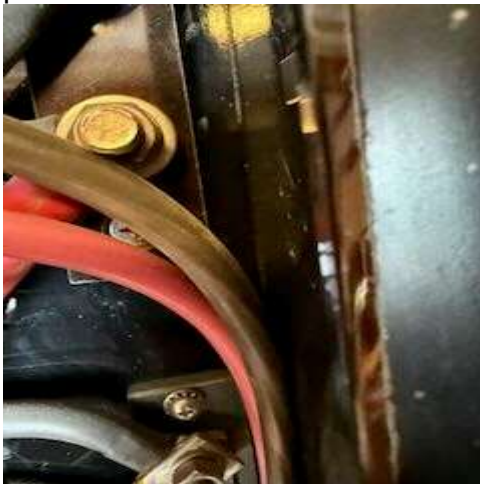
17. ★Single jacketed conductors within the galley distribution panel are resting on the phase connection hardware. Rectify this condition.

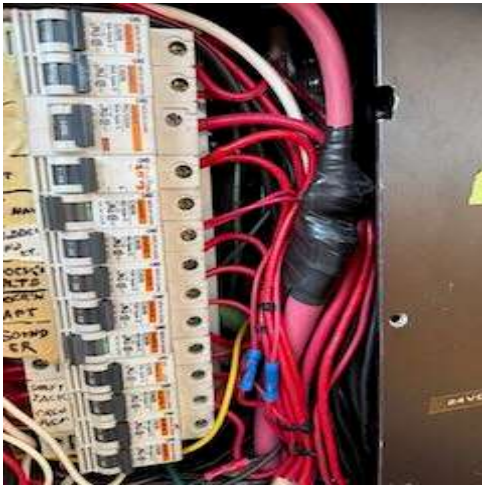
18. The wheelhouse 24VDC distribution panel supply cables has been line spliced and wrapped with electrical tape. Re-connect these cables to an approved connection buss.

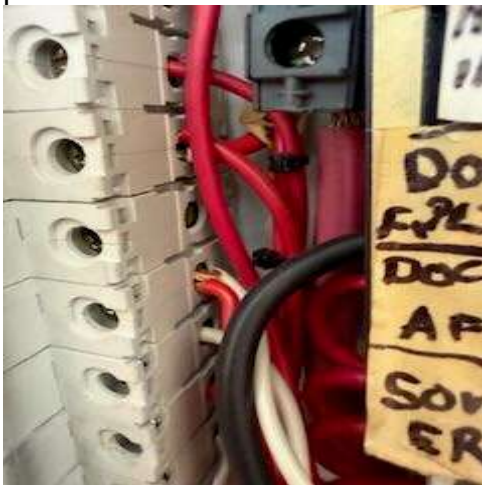
19. Multiple circuit breakers in the wheelhouse 12 and 24 VDC distribution panels are doubled up. Identify all circuits and ensure each circuit is individually over current protected.

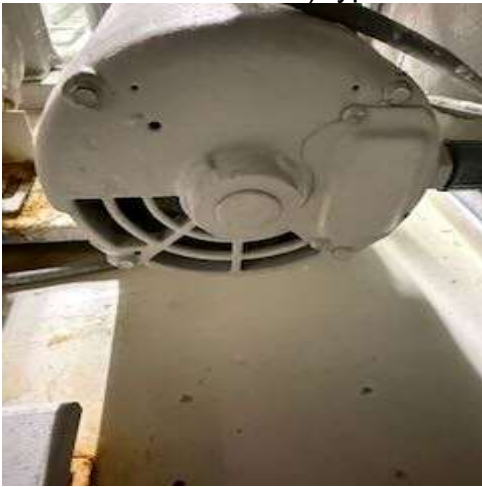
21. The air conditioning sea water supply pump motors are open wound not suitable for machinery space use. Replace these pump motors to T.E.F.C. (Totally Enclosed Fan Cooled) type.

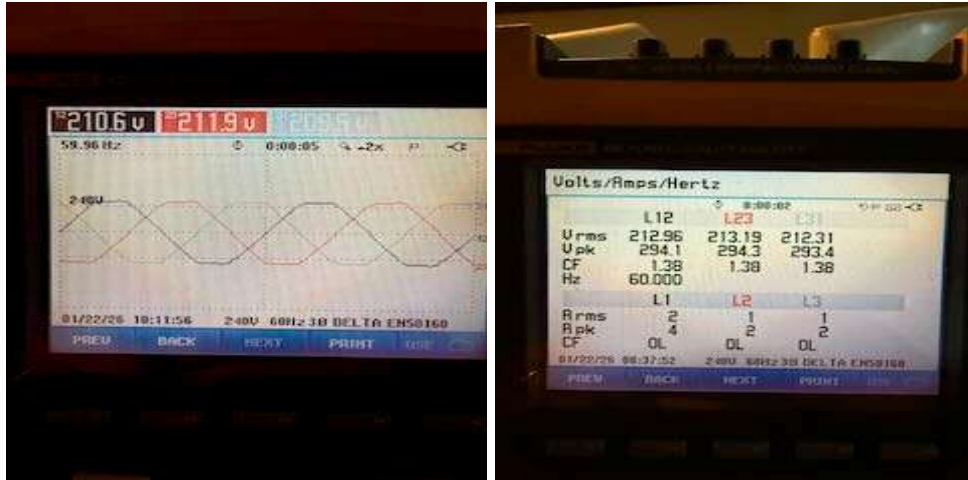
1. The vessels power quality was reviewed, the system has corruption caused by harmonic distortion, the corruption was found to be coming from the air conditioning compressors and air conditioning frequency drives.

The harmonic distortion is distorting the sinusoidal voltage wave form into a flat topping wave form; the voltage crest factor was low at 1.38. A flat topping wave form will not allow electrical systems capacitors to fully recharge risking premature failure.

Perform a harmonics analysis, anticipate installing passive line reactors, failure to address the harmonic distortion issues could lead to premature equipment and electronics failures, and a multitude of related issues.

Before any onboard systems failures can be correctly diagnosed, the vessels power system is to be a "clean system," failure to address the vessels THD, the likelihood of experiencing problems will continue to increase.

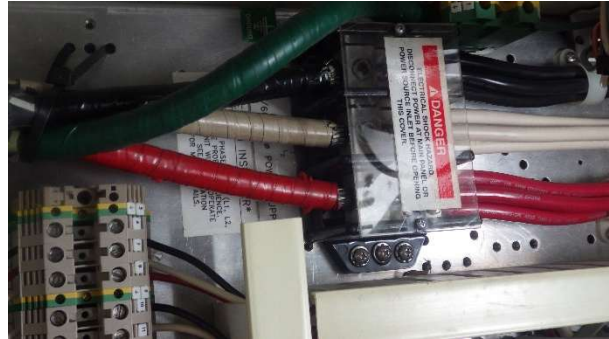
16. Pins and/or ferrules are not being used on main terminations within the Cruisair control enclosure. Same deficiency applies to the raw water switch which is not labeled. Install pins and/or ferrules as needed and label switch.

**PINS OR FERRULES ARE NOT INSTALLED ON WIRING WITHIN HVAC ENCLOSURE  
COLOR CODING IS TO NO RECOGNIZED STANDARD. RAW WATER SWITCH NOT LABELED**

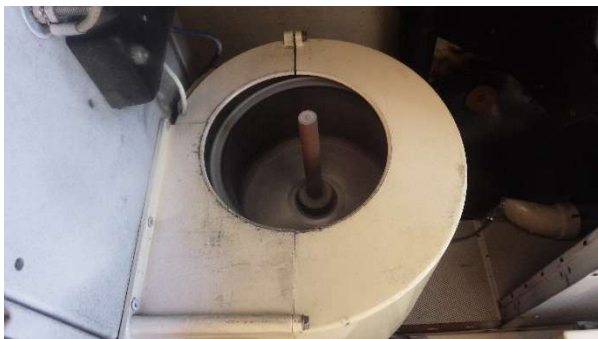
14. The suction and pressure analogue gauges are heavily fouled and distorted. Anticipate replacement.
15. A protective screen/guard is missing from the rotating squirrel cage assembly located on the fan coil unit above the chiller plant. Install protective guard to protect personnel from rotating machinery.

**PROTECTIVE GRILL MISSING FROM  
SQUIRREL CAGE BLOWER ABOVE CHILLERS**

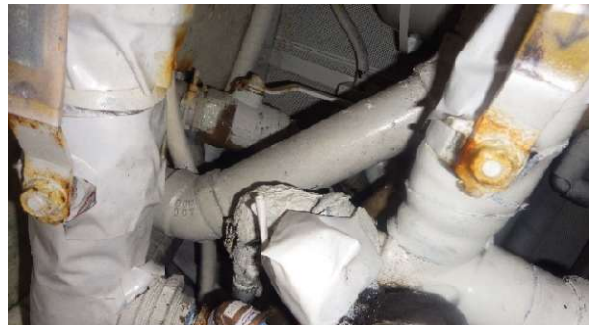
**SEIZED VALVES UNDER HVAC CHILLER**

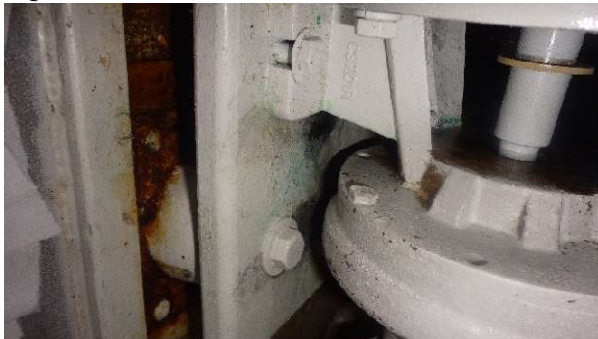
12. Long sections of rubber hose coming off the chilled water pump are not insulated and freely dripping condensate into the floor and bilge area.
13. The mounting feet/pads on the chilled water pump are severely corroded. Anticipate replacement.

**CORRODED FEET ON CHILL WATER PUMP**

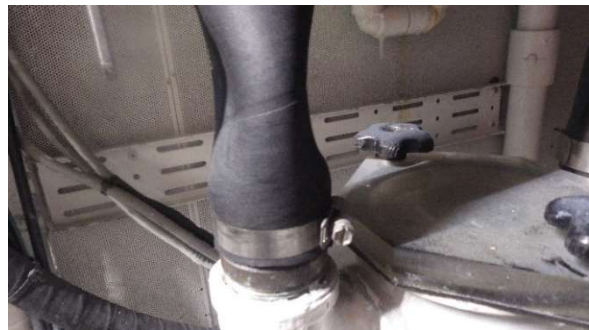
**RAW WATER SUCTION HOSE COLAPSED**

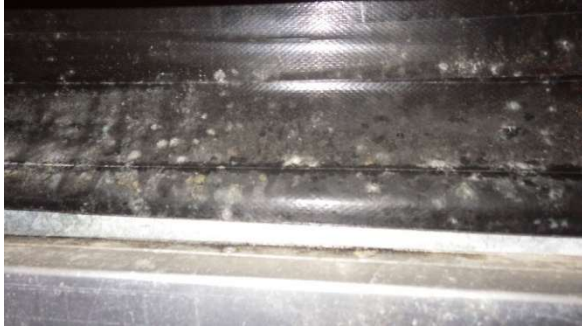
**WHITE MOLD IN GALLEY**

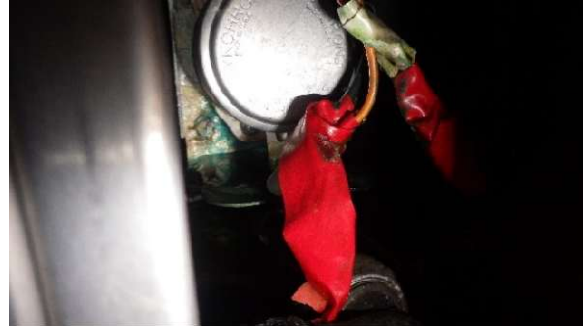
**RESIDENTIAL WIRE JOINTS ON WIRING**

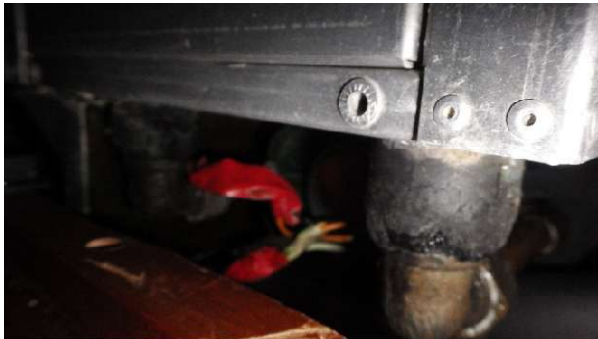
**MOLD OBSERVED THROUGHOUT THE YACHT WITHIN MULTIPLE FAN COIL UNITS**

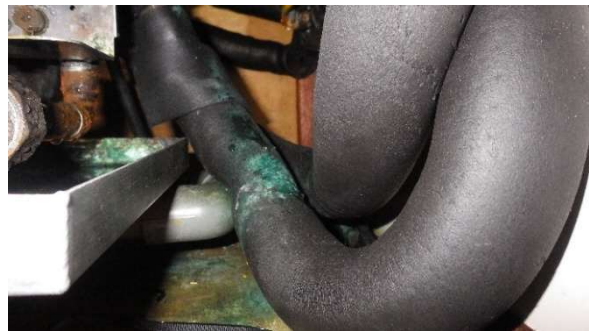
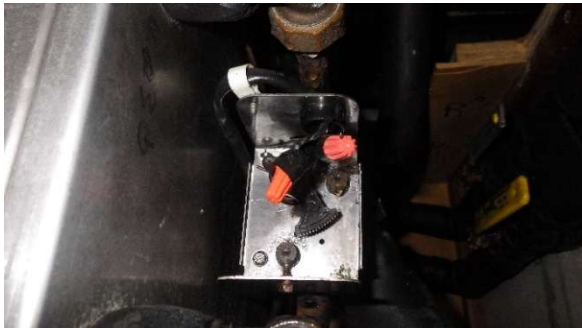
**WIRE JOINTS AND MOLDY WATER VALVES THROUGHOUT FAN COIL**

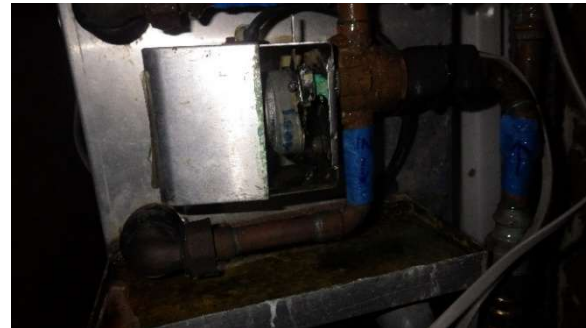
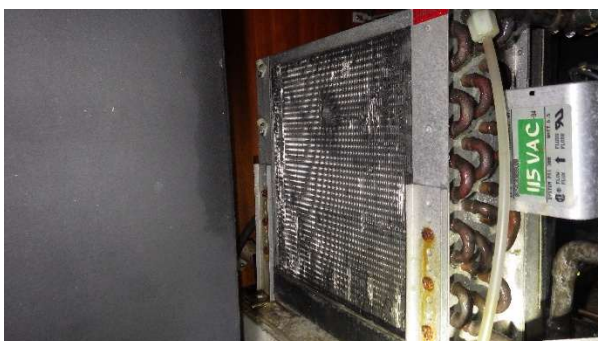
20. Most of the fan coil units throughout the yacht are missing air intake filters. Evaporator fins are fouled. Clean fins and install air intake screens.

**NO AIR INTAKE SCREEN ON MISC. FCU'S**

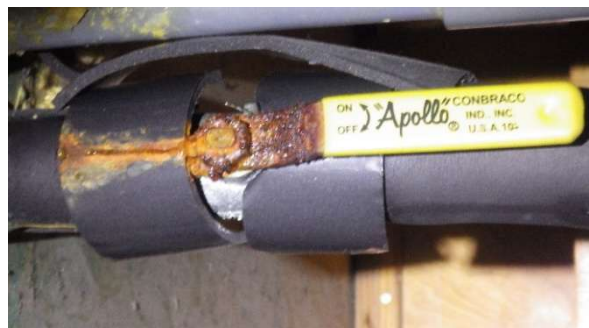
**HEAVY CORROSION ON ISOLATION  
VALVES AT EACH FAN COIL UNIT**

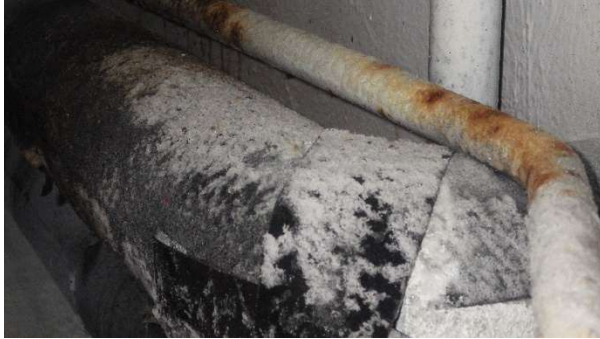
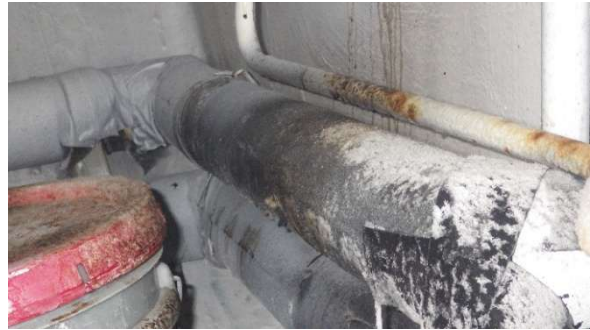
**WHITE MOLD OBSERVED IN THE LAZARETTE – BE CAUTIOUS**

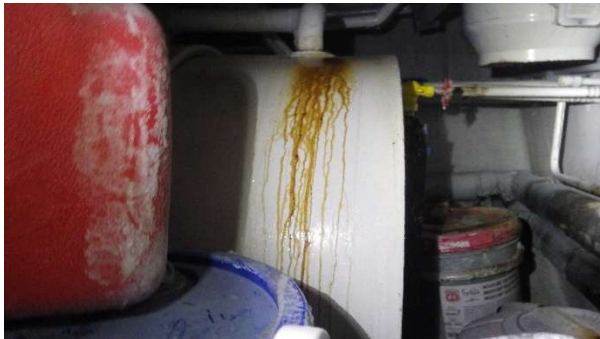
**CONDENSATE FREELY DRIPPING INTO  
BILGE UNDER CHILLER RACK**

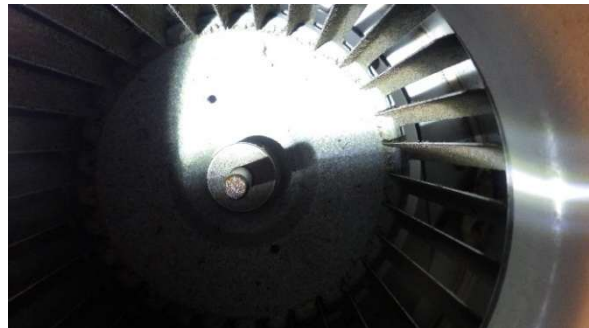
**NO PROTECTIVE COVER ON FAN LOCATED  
IN LAZARETTE**

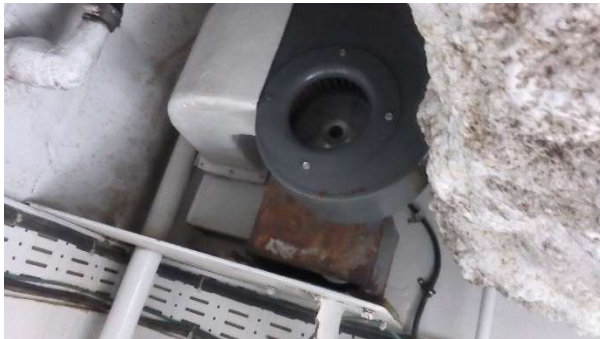
**MOLD UNDER KILL BOX LAZARETTE**

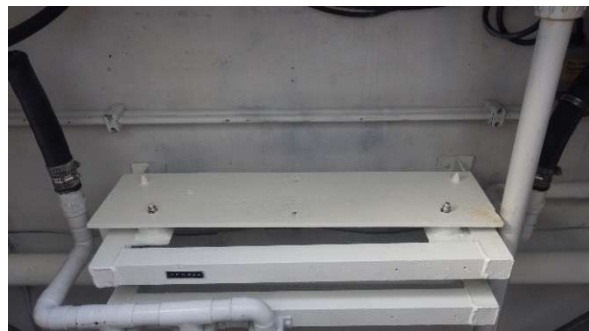
**MISSING BILGE PUMP MOTOR ASSEMBLY  
IN LAZARETTE**

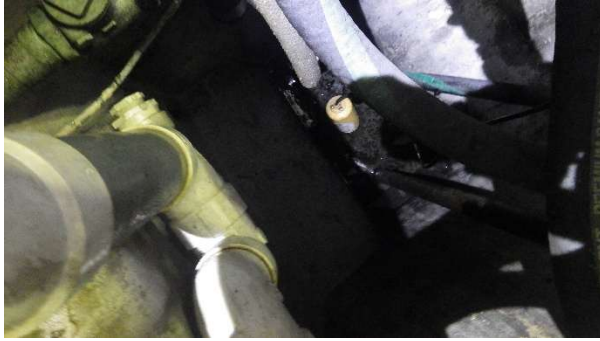
**NEOPRENE INSULATION FAILING  
THROUGHOUT THE VESSEL. MULTIPLE  
OVERHEAD LEAKS NOTICED.**

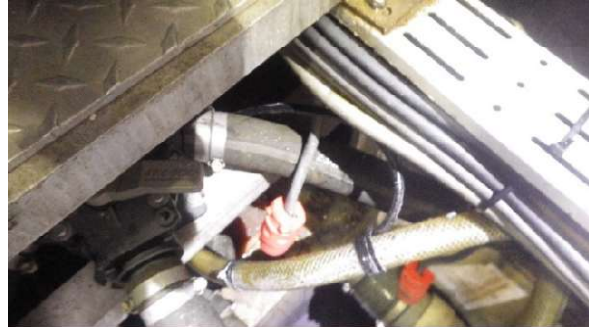
**LOOSE 120VAC OUTLETS HANGING OUT  
CENTERLINE BILGE ENGINE ROOM**

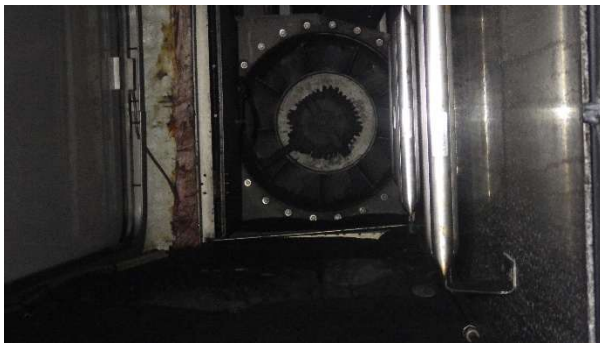
**MAIN ENGINE ROOM EXHAUST FANS INSTALLED WITHOUT PROTECTIVE GUARD/SCREENS**

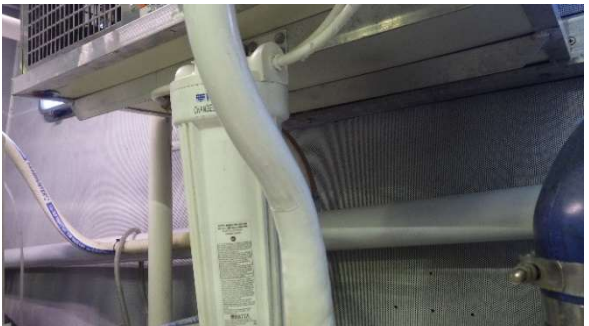
**WATER LEAKING FROM DISPENSER**

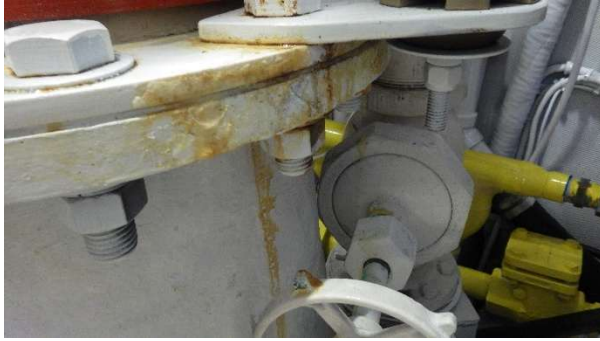
**WATER LEAK PORT M/E EXHAUST**

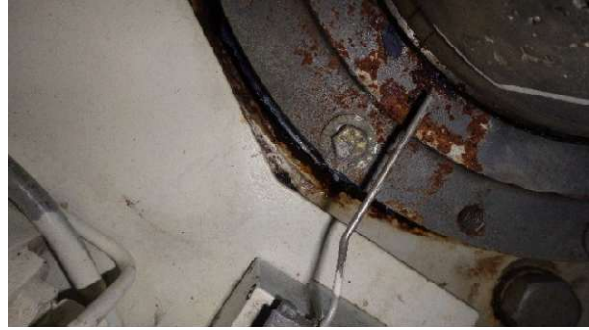
**WATER LEAKING FROM PORT FIN**

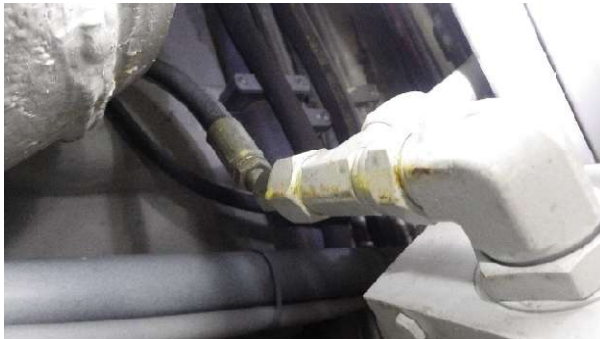
**HYDRAULIC OIL LEAKING STARBOARD  
STABILIZER**
