**PATTON MARINE INC.  
SURVEYORS AND CONSULTANTS  
P.O. Box 331884  
Miami, FL 33233-1884, USA**

**October 10, 2026  
File No.: 14048-26  
Page 1 of 21**

**RE: "WELL DONE", 2000,  
84', Burger Flybridge Motor Yacht**

**RECOMMENDATIONS**

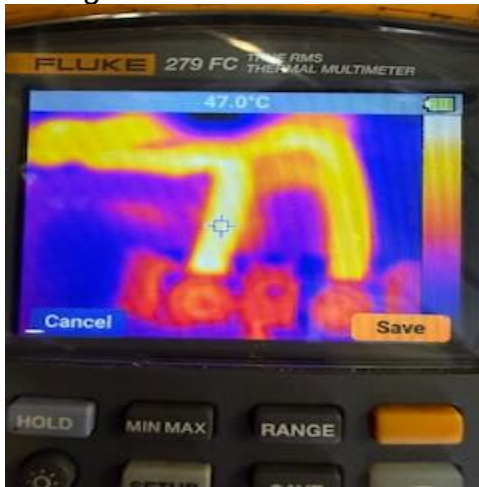
1. The aft 100-amp square D shore power input breakers running temperature was captured at 47.0°C/ 116.6°F. Verify the associated electrical connections are clean and tight.

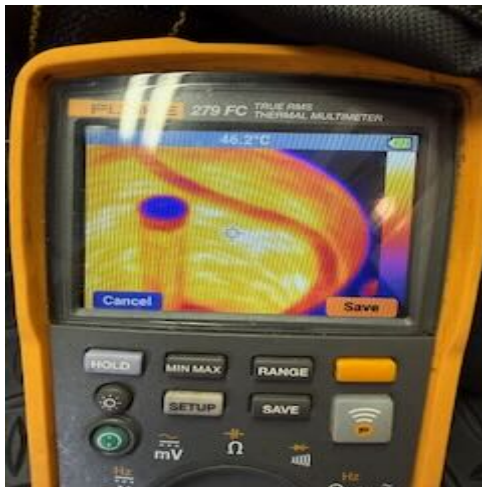
2. The aft 100 amp shore power cable was in use, during this time the majority of the associated shore power cable remained in the storage bin, the temperature of the cable was captured at 46.2°C/ 115.15°F. Flake out shore power cord(s) when in use to reduce the risk over overheating the cables.

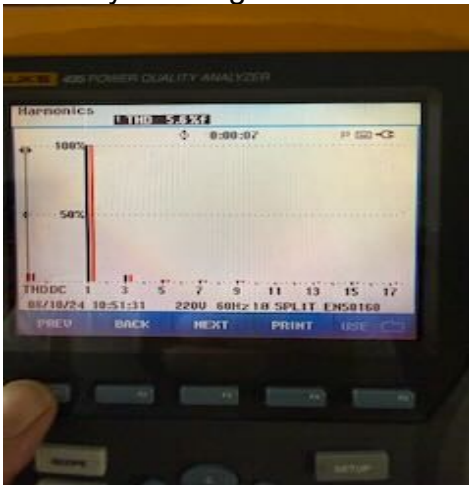
3. The vessels shore power arrangement includes a retractable cable and telephone connection system which is no longer used. Remove the retractable reel and associated cable.
4. The Staco voltage regulator manufacture suggests the carbon brush gear be inspected yearly and the internal components be cleaned every 3-6 months. Perform manufacture suggest maintenance.
5. The Staco manufacture states that the voltage regulators alters the voltage magnitude without chopping the wave form, during harmonics review this was not the case, as during operation with the air conditioning compressors off the system still caused a flat topping wave form and a harmonic distortion of approximately 5.6%. Further review this condition, verify all manufacture service has been completed and that the shore power arrangement is connected correctly and in good condition.

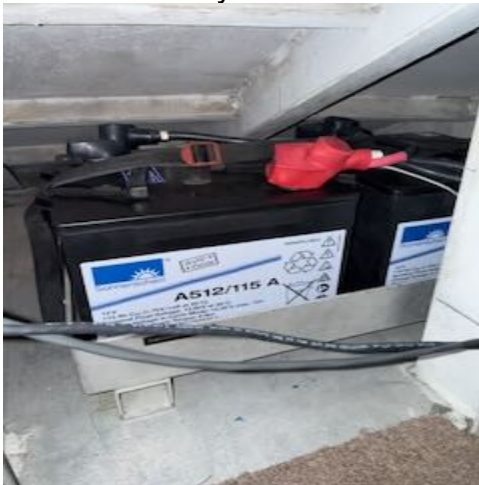
1. The vessels battery banks were not load tested. Load test all battery banks regardless of age.
2. The vessels engine and generator battery banks are not secured against vertical movement. Provide means to secure all onboard batteries against vertical movement.
3. The vessels battery banks are not stored in battery boxes which are resistant to spilled battery electrolyte. Install purposed made type battery boxes for all onboard battery banks or at minimum coat the inner linings of the existing boxes with an electrolyte resistant material.

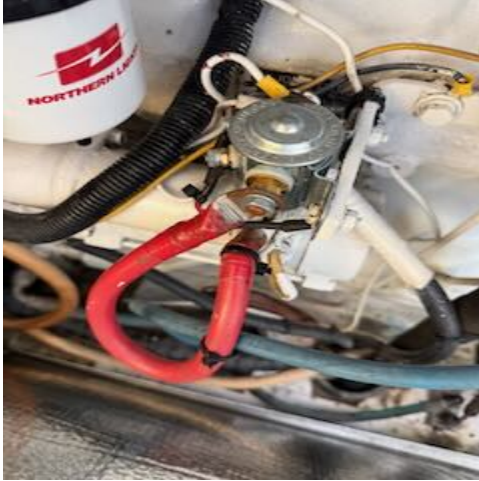
5. The aft generators starter and slave solenoid connections are exposed. Install suitable “boot” type protection covers.

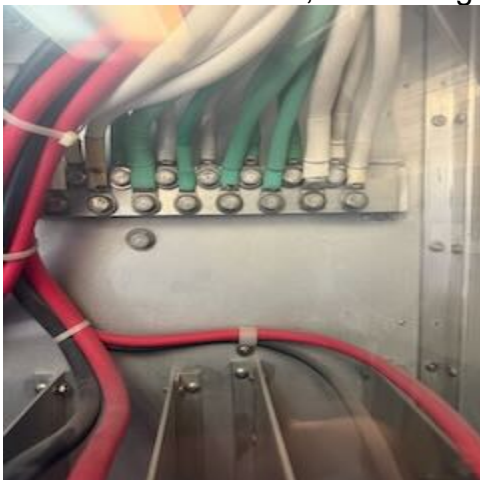
5. The vessels ground and neutrals are connected to a common collector buss in the main switchboard, this arrangement will not allow for ground fault monitoring.

It is suggested safety could be improved by the following recommendation.

Re-configure the vessels grounding system as a T-NS system, that meaning a separate protective earth (PE) and neutral (N) with a single neutral to ground connection on the main switchboard, this configuration will allow for ground fault monitoring.

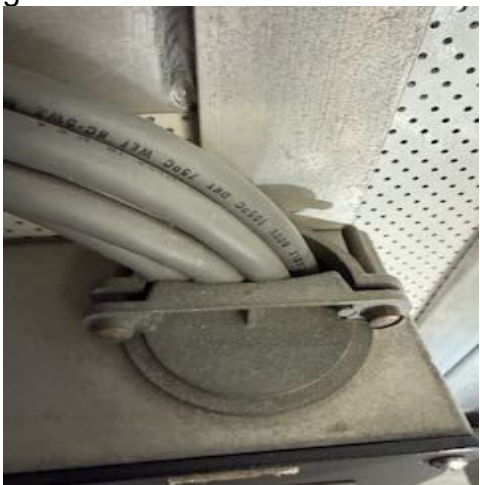
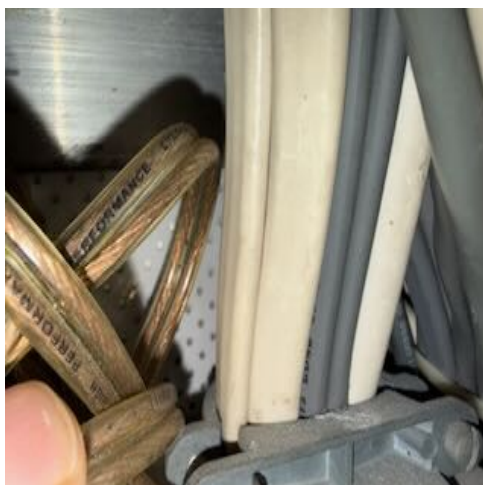
1. Multiple control and switch enclosure and distribution panel cable entries throughout the vessel's machinery spaces are not sealed reducing the enclosures required I.P. rating. It is understood this condition is the yacht builder's standard however it is suggested safety could be improved by the following recommendation. Seal all openings and/or install cable glands for protection against moisture intrusion and to prevent the spread of fire/ smoke/ gas.

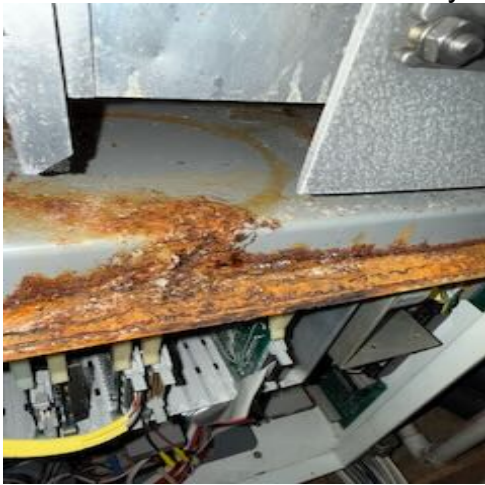
2. Evidence of water intrusion can be seen under the wheelhouse console; contamination can be seen on the stabilizer control enclosure. Further review cause of the intrusion and rectify.

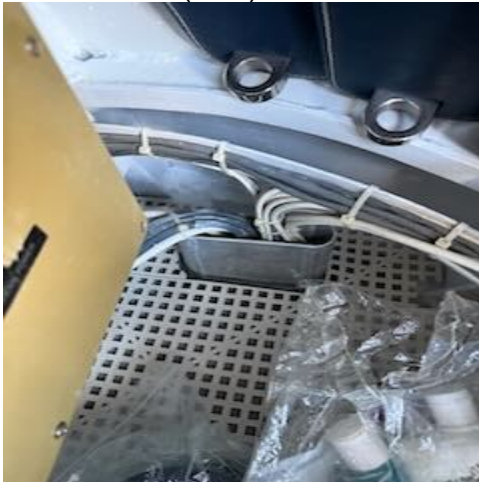
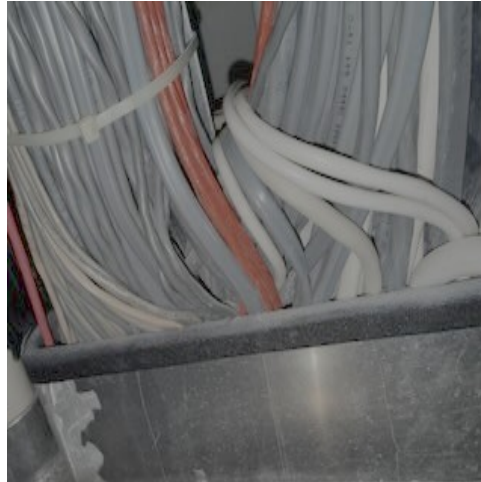
3. The machinery space distribution panels are not fitted with internal voltage plaques. Provide distribution panel internal voltage labels.
4. The through deck cable glands are not sealed, this is common practice throughout the vessel. It is understood this condition is the yacht builder's standard however it is suggested safety could be improved by the following recommendation. Seal all openings to for protection against moisture intrusion and to prevent the spread of fire/ smoke/ gas and to contain electromagnetic interference (EMI).

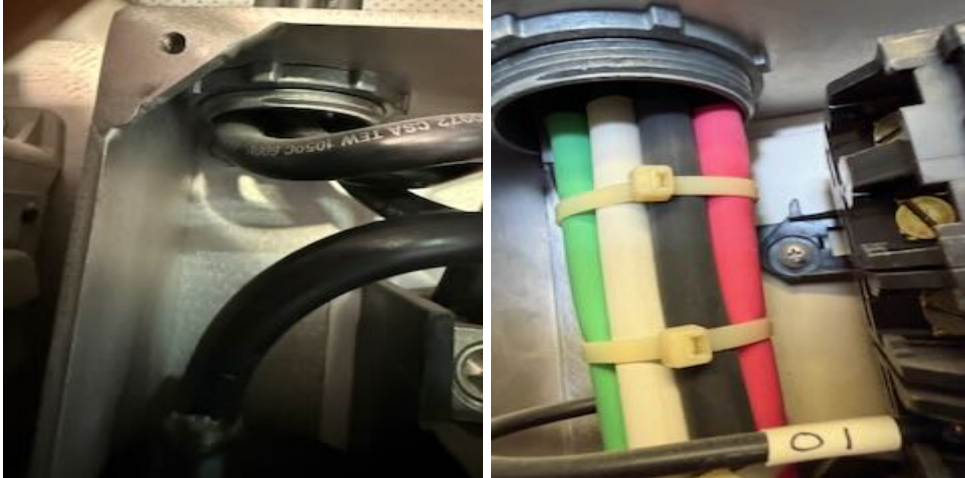
5. The cable entries into the vessels distribution panes and machinery associated control boxes are run through metallic cable glads without cable chafe protection, several energized conductors are resting hard against such cable glads. Further review all electrical services cable entries and ensure adequate cable chafe protection has been provided.

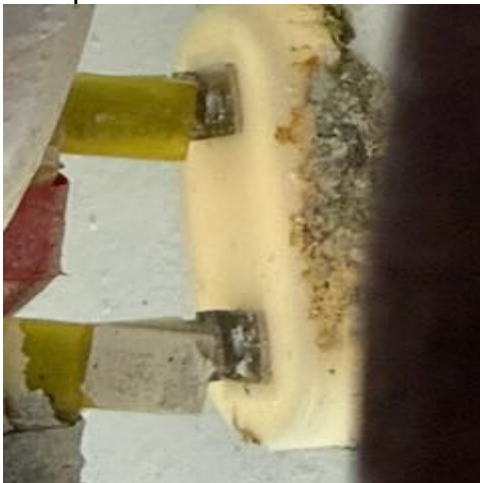
6. Multiple deck foot lights show slight contamination and in addition the connections are not fully encapsulated. Further review the deck foot lights and ensure are all sealed to the respective openings and they connections are fully encapsulated.

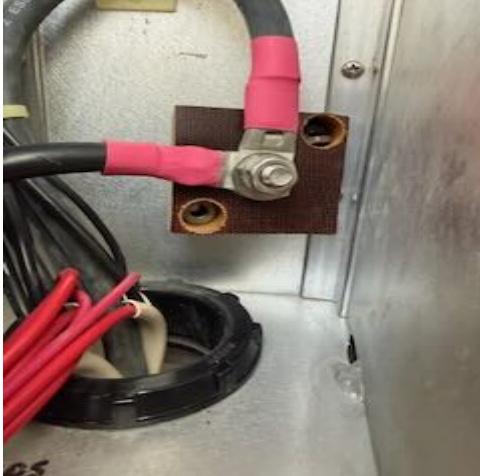
7. The wheelhouse 12 VDC distribution panels positive connection block has separated from the backing plate. Re-secured this connection block.

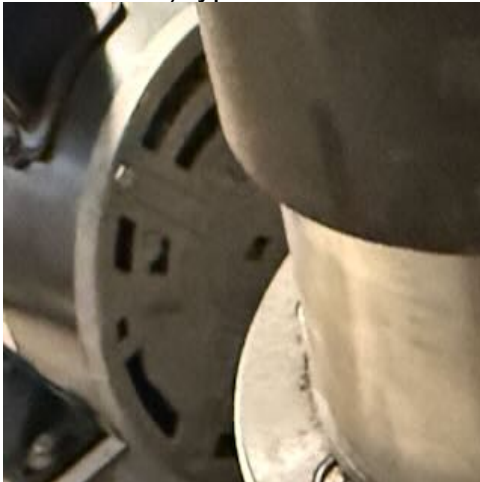
8. The steering flats mounted black water pump is an open would type not suitable for machinery space use. Replace this motor with a T.E.F.C. (Totally Enclosed Fan Cooled) type motor.

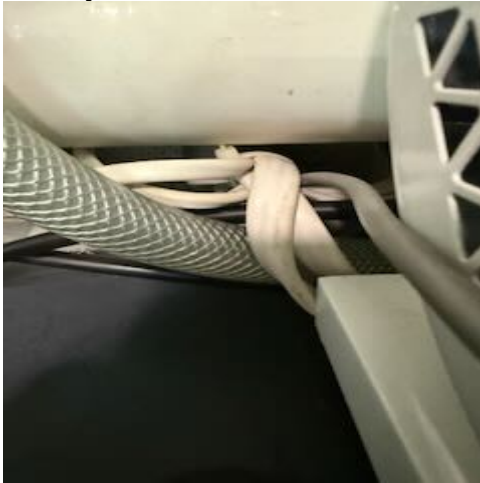
11. Water maker associated cables lack adequate support and chafe protection. Rectify these conditions.

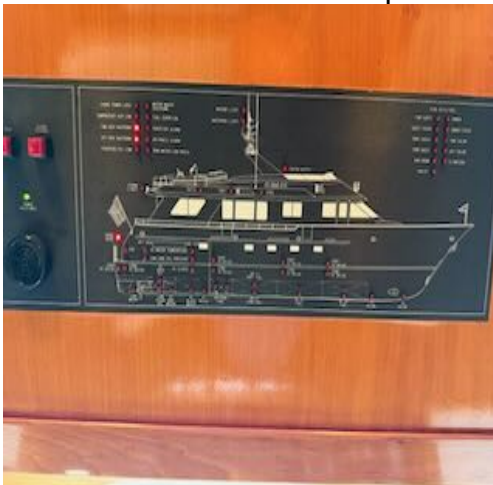
12. The navigation light system is arranged with a mimic panel on the wheelhouse upper console, during navigation light operations the respective LED lights on the mimic panel did not illuminate. Further review this condition and rectify, in addition verify all LED indicator lights on this mimic panel for bilges, pumps, doors and fire alarms are operational.

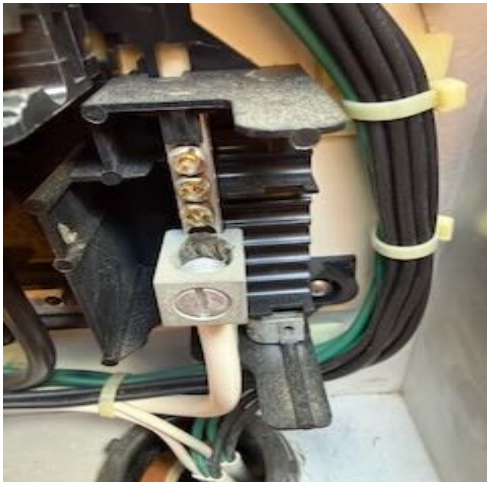
14. The phase and neutral supply cables connected to the machinery space 120/240 VAC distribution panels without the use of pins or ferrules, the securing screws bears down directly to the copper conductors. Re-connect supply phase and neutral cables with pins or ferrules to reduce the risk of damage to the copper conductors.

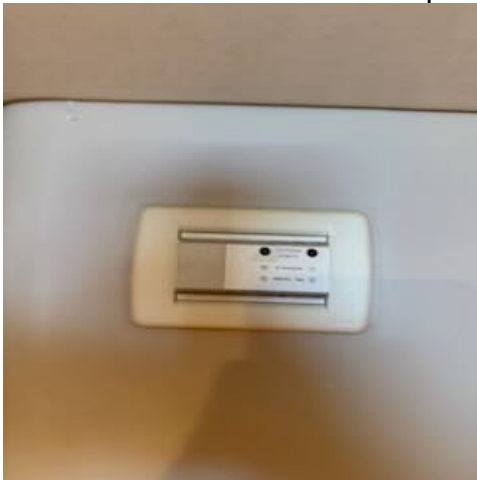
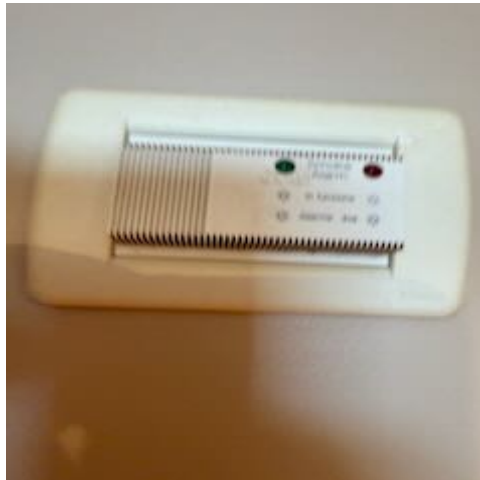
15. ★The smoke sensors located in the port guest twin cabin, and forward guest cabin are not operational, in addition the sensor in the starboard guest cabin is pushed back in to the backing box, in addition it was not verify type of test canned smoke is compatible with this type of sensor, therefore the fire alarm system was not demonstrated. Further ensure all sensors are correctly secured and operational then test provide the entire system operational including audio annunciation and helm mimic panel indication.

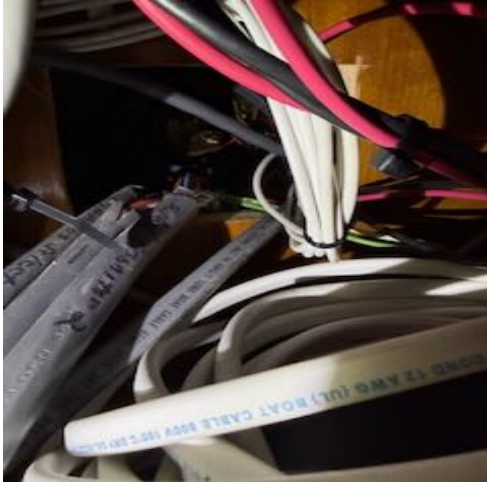
16. Cables lack support and protection inboard of the wheelhouse distribution panels; in addition the rear of this panel is wide open to under the console. Provide additional cable support and protection and seal this enclosures cable entry.

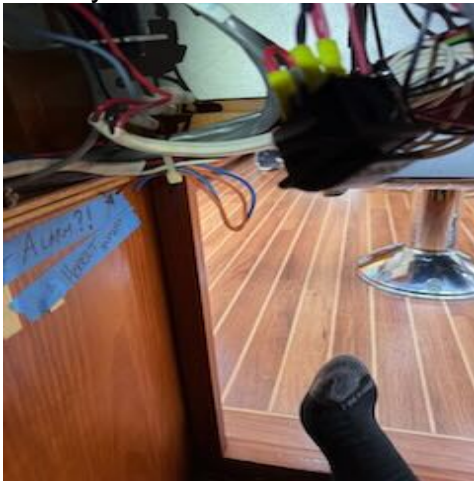
17. An unidentified rocker switch is free swinging under the wheelhouse console. Identify this switch and re-secure.

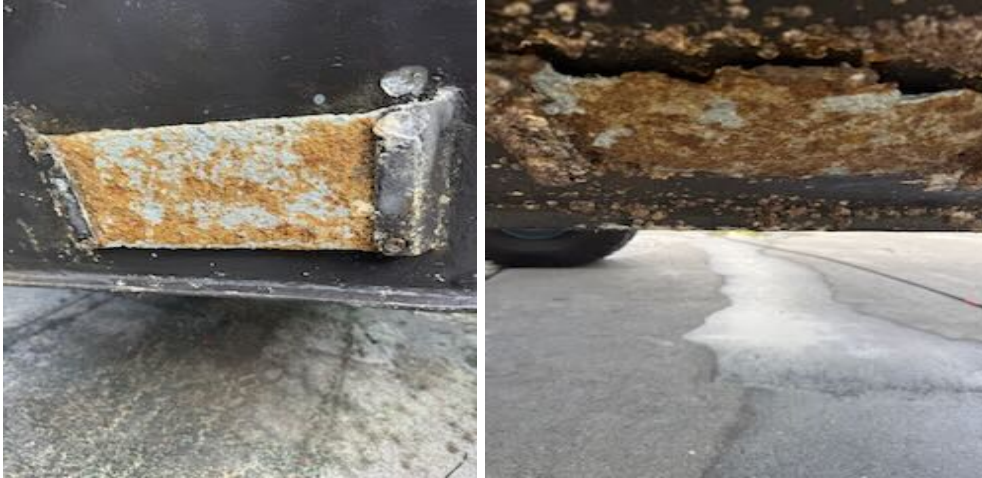
18. Several hull mounted zinc and sea chest pencil zincs are reaching the end of these usable life; in addition, multiple zinc are showing signs of passivation which occurs when the anode becomes coated with a barrier of oxide or corrosion that prevents it from working. Anticipate full anode replacements.

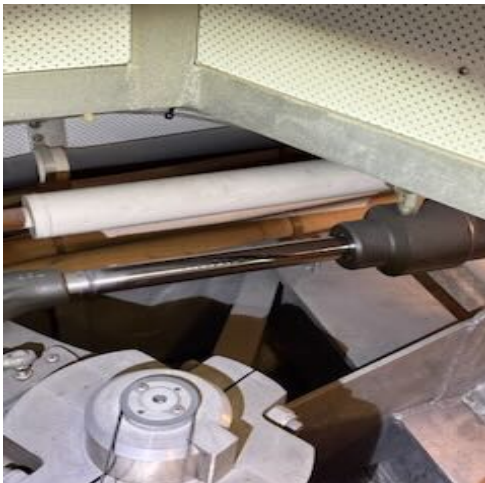
1. The starboard steering hydraulic ram shows discoloration, cause of which was not determined, this condition can be caused by many factors such as oxidation, contamination, worn seals and overheating. These issues can lead to significant wear on internal components, indicating potential system failures that require immediate attention. Further reviewing this condition, anticipate hydraulic ram service.

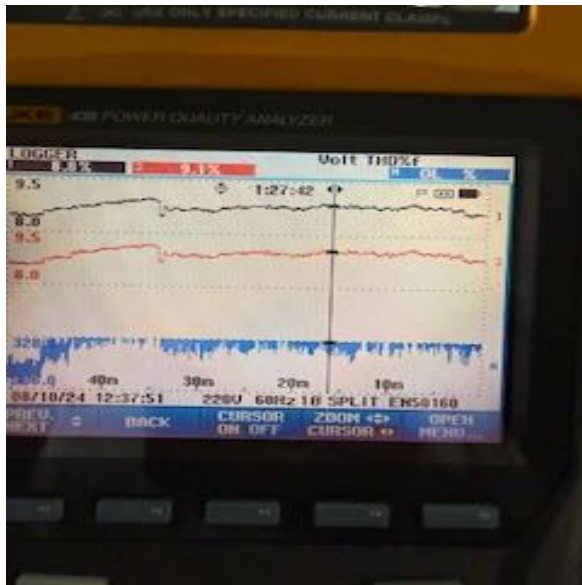
Test results indicate that the vessels electrical system has a THD (Total harmonic distortion) peaking to approximately 9.1%.

Graph below shows the total harmonic distortion above the acceptable level of 8% to 9.1%.

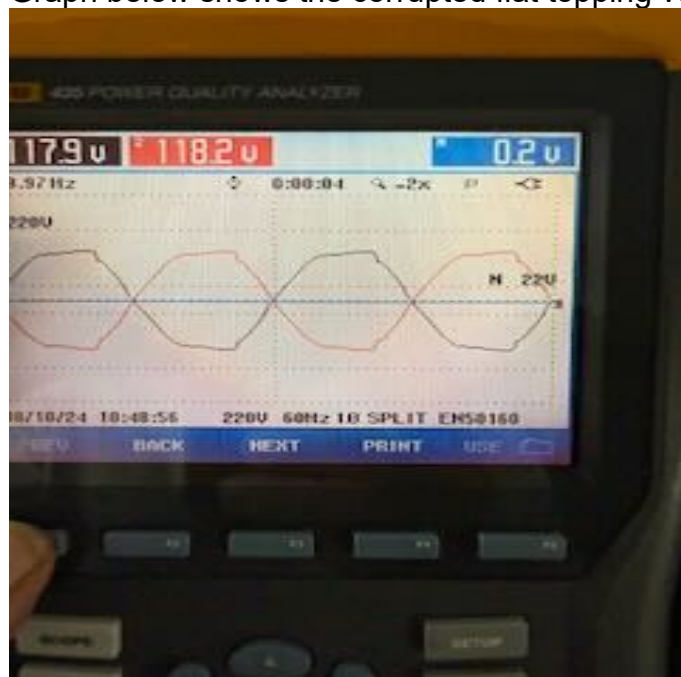
Graph below shows the corrupted flat topping voltage wave form.

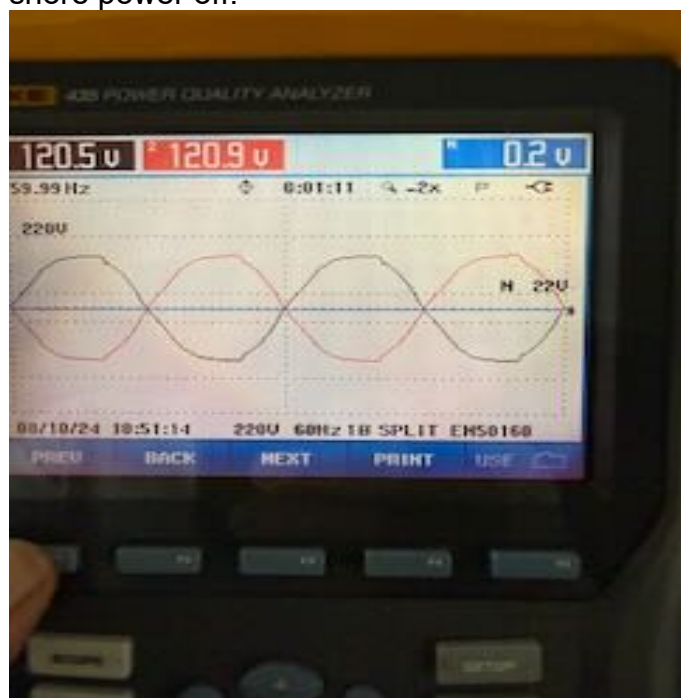
Graph below shows the sinusoidal voltage wave form with the air conditioning and shore power off.

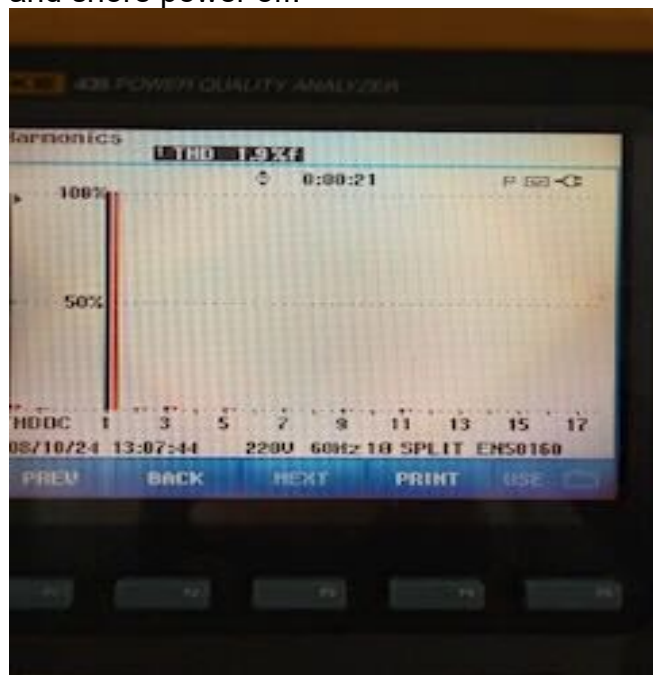
Graph below shows the total harmonic distortion good to 1.9% with the air conditioning and shore power off.

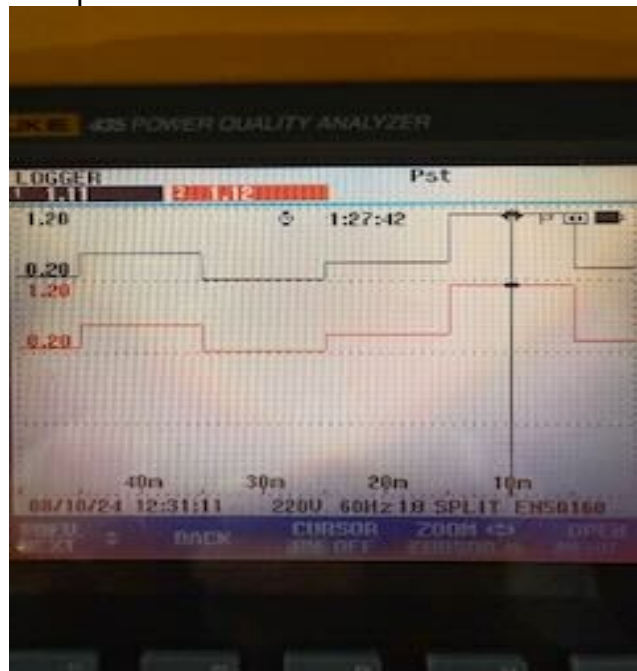
Graph below shows the PST (Perspective Short term) light flicker up from the acceptable level of 1 to 1.12.

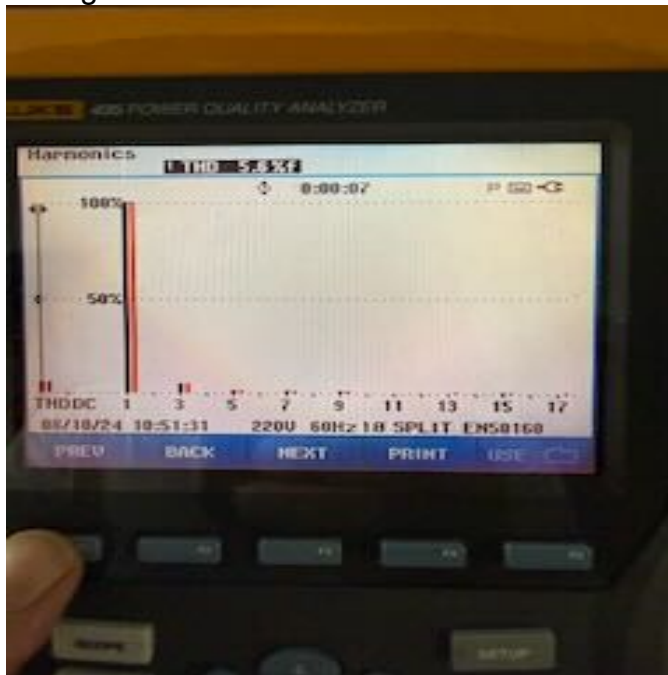
Graph below shows the total harmonic distortion dropping from 9.1 % to 5.6% after turning off the air conditioning, the harmonics was being caused by the shore power arrangement.

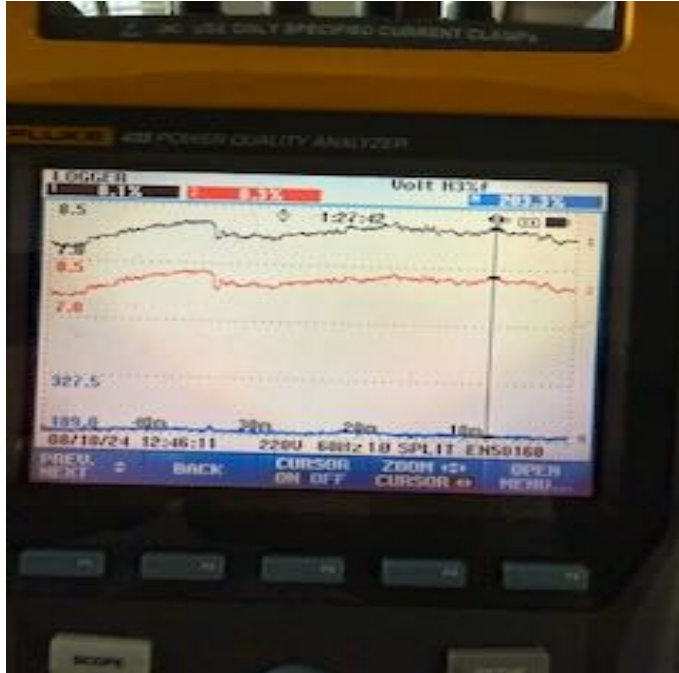
Graph below shows the 3rd harmonic (180Hz) above the recommended level of 3% to 8.3%.
