**PATTON MARINE SURVEYORS  
AND CONSULTANTS, INC.**

**June 12, 2026**  
**File No.: 13993-26**  
**Page 1 of 31**

**RE: "ESCAPE of LONDON", 1997,  
36.46 Meter TRIDENT Motor Yacht**

| Scope of Inspections: | Pre-purchase |

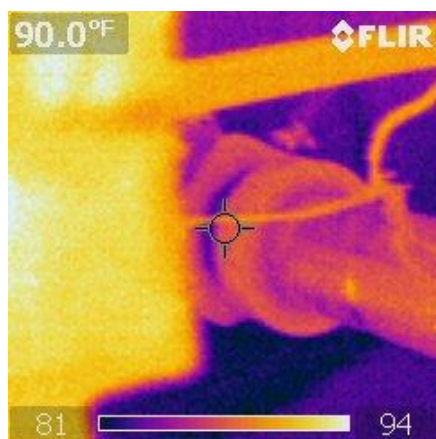
**STARBOARD SHAFT LOG (TIDE SEAL)**

| Starboard shaft log leaking?: | One drop every 20 seconds |

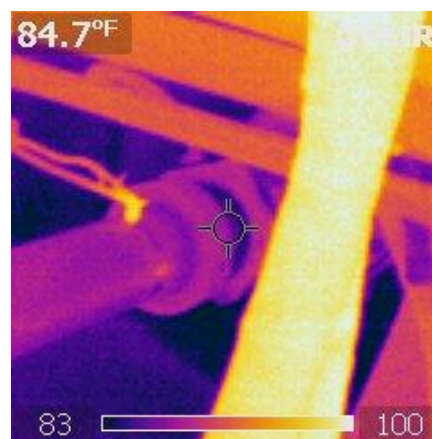
**PORT SHAFT LOG (TIDE SEAL)**

| Port shaft log leaking?: | Tight – No dripping |
