# Pantropic Power TA1 Marine Engine Inspection Form

Inspection Number	21435104	Customer No	2974218576
Serial Number	RPM01139	Customer Name	MV IONIAN PRINCESS
Make	CATERPILLAR	Completed On	2/26/2025 1:16:02 PM
Model	C32	Inspector	Alex Seda
Equipment Family	ENGINE - MARINE	PDF Generated On	2/26/2025
Asset ID	Port	SMU	139 Hours
Location	1601 SW 20th St, Fort Lauderdale, FL	Coordinates	4.17741110228122, -26.0980227446999, -80.1636510558572

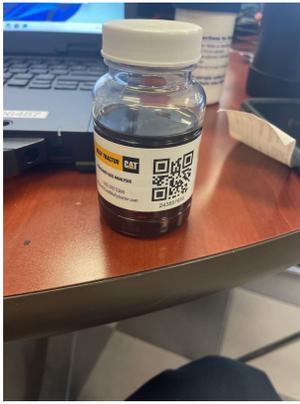
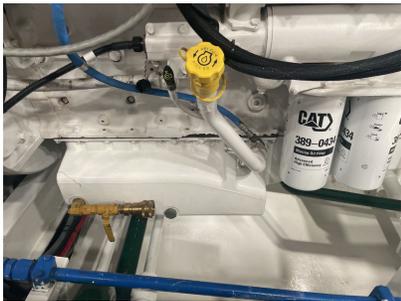
Comments: No sign of leaks.

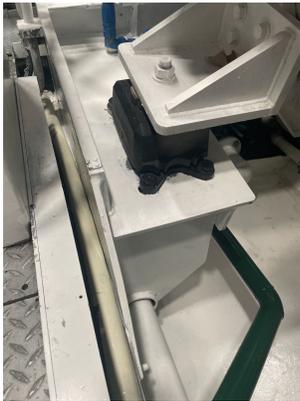
**Image Comment(s):**Outboard engine mount. **Image Comment(s):**Outboard transmission mount.

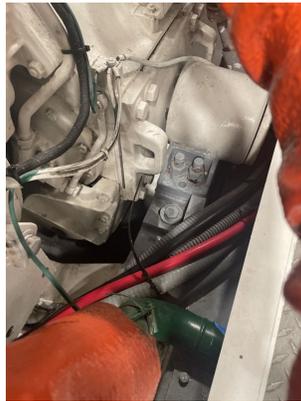
**Image Comment(s):**Inboard transmission mount.

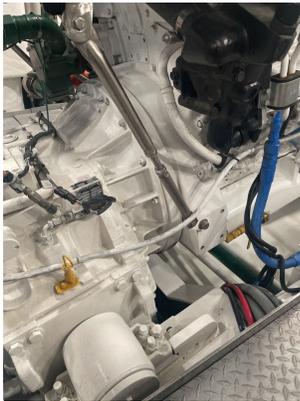
Image Comment(s):Inboard side. Image Comment(s):Rear.

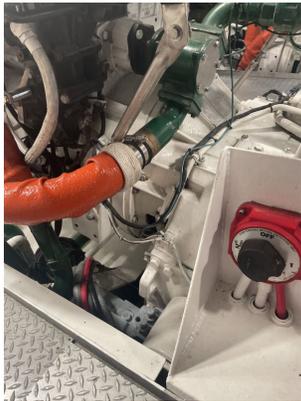
Image Comment(s):Outboard side.

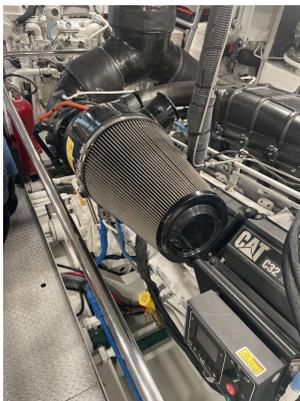
Image Comment(s):Inboard side. Image Comment(s):Outboard side.

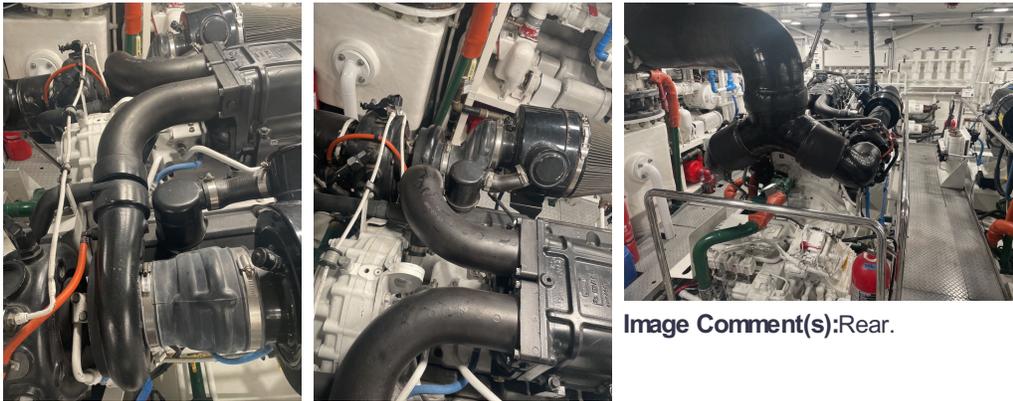
Image Comment(s):Rear.

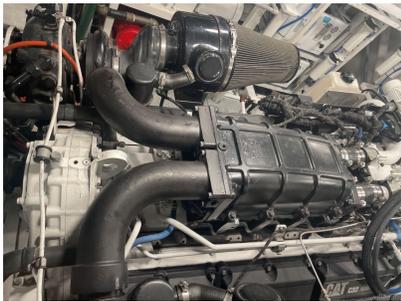
Comments: No signs of leaks.

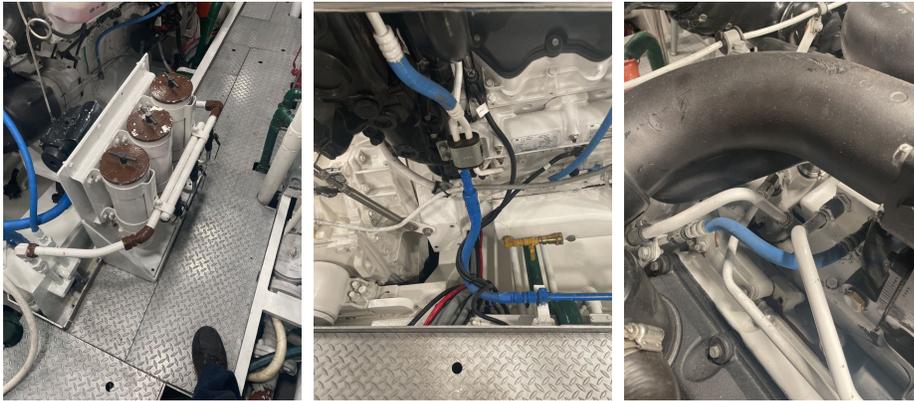
Image Comment(s): Transfer pump.
