REPORT OF MARINE SURVEY
Pre-purchase condition & value survey
of the vessel

"FREE RANGE CHICKEN"
2006 Custom Perry 59

Survey file no: H1222817.CVS.Stewart
Date of survey: October 12, 2022
Date of written report: October 13, 2022
Type of survey: Pre-purchase condition & value survey
Survey conducted by: Robert A. Noyce
Requested by: This survey was performed at the request of the purchaser Michael Stewart who was present at the time of the survey.
Purpose of survey: Assess the overall condition and value of vessel for pre-purchase decision making.
Vessel surveyed at: Bert Jabin's Yacht Yard
Survey conducted with vessel: The vessel was surveyed both while afloat & hauled out of the water.
Sea trial: A sea trial was performed as part of this survey. The results are included in the Sea Trial section.
Engine survey: The engine survey was conducted by Jeff Leitch of Bay Shore Marine.
Sailboat rigging: The mast, boom, standing and running rigging were inspected from deck level only.

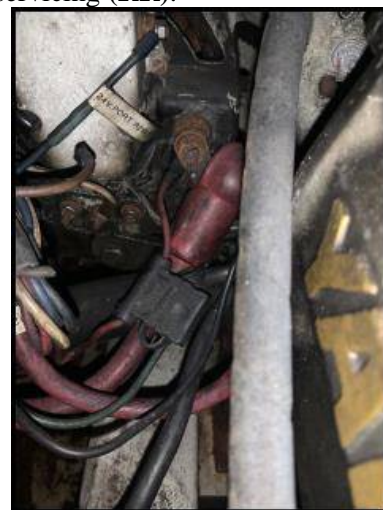
Starter/Alternator There are two 24 volt and one 12 volt alternator. Assure that the positive terminals are cleaned and protected from contact (**RR**). The alternator brackets may need some service, adjustment or repair.

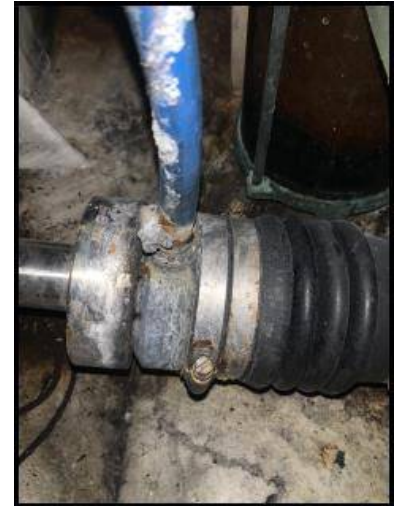
Water-injected Packless shaft seal system. Service packing gland per manufacturer **(ER)**. Note: It is recommended by manufacturers that shaft seal system is serviced or replaced as required and every 5 years and checked on a regular basis.

Vibrations: There were no excessive vibrations noted at any time during the sea trial run.
Packing Gland: The PSS shaft seal leaked during seatrial, service is required **(ER)**.
Shaft Creep: There was no noticeable shaft creep while gears in neutral.
Leaks: See engine survey for details.
Generator: Generator Output was recorded at 119 Volts and 60 HZ.
Other Observations: The Python Drive system should be inspected and considered for repair service or rebuilding **(ER)**.
Comments: **THERE MAY BE AN ENGINE OIL LEAK THAT CANNOT BE OBSERVED, SEE BAY BHOORE REPORT FOR RECOMENDATIONS (ER).**

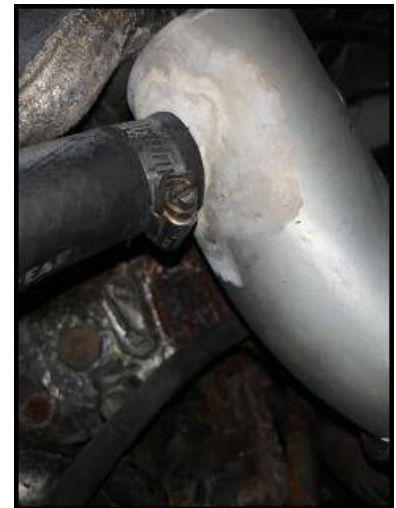
The stainless steel elbow appeared serviceable however there are stains and minor corrosion observed. The raw water injection hose appeared worn. It is prudent to have a mechanic disassemble and inspect the hoses and elbow for wear **(RR)**.

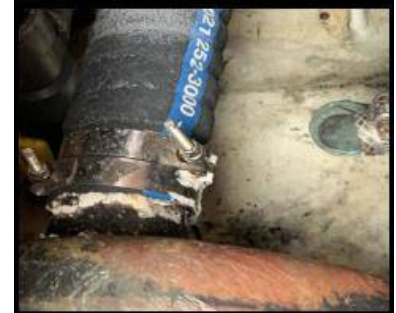
Fiberglass inline waterlift muffler appeared in serviceable condition however the hose ends at the nipples appear to be leaking (salt build up) and should be disassembled for inspection and service. That is to determine if hoses are deteriorated enough for replacement **(ER)**.

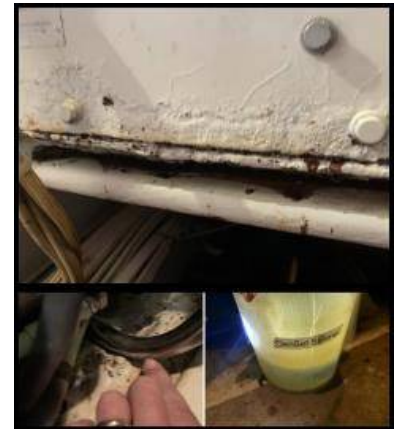
Number / Type: One Diesel
Manufacturer: Onan
Number of cylinders: Four cylinders.
Kilowatt rating: Rated at 11.5 KW.
Serial numbers: SN: C050757040
Model numbers: 11.5MDKAW-1953B
Hour meter: 5986 hrs on meter.
Location: Utility space below cockpit.
Fuel type: Diesel
Fuel hoses and clamps: Type A1 fuel hose is installed.
Fuel filters/water separators: A remote Racor is installed. No fire bowl located under filter assembly as per ABYC 33.5.6: Glass or clear sight bowl under filter or plastic filter assemblies do not comply with a 2-½ minute burn exposure, install proper fire bowl assembly or move filter outside of engine space **(RR)**.
Hoses and clamps: Serviceable.
Belts and pulleys: Serviceable.
Gauges: Remote panel.
Type of installation: In enclosed box. **Note rust damage to hush box.**

Cooling systems: Fresh water cooled, raw water heat exchanger -- internal strainer installed. There is a metal cooling water pipe that is chafing on the drip pan under the generator motor. The pipe should be inspected and effort made to determine cause of water leaks, chafe material should be installed to avoid future damage. The pan should be restored (rust and waste oil).

NOTE: The strainers acrylic bowl is fractured and must be replaced (ER).

Oil level and condition: No water or cuttings noted.
Exhaust components: Water-injected elbow to muffler to overboard discharge.
Exhaust hose connections double clamped: Yes.
Mufflers: Fiberglass waterlift.
Water-injected elbows: Serviceable.
Ventilation: Good.
Insulation: Loose, service as needed **(R)**.
Accessibility: Good.
Generator set operated: Yes. operated at sea trial.
Raw water intake - generator: Bronze seacock ball valve installed, it is prudent to inspect the hoses for replacement **(RR)**.

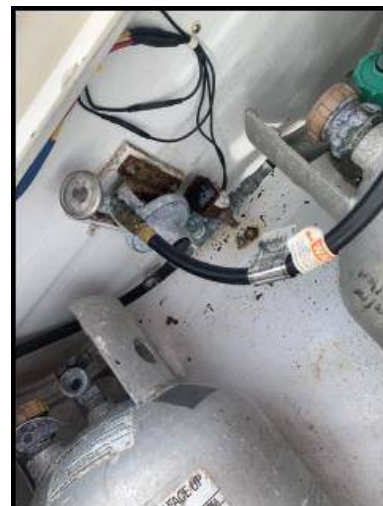
Tanks condition: Two tanks aluminum alloy, poor condition.
Secured: Yes.
Locker vented: Yes.
Regulator: Yes - Appropriate LPG regulator.
Pressure gauge: Yes.

Shut off valves: LPG shut off valve at the tank top. In addition, an LPG electrical solenoid shut-off valve switch is available near the galley and is functional. **NOTE: The DC solenoid is badly rusted and should be replaced (ER).**

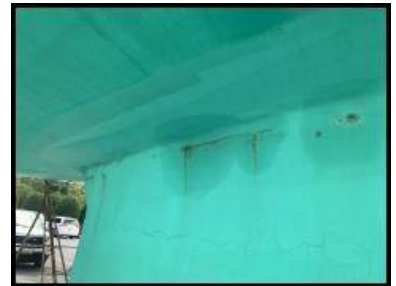
- Keel Root:** The keel root has some moisture behind the fairing and should be repaired when hauled next for bottom painting (**RR**).

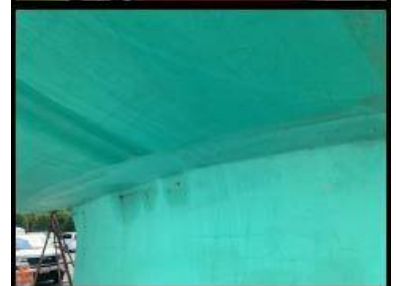
- Bottom paint:** The anti-fouling bottom paint is in need of refreshing, some of the paint is "stretching" and come loose (**R**).

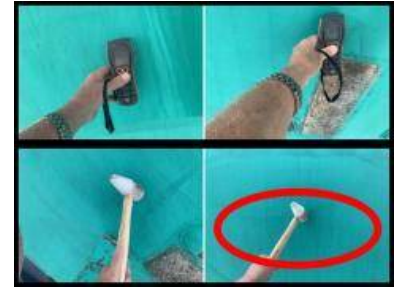
Delamination: There is an area at the port side about 10 feet aft of the stem that appears to have some delamination. It may be static compression damage from blocking. **Have that area inspected by a qualified FRP technician for repair (ER).**

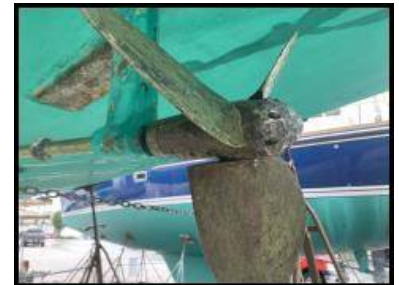
Transmissions: The transmissions operated normally/smoothly. The back-down test was satisfactory. Engine mounts secure & no unusual movement of the engines was sighted. **NOTE: THE propeller failed tp feather when under sail. See propeller information (RR).**

Number and type of blades: Maxprop, three blade feathering type. **NOTE: The MAXPROP did not feather while on sea trial (RR).**

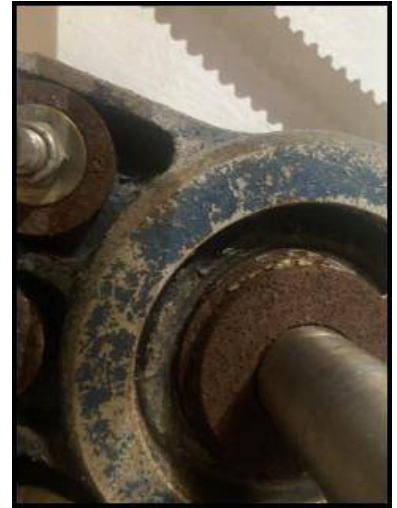
There is a Python Drive system (constant velocity drive shaft system) that may require service (rusty) **(RR)**. Shafts cannot be inspected within cutless bearings, stuffing boxes, couplings and prop hubs. The shaft and propeller were coated with Prospeed, it is in poor condition, **prep and reapply when painting bottom.**

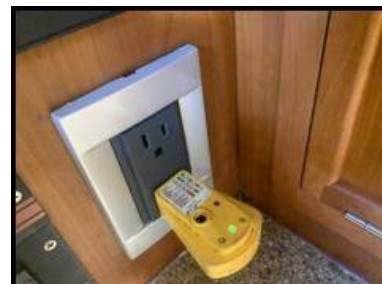
Polarity Test: Polarity test indicated portions of wiring are not connected properly, an OPEN GROUND may be present, service is needed (**ER**).

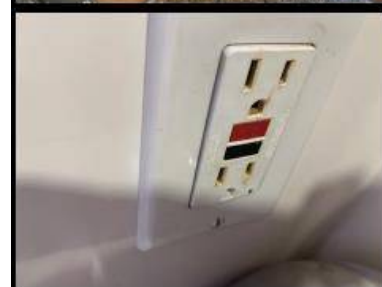
GFCI protection: Burnt outlet sighted at galley area replace as required (**ER**).

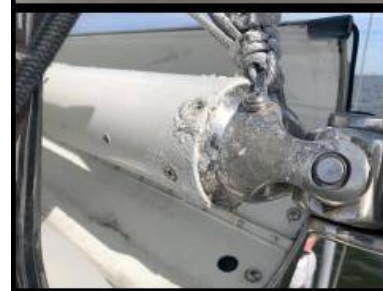
Forespar Leisurefurl in-boom furler. **NOTE: The inboard end of the boom and universal gear should be cleaned (salt and corrosion) and lubricated. Assure that there is no built up salt and corrosion regularly (RR).**

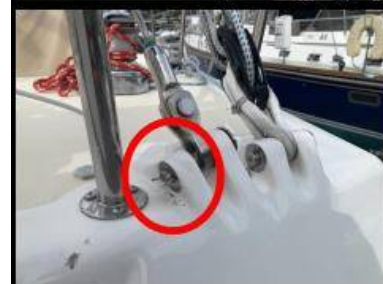
The chainplate attachment are made of carbon fiber. The fixtures do show some fractures and loose coating. It is prudent to have them inspected by a qualified FRP technician (**RR**).
