### ENGINE SURVEY

DATE: 23/5/2025  
VESSEL NAME: S/Y SEAQUELL  
LOCATION: MARINA VELA, BARCELONA

ENGINEER CARRYING OUT SURVEY: HOWARD MAINWARING SMART

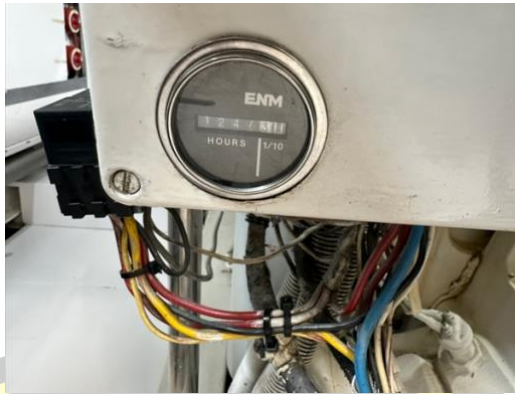
**Running hours: 12473 + On this counter there are a marking indicating this is not correct and extra hours to be added. The real hours I do not know 100%.**

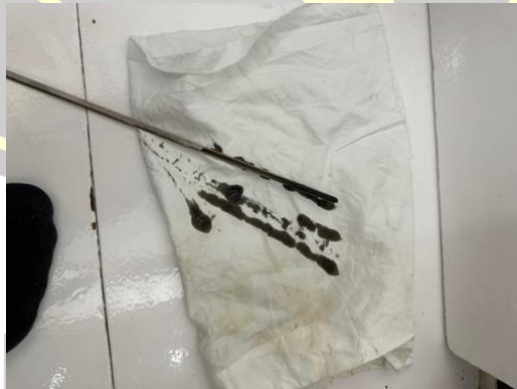
**Engine oil checks. The oil level was correct and the oil Viscosity seemed ok without Oil sample checks only visual and feel test. They does seem some carbon content as you can see in the on the white cloth. Although normal I would recommend a engine oil change soon.**

**No metal file content could be seen or any hard materials found inside the oil from this visual check.**

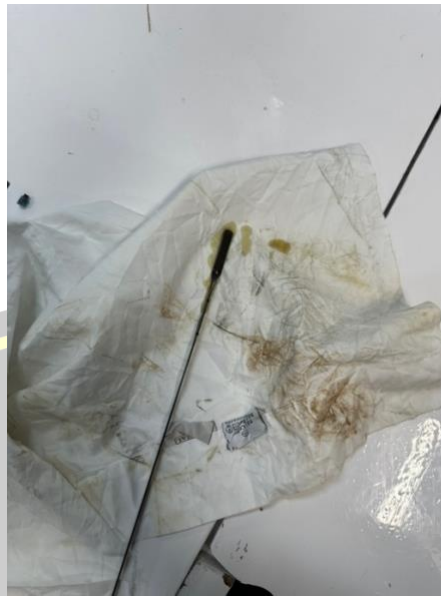
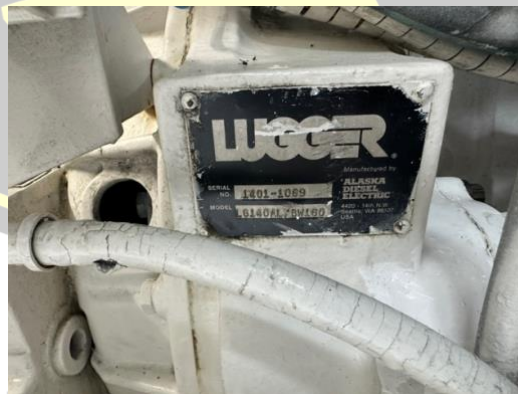
**Gear box oil below. The level was correct and no visual signs of water content from the color. This oil is in very good condition and is clean. No oil samples were taken only visual checks.**

**Original engine plate still present.  
Lugger Serial: 1401 – 1069  
Model: L6140AL / BW160**

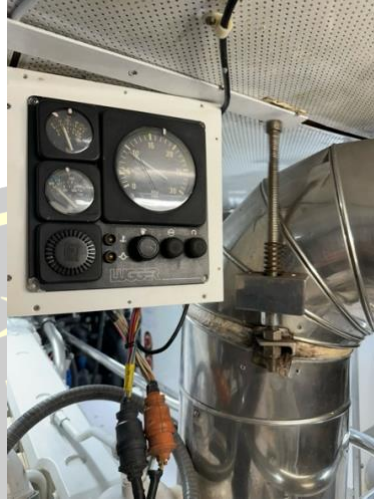
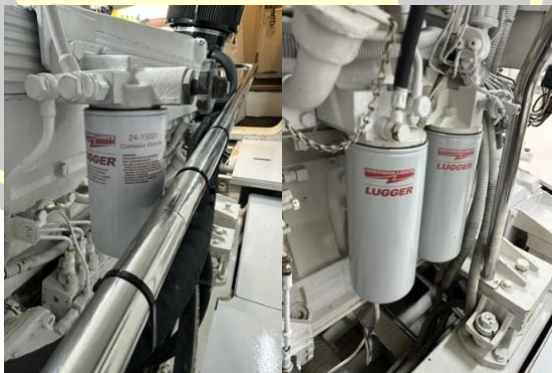
Engine first start up there is visual oil pressure 3.2Bar or around this pressure from analogue gauge with only around 40 degrees. Engine starts first time and runs correctly. We would expect to see higher oil pressure on start up around 4.7 – 5Bar. This would indicated that the engine is soon due a overhaul or investigation into the oil pressure. Once engine running we could also hear that the valves were tapping and would definitely recommend valve clearance checks & adjustments be carried out soon. Adjustments to the owners manual.

All filters are visually new and genuine units.

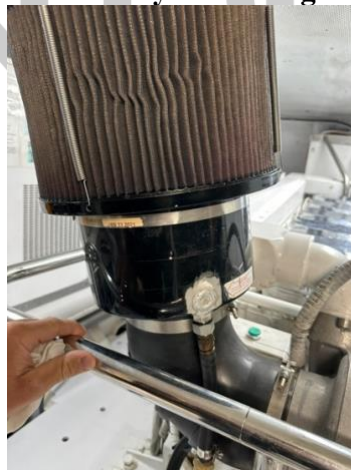
We can see in the photo the air filter housing has had a modification. Filter was working but recommend cleaning or replacement.

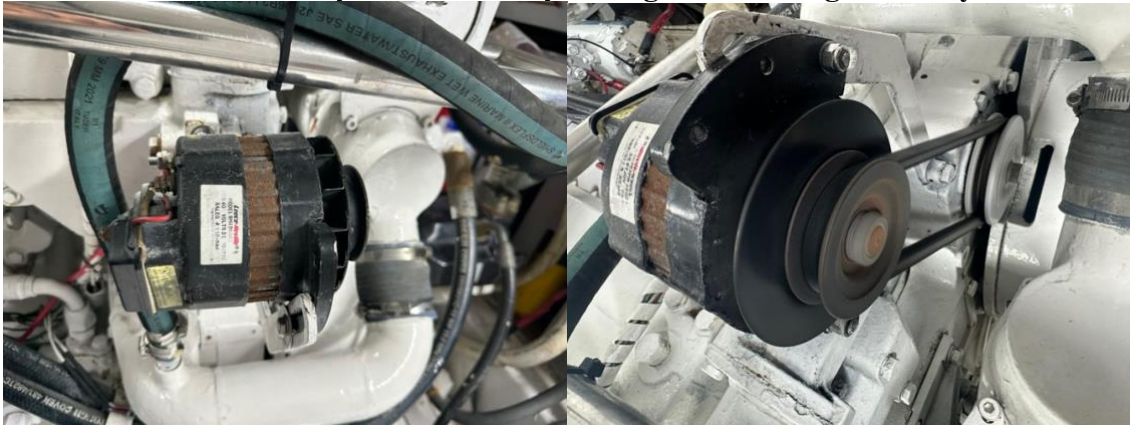
**Engine alternator functioning and operating correct output from gauge I can see. When running we can hear the bearing noise. I would recommend this unit be serviced or replaced. But is operating and working currently.**

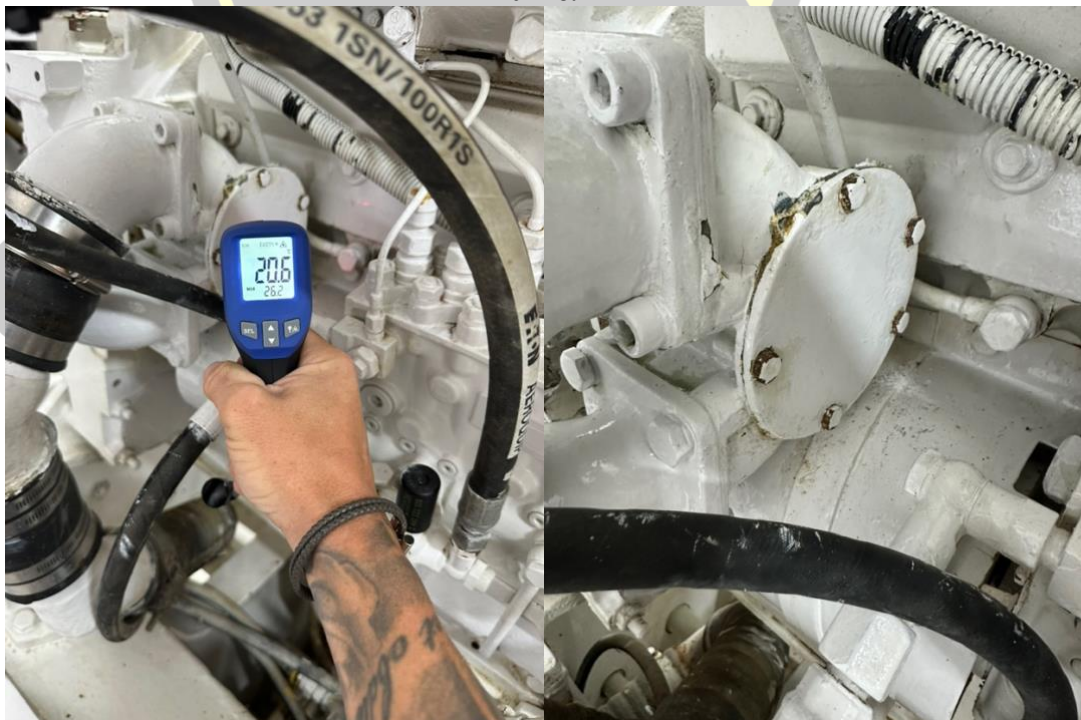
**Engine sea water pump No leaks present and running correct temperature. Salt debris and flaking to the rear impeller plate. No heat signs on the plate. Visually checking the sea water pump from the tell tail signs I recommend the sea water pump be removed and serviced. The rear gasket normal perish on the rear plates due to salt water and normally indicates the impeller has not been replaced for some time.**

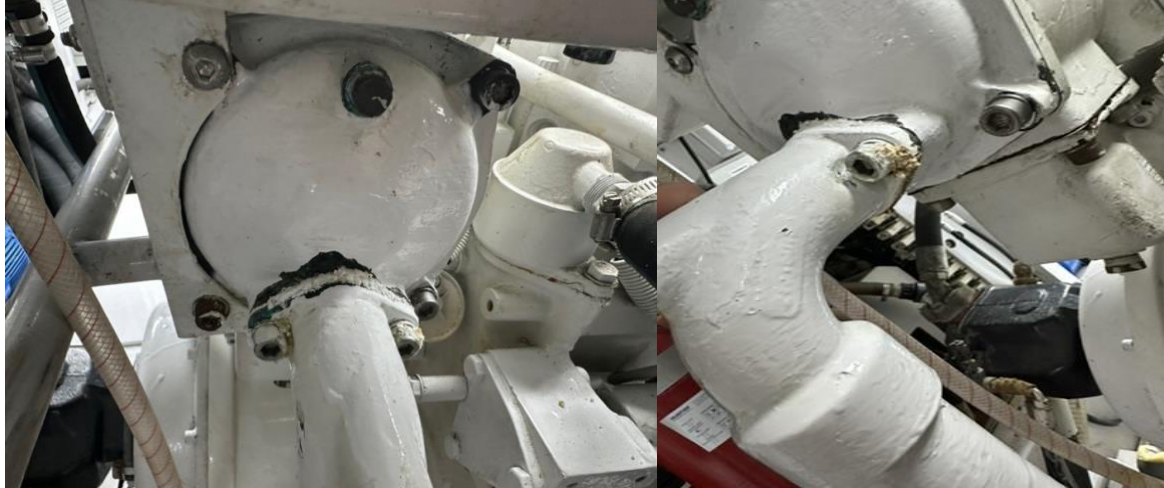
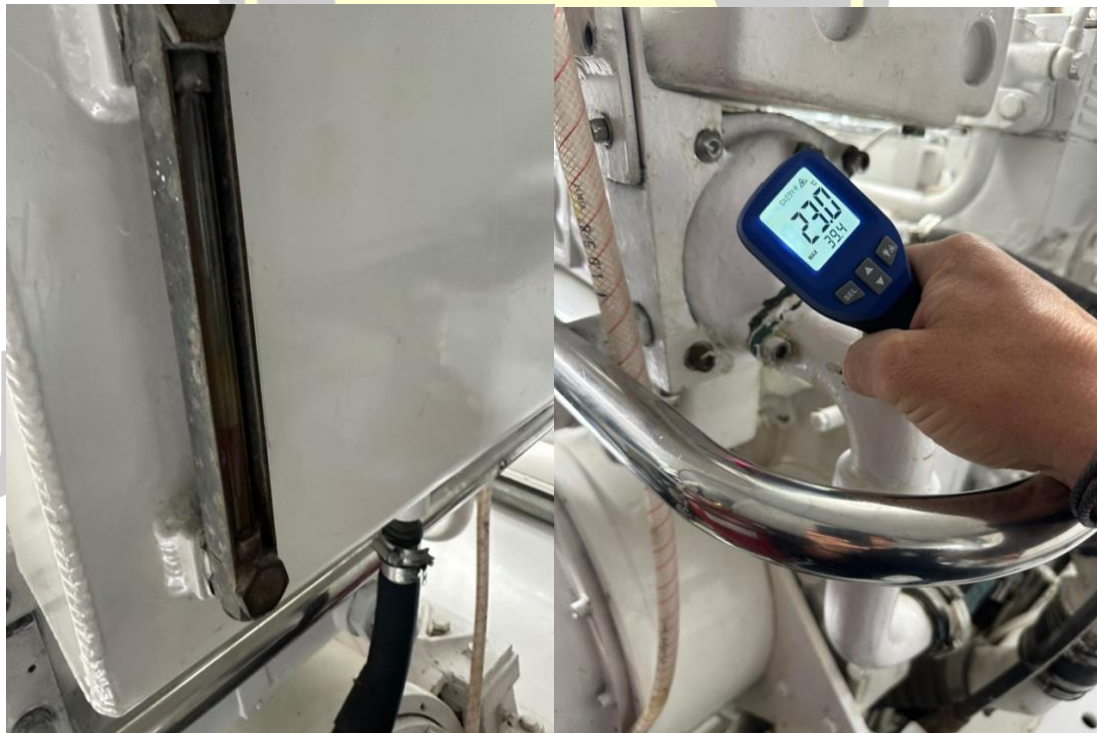
**Engine sea water heat exchangers and coolers. Coolant level was correct and no signs of debris. Temperature was a good and consistent. No signs of overheating. Visual checks as you can see in the photos again the gaskets are perished and salt is protruding the connection. I would recommend anodes be checked and replaced. Heat exchangers removed, serviced and pressure tested. No visual leaks present hot or cold**

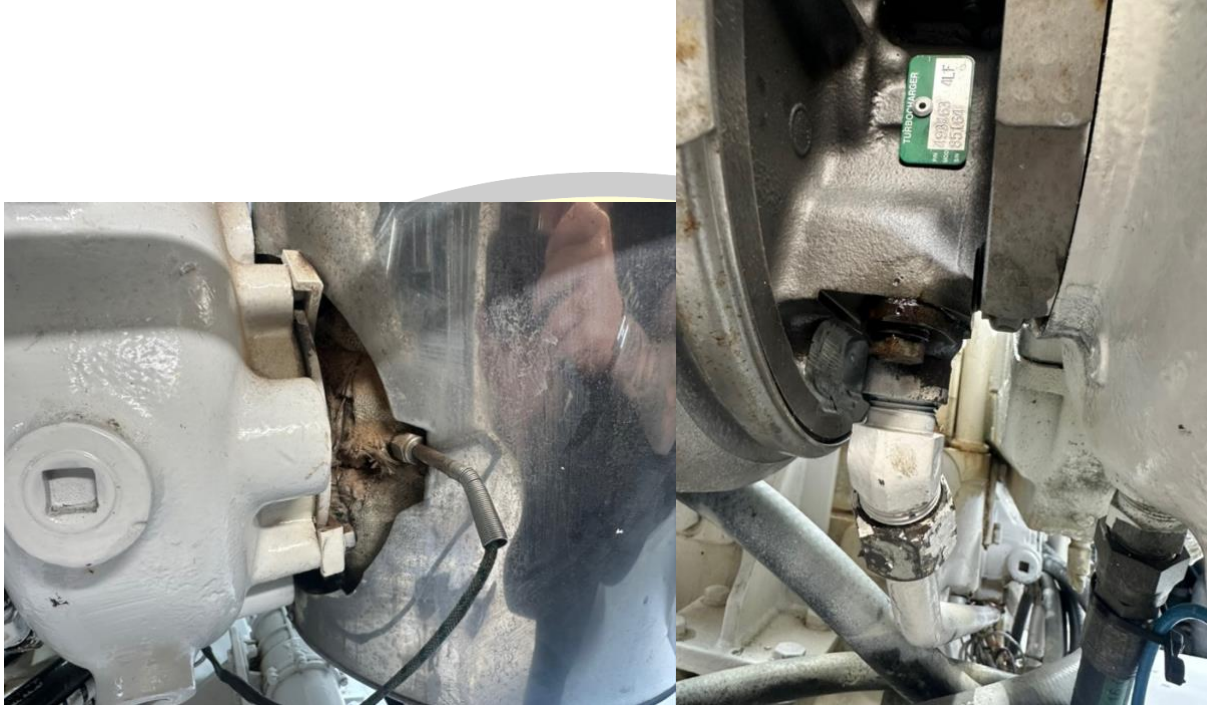
**Engine turbo. No signs of smoke or overheating Internally. There is a small oil leak on the turbo oil return. I would say the turbo looks in good condition and the Cartridge for the turbo is new but not a genuine unit. Operation of the turbo was correct and boosting pressures correct.**

**The exhaust heat wrap material you can see inside is burnt. This happens over long periods and is very normally but I would recommend replacement to stop the fiber particle material going inside the engine and clogging the air filter.**

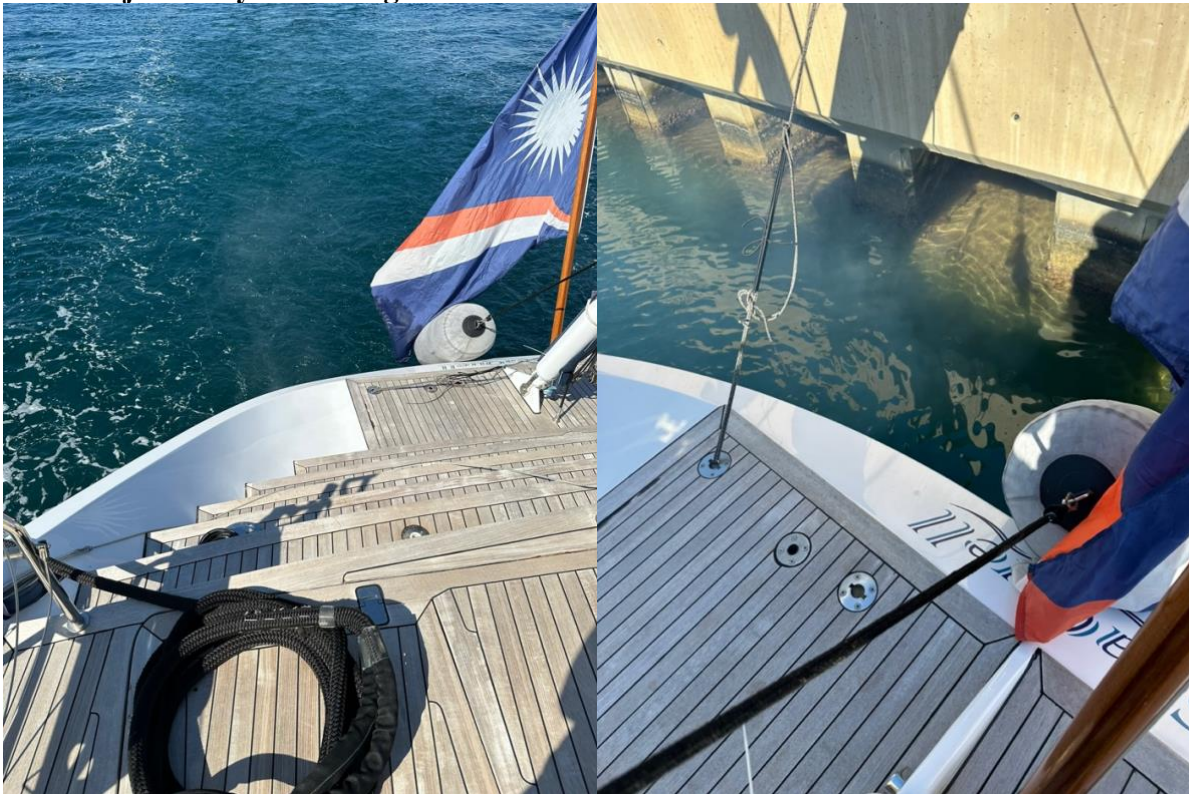
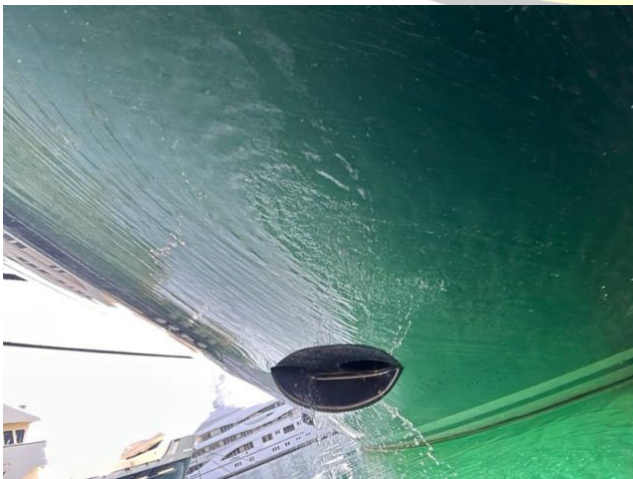
**External exhaust visual black smoke worse when cold but also visual on the trip. This would need more investigation. Can be a number of factors starting with turbo outlets being clean to fuel injection system being checked.**

**Over boat outlets working well and a good flow of water coming out from the engines.**

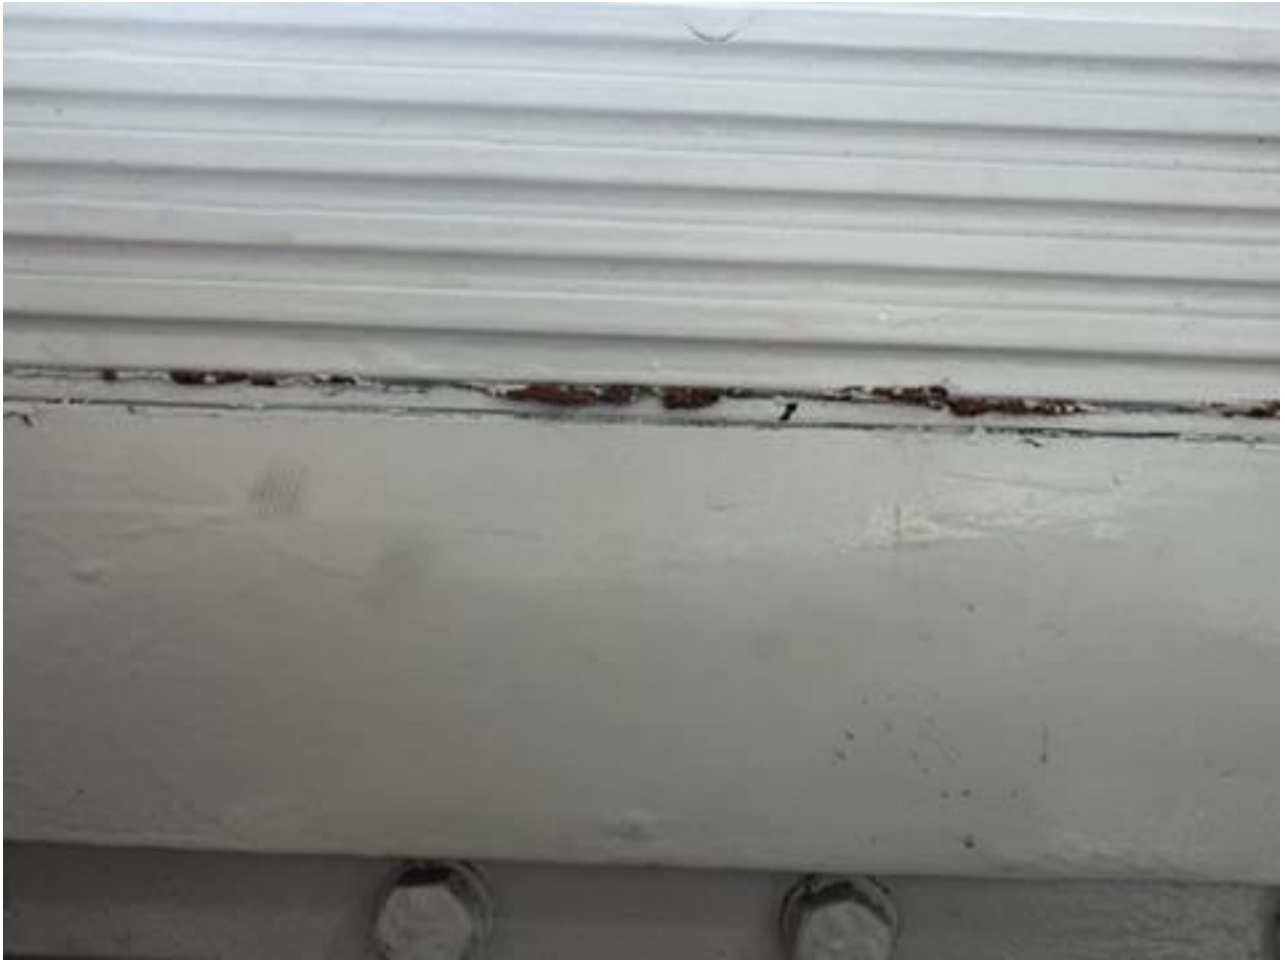
**This is the gasket from the exhaust manifold cooler and would suggest it has been removed and service from the silicone gasket sealant used. Unsure if there is a original gasket present. No signs of any leaks.**

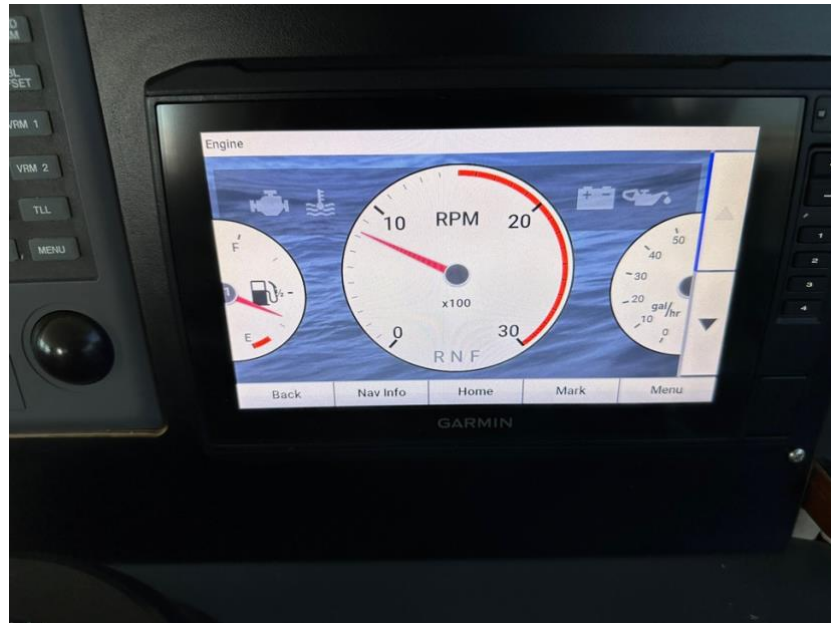
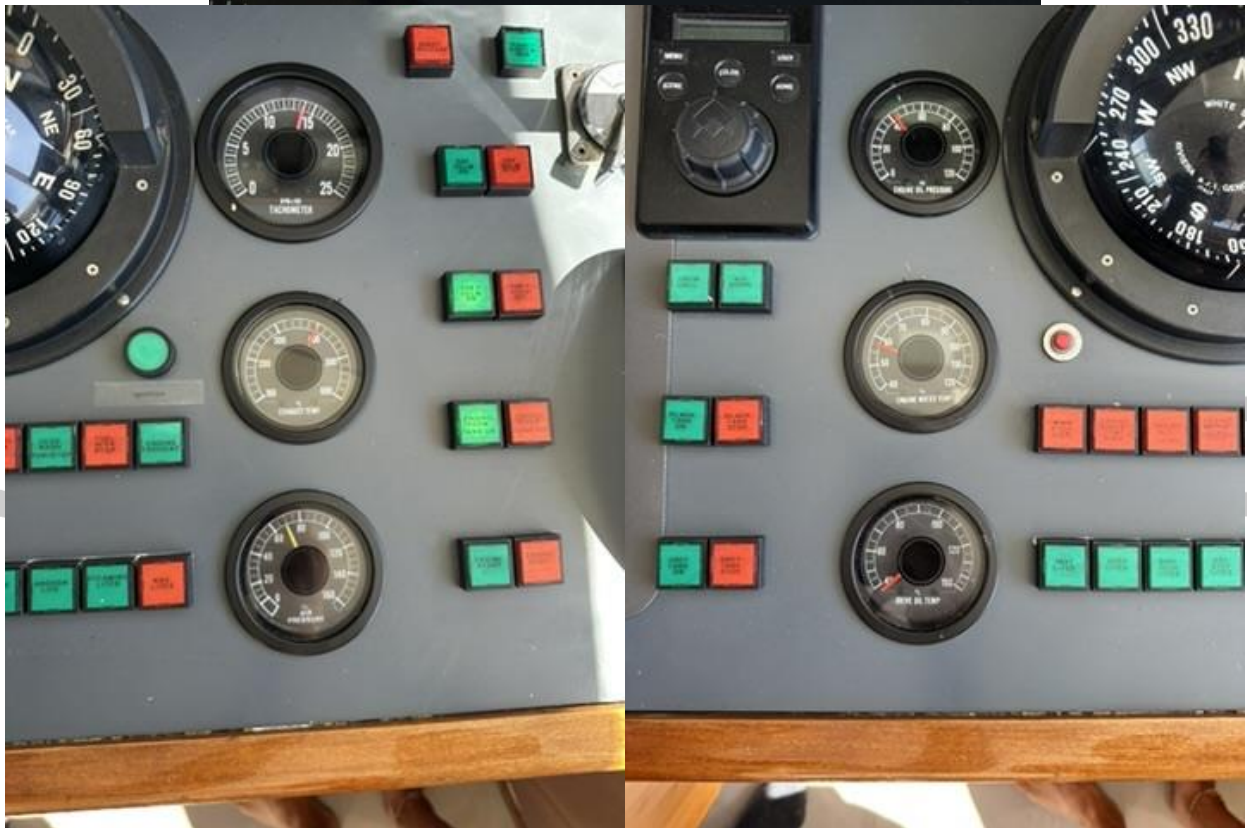
**Engine Digital and analogue gauges working. Digital gauge slight delay but this is to be expected.**

**The gauge in the right bottom photo was not functional would need investigation.**
