CONDITION SURVEY REPORT

SAILING YACHT :
" SURAMA "

DATE:
March 23, 2026

REPORT NUMBER:
CS02Q19

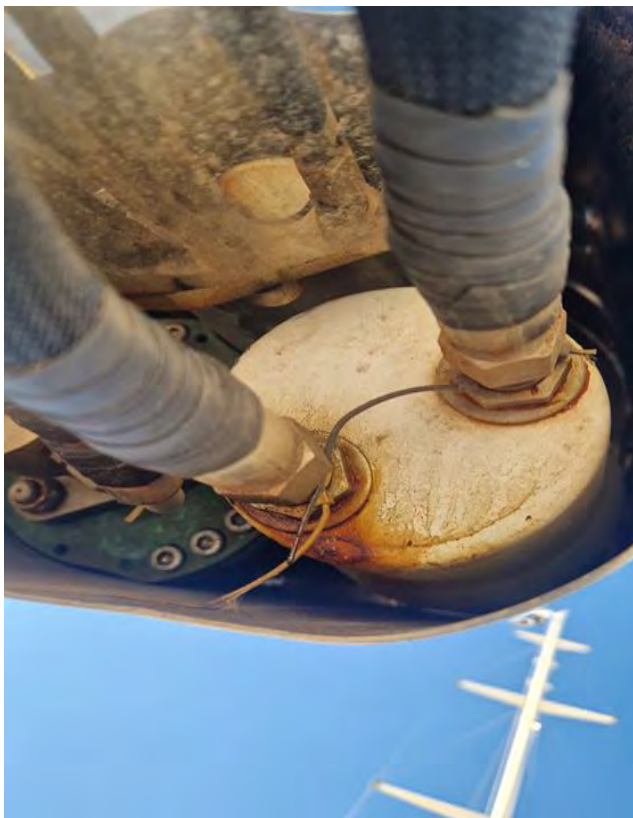
Hydraulic motor minor rust and leak (pic1)

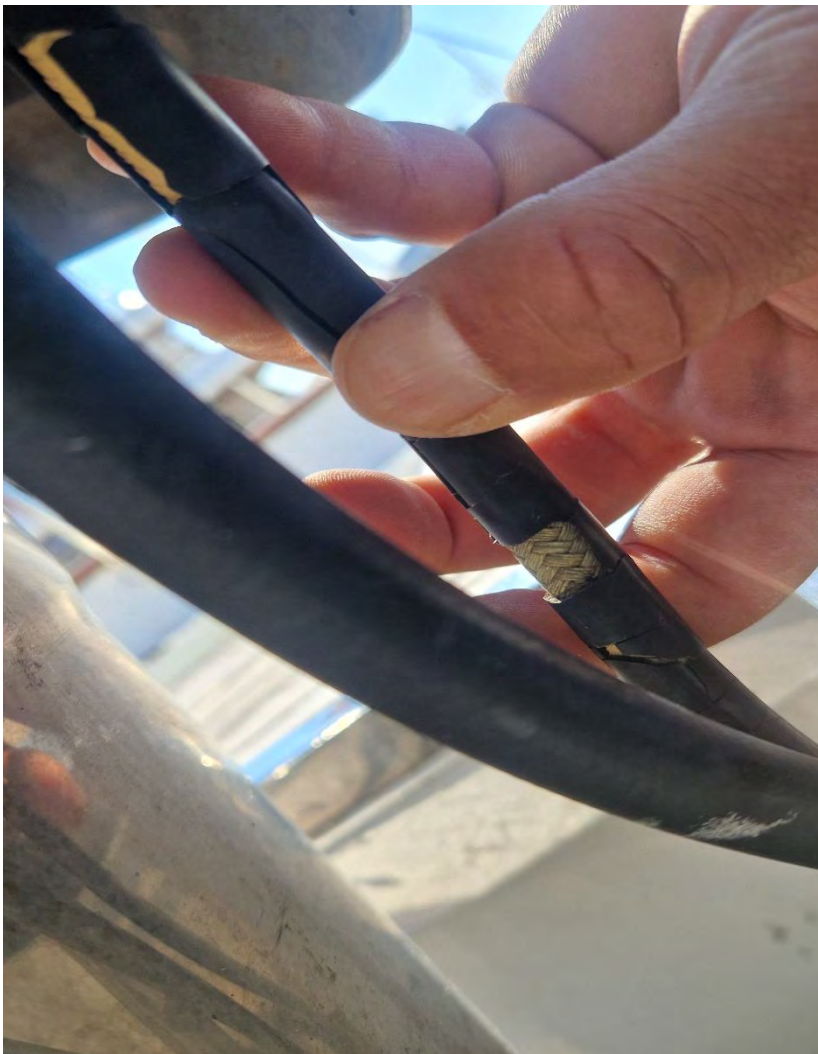
Tensorer hose needs replacement (pic2)

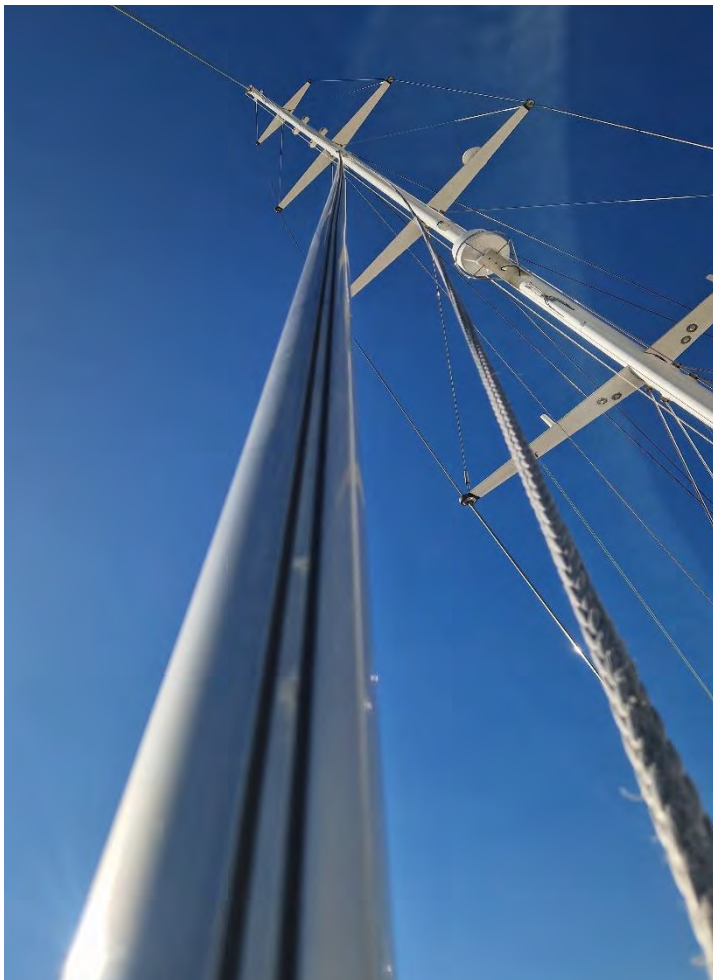
Small bend in lower profile (pic3)

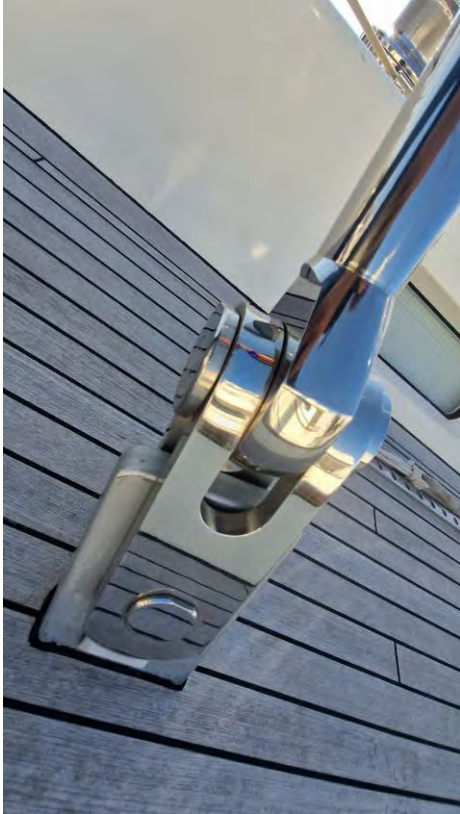
Chainplate in good condition (pic 4)

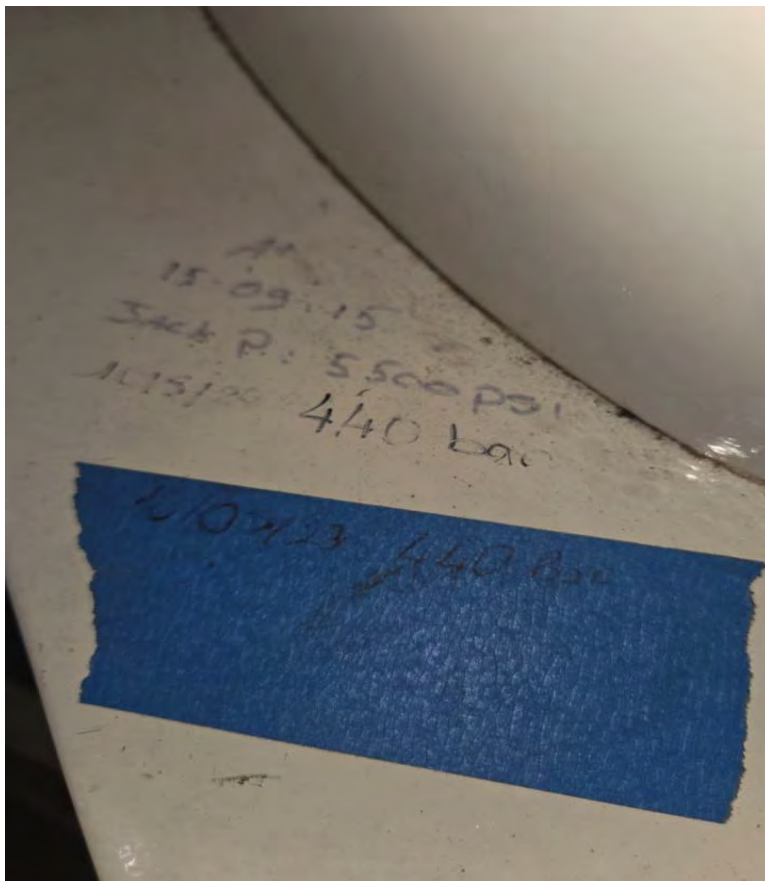
Minor paint bubbling, in good condition in general

PS: we did not perform hydraulic test but there is a 16/5/2023 sticker that indicates pressure measurement at 440 bar (pic5)

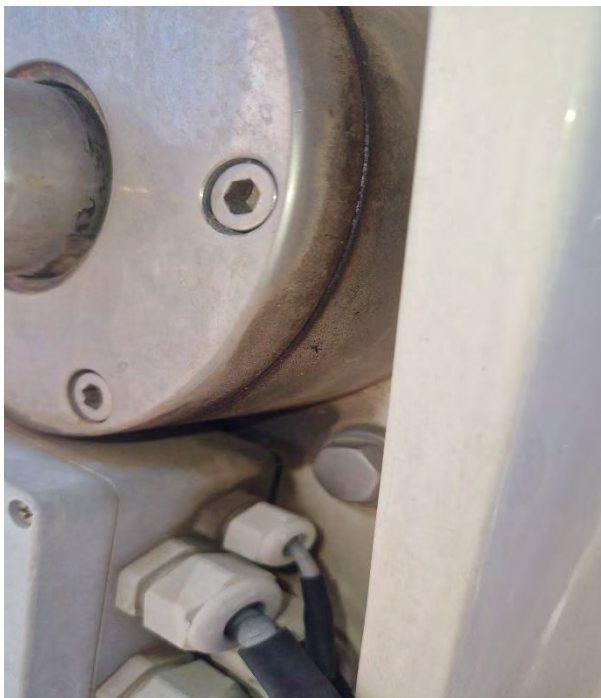
Small crack on the join plate carbon/aluminium NEED TO BE INSPECTED (pic6)

Mandrel hydraulic motor minor leak (pic7)

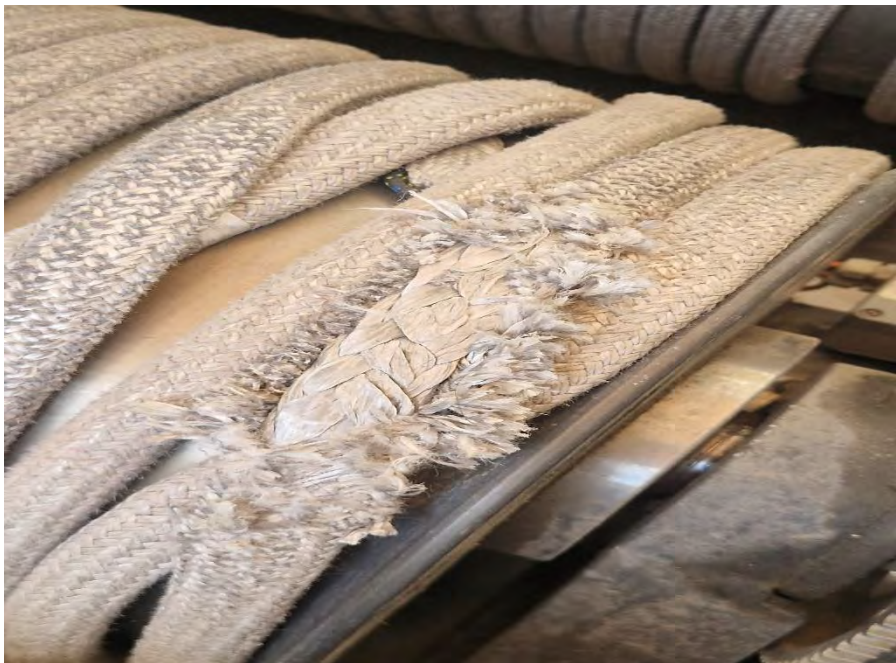
One heavy chafe on the port genoa sheet (pic8)

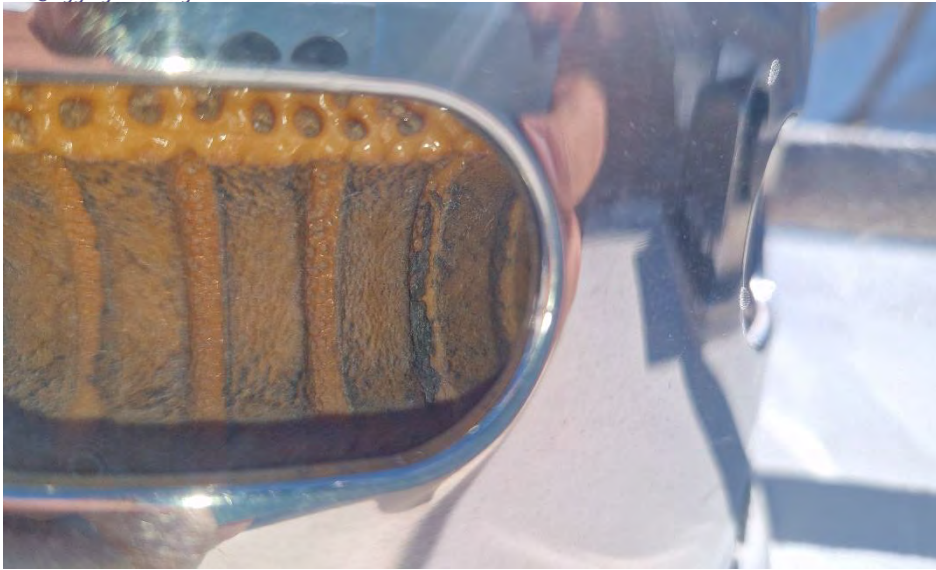
RONDAL prefeeder wheels in medium condition (pic9)
