**CONDITION AND VALUATION REPORT FOR PRE
PURCHASE PURPOSES**

NAME OF VESSEL "TA-BOO" 1970 Rybovich 54' Sport Fisherman			
FILE NO. 062725			
SURVEY REQUESTED BY Dale Matteson P.O. Box 981, Palm Beach, Florida 33480			
UNDERWRITER OR INSURANCE COMPANY Unknown			
CONTACT Dale Matteson 702 592 4200			
OWNER Dale Matteson			
MASTER Same			
SURVEY DATE 02/27/2025, 06/25/2025, and 06/27/2025		DATE OF THIS REPORT 06/27/2025	
DOCUMENTED NO. 524622	STATE REG. NO. N/A	REG. PORT Ocean Reef, Fl.	
USE Pleasure			
LOA: 54'	LWL	BEAM: 15'6"	DRAFT: Per 3'6" Reported
G.T. 40 GRT Per document	N.T. 32NRT Per document	SPEED 20.8 Knots Cruise at sea trial	
HULL NO. 72 Reported/ No Hull ID		ENGINES Two Mann 2848LE403's 800 HP reported with ZF transmissions	
HULL MATERIAL / CONSTRUCTION Cold Molded Wood/Fiberglass			
WHERE PURCHASED Unknown			
ORIGINAL PURCHASE PRICE UNKNOWN			
DATE LAST HAULED February 2025 Cracker Boy Boat Works, Riviera Beach, Florida			
DATE OF PRESENT HAULING, IF APPLICABLE Same/ Survey was performed in water on 6/20/25 and the haul out February 2025

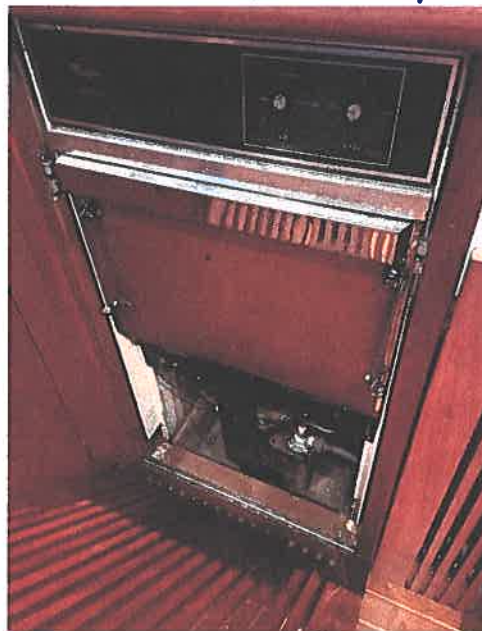
Stove Lots of
CORROSION *

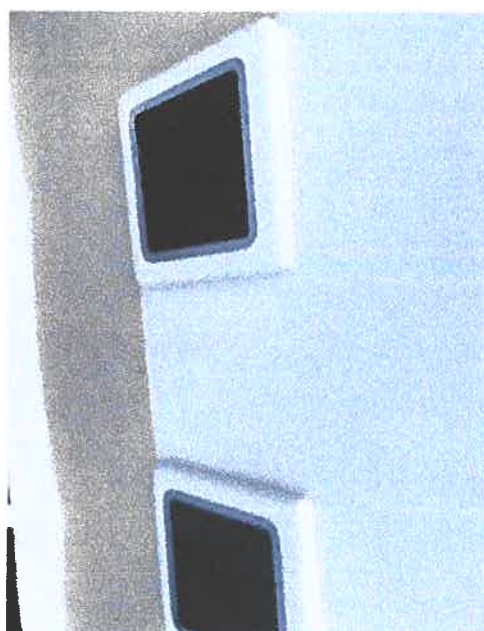
HIGH MOISTURE
WINDASS FOOT SWITCH

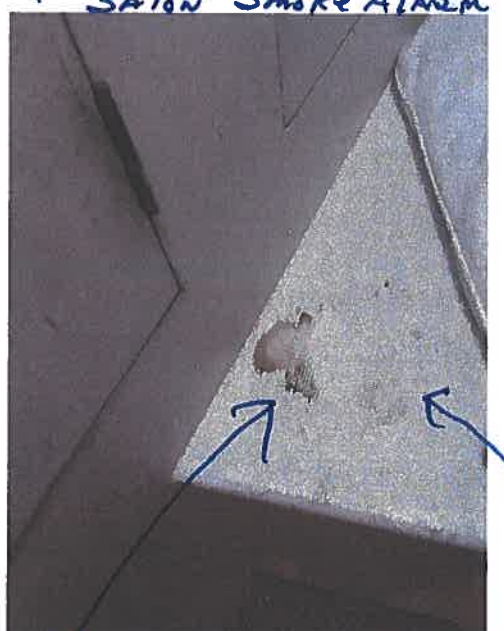
LEAK FROM FORWARD
HATCH

9. Forward windows have been leaking and need to be resealed. Areas inside the salon are already damaged.

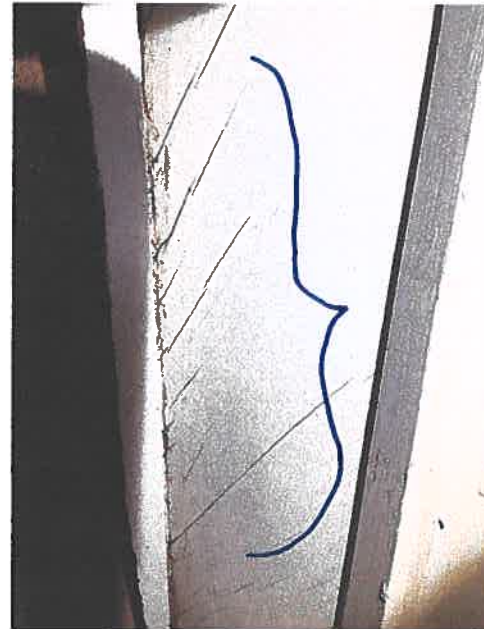
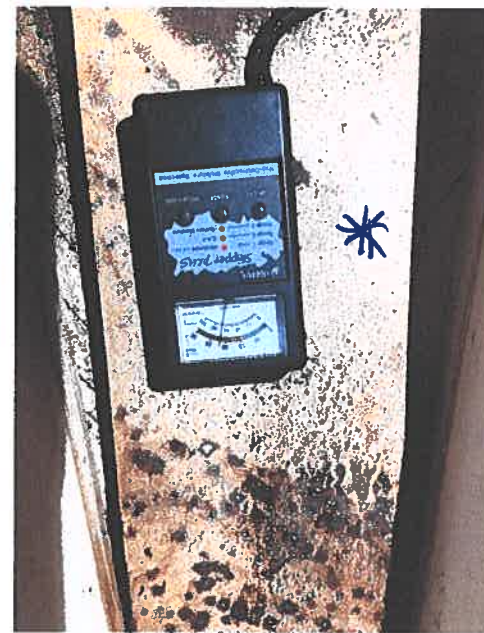
12. The top side of the keel inside the vessel under the staterooms shows

high contents of moisture and some bolt deterioration. Needs to be checked thoroughly to see if the keel is compromised after that area is dried out.

Keel Inside - High Moisture

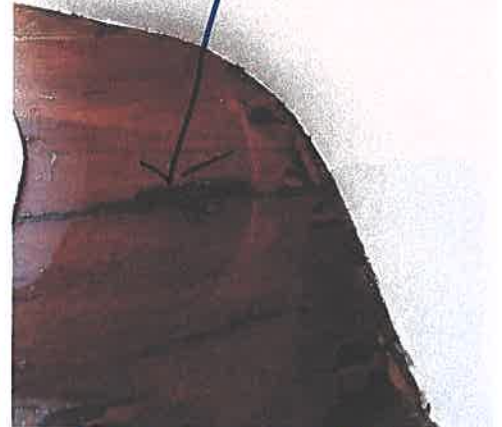
FORWARD WINDOW LEAKING

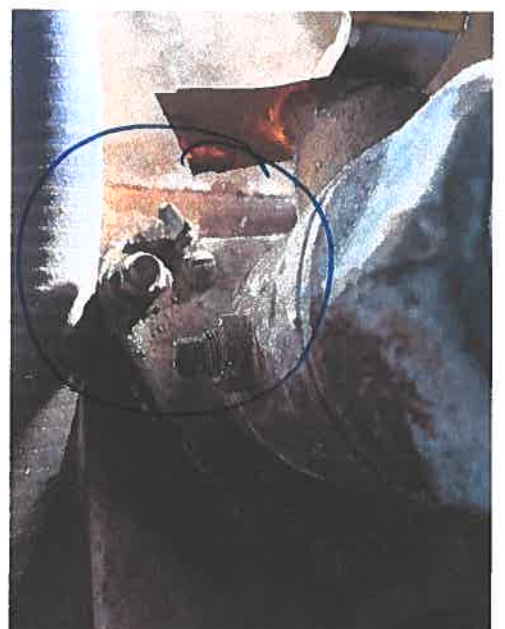
BROKEN BONDING WIRE

FROM THE HULL + INSIDE
NEEDS EXTENSIVE INSPECTIONS *

3. In the aft lazarette, electrolysis was noted around the rudder shafts, broken bonding wires and leaks. Also, the trim tab actuators appear to have issues where they go through the hull. Bonding is crucial to a cold molded vessel and fasteners, suggest a marine electrician to prove bonding system and eliminate any stray current.

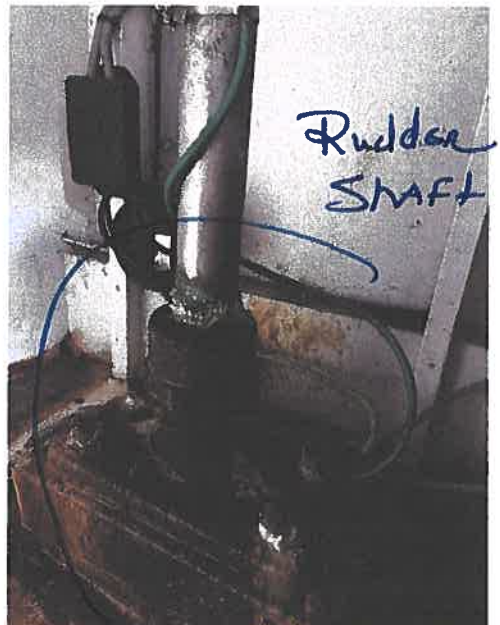
CORROSION Poor Bonding

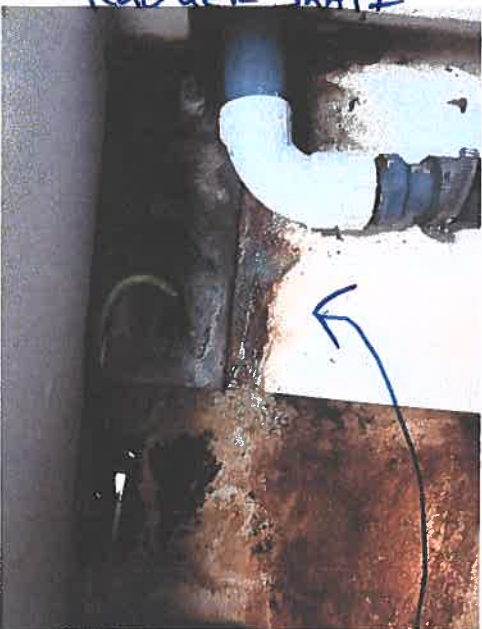
Poor Bonding

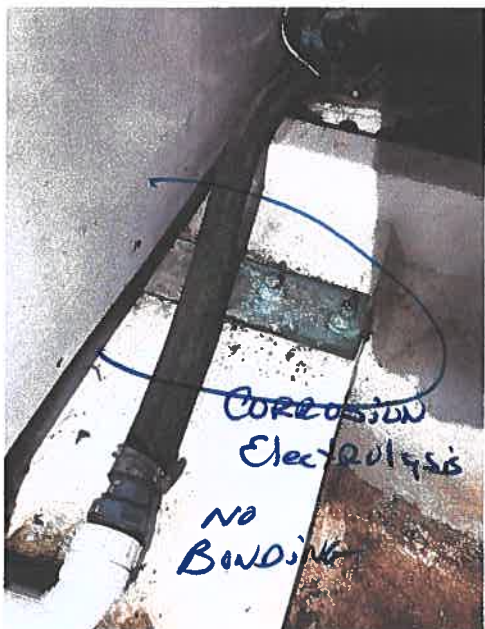
CORROSION
Electrolysis
NO
Bonding

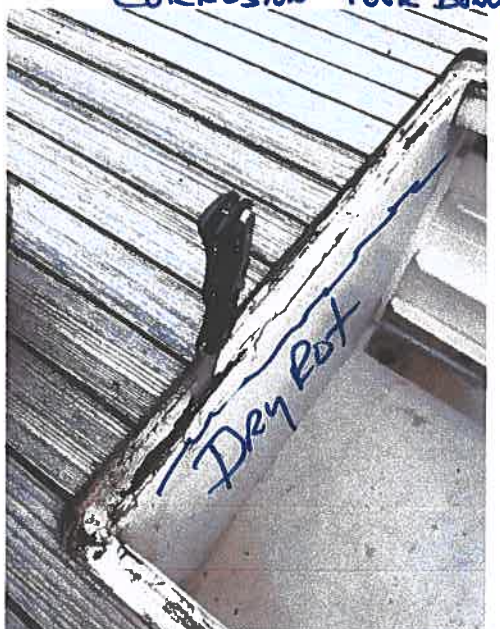
Dry Rot

Aft Deck Compartments AND Dry Rot *

11. Compartments on the back deck show lots of dry rot and will need repair. Check out pictures. Aft teak deck sole is losing its integrity, dry rot by the cabinets, see pictures, Teak on the gunwales will need to be replaced soon from cracks, age and water intrusion.
