Pantropic Power TA1 Marine Engine Inspection Form

Inspection Number	21432898	Customer No	4028411
Serial Number	RPM01142	Customer Name	Blaine Watson
Make	CATERPILLAR	Customer Phone	4432546614
Model	C32	Customer Email	melinda_mercado@pantropic.com
Equipment Family	ENGINE - MARINE	Work Order	SC142299
SMU	138 Hours	Completed On	2/27/2025 3:36:50 PM
Location	1601 SW 20th St, Fort Lauderdale, FL	Inspector	Alex Seda, Fernando Guedez
Coordinates	3.83005110699999, 26.0979865468754, -80.1636130011835	PDF Generated On	2/27/2025
Technician

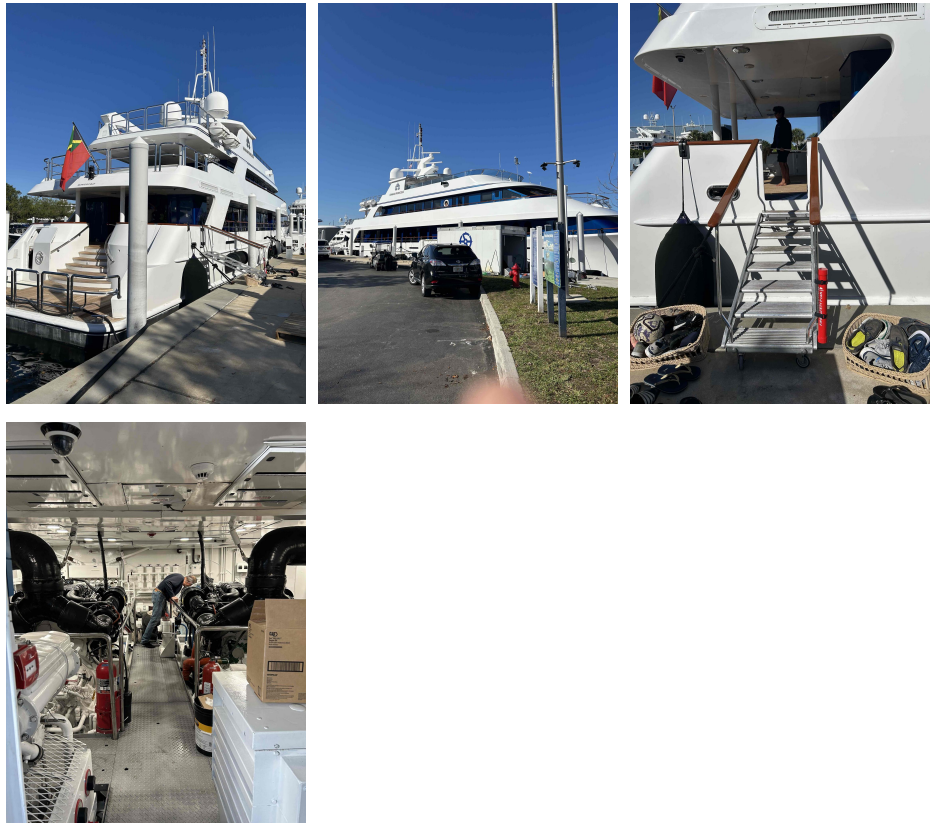
● **General info/Comments** NORMAL

Comments: EPE Inspection

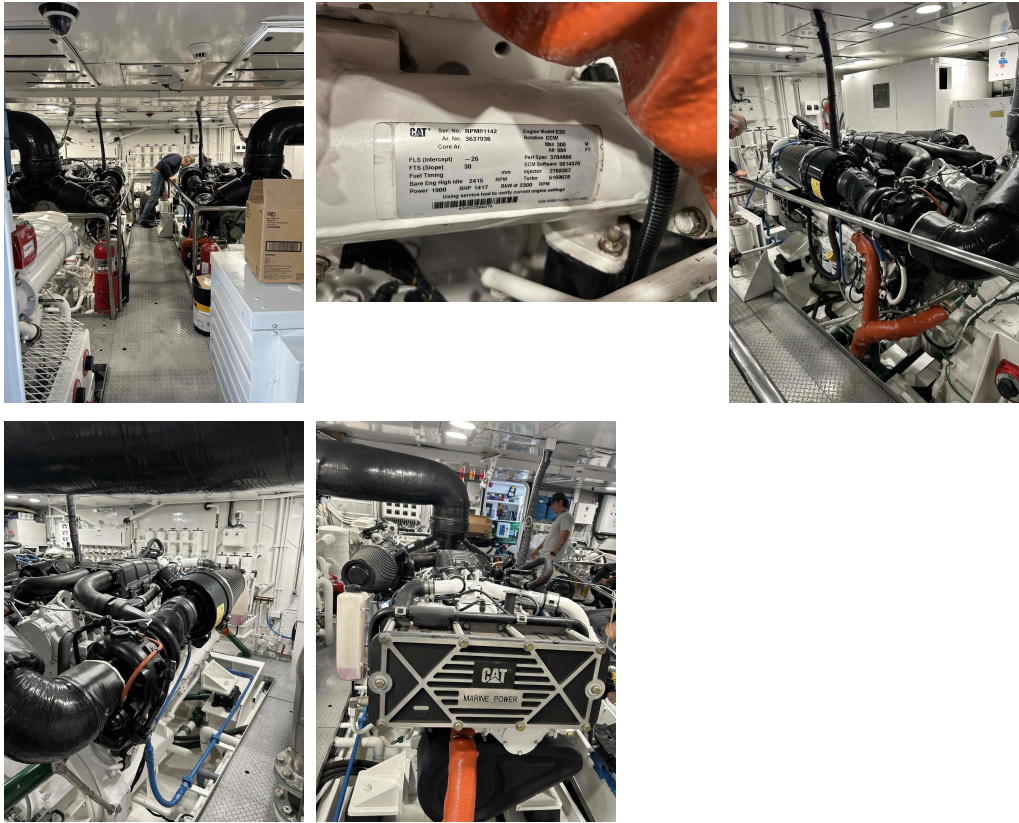
● 1.1 Prepare Marine Engine For Inspection

NORMAL

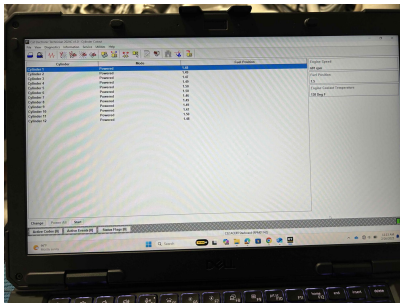
Comments: Took engine PSR
Completed cylinder cutout test

Image Comment(s):@600 RPM

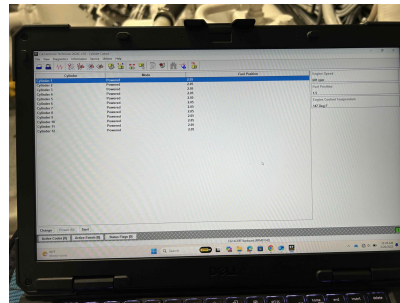
Image Comment(s):@1200 RPM

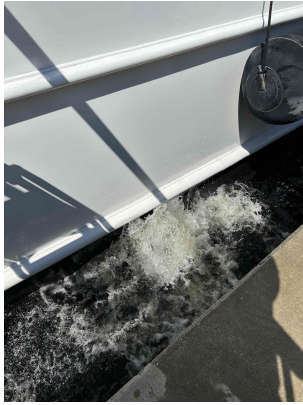
● 1.3 Observe engine exhaust colors and sheen on water.

Comments: No smoke present

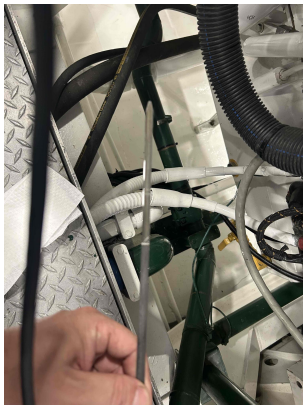
● **2.1 Engine Oil Level**

Comments: -Normal

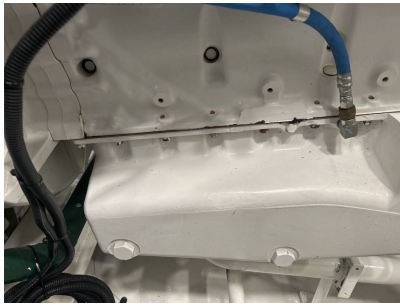
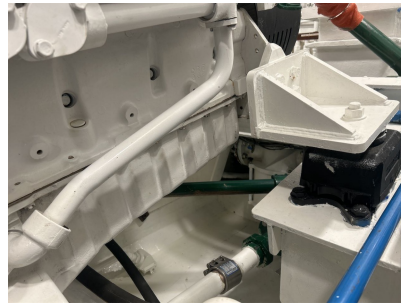
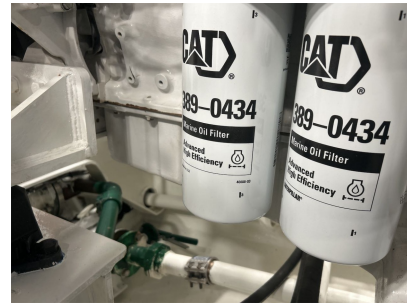
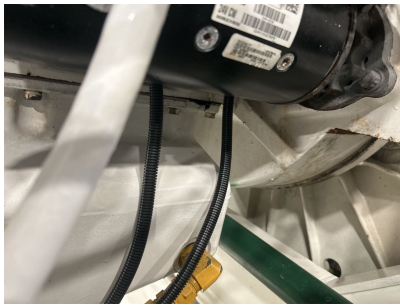
● **2.3 Engine Oil Pan**

Comments: -No leaks

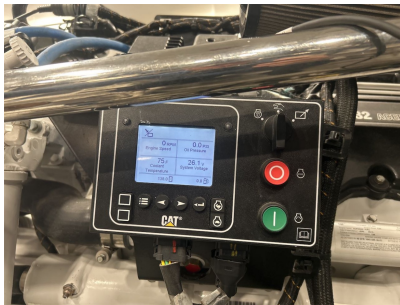
● 2.4 Inspect Indicators & Gauges (Panel)

NORMAL

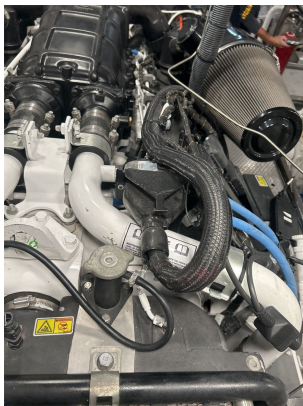
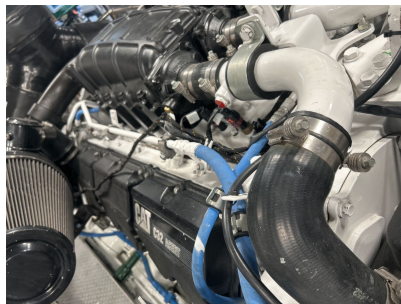
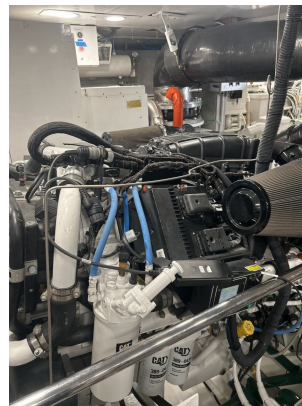
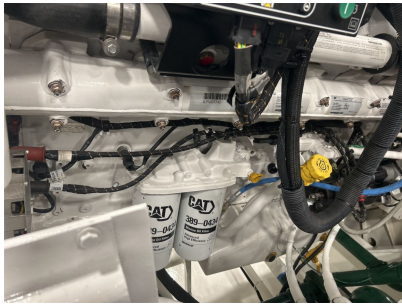
● 2.5 Inspect Engine Wiring & Harness

NORMAL

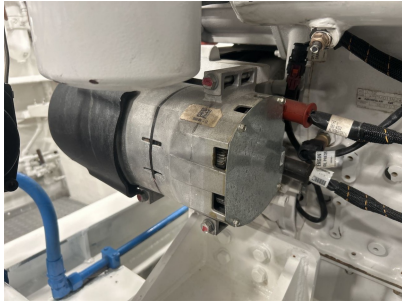
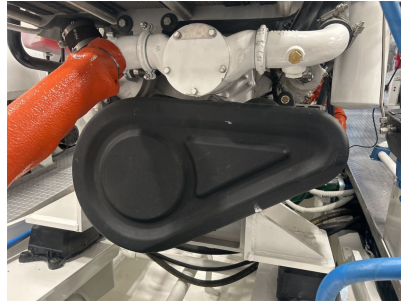
● 2.6 Pulleys, Belts, Compressor, Clutch and Alternator

Image Comment(s): Alternator good condition Image Comment(s): Belt and guard in good condition

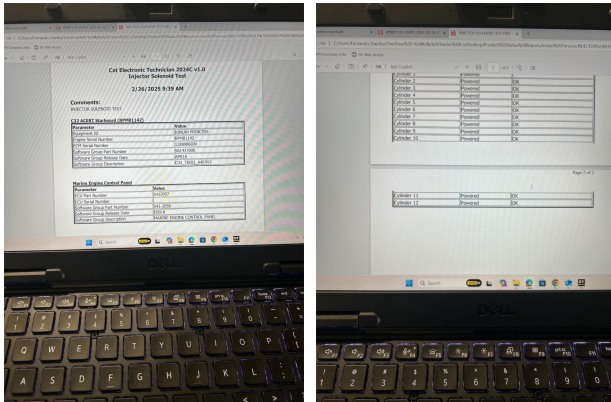
● 2.7 Injectors

NORMAL

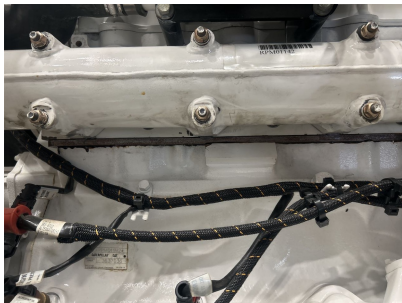
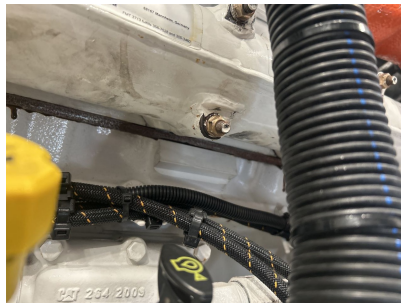
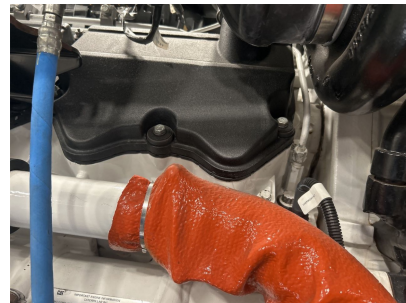
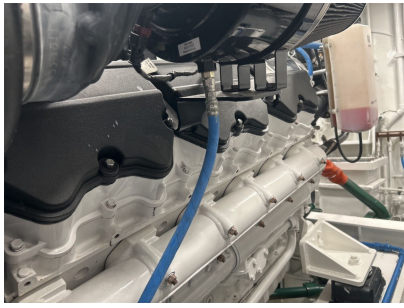
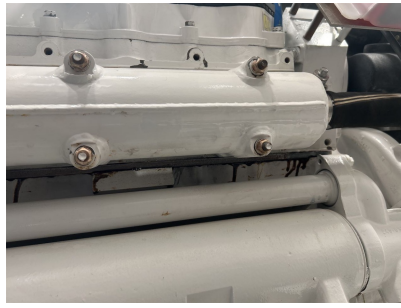
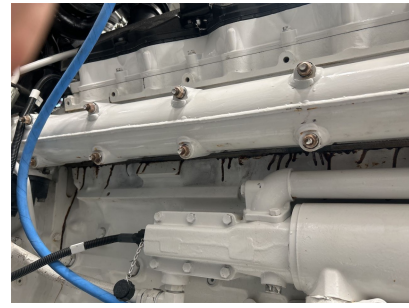
● 2.8 Cylinder Head(s) & Valve Cover(s)

Comments: No leaks

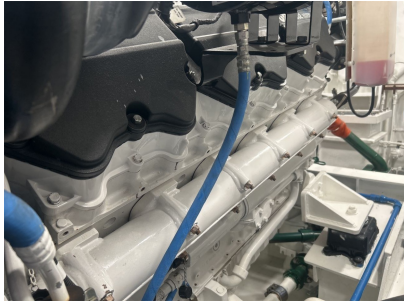
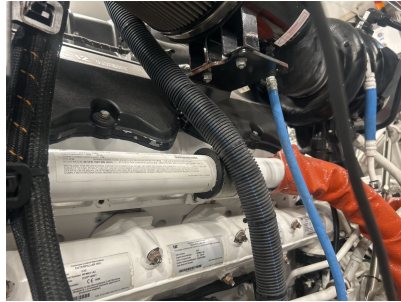
● 2.9 Rocker Boxes

Comments: No leaks

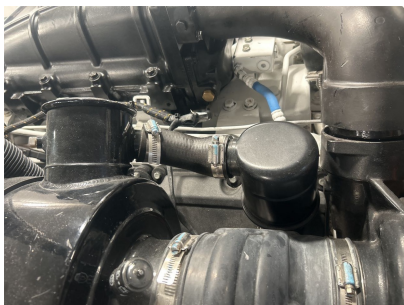
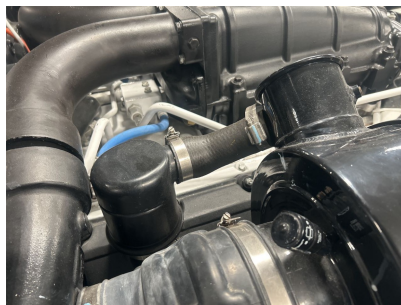
● 2.10 Crankcase Breathers and Piping

Comments: No leaks

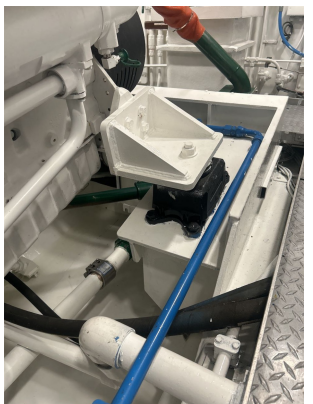
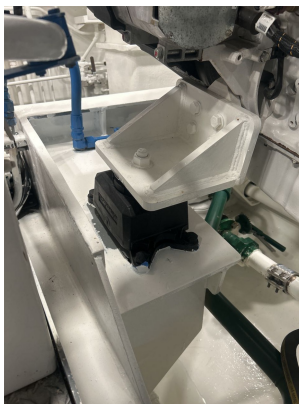
● 2.11 Engine Mounts, Isolators, Supports & Rails

NORMAL

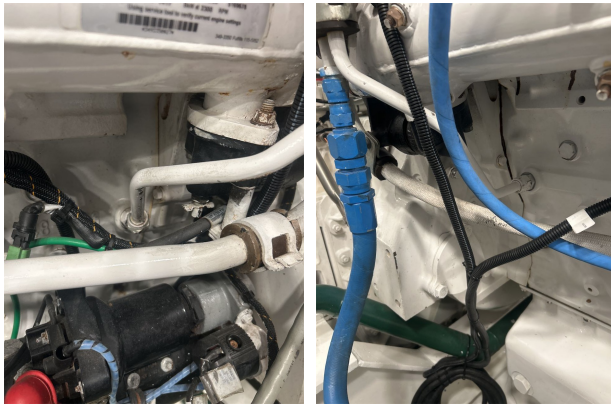
● 2.12 Flywheel Housing

Comments: No leaks

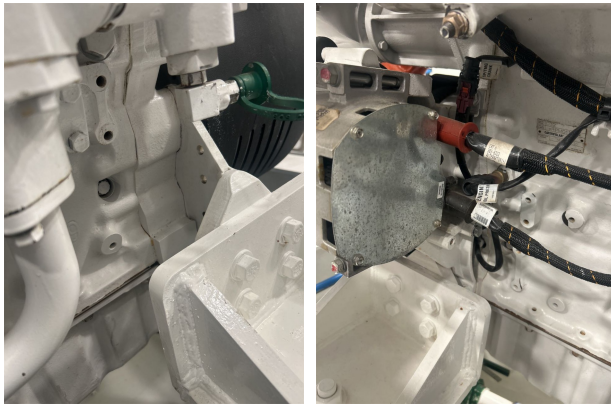
● 2.13 Front Housing & Covers

Comments: No leaks

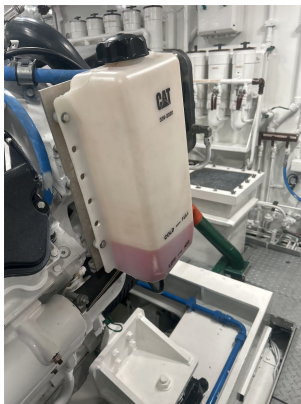
● 3.1 Engine Coolant

Comments: Ok

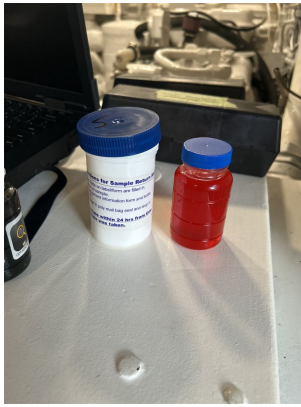
● 3.2 Collect Coolant Sample for Analysis

Comments: Took it and send it to lab

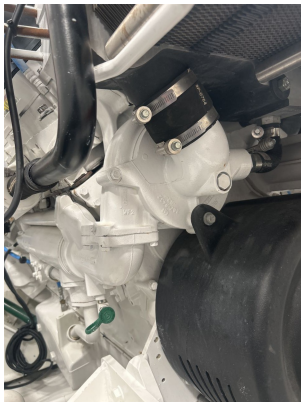
Comments: No leaks

Image Comment(s):Coolant pump

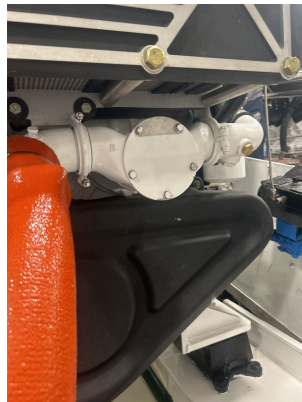
Image Comment(s):Sea water pump

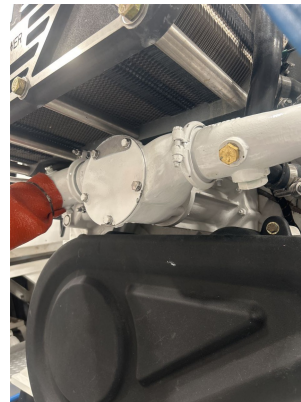
Image Comment(s):Sea water pump

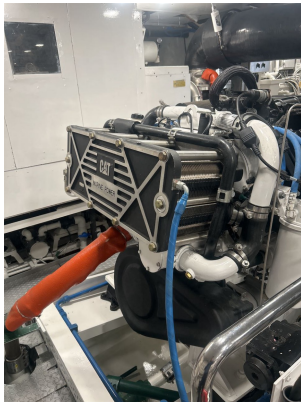
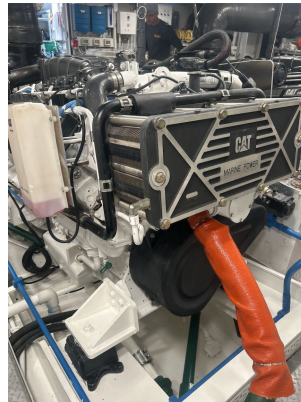
● **3.4 Radiator / Heat Exchanger Cap**

Comments: No leaks

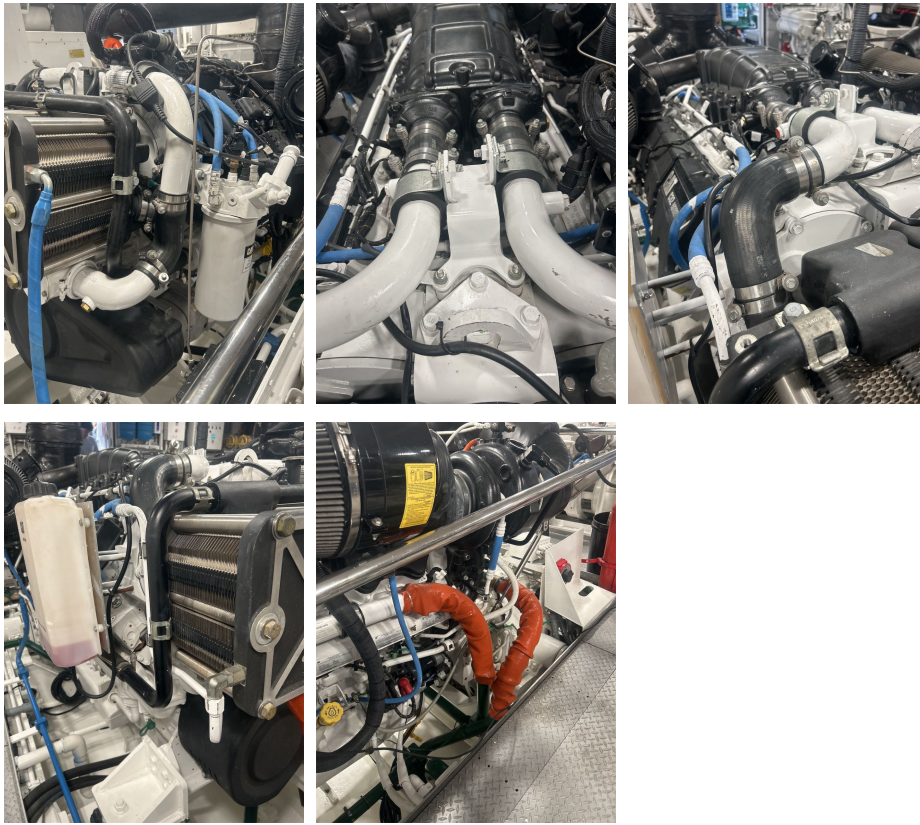
● **3.5 Water Hoses / Lines**

Comments: Good conditions

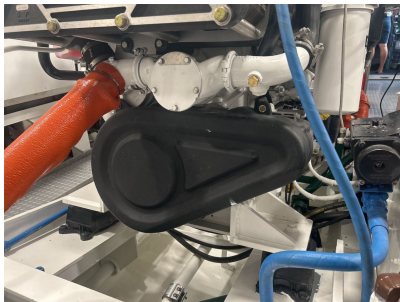
● **3.6 Belt Guards**

Comments: Good condition

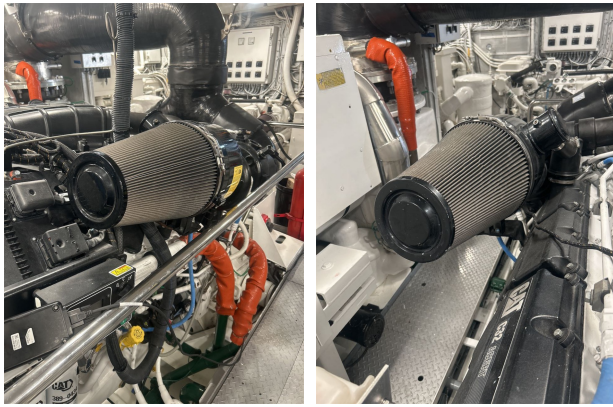
● **4.1 Air Cleaner and Precleaner**

MONITOR

Comments: They need to be lubricated

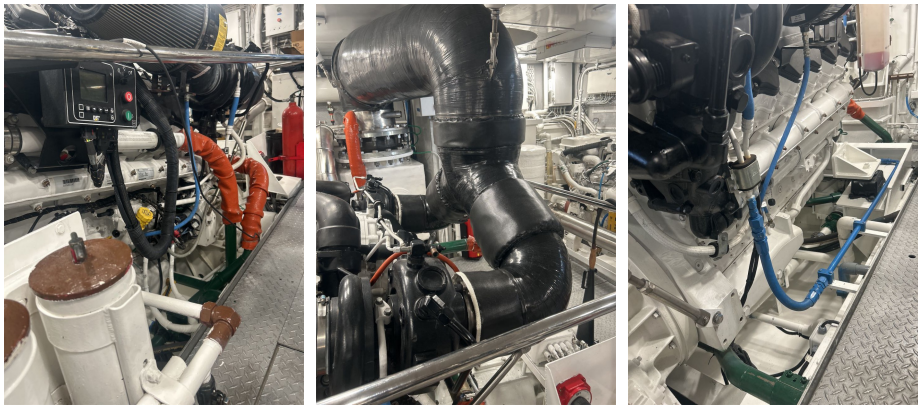
● 4.2 Air & Exhaust Lines

Comments: Good condition

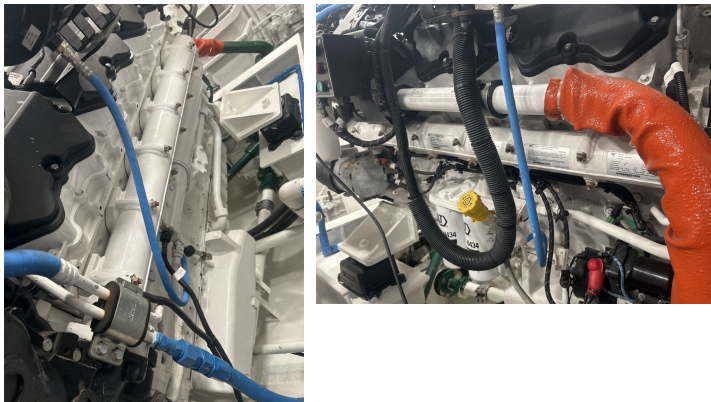
● 4.3 Exhaust Manifolds and Studs

NORMAL

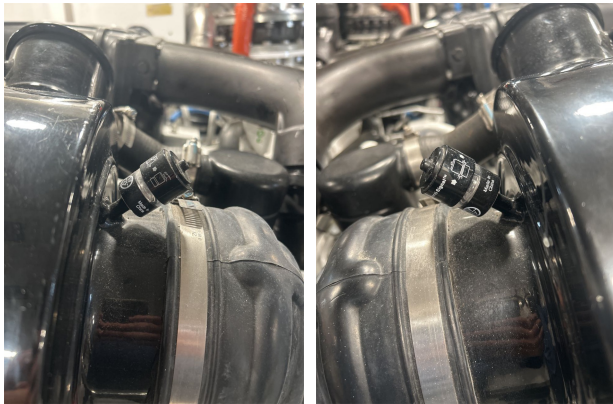
● 4.4 Air Restriction Indicator

NORMAL

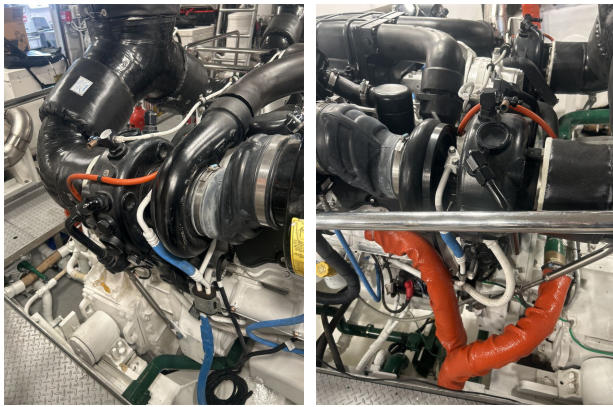
● 4.5 Turbocharger(s)

Comments: No leaks

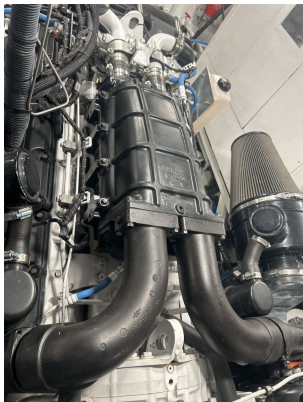
● 4.6 Aftercooler Housing(s) & Core(s)

NORMAL

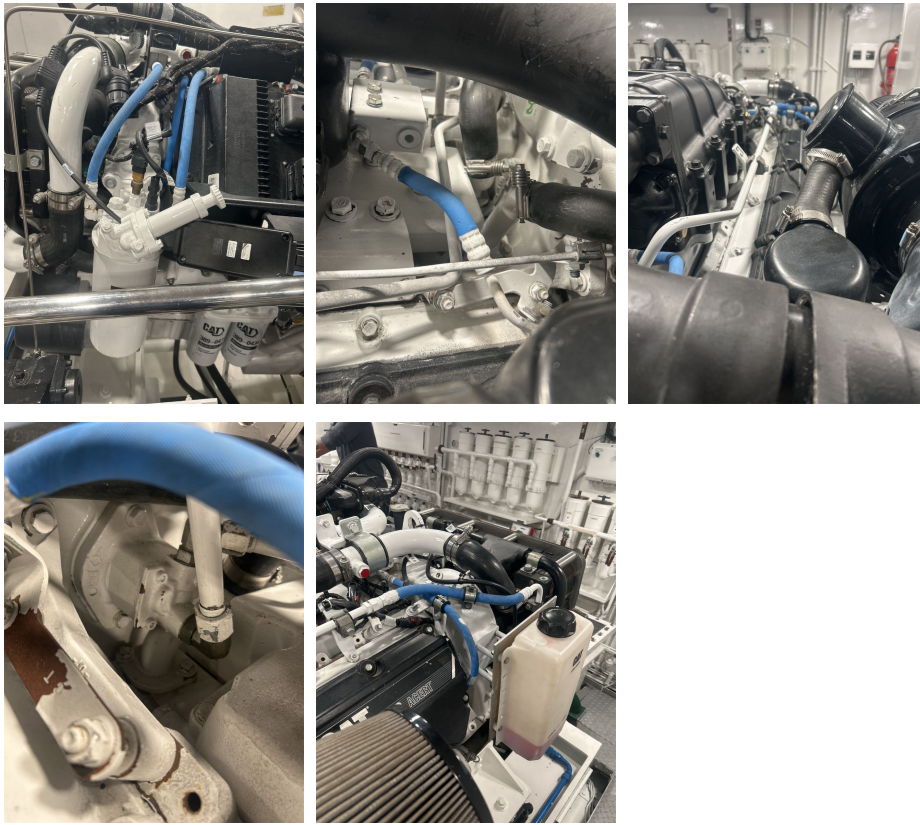
● 5.1 Fuel Lines, Fuel Pump and Fuel Filter Base

NORMAL

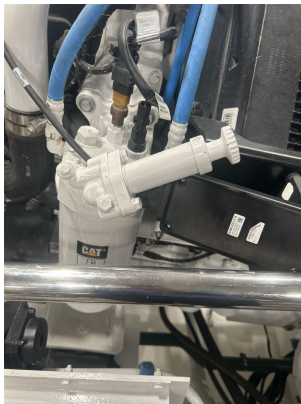
● **5.2 Fuel Priming Pump**

Comments: Good condition

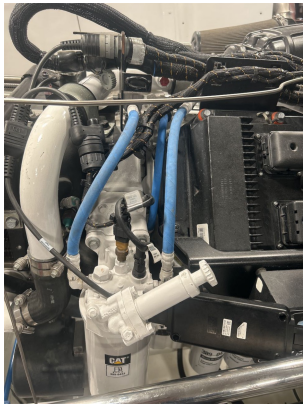
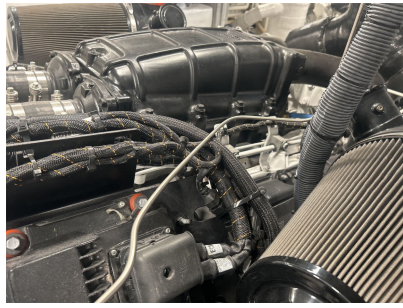
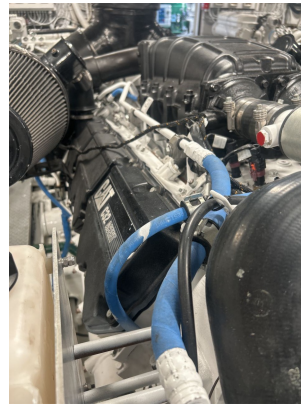
● **5.3 Fuel Injection Lines / Retainers**

Comments: Good condition

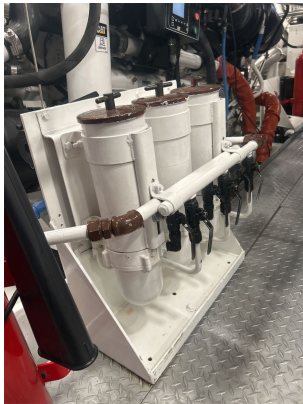
● 5.4 Water Separator(s)

NORMAL
