**PATTON MARINE SURVEYORS
And CONSULTANTS, INC.**
P.O. Box 331884
Miami, FL 33233-1884, USA

December 14, 2024
File No.: 13717-24
Page 1 of 22

**RE: "SAPPHIRE", 2009,
50.44 Meter Trinity Motor Yacht**

RECOMMENDATIONS

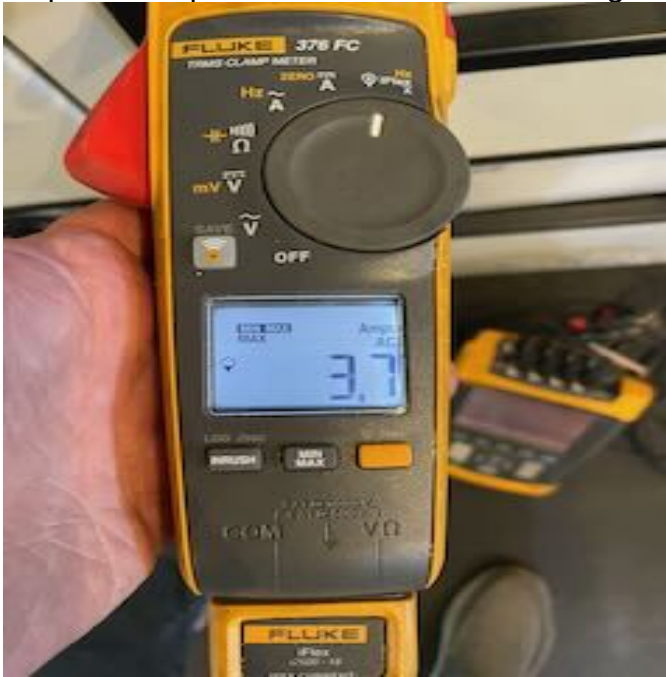
1. During dock side connection a Fluke Clamp on amp meter was place on the neutral to ground connection within the main switch board, a ground fault of > 3.7 amps was captured. Trace and remove all ground faults.

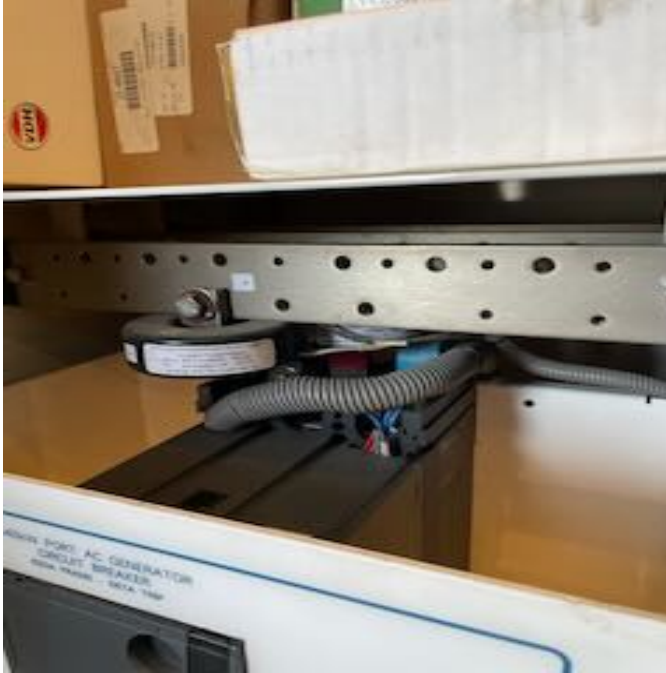
5. The main switchboard generator and shore power energized buss connections are exposed. Provide clear protection covers.

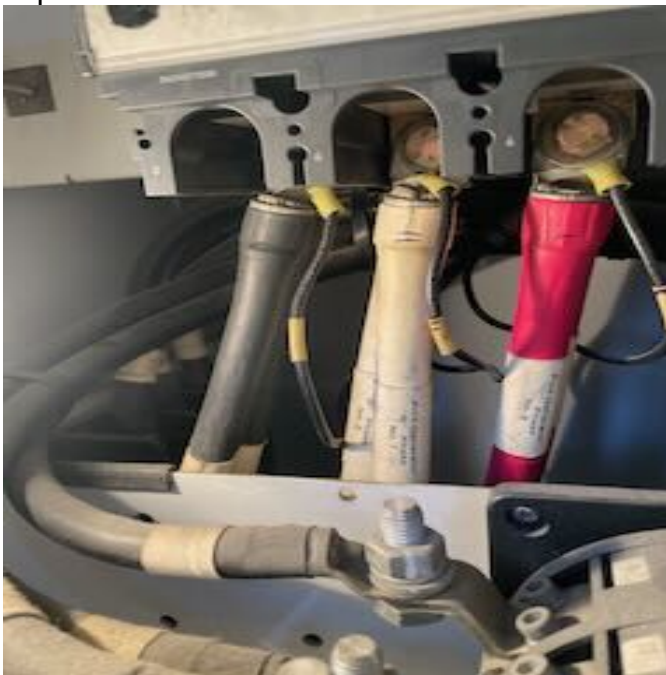
6. Main switchboard shore power, generator and heavy consumer over current protection breakers are not fitted with phase separation sheets. Install phase separation sheets.

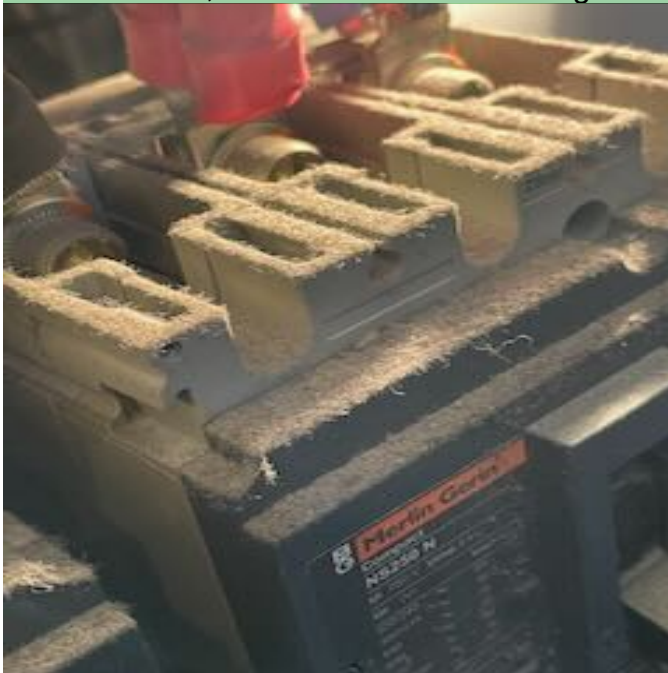
7. The main switchboard meters for shore power and generators are not hash marked to show nominal volts or amps. Hash mark switchboard meters.
8. Several of the main switchboard analog meters were found slightly out of calibration when compared to a calibrated Fluke 435 power analyzer. Re-calibrate all main switchboard meters.
9. No Classification approval stamp for the main switchboard was located. Verify this switchboard has classification approval.
10. The main switchboard neutral to ground connection (TN-S) is a fixed connection, no removable link has been provided. Provide removable link in this connection for service and testing.
11. Dust accumulation can be readily seen in the main switchboard especially in the lower sections, which can lead to tracking. Clean the main switchboard.

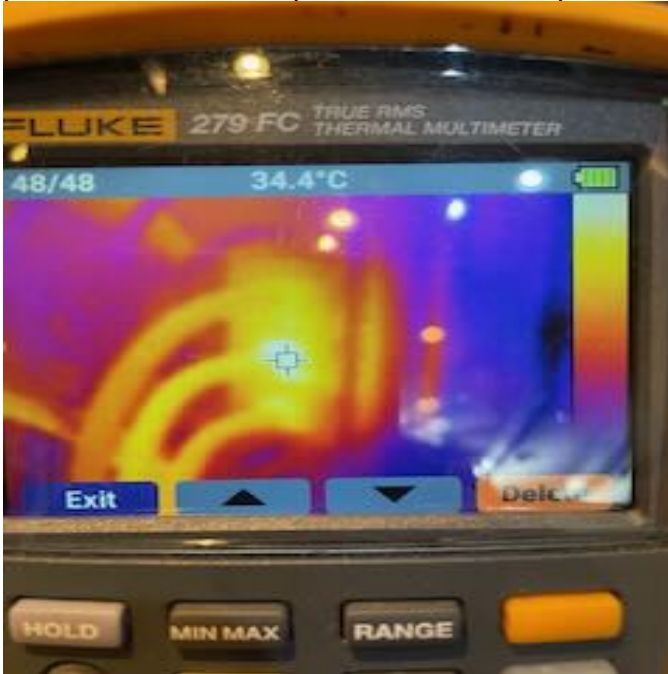
13. The main switchboard air conditioning system #1 protection breakers running temperature was captured at 34.4°C, load at this time was captured at 28 amps. Further review this condition and ensure correctly sized cable and over current protection has been provided for the expected load.

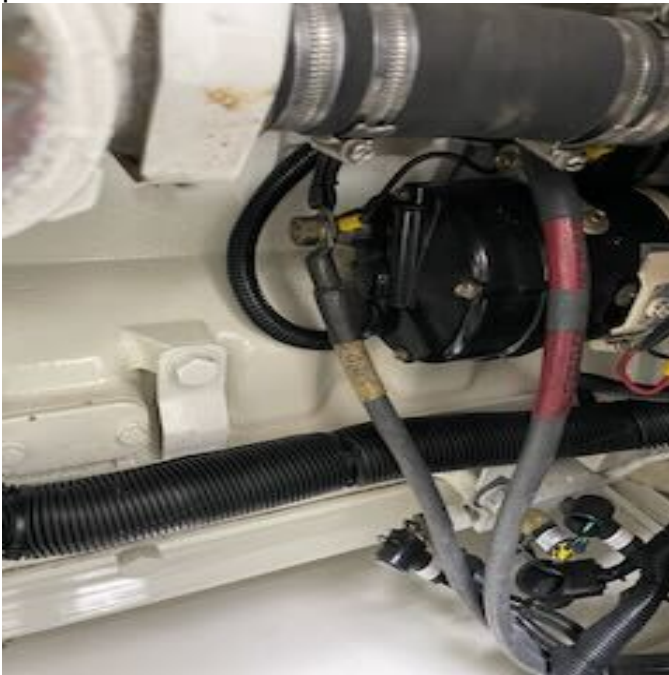
4. The port and starboard main engines and generator starter and slave solenoids potentially energized positive connections are exposed. Provide “boot” type protection covers or similar.

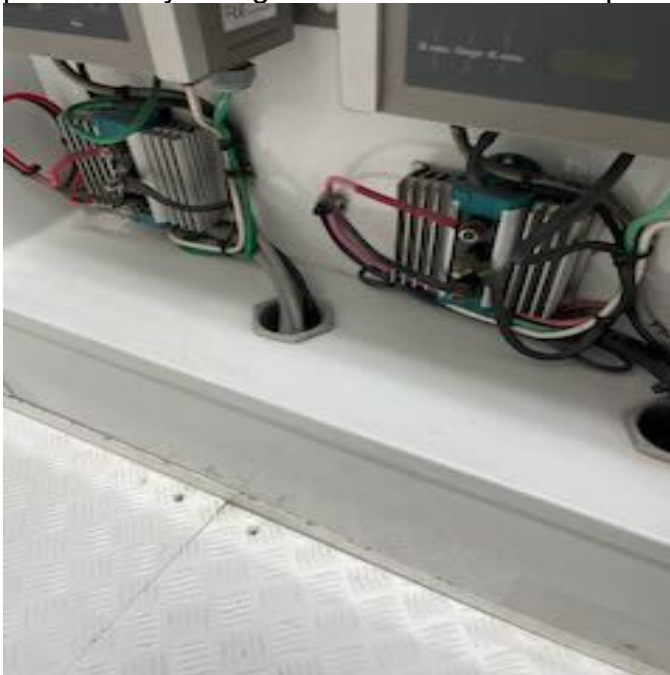
3. The provided electrical drawings show the main engine starting switch arrangement was break before make isolation switches able to select either bank, but not in parallel. The system has been modified to include on/off switches and maintained parallel switches; in addition, the banks are in permanent parallel by cross connection cables. Re-connect the starting system back to the original design.
4. The vessels VDC system has V- ground faults. Trace and remove all VDC ground faults.
5. The emergency fire pumps batteries permanently energized connections, and the motor starter and solenoid connections are exposed. Provide suitable protection covers.
6. The generator and main engine battery chargers associated charge dividers permanently energized connections are exposed. Provide connection covers.

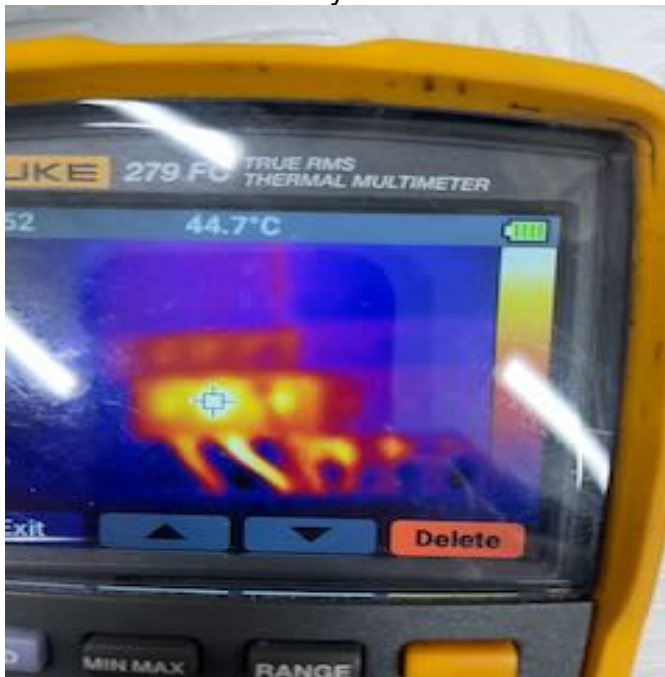
1. The air conditioning main control enclosure doors are not fitted with hold open devices. Install hold open devices.
2. Motor starter breaker #5F3 running temperature was captured at 44.7°C. Further review this condition and verify the over current protection and associated conductors are correctly sized for the full running load.

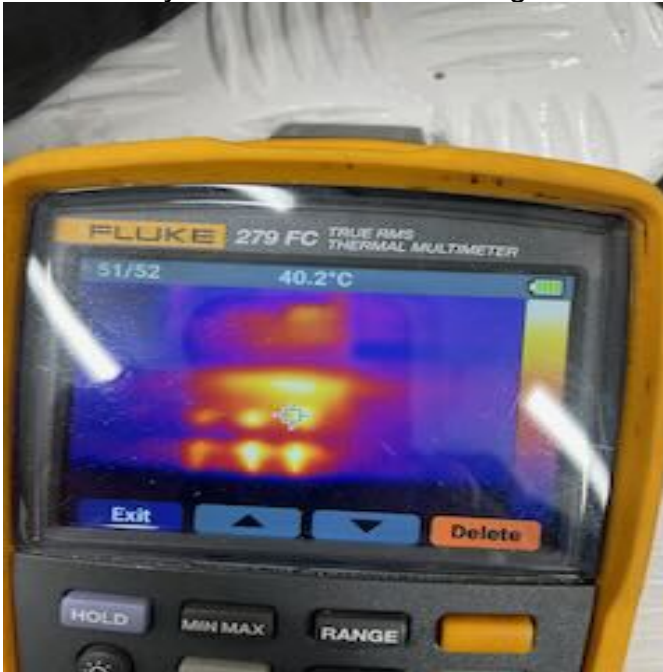
3. Contactor #1206 running temperature was captured at 40.2°C. Further review this condition and verify the over current protection and associated conductors are correctly sized for the full running load.

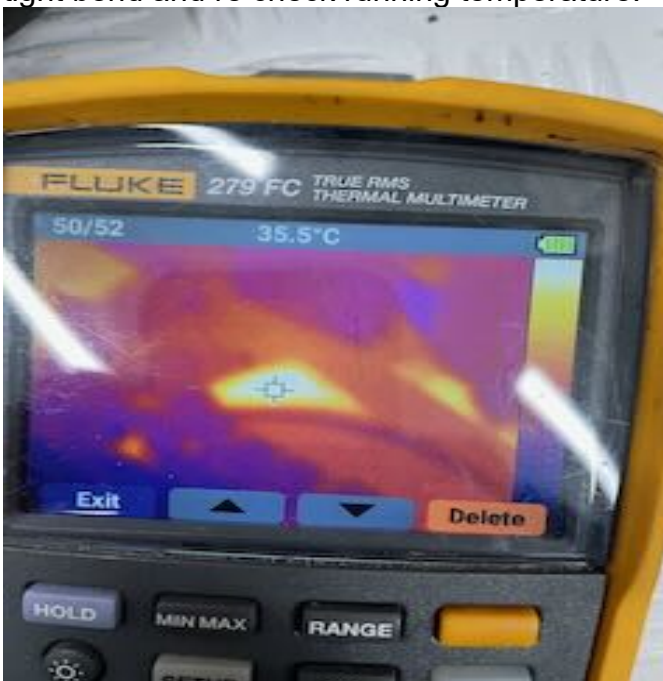
4. The air conditioning systems supply cable is not conforming to bend radius minimums, the cable is generating heat captured at 35.5°C. Relieve this cables tight bend and re check running temperature.

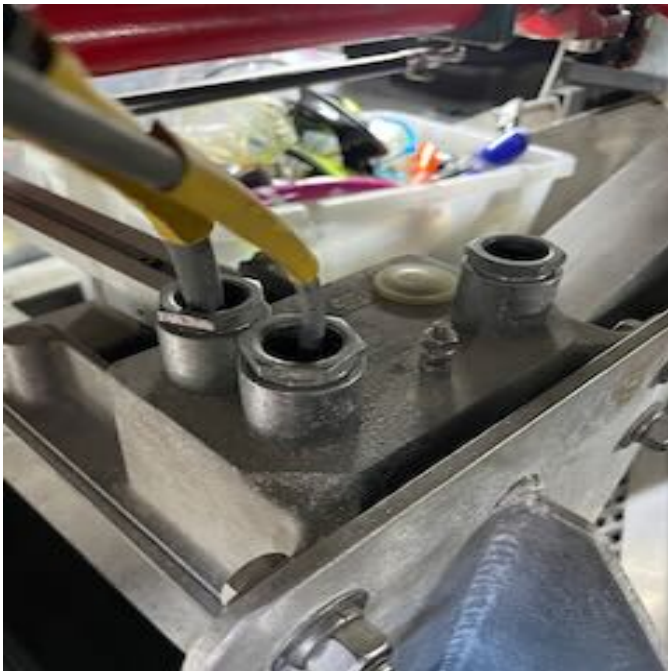
1. All main arteries, and heavy consumer cables appears to be original, it is our professional opinion that safety could be improved by the following recommendation. Megger test all main artery and heavy consumer cables.
2. Multiple cable runs in the lazarette require additional cable support and protection. Further review lazarette cable runs and provide additional cable support and protection as necessary.
3. Cables exiting the starboard generators at the sound shield lack chafe protection. Provide additional cable chafe protection.
4. Cables to the steering feed back connection housing are not sealed. Seal these cable entries.

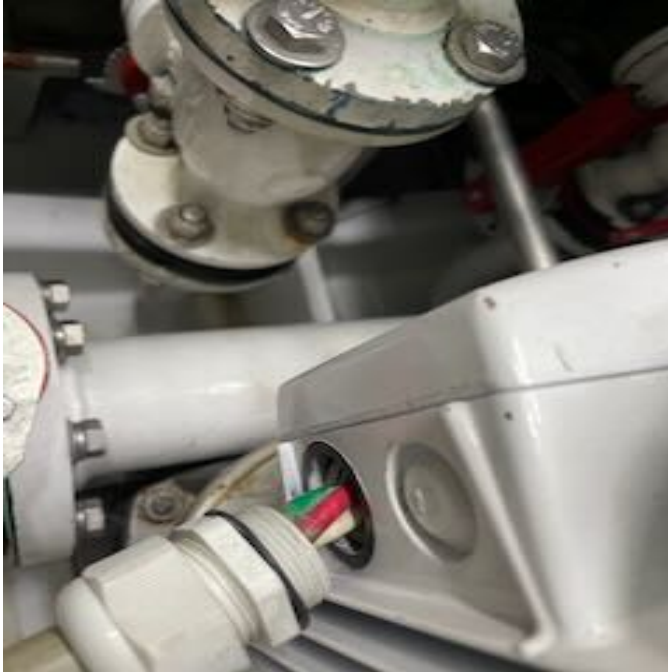
6. There is a corroded junction box, located below the deck plating in the Engine Room, adjacent to the Bilge and Fire pumps. The junction box cable gland is also incorrectly fitted. Recommend replacing the junction box and remaking the cable connection and glands.

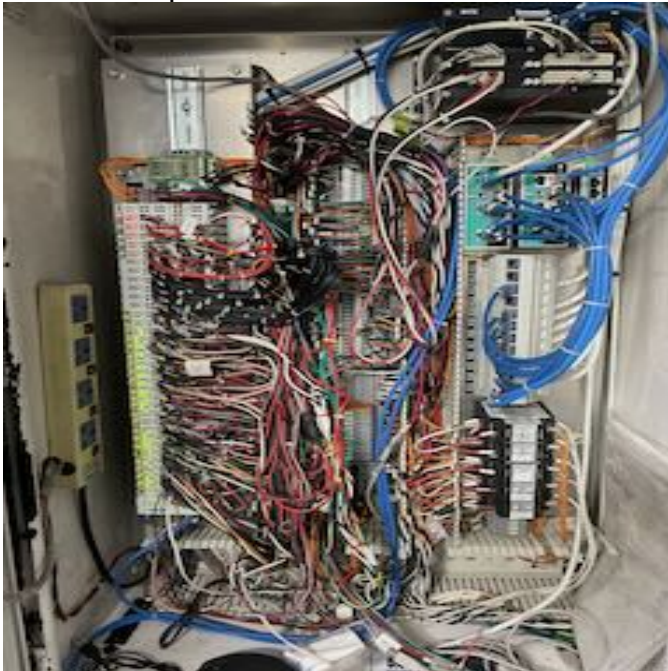
7. The engine room Servowatch PLC connection panels internal wiring is considered poor. Further review these conditions and rectify.

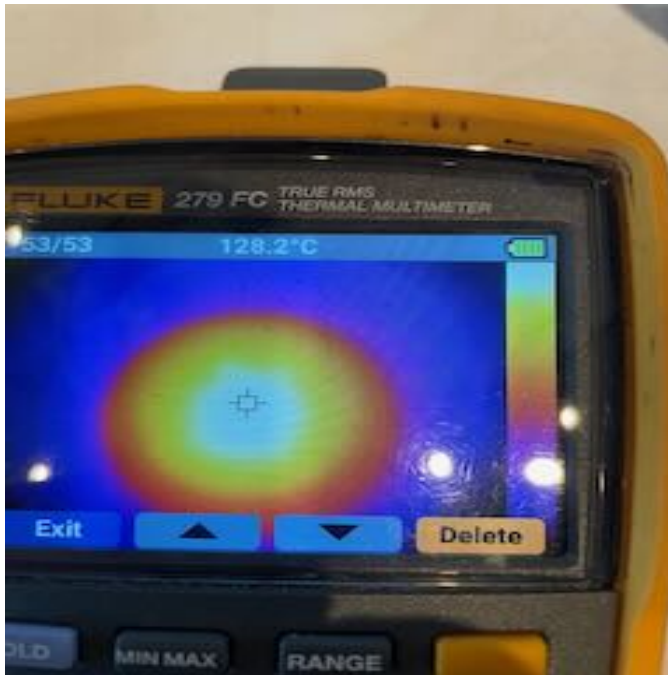
1. The overhead halogen lights in the wheelhouse are generating heat captured at 115.2°C, lights in the dinning room at 128.2°C and > 200°C in the dinning room, heat generated by these lights lowers the ignition point of the surrounding materials and could become a hazard. Replace all halogen lights with low voltage LED or similar.

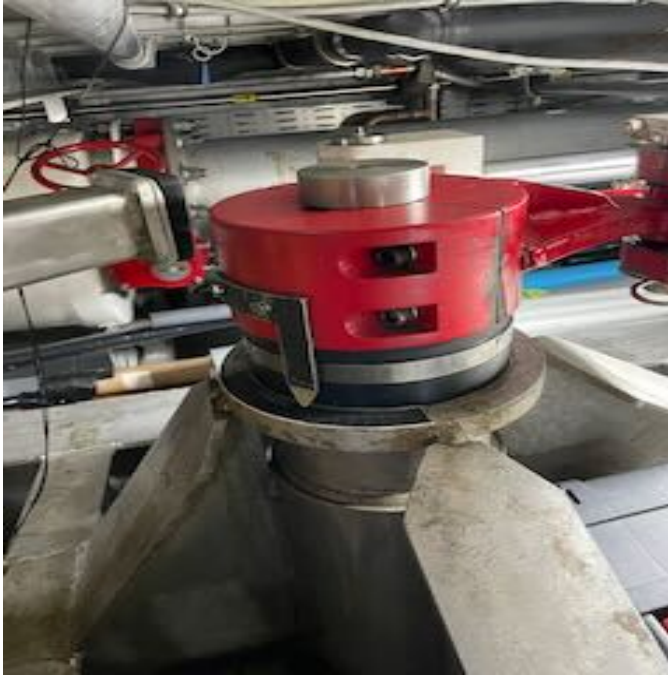
3. The rudder stocks are not grounded. Ground the rudder stocks.

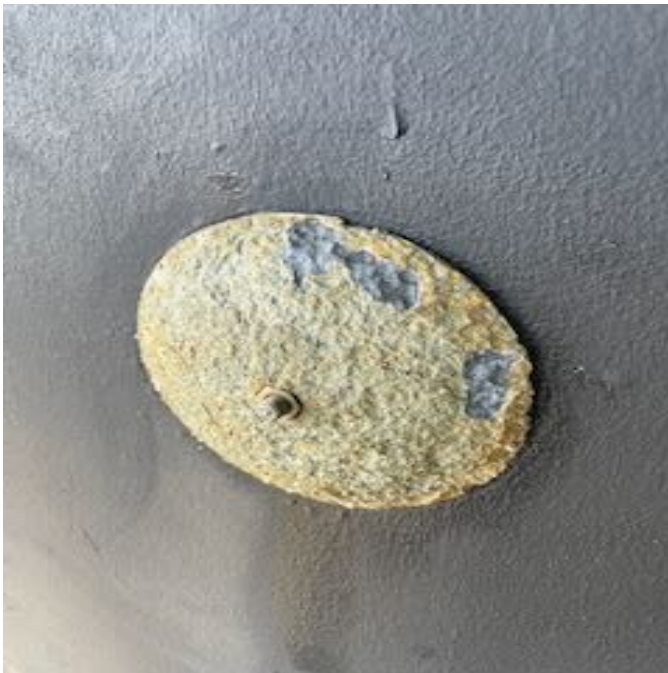
1. Several of the hull mounted sacrificial zinc anodes have crusted over (Passivation), this condition will prevent the anodes from working correctly. Clean anodes.

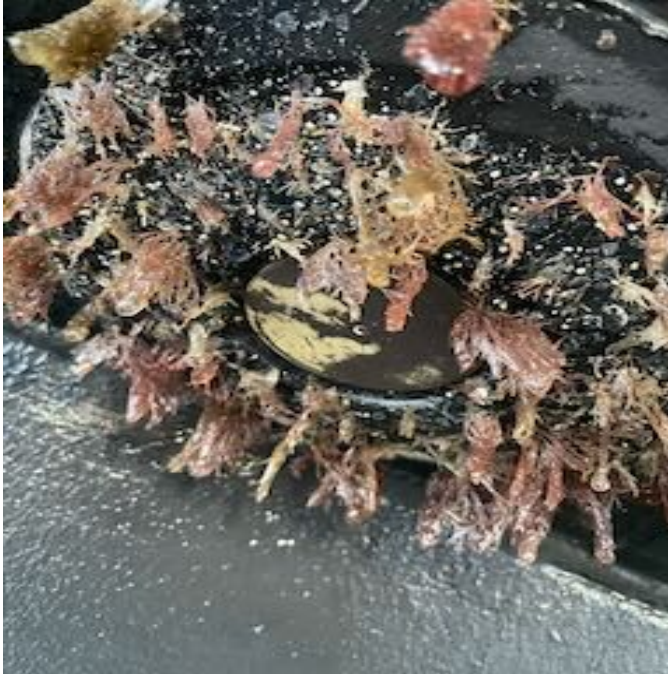
2. The vessels Cathelco C-Shield propeller shaft earthing system is not operational, in addition the hull mounted reference cells are contaminated. Service the entire system.
