**Marine Surveyor Group**  
**1005 W. State Road 84 #511**  
**Fort Lauderdale, Florida 33315**  
**Phone: 954-612-6834**

VESSEL: RISK & REWARD  
HULL #: QEO11923A404  
FILE #: 25189  
DATE: August 26-28, 2026

## **REPORT OF SURVEY**

The above captioned vessel was surveyed on August 26-28, 2026 for the purpose of pre-purchase hull condition and marine risk.

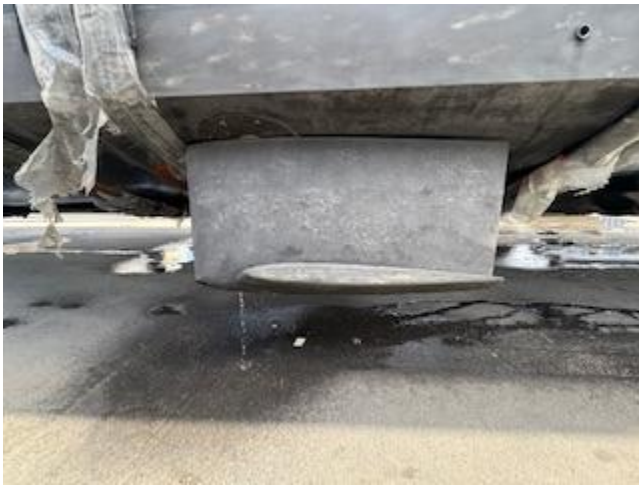
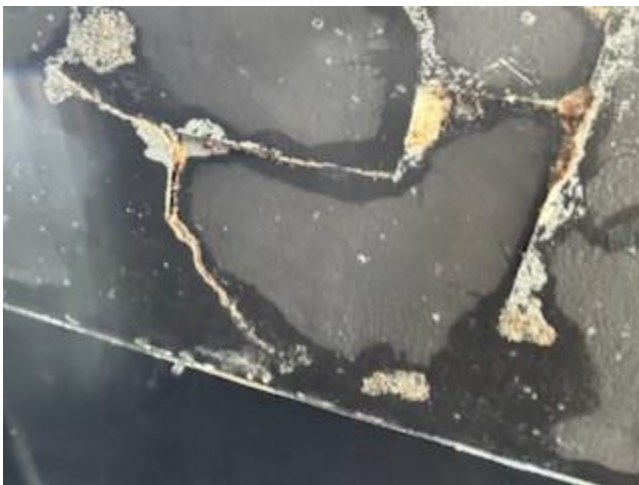
1. The port bow thruster zinc is missing.
2. The starboard transom underwater light is inoperative. Service and prove.
3. The port main cutlass bearing exhibits uneven wear. Lateral motion at the flex section of the shaft log was noted while underway. Check engine alignment. Balance the propellers and check trueness of the shaft as deemed necessary.
4. The underside of the port fiberglass stabilizer fin exhibits fractured fiberglass over a 18 inch area. Repair in accordance with good marine practices.
