**PATTON MARINE SURVEYORS
And CONSULTANTS, INC.**
P.O. Box 331884
Miami, FL 33233-1884, USA

**RE: "SAPPHIRE", 2009,
50.44 Meter Trinity Motor Yacht**

RECOMMENDATIONS

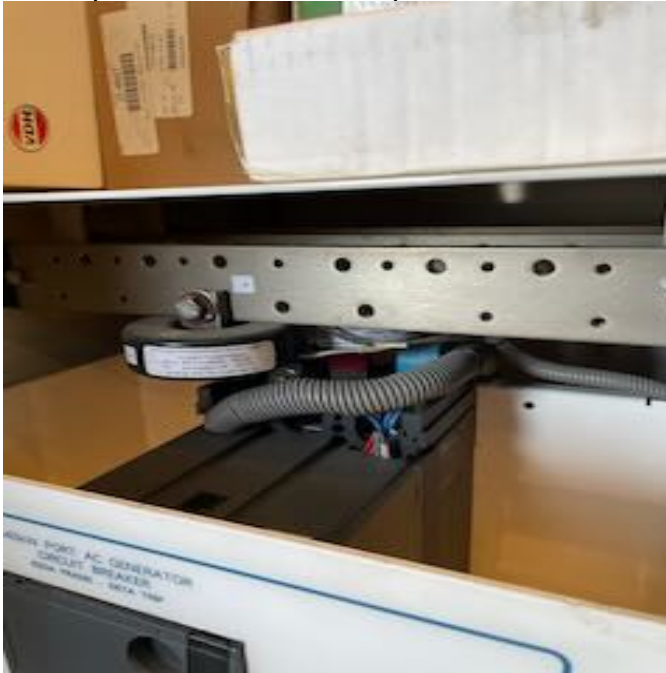
5. The main switchboard generator and shore power energized buss connections are exposed. Provide clear protection covers.

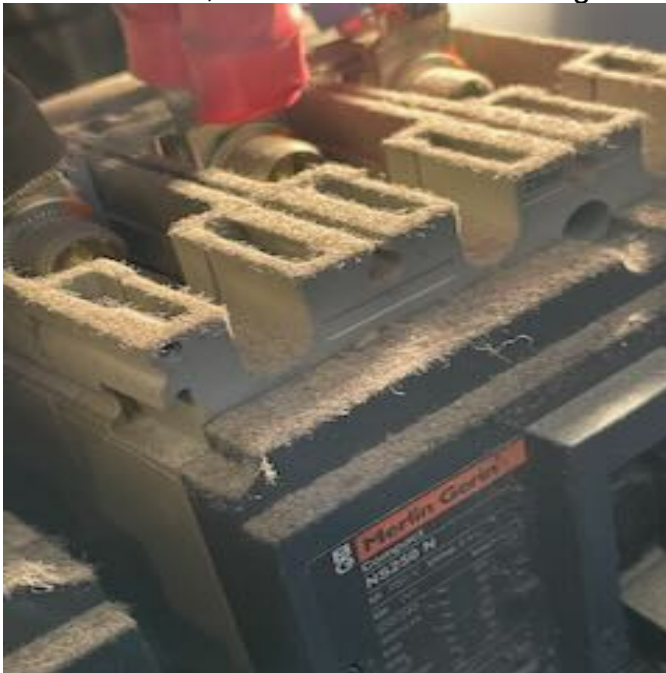
7. The main switchboard meters for shore power and generators are not hash marked to show nominal volts or amps. Hash mark switchboard meters.
8. Several of the main switchboard analog meters were found slightly out of calibration when compared to a calibrated Fluke 435 power analyzer. Re-calibrate all main switchboard meters.
9. No Classification approval stamp for the main switchboard was located. Verify this switchboard has classification approval.
10. The main switchboard neutral to ground connection (TN-S) is a fixed connection, no removable link has been provided. Provide removable link in this connection for service and testing.
11. Dust accumulation can be readily seen in the main switchboard especially in the lower sections, which can lead to tracking. Clean the main switchboard.

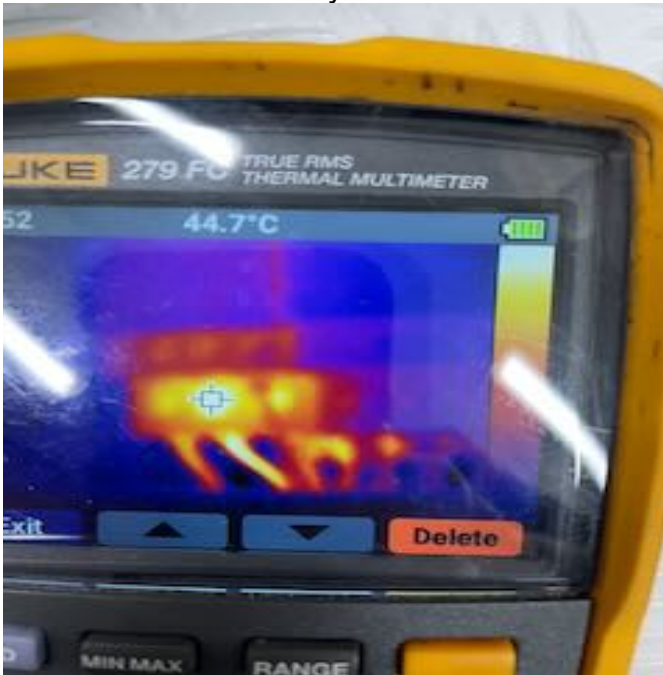
1. The air conditioning main control enclosure doors are not fitted with hold open devices. Install hold open devices.
2. Motor starter breaker #5F3 running temperature was captured at 44.7°C. Further review this condition and verify the over current protection and associated conductors are correctly sized for the full running load.

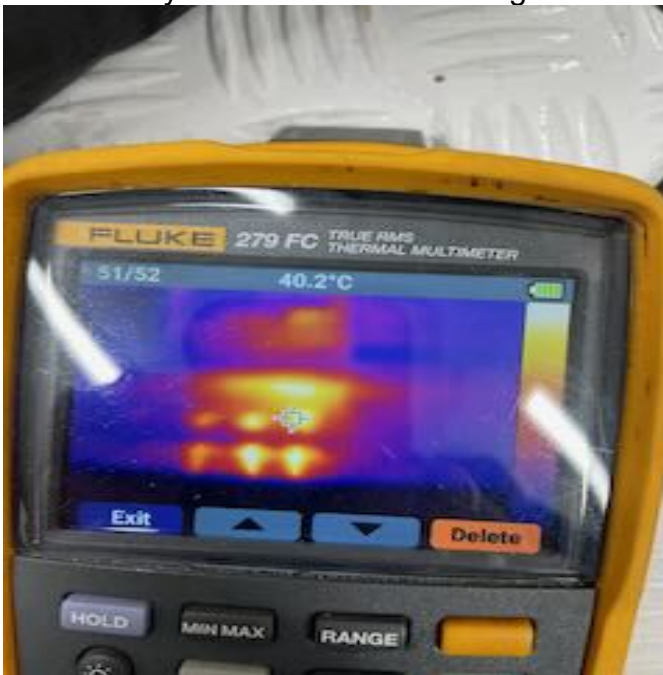
3. Contactor #1206 running temperature was captured at 40.2°C. Further review this condition and verify the over current protection and associated conductors are correctly sized for the full running load.

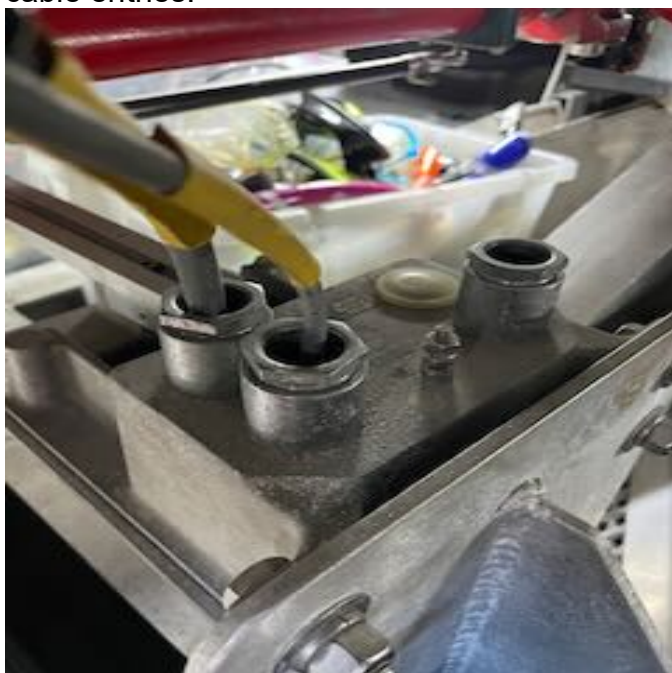
1. All main arteries, and heavy consumer cables appears to be original, it is our professional opinion that safety could be improved by the following recommendation. Megger test all main artery and heavy consumer cables.
2. Multiple cable runs in the lazarette require additional cable support and protection. Further review lazarette cable runs and provide additional cable support and protection as necessary.
3. Cables exiting the starboard generators at the sound shield lack chafe protection. Provide additional cable chafe protection.
4. Cables to the steering feed back connection housing are not sealed. Seal these cable entries.

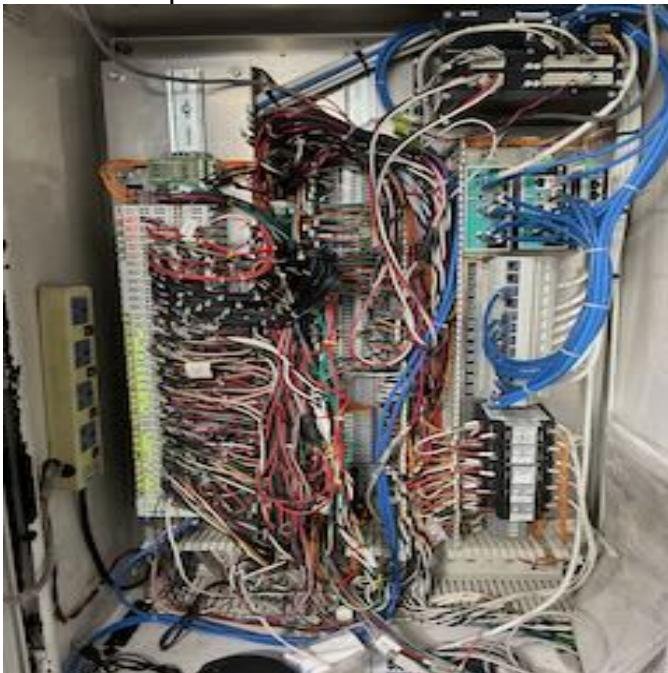
7. The engine room Servowatch PLC connection panels internal wiring is considered poor. Further review these conditions and rectify.

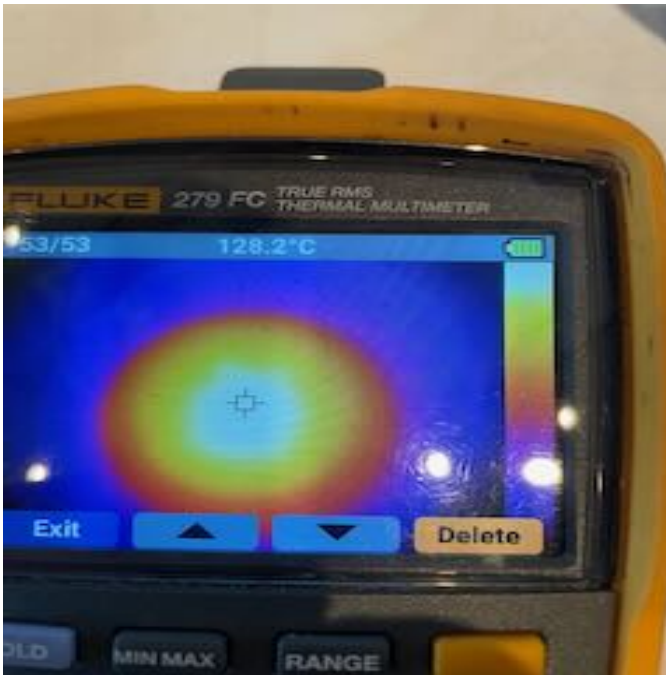
1. The overhead halogen lights in the wheelhouse are generating heat captured at 115.2°C, lights in the dinning room at 128.2°C and > 200°C in the dinning room, heat generated by these lights lowers the ignition point of the surrounding materials and could become a hazard. Replace all halogen lights with low voltage LED or similar.
