**PATTON MARINE SURVEYORS
And CONSULTANTS, INC.
P.O. Box 331884
Miami, FL 33233-1884, USA**

**December 20, 2023
File No.: 13560-24
Page 1 of 17**

**RE: "ARIADNE", 1979,
124' Breaux Bay Craft Motor Yacht**

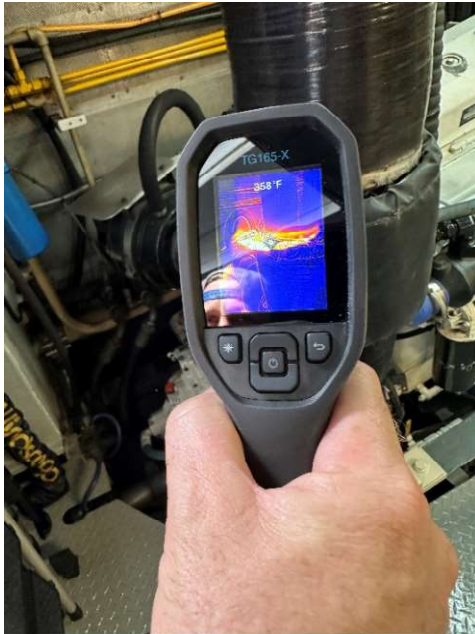
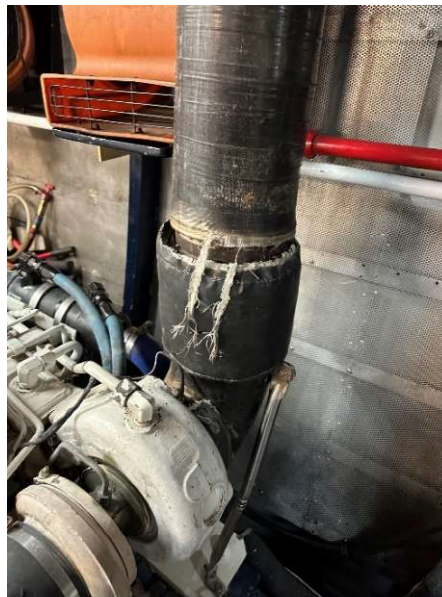
Exposed main Engine exhaust Hot spots

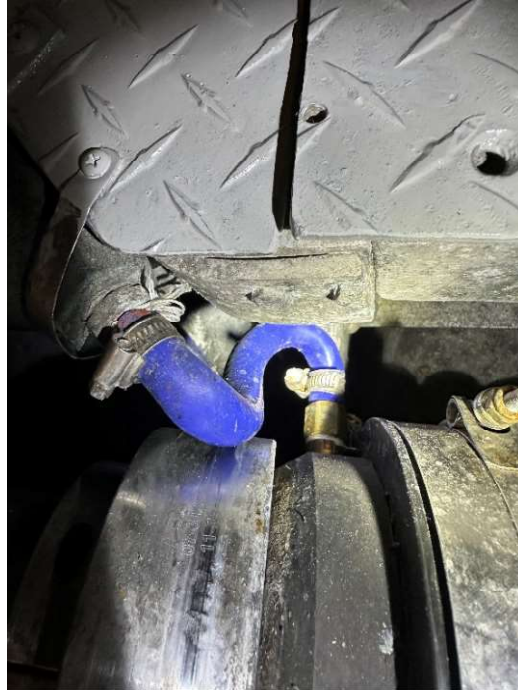
Chaffing and single clamped sea water shaft supply hose.

8. ★There are no isolation valves for the seawater cooling supply water to the four driveline shaft seals. Install isolation valves.
9. ★The seawater supply hoses to the shaft seals are not double clamped. Double clamp for safety.

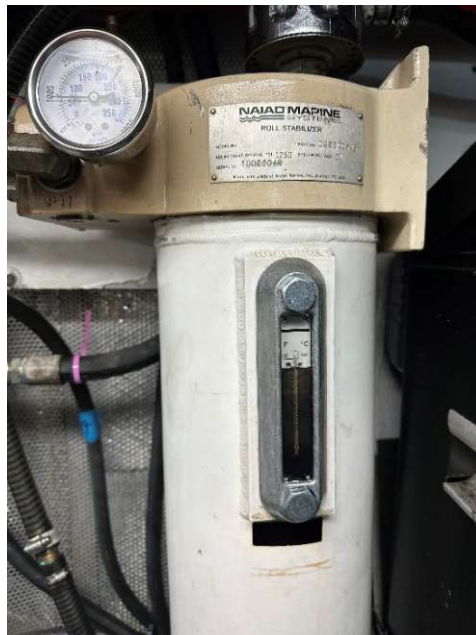
Stabilizer hydraulic fluid was changed after the last sea trial attempt and is Discolored again.

1. The oil in the stabilizer filter/ tank system is very black. Perform oil analysis. Anticipate repairs and maintenance. There are also small oil leaks at the hydraulic connections at both fin actuators. Repair the oil leaks.
