Blake Stahl & Associates
2560 SE Downwinds Road
Jupiter, Florida 33478
Phone: 561-722-1874

VESSEL: NO NAME
HULL #: MCR50001K122
FILE #: 25964
DATE: December 8, 2023 and January 26, 2024

REPORT OF SURVEY

The above captioned vessel was surveyed on December 8, 2023 and January 26, 2024, at the request of Jeremy Floden, representing Larry Drivon, for the purpose of pre-purchase hull condition and marine risk.

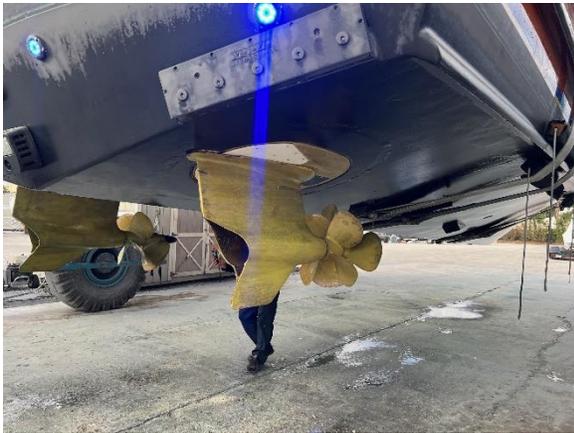
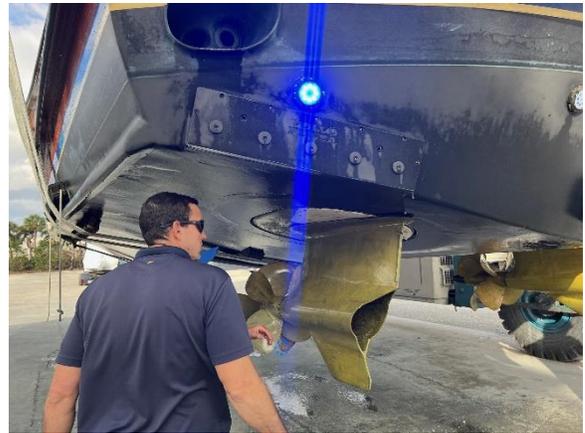
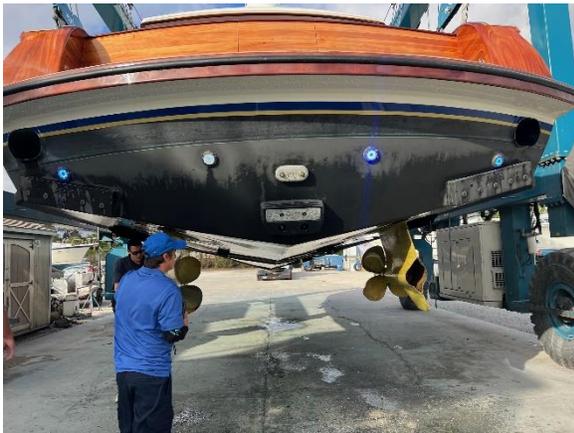
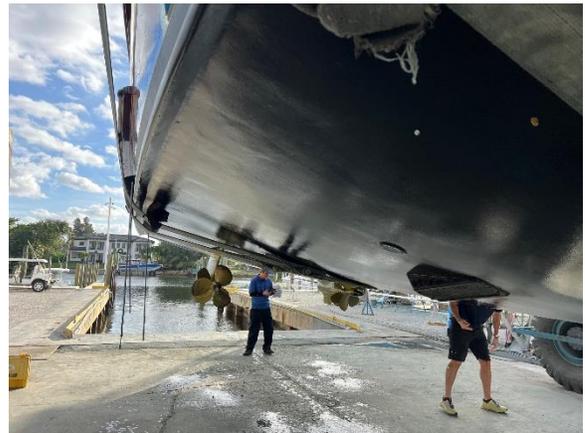
BOTTOM PHOTOGRAPHS:

The bottom was sounded with a phenolic hammer and found to be sound. No moisture or thermography testing was conducted at this time.

The propellers were inspected and appear in excellent condition.

The transom zinc and Volvo anodes were noted to be within limits of acceptability, as was the antifouling paint.

All underwater appendages showed no excessive signs of deterioration due to galvanic or electrolytic corrosion. There were no major scars or gouges.

1. The anti-foulant is within limits of acceptability.
2. The IPS drive sacrificial zincs were replaced at this haulout.
3. The transom mounted Volvo anode was within limits of acceptability.
4. See diesel survey for an in-depth report as to the condition of the IPS drive pods.
5. The port inboard LED underwater light does not illuminate fully. Service or replace. A faulty driver is suspected.
