**PATTON MARINE SURVEYORS  
AND CONSULTANTS, INC.**

**June 12, 2026**  
**File No.: 13993-26**  
**Page 1 of 29**

**RE: "ESCAPE of LONDON", 1997,  
36.46 Meter TRIDENT Motor Yacht**

**RECOMMENDATIONS**

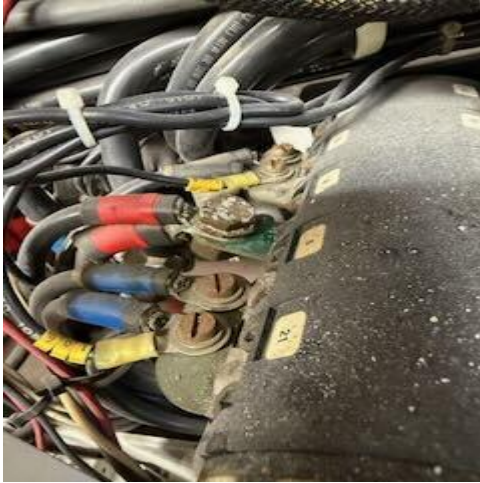
2. ★Evidence of water intrusion was observed in the main switchboard, reportedly originating from the above overhead perforated sheeting. Water damage is visible on the load center selector switch connections, resulting in corrosion at these points. Additionally, water stains are present on the interior surfaces of the switchboard doors. Trace source of water intrusion and replace all water damaged electrical components.

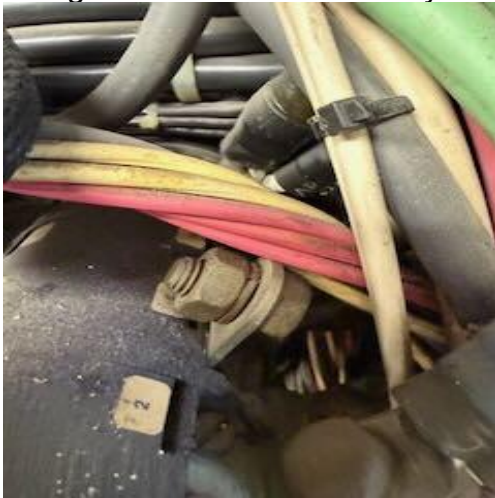
3. The main switchboard Merlin Gerin multi 9 series consumer breakers have been ordered and reportedly due to arrive in June 2026 for replacement.
4. ★The main switchboard internal condition is considered poor, the internal wiring lacks chafe protection and support, conductors are resting on permanently energized connections. Rectify these conditions.

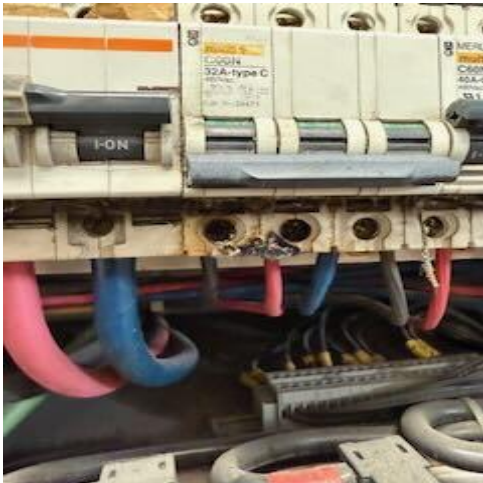
5. ★The 32-amp three phase protection breaker for the starboard aft warping capstan has overheated. Further review cause of the overheating, ensure the breaker and associated conductors are correctly sized for the loads expected.

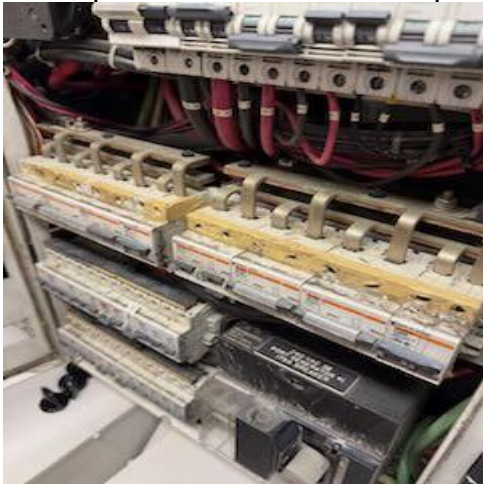
6. ★Permanently energized buss bars and connections within the main switchboard are exposed. Provide suitable protection covers.

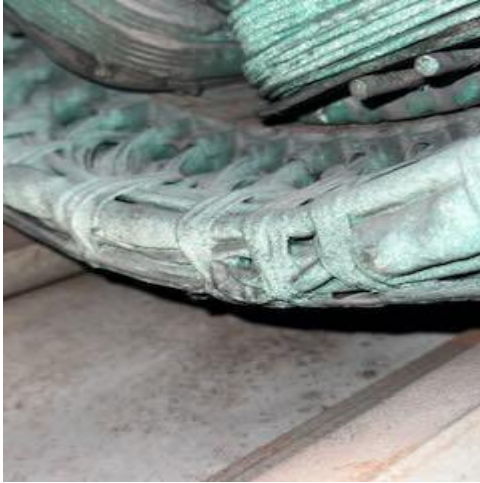
3. The generator alternator ends have been cleaned, but both generators have exceeded 12,000 operating hours. Inspection of the electrical system reveals that the rotating rectifier diodes are contaminated and the stator plates show significant corrosion. Additionally, both the front and rear bearings require replacement. Based on the cost-benefit analysis, this surveyor recommends replacing both generator electrical ends.

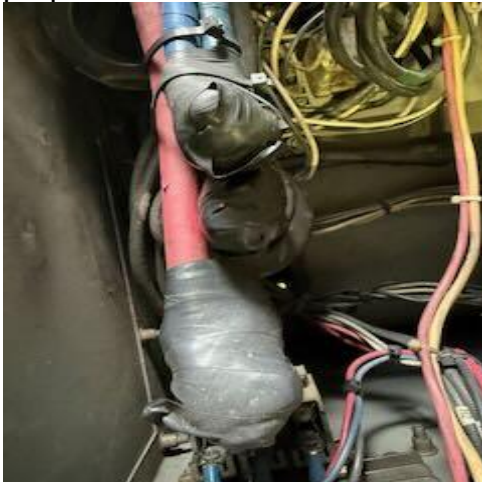
4. Both generator electrical ends were reviewed, the phase connections are connected using nuts and bolts then wrapped with electrical tape which is not rated for the expected currents. Re-connect both generators phase connections to purpose made connection blocks.

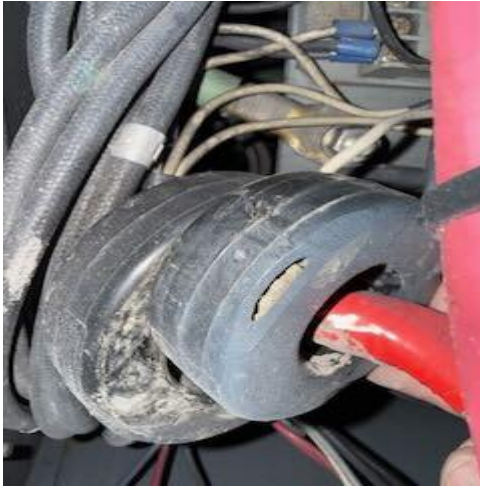
5. The current transformers in both generator electrical ends are unsecured and wearing on the end casings; one in the port generator has worn through to the windings, creating a hazardous condition. Replace damaged current transformers and ensure all are secured.

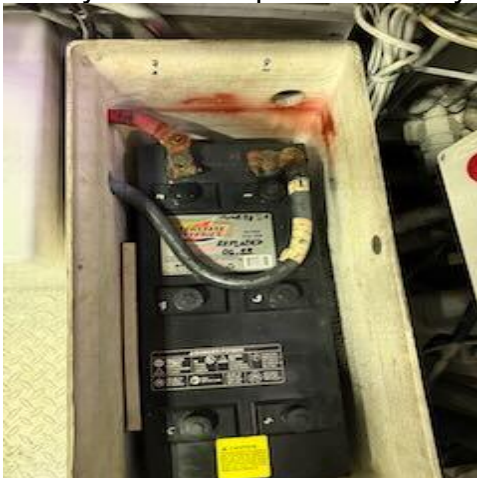
1. The vessels battery banks are not identified. Label all battery banks
2. The vessels battery banks were not load tested. Load tests all of the onboard batteries.
3. The vessels battery banks are not secured against vertical and horizontal movement. Strap down all batteries.
4. The starting battery banks permanently energized connection posts are exposed; no protection boots have been provided. Install battery post protection covers.
5. ★The starboard starting bank outermost battery is of a different manufacture to the rest of the bank, this battery appears to have been gassing, electrolyte can be readily seen on top of the battery. Further review this condition and rectify.

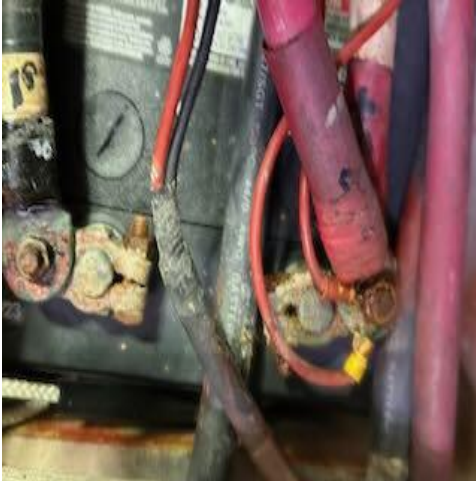
6. Multiple starting bank battery posts are contaminated. Chemically clean all battery post connections.

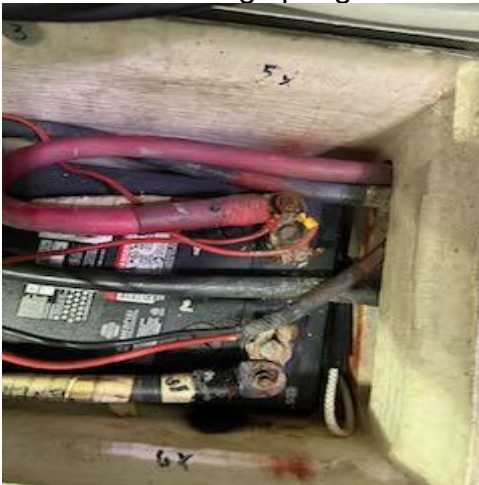
7. Multiple starting bank battery posts are not secured using lock or spring washers to aid in preventing the connections from working loose. Ensure all battery posts are secured using spring or lock washers.

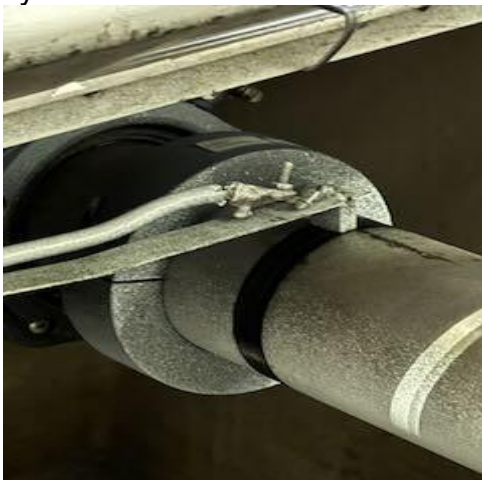
1. ★No bonding straps have been fitted to the fuel pipe works. Bond the fuel systems pipe works in its entirety.
2. The vessels cable trays are not grounded. Ground all cable trays including lone sections.
3. The control room motor control center (MCC) cabinet doors are not grounded. Ground these doors.
4. No ground conductor was sighted for both of the gear boxes. Ground both gear boxes.
5. Both propeller shafts are fitted with homemade type grounding brush gear, resistance from the port shaft to ground was captured at 2.9  $\Omega$  Ohms and the starboard at 3.1 $\Omega$  Ohms. Clean both brushes to ensure resistance of less than 1.0  $\Omega$  Ohms, suggestion is made to replace with a purpose made propeller grounding system.

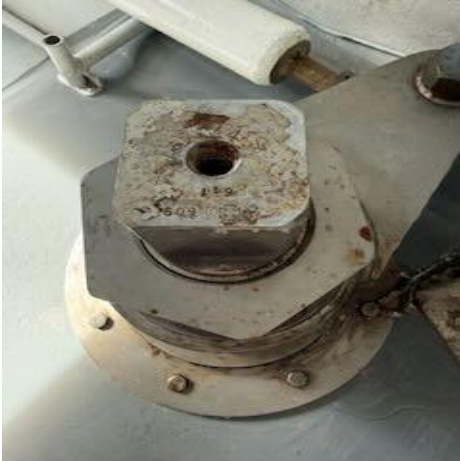
6. The port and starboard rudder housings are grounded; the rudder stocks are not. Ground both rudder stocks, suggestion is to use the stock lifting eye female threaded shaft.

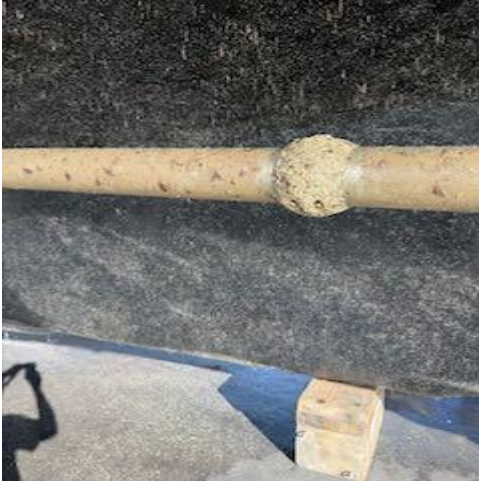
7. The hull mounted ground dyna plates and lightening plate are contaminated. Wire brush the plates.
8. The majority of the hull mounted sacrificial zinc are passivated which occurs when the anode becomes coated with a barrier of oxide or corrosion that prevents it from working. Wire brush all zincs.

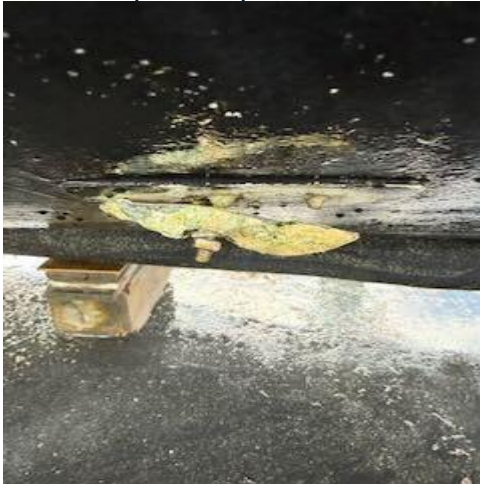
9. Multiple underwater zincs are either missing or have reached the end of their usable life; it was noted that many were replaced during haul out but many were not. Complete replacement of hull mounted sacrificial zincs.

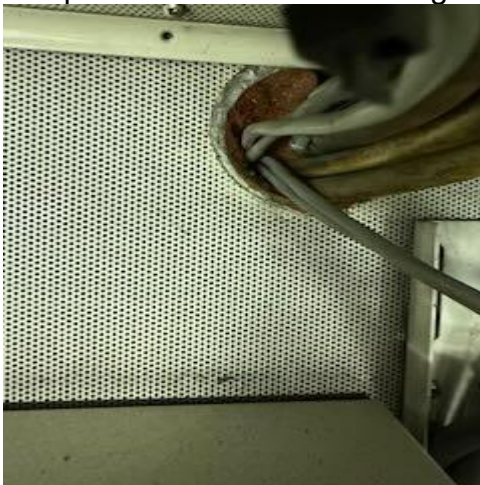
1. ★The engine room 120-volt 60 Hz receptacles are not ground fault protected. Ensure all receptacles located in machinery spaces, laundry, galleys, heads, weather decks and any other areas susceptible to water intrusion are ground fault protected.
2. The generator fuel filters are not fitted with catch bowls. Provide fuel catch bowls.
3. No compressor drive belt covers have been fitted to the engine room air compressors. Install drive belt covers.
4. The cable gland port forward engine room running into the control room has been compromised. Seal this cable gland.

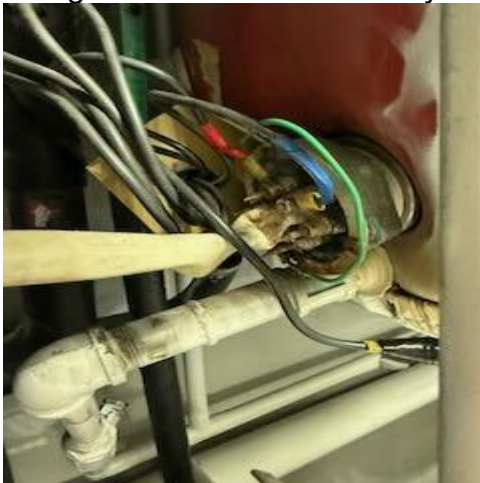
5. ★The port engine room water heater element connection cover is adrift exposing energized connections. Rectify this condition.

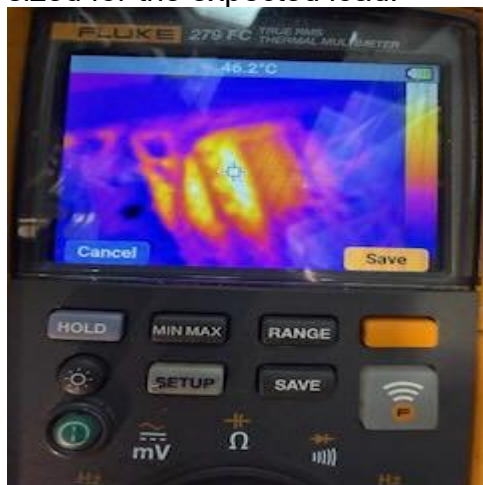
6. The aft capstans are fitted with a toggle switch to each contactor enclosure in the lazarette, the switches turn off or on the supply to the deck switches. Label these switches.
7. The air conditioning sea water pumps three phase breakers running temperature was captured at 46.2°C. Further review this condition and ensure the connections are clean and tight and that the breaker and associated conductors are correctly sized for the expected load.

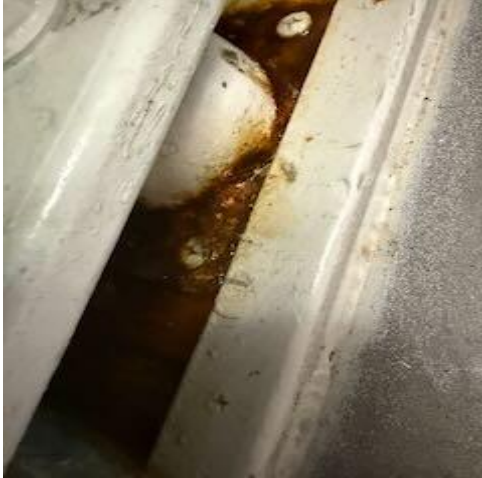
8. The air conditioning chilled water pumps vibration mounts are corroding. Further review this condition, anticipate vibration mount replacement.

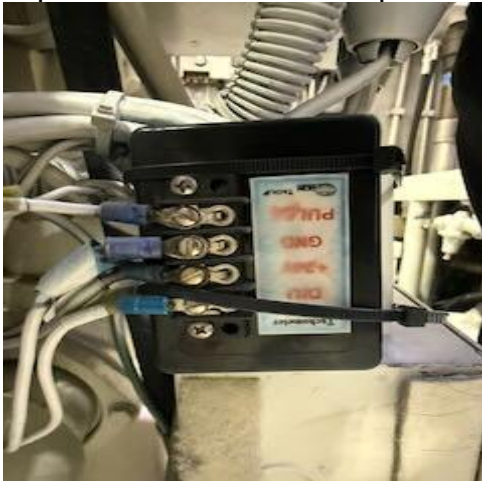
9. The fan above the chiller plant has been replaced.
10. Port and starboard main engine mounted Tachometer modules connections are exposed. Provide suitable protection covers.

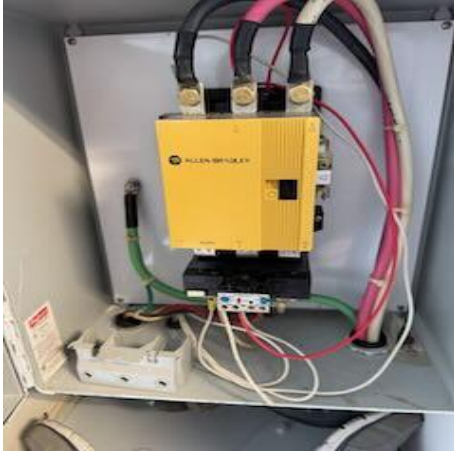
12. An unidentified Allen Bradley contactor is mounted in the lazarette. Identify this contactor.

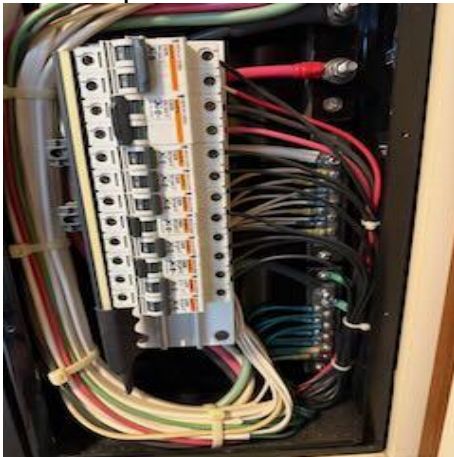
13. ★The vessels distribution panels were opened for review; it was noted that in all the 120/240 distributions the phase connection posts are exposed. Provide suitable protection covers.

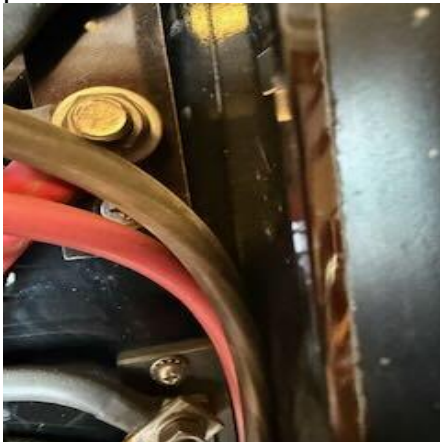
14. ★Single jacketed conductors within the galley distribution panel are resting on the phase connection hardware. Rectify this condition.

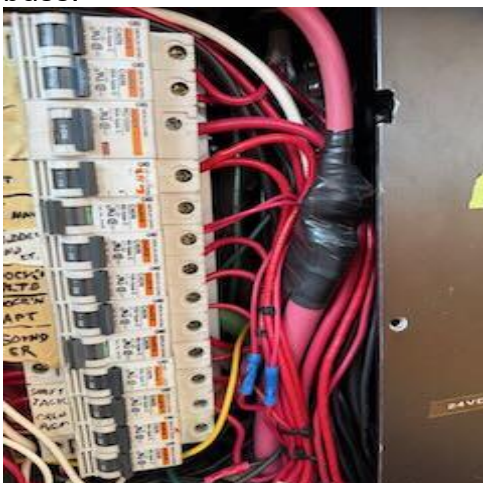
15. The wheelhouse 24VDC distribution panel supply cables has been line spliced and wrapped with electrical tape. Re-connect these cables to an approved connection buss.

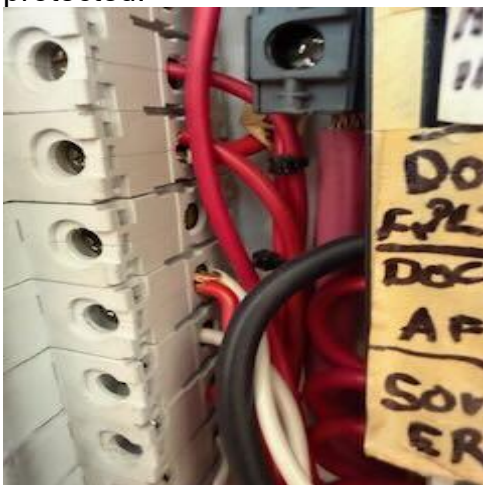
16. Multiple circuit breakers in the wheelhouse 12 and 24 VDC distribution panels are doubled up. Identify all circuits and ensure each circuit is individually over current protected.

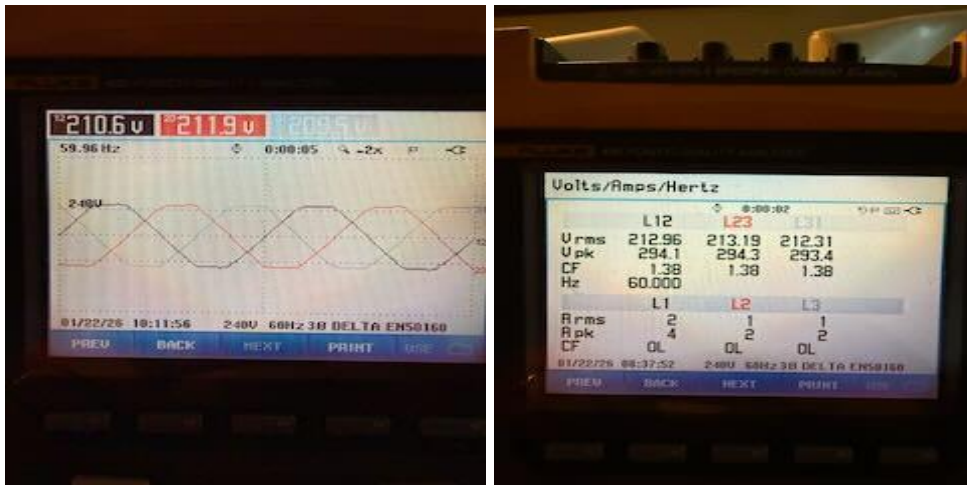
1. The vessels power quality was reviewed, the system has corruption caused by harmonic distortion, the corruption was found to be coming from the air conditioning compressors and air conditioning frequency drives.

The harmonic distortion is distorting the sinusoidal voltage wave form into a flat topping wave form; the voltage crest factor was low at 1.38. A flat topping wave form will not allow electrical systems capacitors to fully recharge risking premature failure.

Perform a harmonics analysis, anticipate installing passive line reactors, failure to address the harmonic distortion issues could lead to premature equipment and electronics failures, and a multitude of related issues.

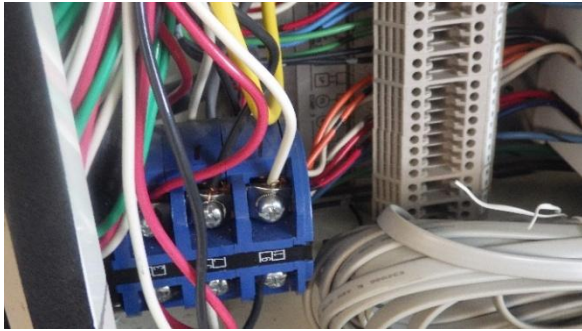
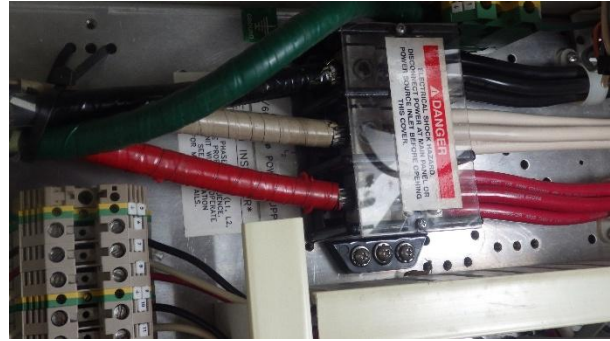
**PINS OR FERRULES ARE NOT INSTALLED ON WIRING WITHIN HVAC ENCLOSURE  
COLOR CODING IS TO NO RECOGNIZED STANDARD. RAW WATER SWITCH NOT LABELED**

13. Pins and/or ferules are not being used on main terminations within the Cruisair control enclosure. Same deficiency applies to the raw water switch which is not labeled. Install pins and/or ferrules as needed and label switch.

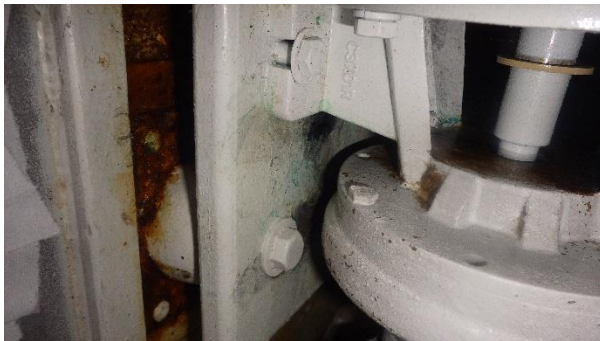
11. Long sections of rubber hose coming off the chilled water pump are not insulated and freely dripping condensate into the floor and bilge area.
12. The mounting feet/pads on the chilled water pump are severely corroded. Anticipate replacement.

**CORRODED FEET ON CHILL WATER PUMP**

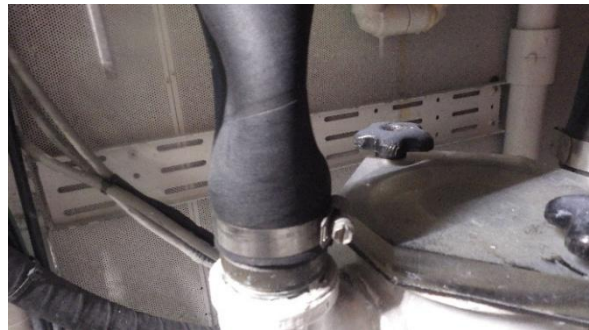
**RAW WATER SUCTION HOSE COLAPSED**

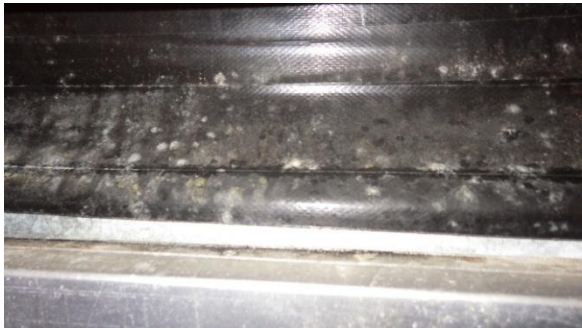
**WHITE MOLD IN GALLEY**

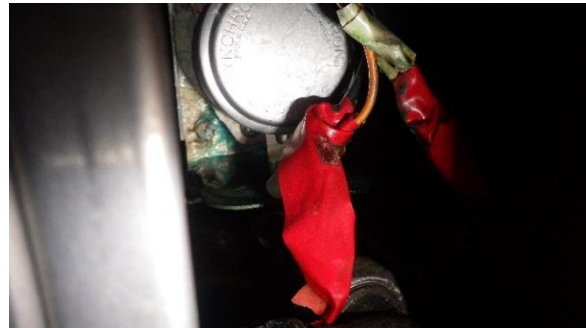
**RESIDENTIAL WIRE JOINTS ON WIRING**

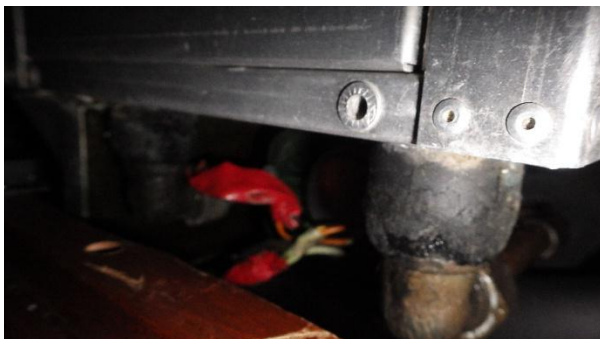
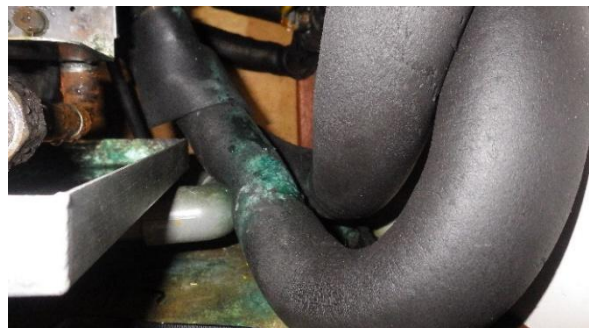
**MOLD OBSERVED THROUGHOUT THE YACHT WITHIN MULTIPLE FAN COIL UNITS**

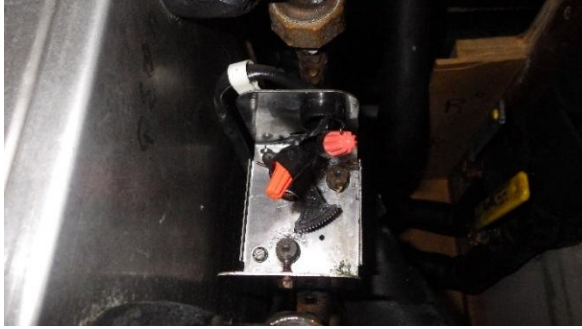
**WIRE JOINTS AND MOLDY WATER VALVES THROUGHOUT FAN COIL**

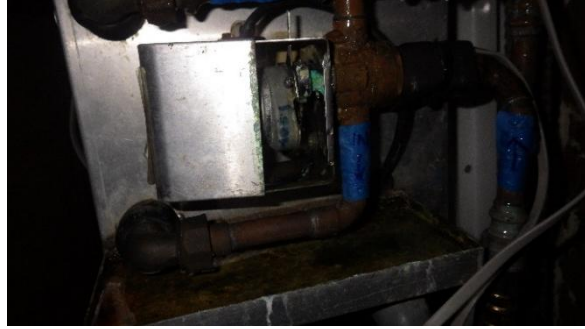
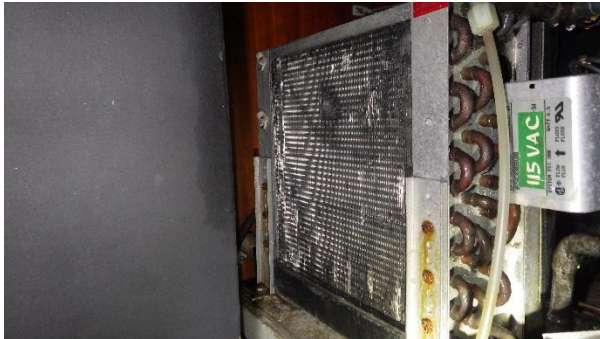
**NO AIR INTAKE SCREEN ON MISC. FCU'S**

17. Most of the fan coil units throughout the yacht are missing air intake filters. Evaporator fins are fouled. Clean fins and install air intake screens.

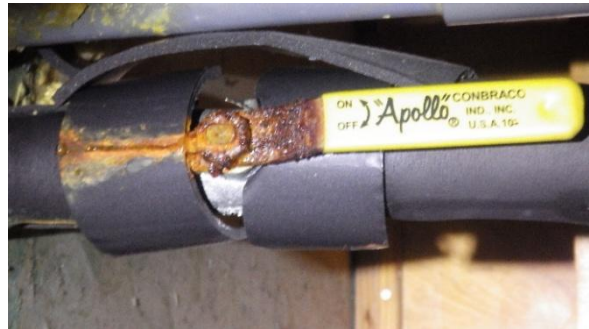
**HEAVY CORROSION ON ISOLATION  
VALVES AT EACH FAN COIL UNIT**

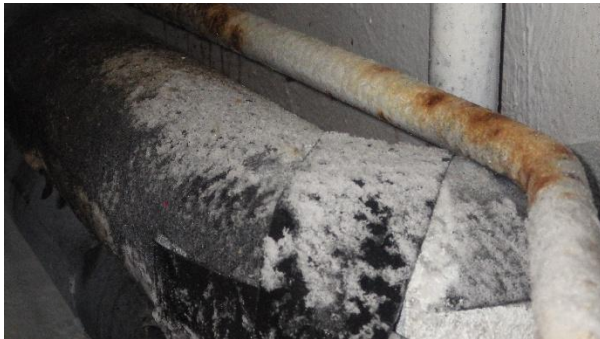
**NEOPRENE INSULATION FAILING  
THROUGHOUT THE VESSEL. MULTIPLE  
OVERHEAD LEAKS NOTICED.**

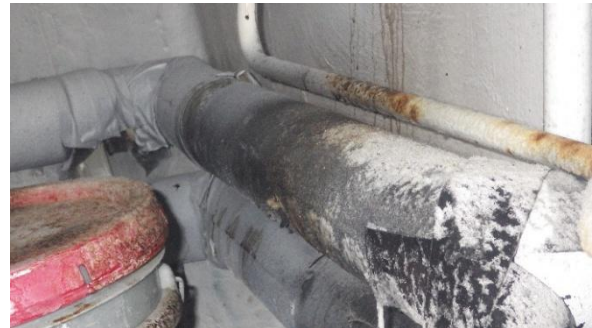
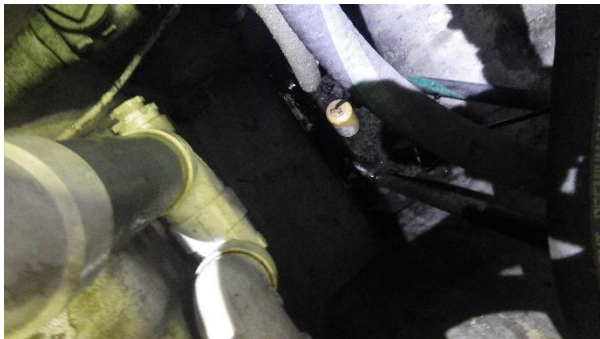
**NEOPRENE INSULATION FAILING  
THROUGHOUT THE VESSEL. MULTIPLE  
OVERHEAD LEAKS NOTICED.**

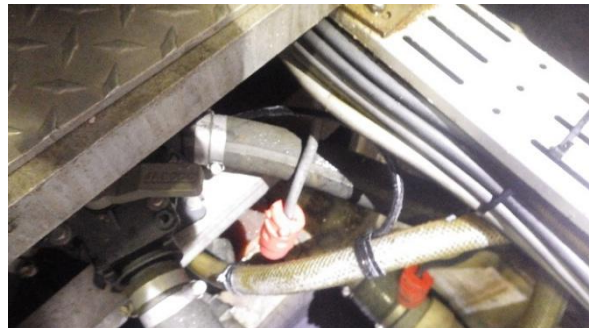
**LOOSE 120VAC OUTLETS HANGING OUT  
CENTERLINE BILGE ENGINE ROOM**

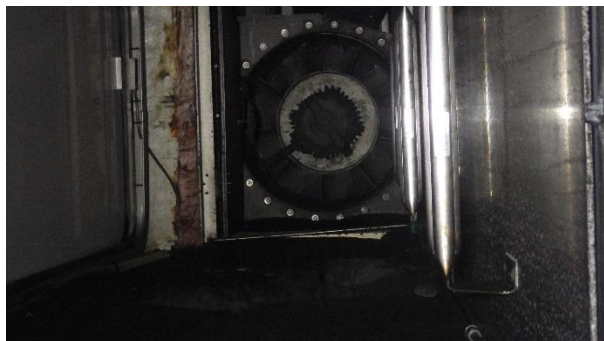
**MAIN ENGINE ROOM EXHAUST FANS INSTALLED WITHOUT PROTECTIVE GUARD/SCREENS**

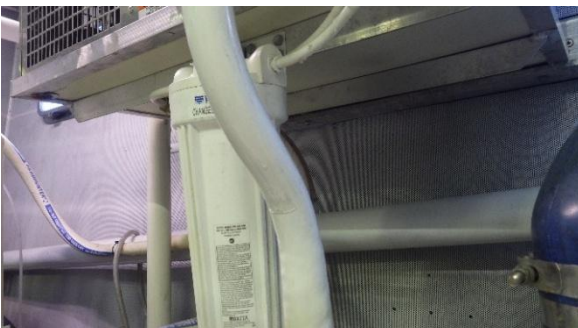
**WATER LEAKING FROM DISPENSER**

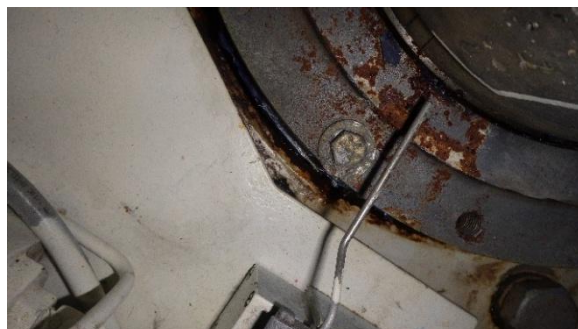
**WATER LEAKING FROM PORT FIN**

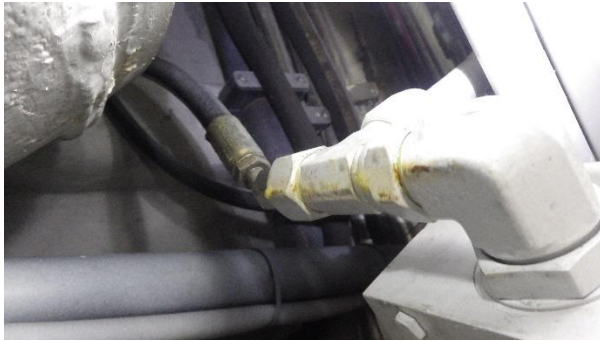
**HYDRAULIC OIL LEAKING STARBOARD  
STABILIZER**
