September 3, 2024

**M/Y Pretti Rose**

**Custom Downeast 54'**

**Condition and Valuation Report**

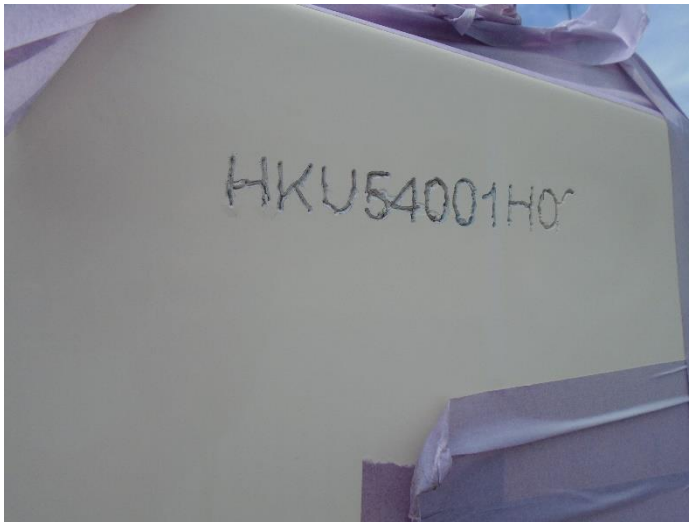
**HID#** HKU-54001HD20 (The last two digits are missing in the photo)

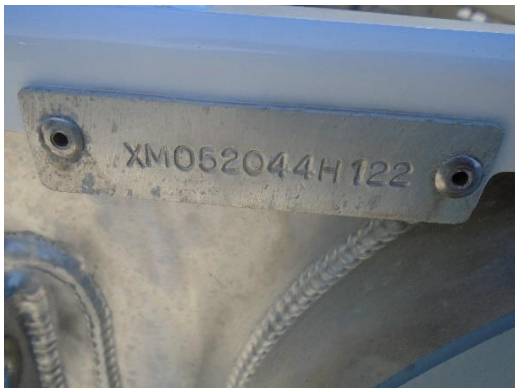
The Tender was stored on deck and was not tested as part of this inspection. The Tender is visually in very good condition
