**2005 73' Park Isle Marine, Sooke, BC Canada Snowbird**

## **"True Love"**

# Report of Marine Survey

**Date Of Survey:** July 31, 2024 & August 1, 2024

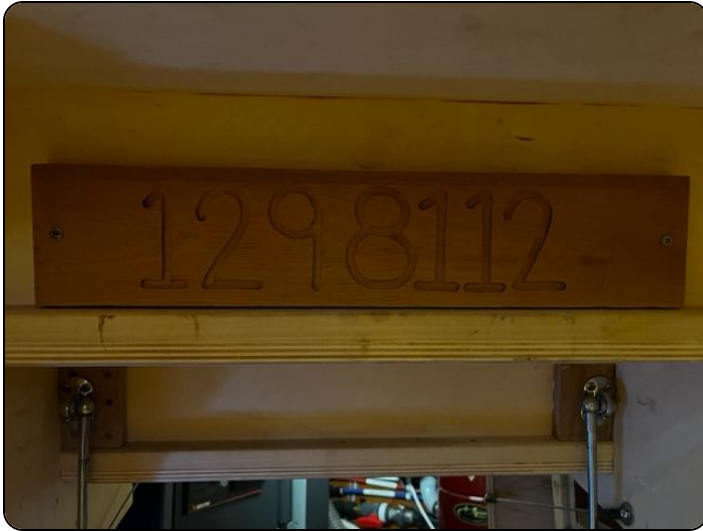
**FINDING C-1**

The vessel's U.S.C.G. Documentation Number was improperly displayed.

Properly display U.S.C.G. Documentation number for compliance. The vessel must have the official documentation number permanently affixed in block-type Arabic numerals of not less than 3 inches in height, preceded by the letters "NO ." on some clearly visible interior integral structural part of the vessel. The number must be permanently affixed so that alteration, removal or replacement would be obvious and cause some scarring or damage to the surrounding hull area.

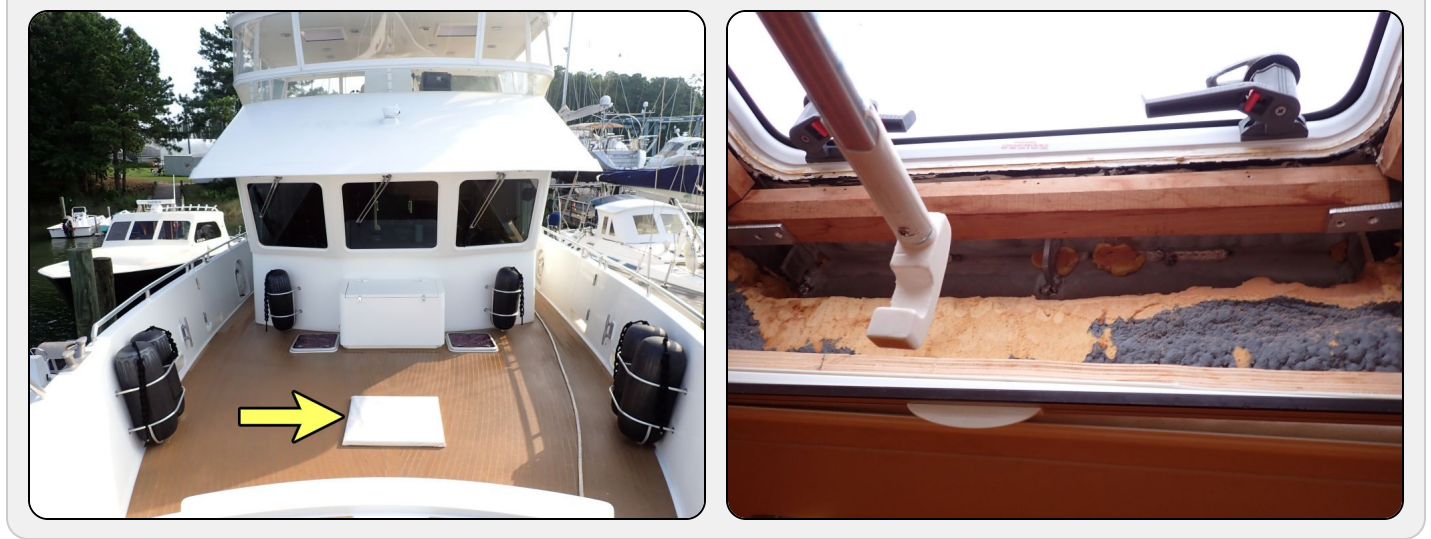
The forward deck center Bomar egress hatch had a shrink wrap cover over the top, and the interior frame was missing. Signs the hatch had been leaking and in a process of repair.

Repair as necessary.

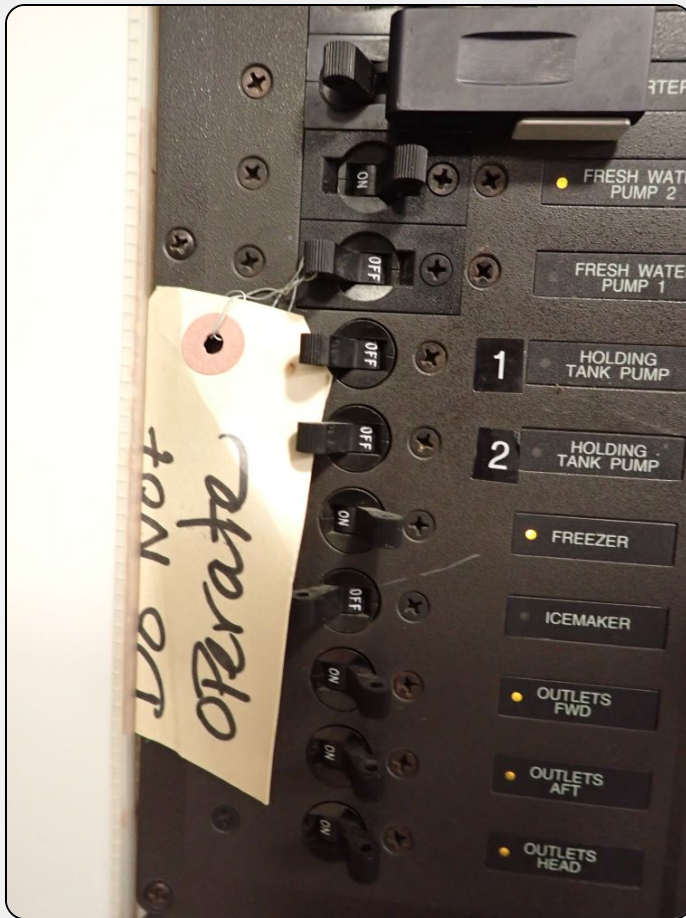
**FINDING B-2 FRESHWATER PUMPS**

The freshwater pump #1 was tagged out "Do Not Operate" in the engine room MDP panel.

Investigate further, and service, repair or replace as necessary.

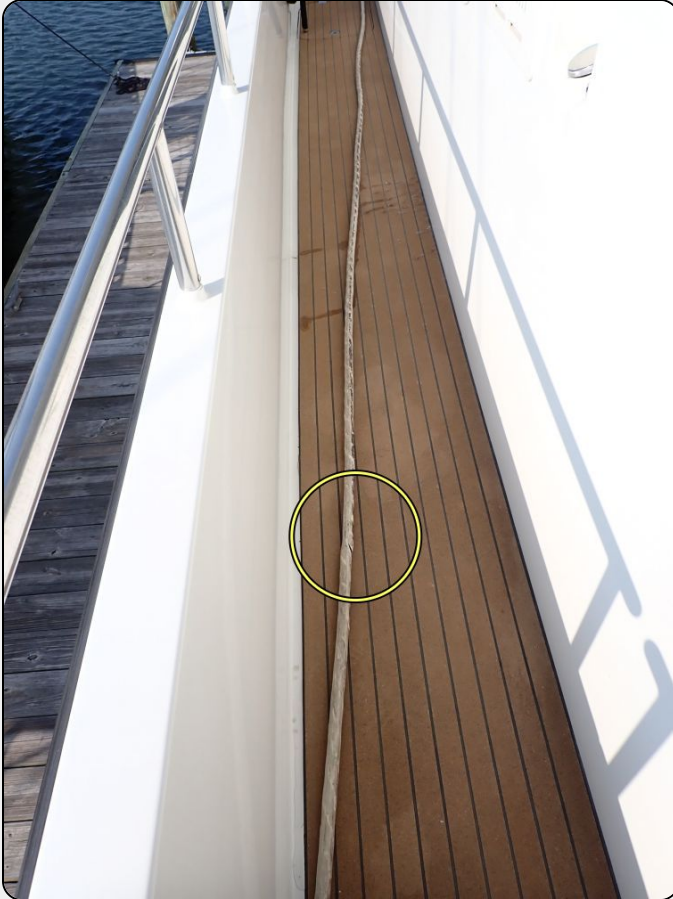
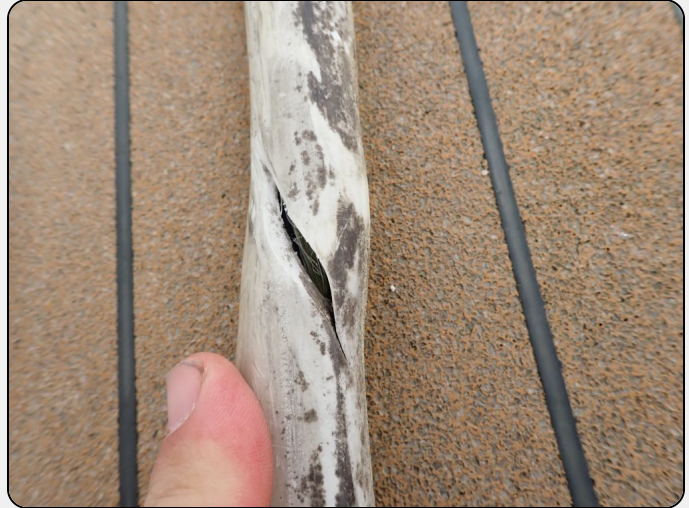
**FINDING B-3 AC SHORE POWER INLETS**

The forward Glendinning 50 Amp cable had a split in the cable sheath.

Replace as necessary.

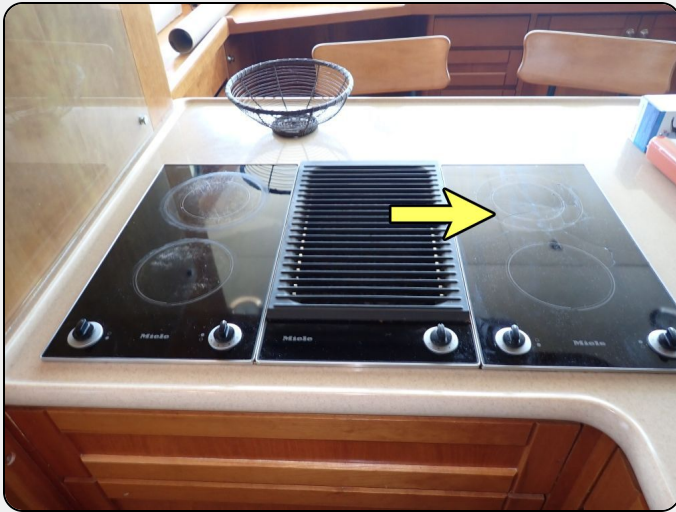
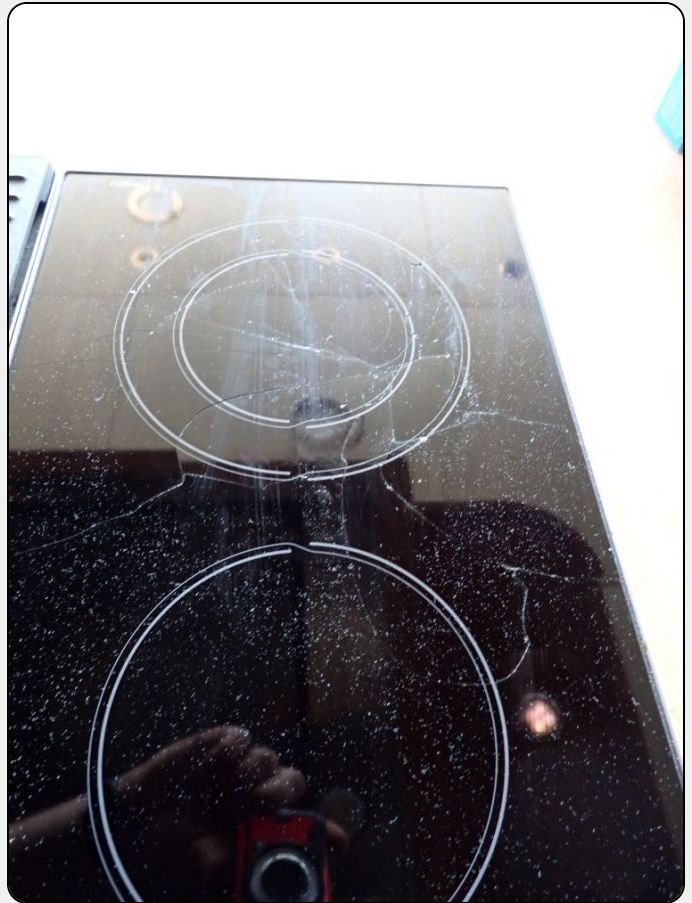
The starboard side glass cooctop panel was cracked.

Replace the panel as necessary.

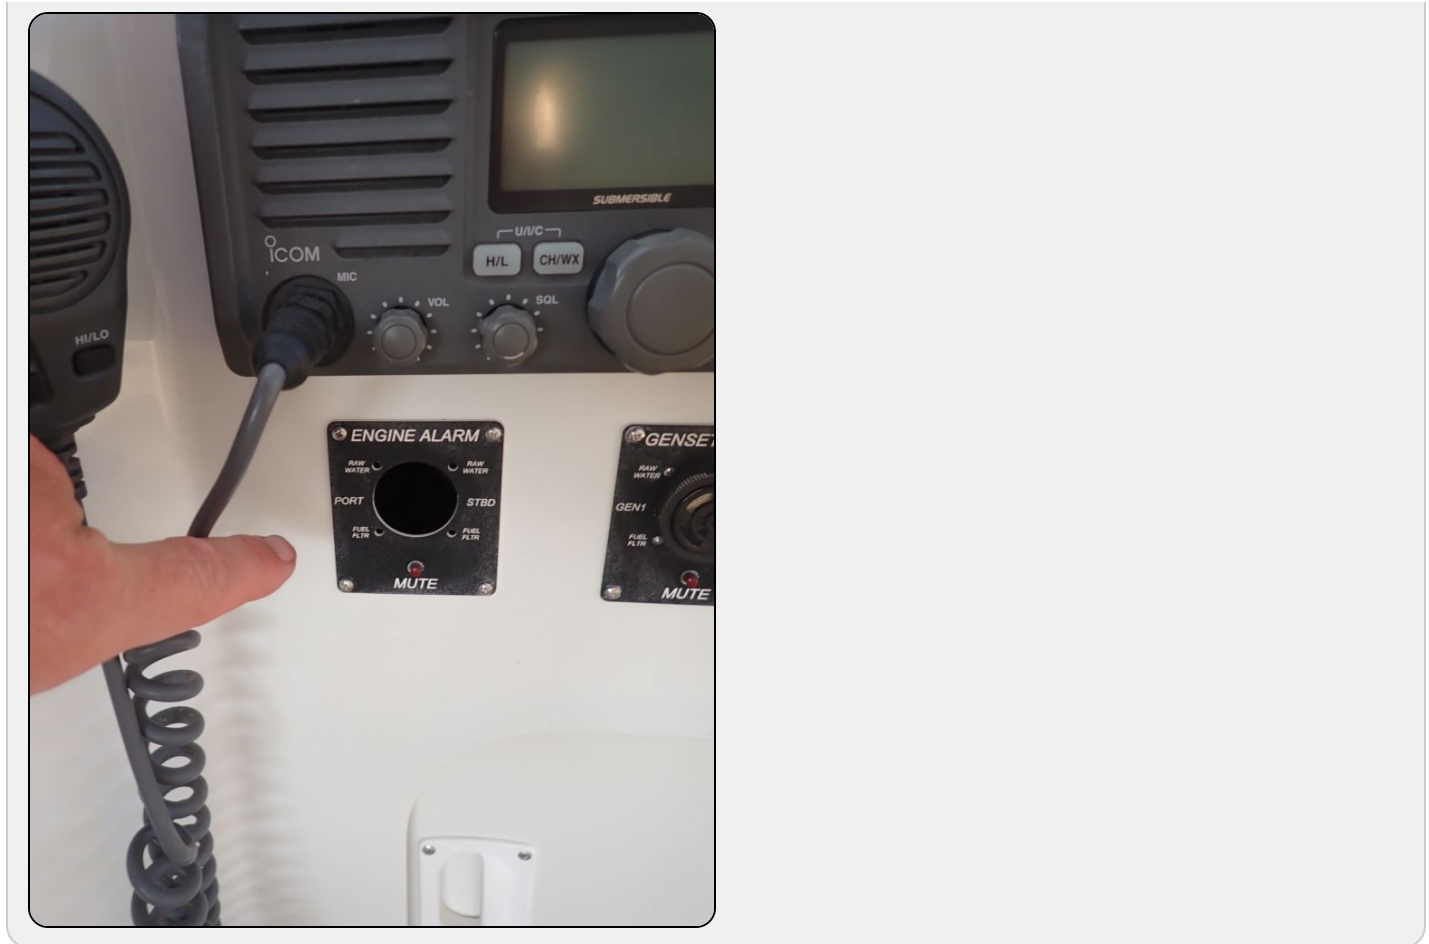
**FINDING B-6** ENGINE ALARMS

The upper helm engine alarm speaker was missing/disconnected.

Replace as necessary.

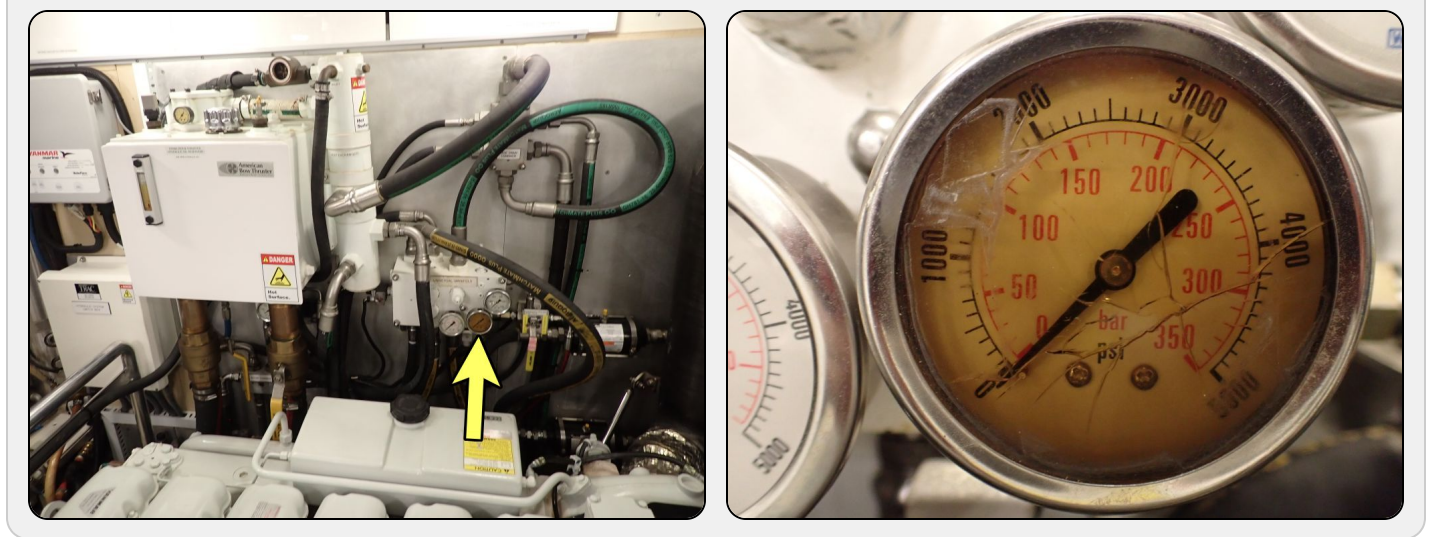
Some residual oil was on the foamed bilge area around the starboard side of the engine space beneath the universal hydraulic manifold. Noted one of the hydraulic gauge lenses was shattered.

Clean bilge areas and replace gauge hardware as necessary.

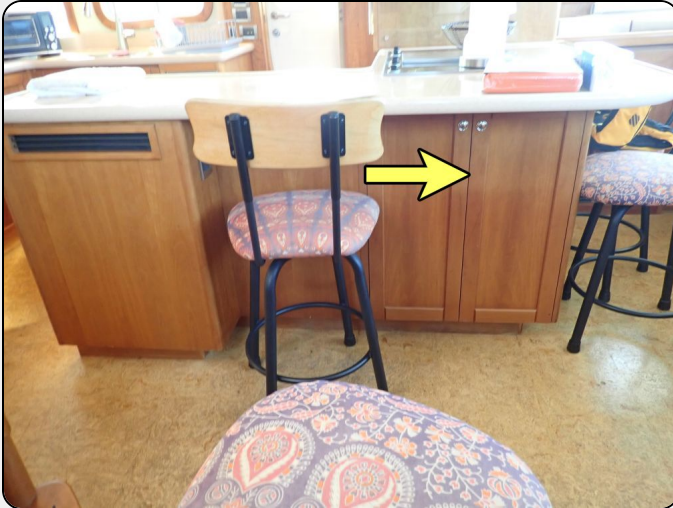
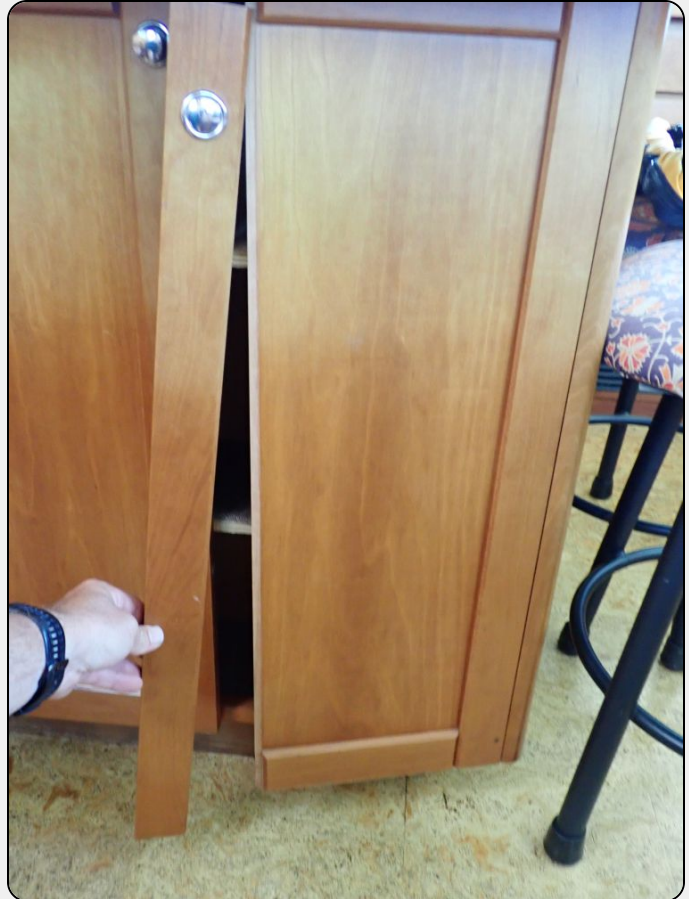
One of the forward lower galley cabinet door stiles was loose.

Repair as necessary.
