May 13, 2024

**S/Y Melinka
1981 Swan 80**

Condition and Valuation Report

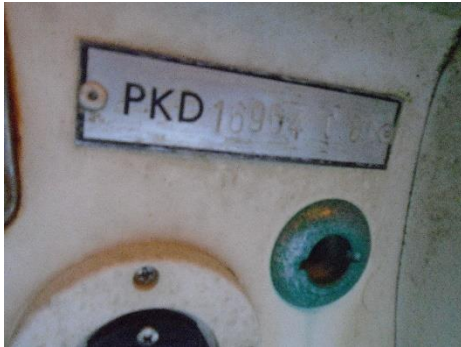
Tender HID# PKD16964C8

The tender was not tested during this inspection. The tender has an electric start engine and is reported to be in good condition. The tender is in good visual condition. The following are installed on the tender:
