MARINE SURVEY INSPECTION ABOARD THE VESSEL

1999 Little Harbor WhisperJet 44 Vesper

MARINE SURVEY INSPECTION & REPORT CONDUCTED BY

| MARINE SURVEY INSPECTION TYPE | Condition & Valuation Survey |

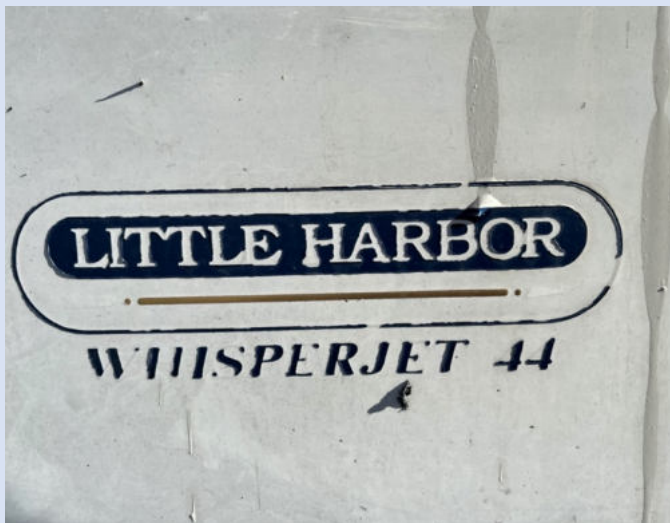
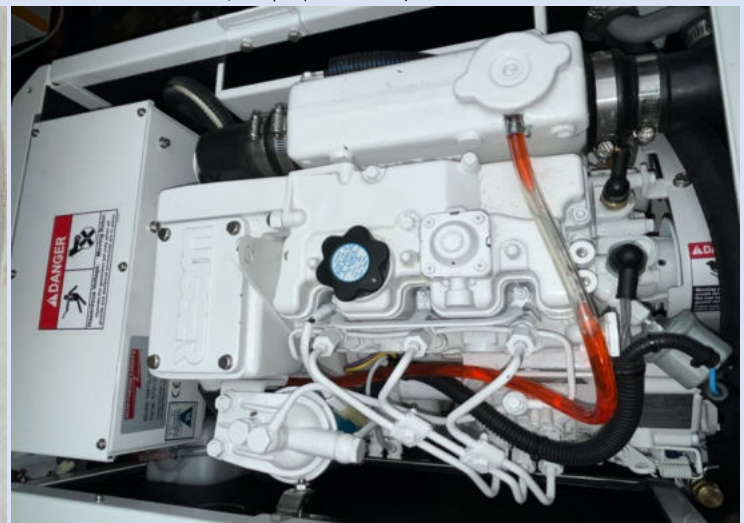
The 44 was surveyed in North Charleston, South Carolina, USA on 01/12/2022 and 1x 6.0kW Northern Lights diesel marine generator is new and recently installed

| MARINE GENERATOR QUANTITY, YEAR, MAKE, MODEL & CONDITION 1x 2021 6.0kW Northern Lights M673L3G.3 60HZ diesel marine generator system, sound shield, components and hardware appear in bristol condition and was recently installed as part of the refit. |

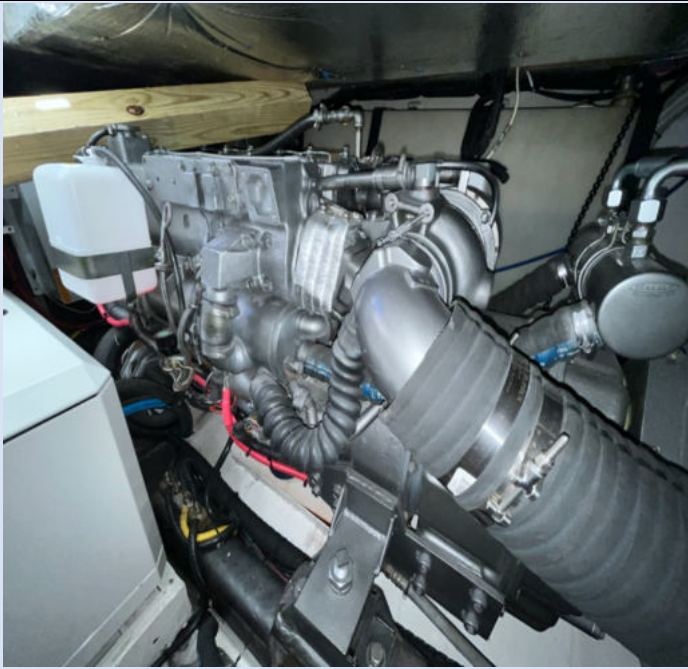
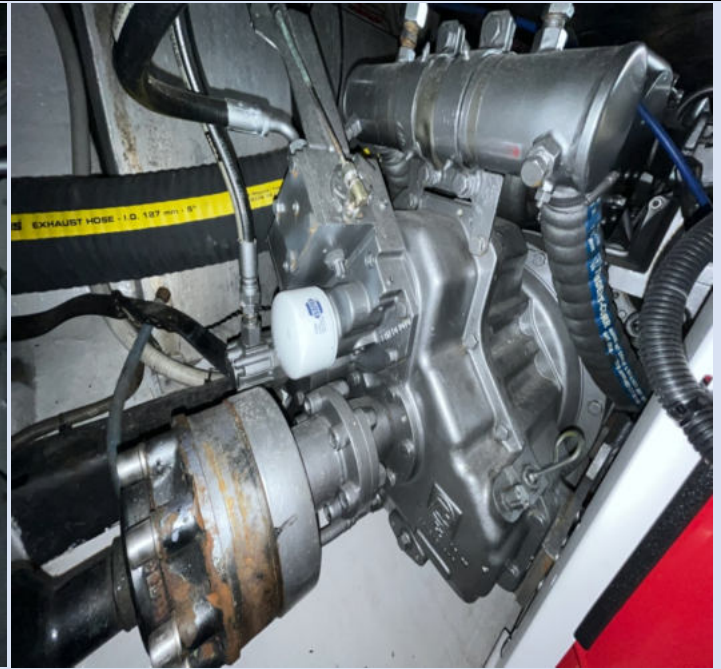
2x Yanmar 440HP diesel engines, 2x ZF Hurth marine transmissions and heat exchangers appear in serviceable condition without corrosion or critical wear

ENGINE CONDITION, ENGINE ROOM SPACE, SOUND INSULATION & BILGE BLOWER SYSTEMS 2x Yanmar 440HP diesel engines, 2x ZF Hurth marine transmissions, 2x HamiltonJet waterjets and all propulsion systems appear in serviceable condition for the age and use of the vessel without noticeable grounding damage, widespread pitting, metal wear or fatigue, pinking to the metals, galvanic or stray current corrosion, active raw-water, oil, coolant, freshwater, transmission fluid or noticeable diesel fuel leaks reported throughout the visual inspection and cold-check. The powerheads and blocks, valve covers, Yanmar engine Racor diesel fuel-water separating filters, sightbowls, inline fuel filters, oil filters, timing belts, all pulleys, belt tensioners, air filters, air inlets, water pumps, fuel pumps, raw-water cooling system hoses, US Coast Guard approved type-A2 fuel lines, gaskets, dipsticks, returns, shut-off valves, hoseclamps, seals, alternators, starters, electrical conductors, main engine harnesses, engine motor mounts and grounding wires appear in serviceable shape without critical corrosion throughout the visual inspection and all systems appear to operate normally. The Yanmar engine oil and transmission fluid appeared at appropriate levels and were not milky, watery, burnt or contaminated by noticeable metal wear, raw-water or fuel intrusion. Zero active alarms were reported underway. 1x full-beam engine room appears in serviceable structural and cosmetic condition, exceptionally clean without spare parts, fluids or leaks observed, freshly painted and blower system powers up. 2x Yanmar 440HP diesel engines were recently rebuilt and the hour meters are reflective since the rebuild.

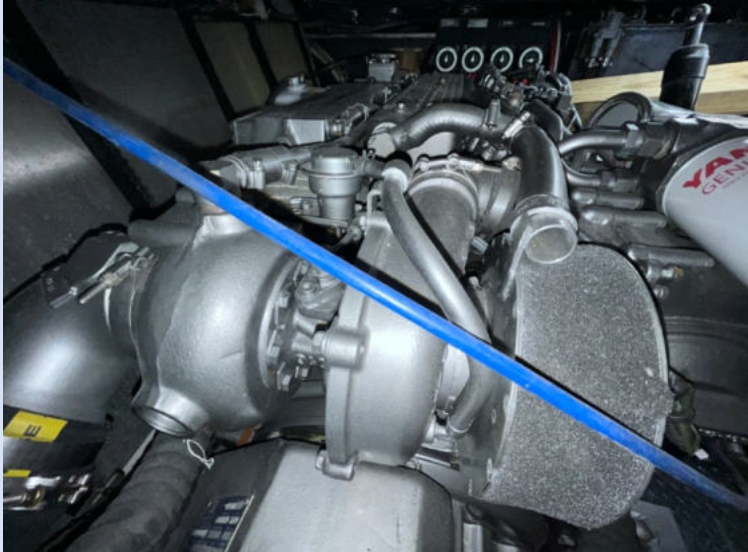
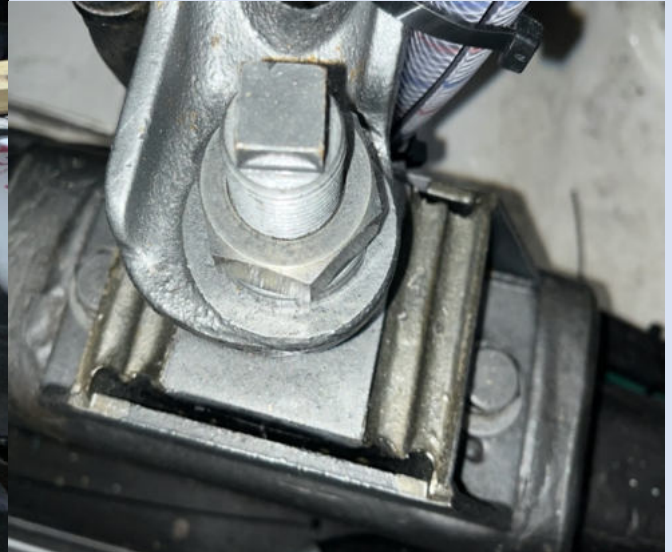
2x Yanmar 440HP diesel engine turbochargers and 8x motor mounts appear in functional condition without widespread surface rust or raw-water corrosion

ENGINE BED, MOUNTING BRACKET & MOTOR MOUNTS FRP engine beds in the engine room, 8x mounting brackets, 12x Yanmar engine and Northern Lights marine generator motor mounts with hardware appears in serviceable condition and did not move noticeably underway.

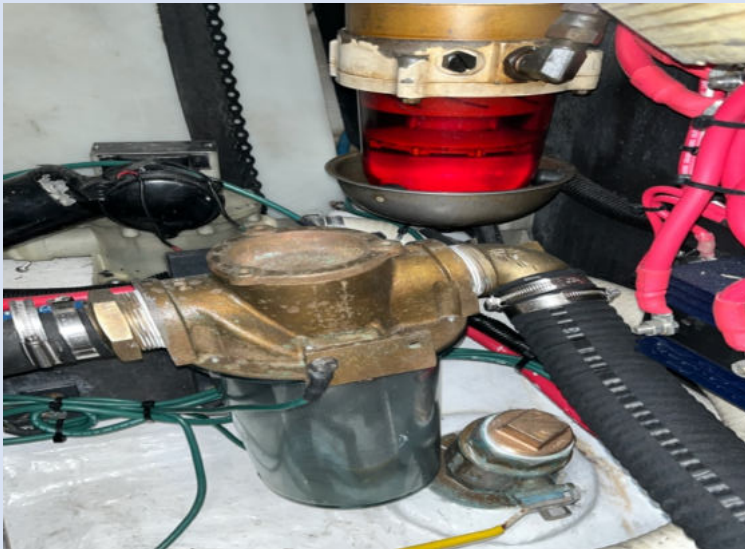
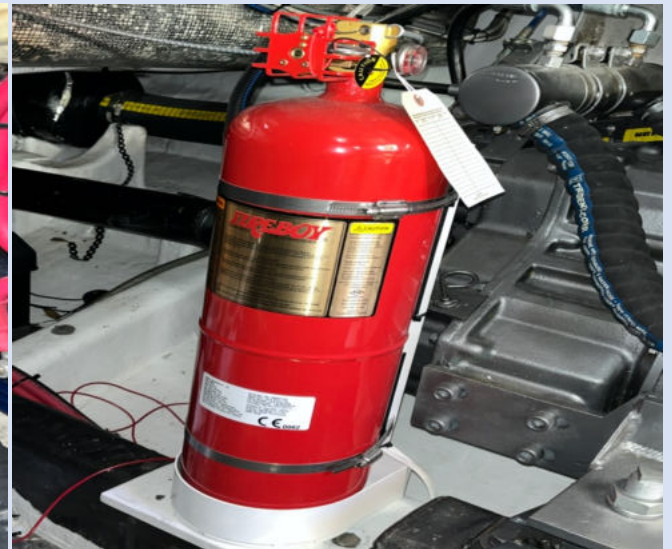
Rubber raw-water hoses, thru-hulls, seacocks, valves, sea-strainers, grounding wires, Racor diesel fuel-water separating filters & Fireboy suppression system is new

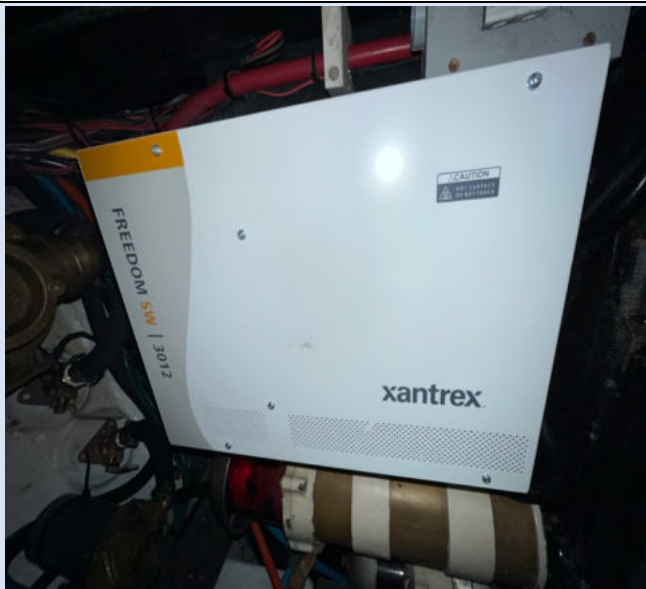
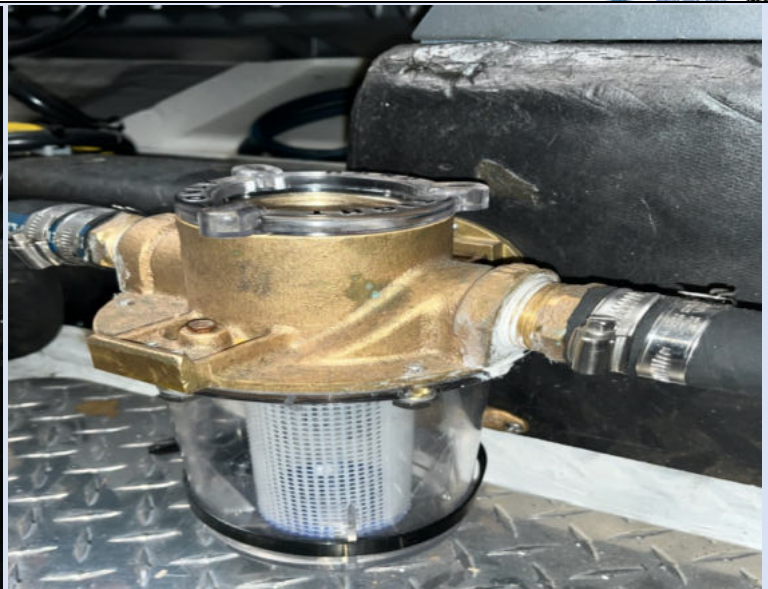
1x 12V DC Xantrex Freedom SW 3012 battery charger and inverter and new sea-strainer appears in bristol condition aboard the 44

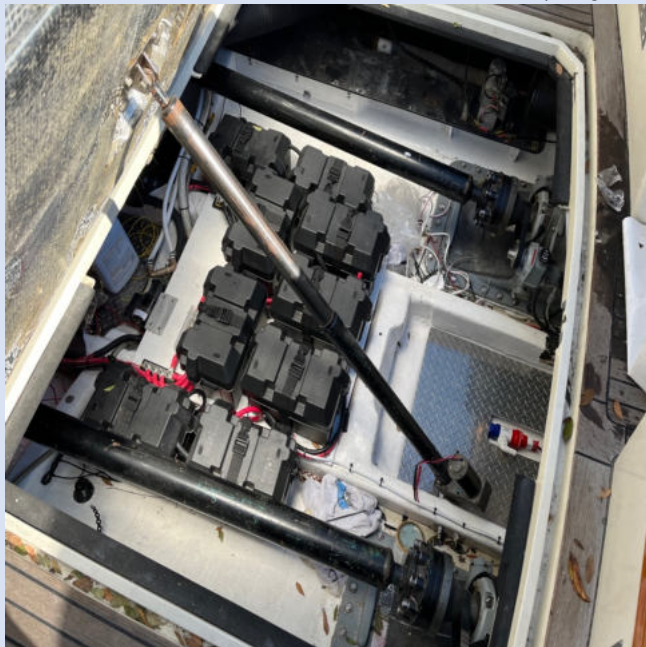
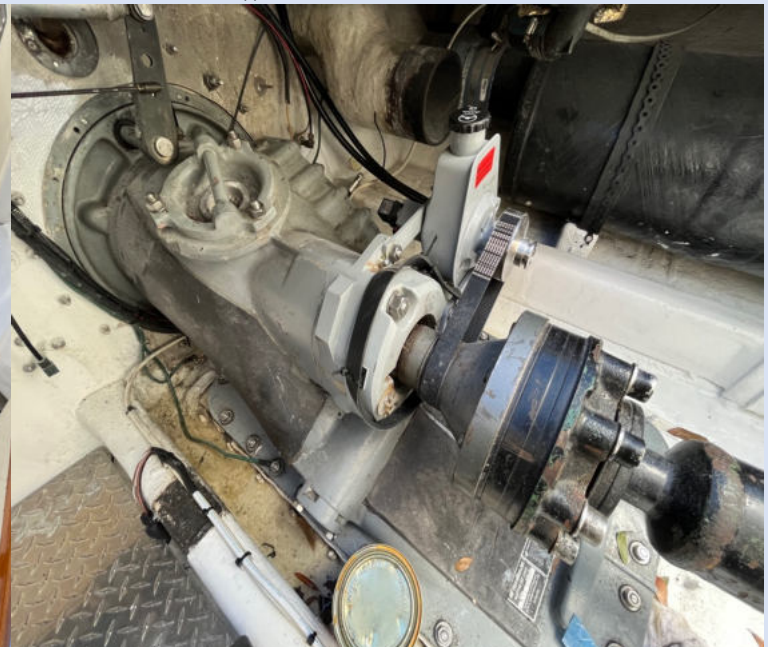
Jet room, stringers, bulkheads and bilges are well-supported and 2x HamiltonJet waterjets appear in serviceable condition

STRINGERS, FRAMING, TABBING & BULKHEADS Hull stiffness is provided by FRP longitudinal stringers and transverse frames on various centers that appear in serviceable, functional, cosmetic and physical condition, well-supported and structurally sound without deficiencies. Zero noticeable critical evidence of active water intrusion, saturation, FRP delamination, soft-spots, voids, excessive wear and tear, acute physical impacts, stress-cracking, fractures, decay, rot, pitting, haloing, saltwater corrosion, blue/green oxidation or surface rust is detected during the visual inspection and percussion tests on the stringers, framing, tabbing and bulkheads. All structural members were scrutinized for structural loss, deterioration and detached bonding without discovery, where accessible. *Due to limited access caused by vessel construction, a comprehensive inspection of the hull interior, stringers, framing, tabbing, bulkheads and all structural support systems were not accomplished, core samples and destructive testing were not performed on the hull.**

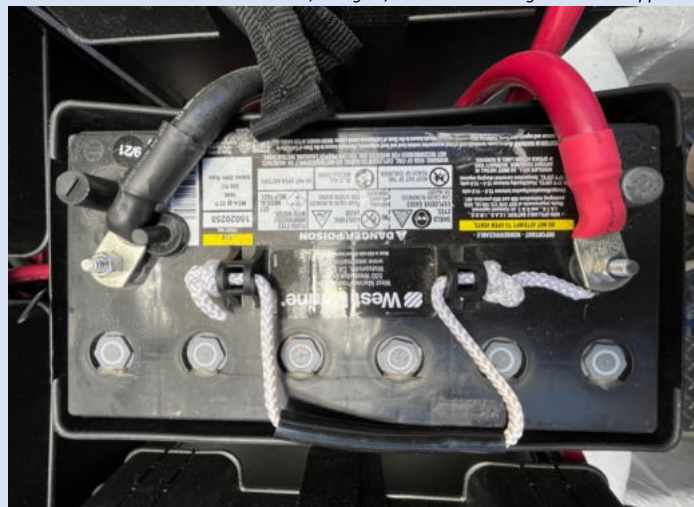
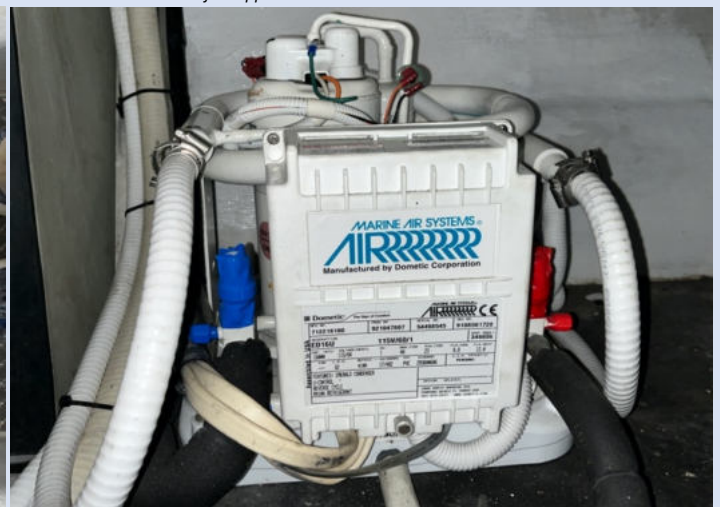
7x 12V DC West Marine Little Harbor house bank, Yanmar engine and Northern Lights marine generator starting batteries and 2x climate control units power up

DC SYSTEM VOLTAGE, BATTERY QUANTITY, AGE, TYPE & COVERS 9x 2021 12V DC West Marine Group Size 31 AGM 105Ah 1,000MCA 800CCA Little Harbor house bank, 2x Yanmar engine and 1x Northern Lights marine generator starting batteries installed in the lazarette jet compartment, battery cables, terminal posts and hardware appear in serviceable shape stored in watertight bins without noticeable burn marks, wing nuts, corrosion, surface rust, blue/green oxidation and voltage was within an acceptable range (nearly 13.6V) on the 44.

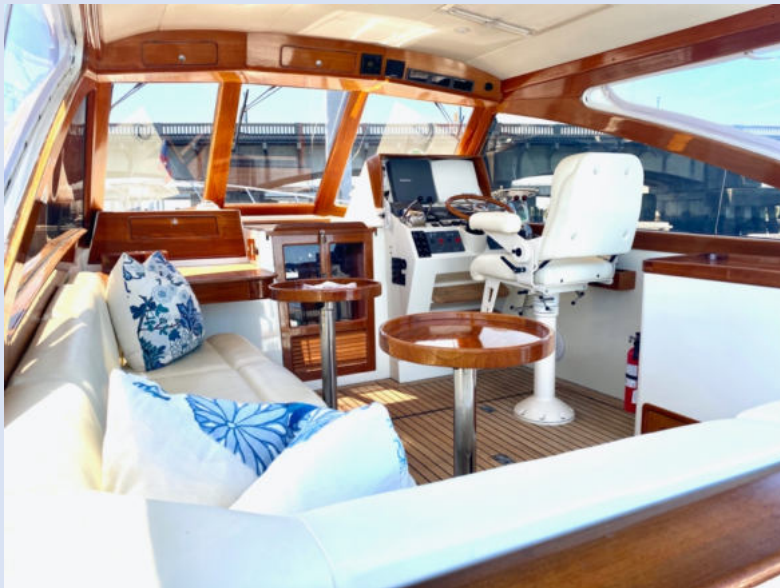
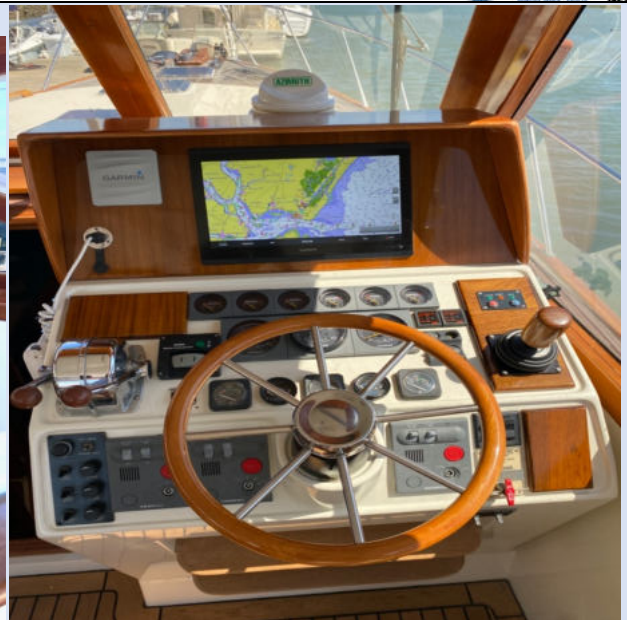
Aft cockpit is well-supported, structurally sound, teak and pilothouse helm station appears in serviceable shape with new Garmin GPS

HELM STATIONS 1x partially enclosed pilothouse FRP helm station to starboard appears in serviceable overall esthetic and structural condition, well-supported and visibility is exceptional for the operator in each direction. 1x 15" Little Harbor 8-spoke stainless-steel and teak steering wheel, hydraulic steering system, steering actuator, ram, gaskets, connections and hardware appear in serviceable condition, well-supported without dire wear and operated smoothly from port to starboard without hydraulic fluid leaks, hesitation, interruption or resistance during the out-of-the-water inspection. 1x set of binnacle mounted Morse control box with Yanmar engine throttle lever control appears in serviceable shape, power up and operate smoothly. On top of the pilothouse dash is 1x Azimuth digital compass that appears in serviceable condition and operates normally. Below the compass on the face of the dash directly in front of the operator is 1x 16" touchscreen Garmin GPSmap 8616XSV GPS chartplotter, sonar depthfinder and radar display, port and starboard analog Yanmar engine gauge cluster, Vetus bow thruster control, 2x Yanmar engine ignition and kill switches, navigation light controls, 3x windshield wipers controls, courtesy light controls, engine hatch control, 2x bilge pump controls, engine alarm systems, hardtop courtesy lights, spot/floodlight control, engine room fire suppression system control and Bennett trim tab controls that appear in serviceable shape and power up routinely during the onboard systems tests.

MAIN DECK, SOLE & COCKPIT FRP and teak foredeck sole, port and starboard sidedecks, aft cockpit sole, aft cockpit space and caulking appears in usable cosmetic and physical condition, well-supported and structurally sound without active concerns. Zero noticeable evidence of dry rot, water intrusion, saturation, FRP delamination, voids, excessive wear and tear, oxidation, acute physical impacts, stress-cracking, fractures, osmotic and paint blistering, decay, rot, pitting, haloing, saltwater corrosion or surface rust is detected during the visual inspection and percussion tests on the main deck, sole and cockpit.

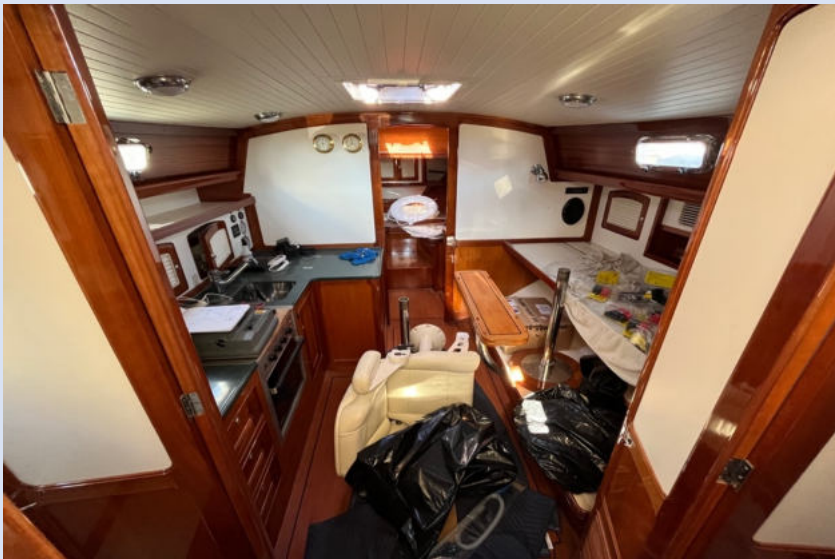
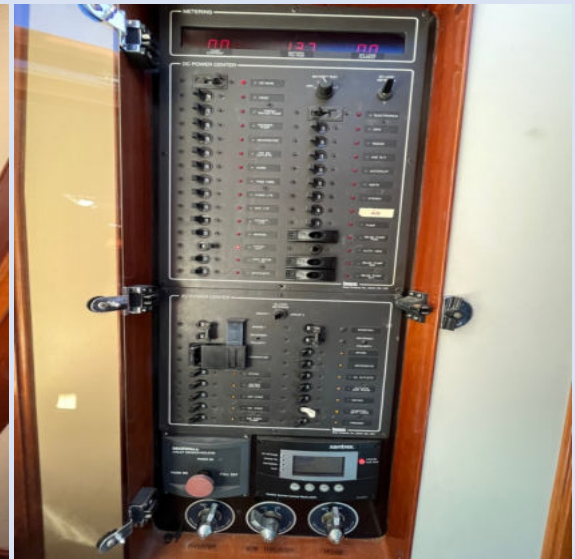
Looking forward in the main salon interior, AC and DC power distribution panel appears in serviceable shape and powers up

| AC & DC POWER DISTRIBUTION PANEL 1x AC and DC power distribution panel installed to port in the companionway, switches and conductors appear in serviceable condition, well-supported and powers up routinely during the onboard systems tests. |

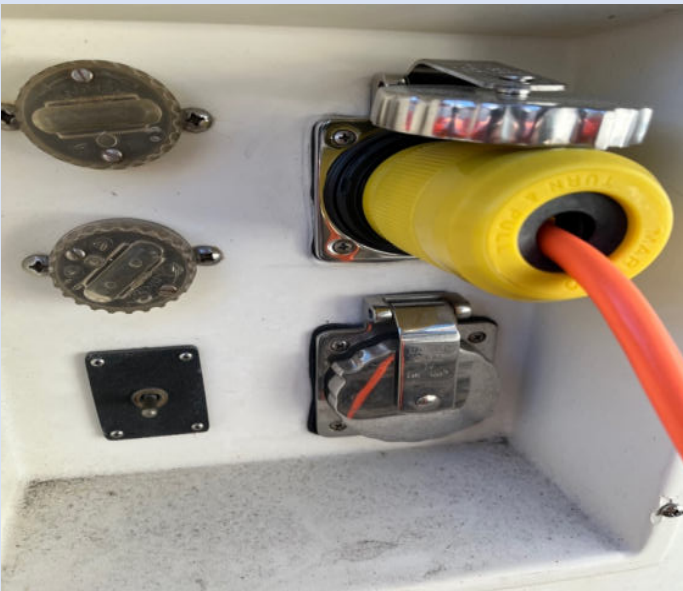
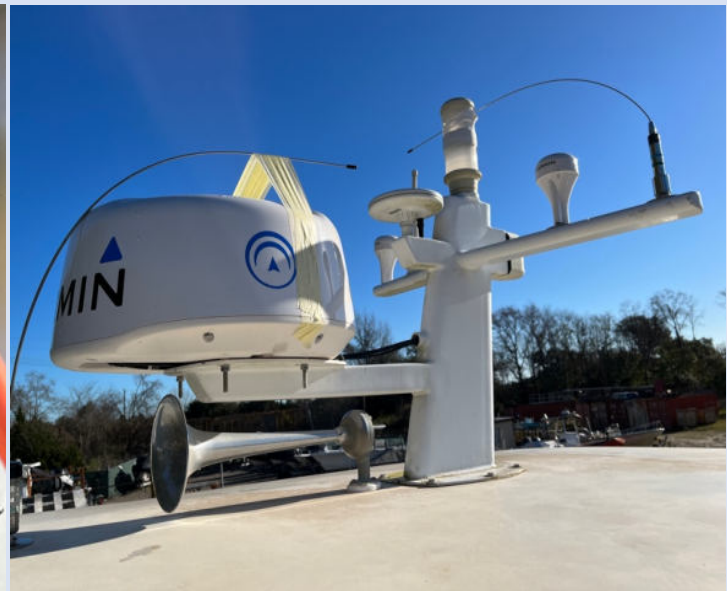
30A 125V shorepower dockside inlet and radar mast with Garmin radar antenna appears in serviceable condition

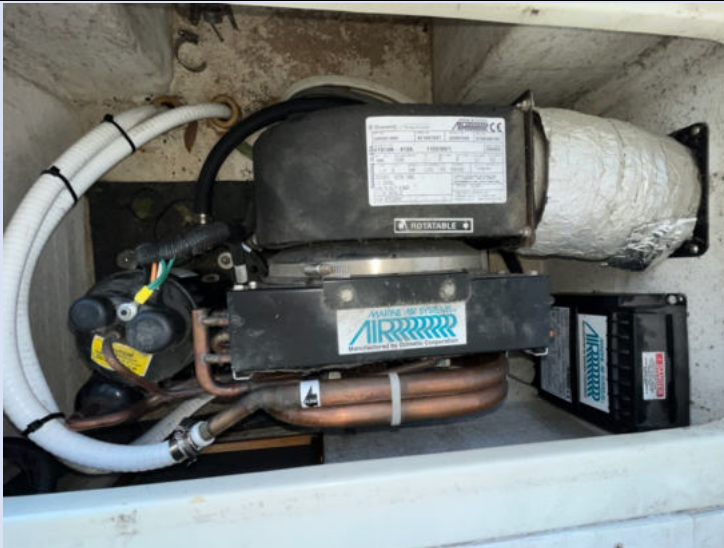
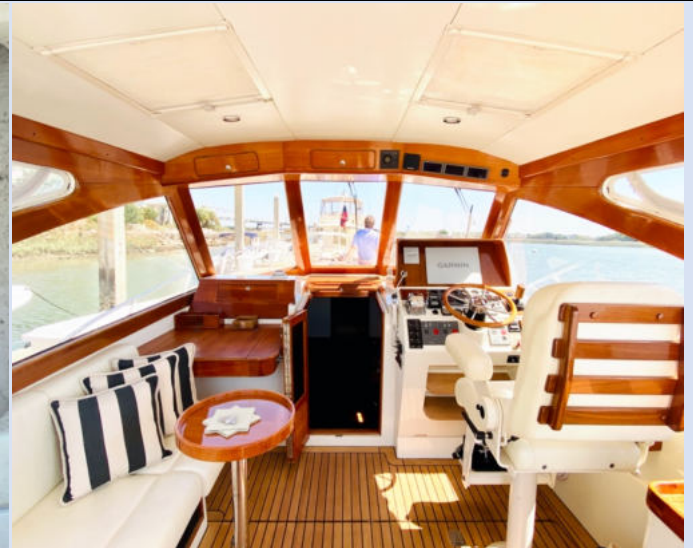
2x Dometic Marine Air Systems reverse cycle climate control units appear in serviceable shape and looking forward in the pilothouse

| CLIMATE CONTROL & THERMOSTAT SYSTEMS 2x Dometic Marine Air Systems 20,000-total BTU reverse cycle climate control units, thru-hulls, seacocks, sea-strainers, compressors, returns, ductwork, 2x water pressure pump, vents and 2x Cruisair digital thermostats appears in serviceable condition without wear. |

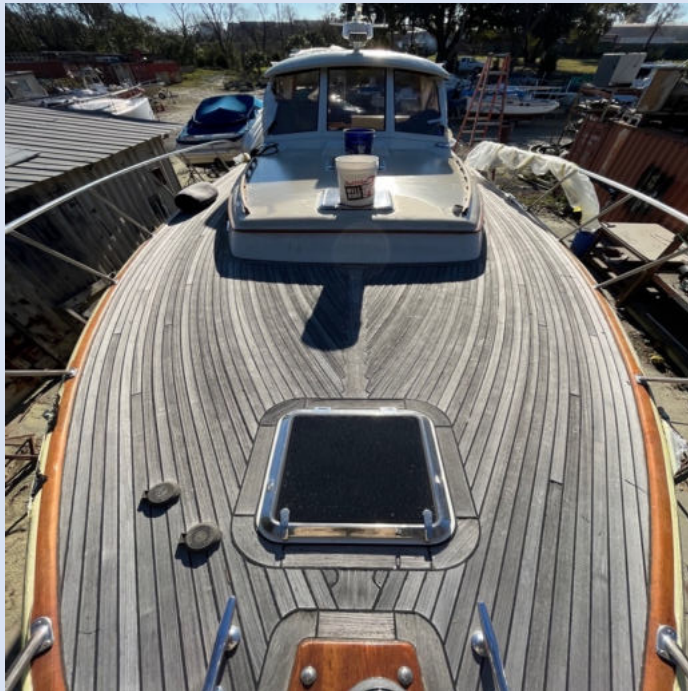
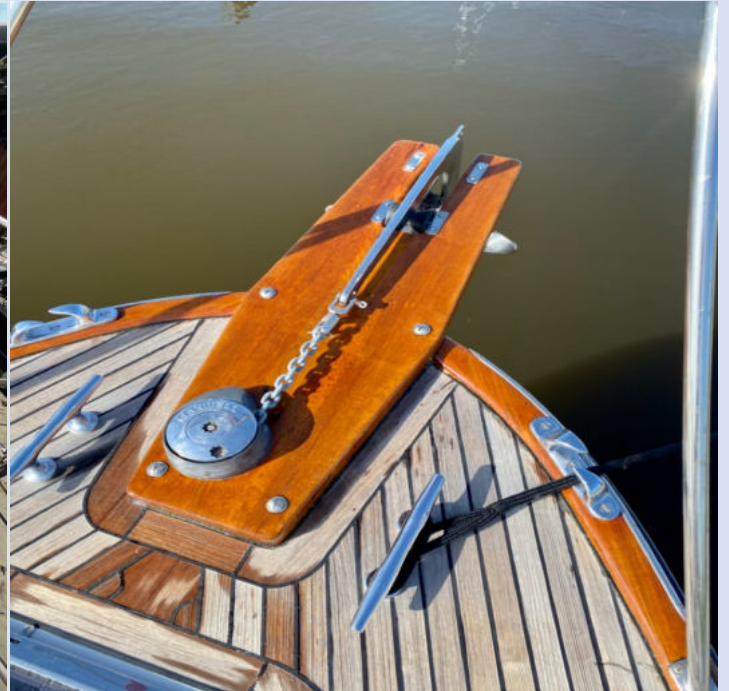
Teak foredeck, cabinhouse, deck hatches, handrails, lifelines, handrails, windshield, pilothouse and Maxwell anchor windlass appears in serviceable condition

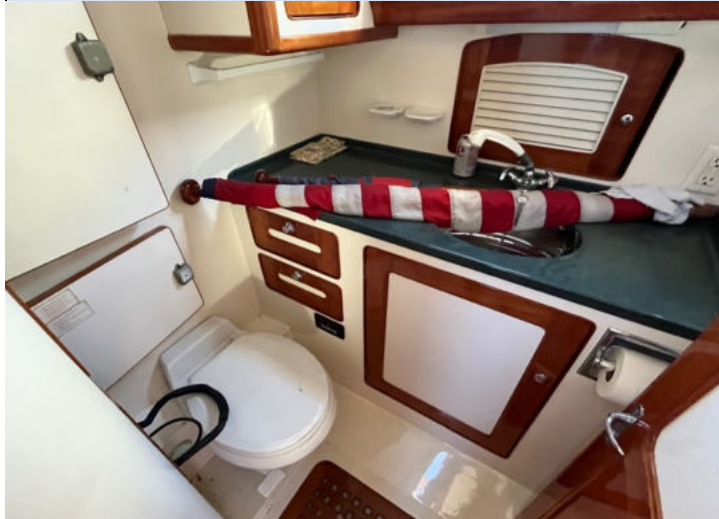
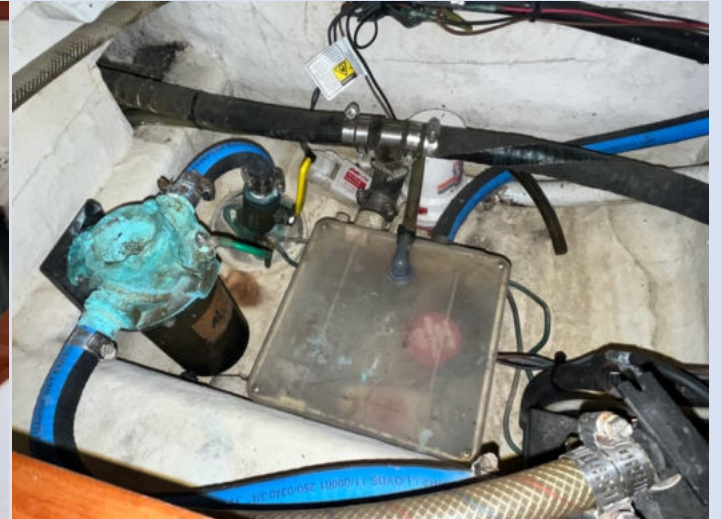
Portside head with Vacuflush toilet, MSD system, freshwater system, midship bilge pump, thru-hulls and sump pump appears in serviceable shape

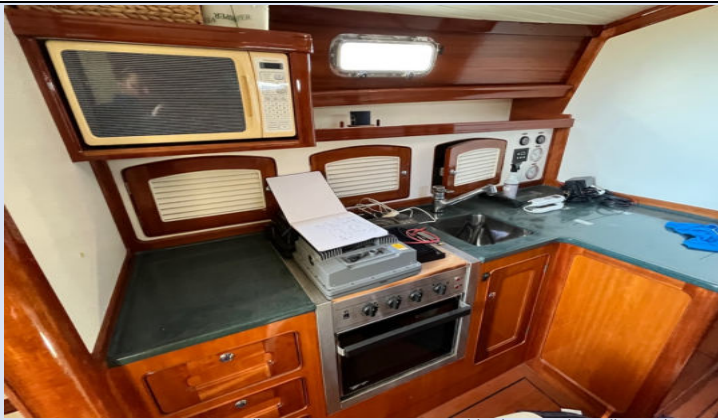
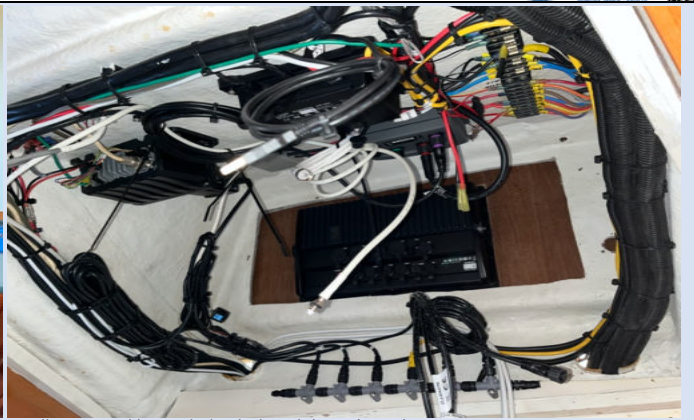
All systems appear in serviceable shape in the galley and wiring is well-supported beneath the dash and throughout the 44

| CONDUCTOR ROUTING 600V marine grade 16-gauge multi-strand copper electrical conductors, wiring, looming and all other conductors appear in serviceable shape and well-supported without burn marks, fire/water damage, worn looming, damaged butt connectors, widespread deficiencies or other loss, where seen. Ages, internal conditions and service histories of all AC and DC electrical conductors are unverified. |

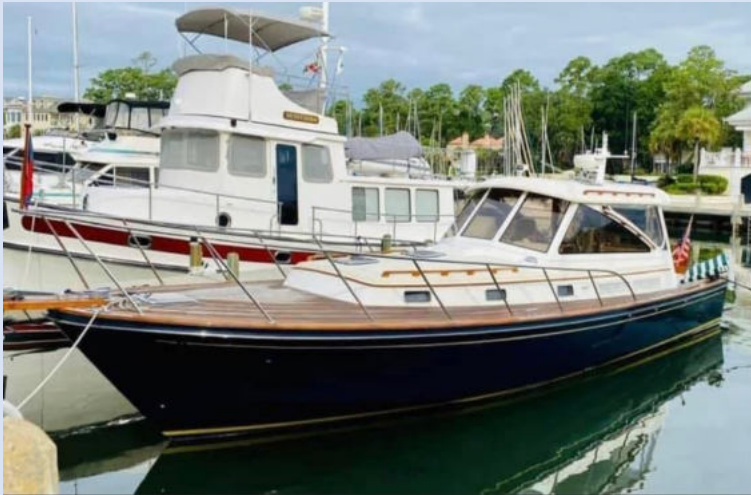
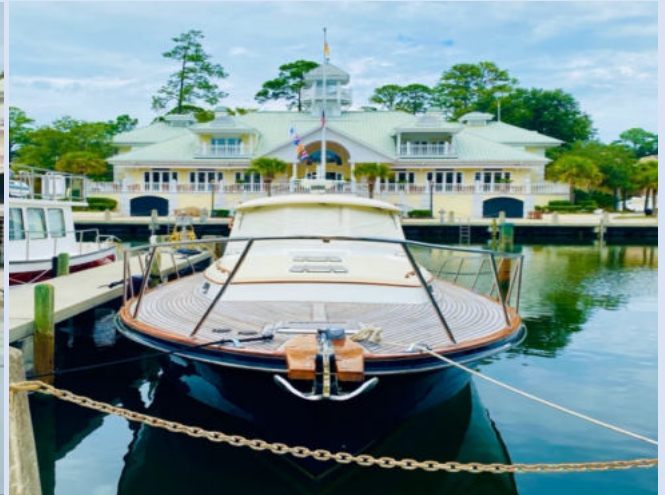
Port and starboard FRP topsides, hull bottom and keel appear in serviceable structural and cosmetic condition without delamination, water intrusion or soft-spots

VESSEL HULL EXTERIOR, TOPSIDES & HULL-TO-DECK JOINT Aboard the 1999 Little Harbor WhisperJet 44 *Vesper* powerboat, the port and starboard fiber-reinforced plastic (FRP) and Kevlar dark green gelcoat finished hull exterior, topsides, white bootstripe and gold covestripe appears in serviceable visual, cosmetic and structural condition, well-supported and operationally sound without significant defects for a vessel of this age, size and use. Zero noticeable evidence of active water intrusion, saturation, FRP delamination, soft-spots, voids, excessive wear and tear, UV oxidation, grounding damage, marine growth, acute physical impacts, stress-cracking, fractures, osmotic and paint blistering, fractures, decay, rot, pitting, haloing, saltwater corrosion or surface rust is detected during the visual inspection and percussion tests on the hull exterior and topsides. Using a phenolic hammer every 2-4 inches, percussive soundings were manually performed from stem to stern above and below the waterline throughout the hull exterior, in the interior and on structural support members, where accessible. Dry and acceptable percussion, Tramex moisture readings and FLIR thermal images were verified, where seen. The hull-to-deck joint and all corresponding hardware appears in operative condition, well-supported and bonded without separation or water intrusion around the vessel. The hull was repainted in Spring 2022.

HULLS WETTED SURFACE AREA, KEEL, BOLTS & BOTTOM PAINT Port and starboard FRP finished hulls wetted surface areas and the FRP keel appears in functional cosmetic and material condition, well-supported and structurally sound without glaring imperfections. Zero obvious evidence of active water intrusion, saturation, FRP delamination, soft-spots, voids, excessive wear and tear, grounding damage, acute physical impacts, fractures, osmotic and paint blistering, fractures, decay, rot, pitting, haloing, saltwater corrosion, marine growth or surface rust is detected during the visual inspection and percussion tests on the hulls wetted surface area and keel. Black marine grade antifouling bottom paint appears in serviceable shape without widespread bare spots, thinly coated areas or marine growth.

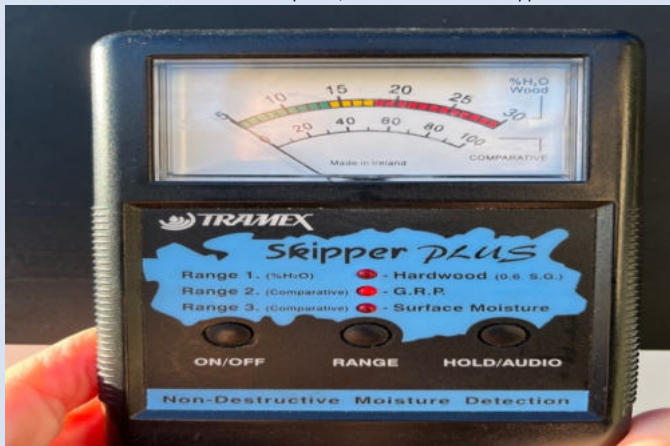
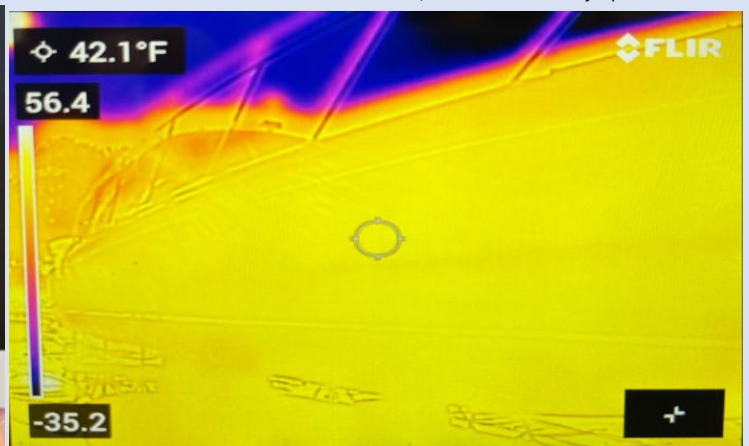
Normal, dry and acceptable Tramex moisture readings and FLIR thermal readings were taken throughout the hull exterior, on deck and structural support members

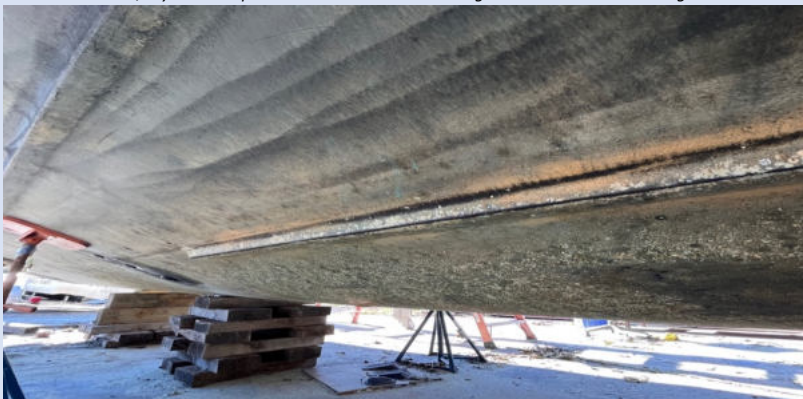
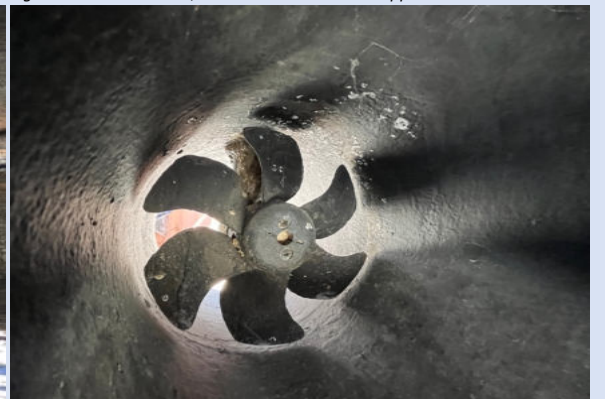
No grounding damage was reported to the hull bottom without osmotic blistering, FRP thruster tube and bow thruster appears in serviceable shape
