# **Certificate of Marine Survey THERIAULT MARINE CONSULTING, LLC**

## SURVEY NUMBER: 23TS2621

VESSEL NAME:	SUNFLOWER
TYPE OF VESSEL:	FRP; AUXILIARY SLOOP [Beneteau Oceanis 523 Clipper]
HULL IDENTIFICATION NUMBER:	BEYE3009B505
VESSEL HAILING PORT:	HARPSWELL, ME
FLAG:	United States of America
DATE SURVEYED:	07 March 2023
LOCATION SURVEYED:	Safe Harbor Great Island Harpswell, Maine
CLIENT/ADDRESS:	Mr. Mark Lenci 18 Woronoco Drive Natick, MA 01760
TELEPHONE:	617.525.8050
EMAIL:	marklenci@gmail.com
VESSEL BUILDER:	BENETEAU YACHTS
BUILDER LOCATION:	Marion, SC & Chantiers, France
YEAR VESSEL BUILT:	2005
LENGTH OVERALL:	53'01"
BEAM:	16'00"
DRAFT:	7'06″

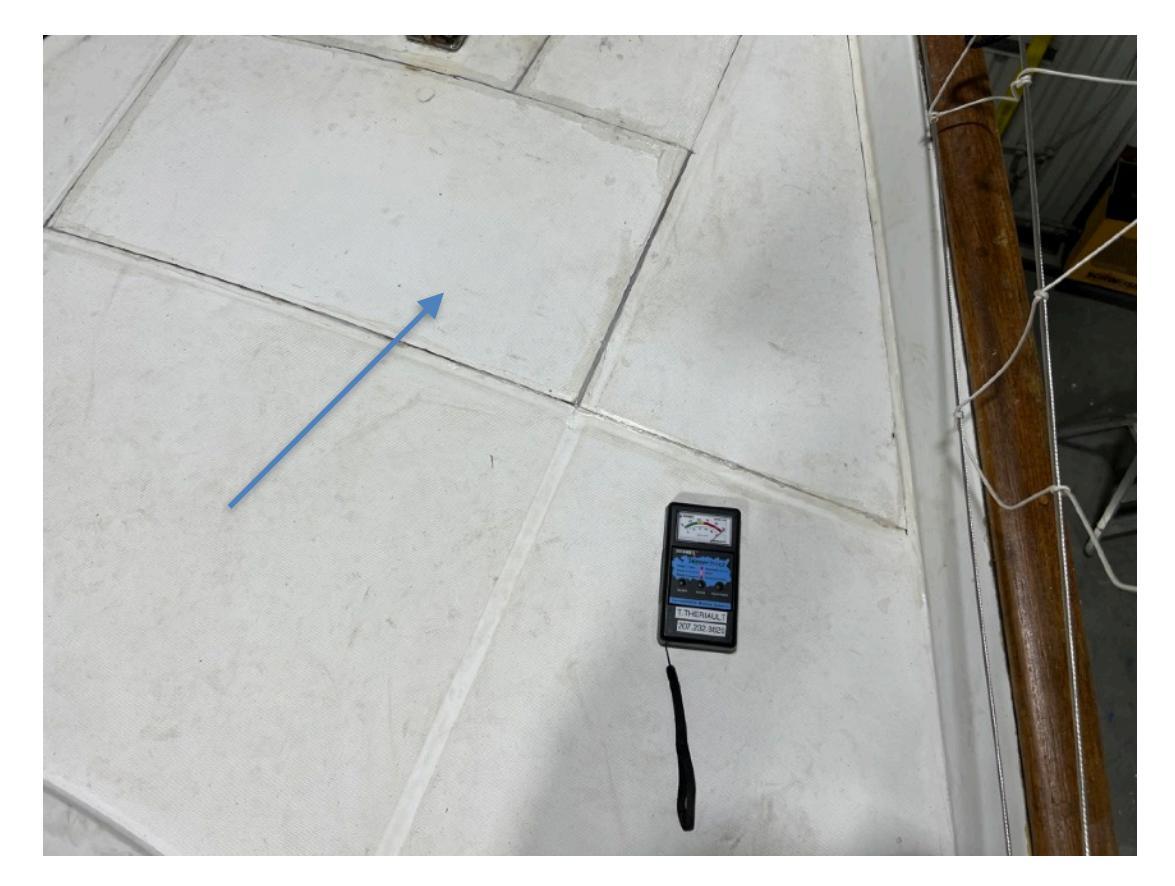
For the Record: Sections of the deck have been and are to be repaired due to high moisture meter readings they include:

- Starboard weather deck walk walk way amidships
- Bow foredeck +/- 24" inches aft of anchor windlass across port to starboard
- Port side weather deck walk way in way of 3rd stanchion aft.

FOREDECK DECK WORK COMPLETED AND TO BE DONE

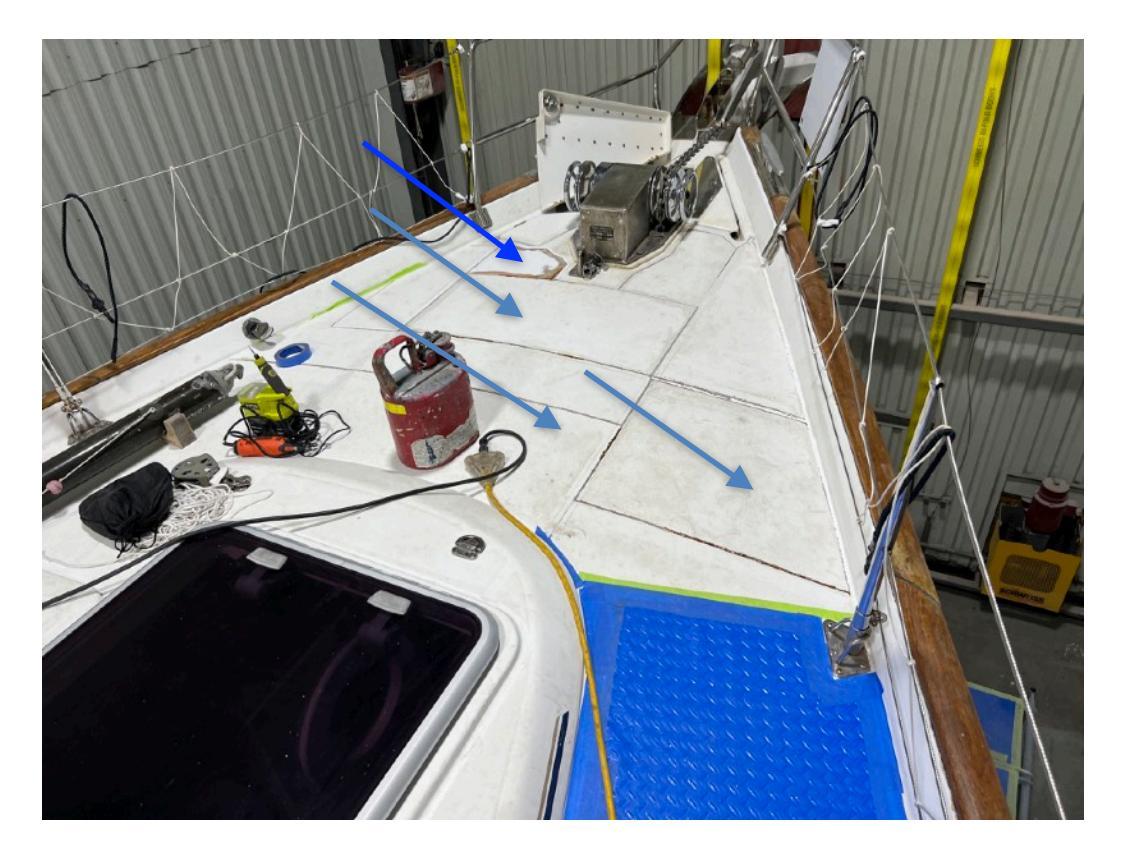
Fore deck

The panels that were described in survey #23TS2621 - the bow foredeck & port side weather deck have been repaired.

<u>SUMMARY:</u> The work was to solid dry and performed in a good workmanship manner.

- Areas of wet core cut open & wet core material removed
- Sections dried
- Section ground back to good laminate
- Fresh Corecell foam core epoxied in place
- FRP skins epoxied in place
