Full Survey S/Y SeaQuell

YOUR YACHT SURVEYOR by YOUR YACHT GROUP

Survey: Marina Vela - E/M/V Badalona (Catalunya - Spain) Date of Survey: 23th of May 2025

Pre-Purchase Inspection

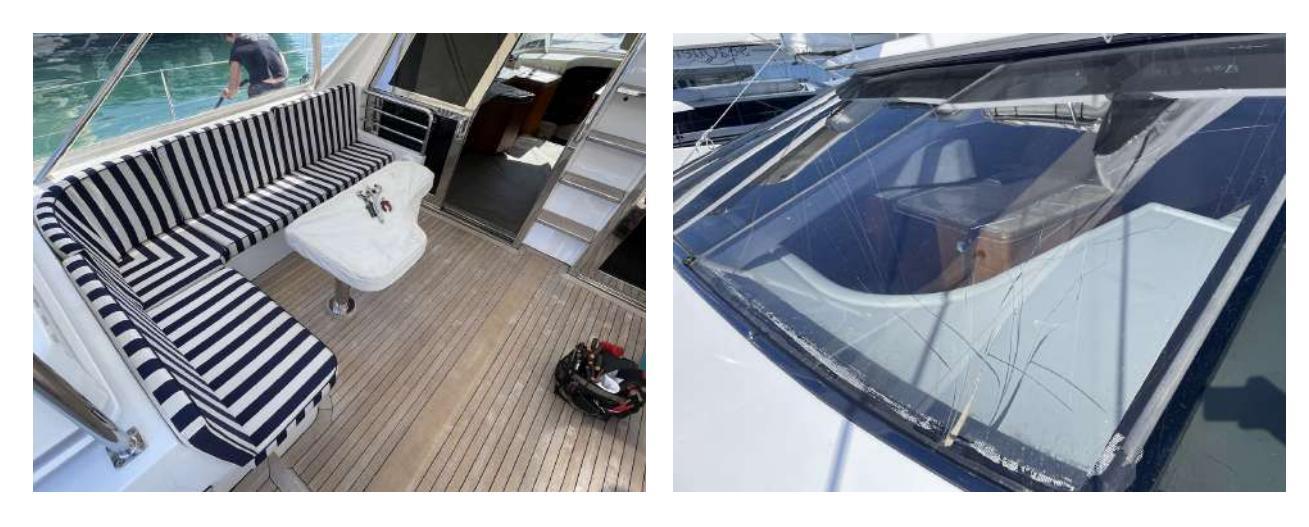
Broken window

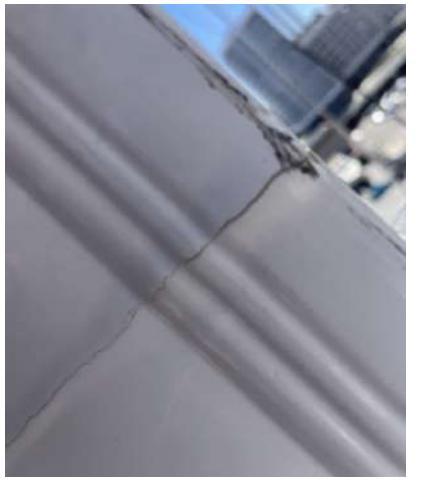
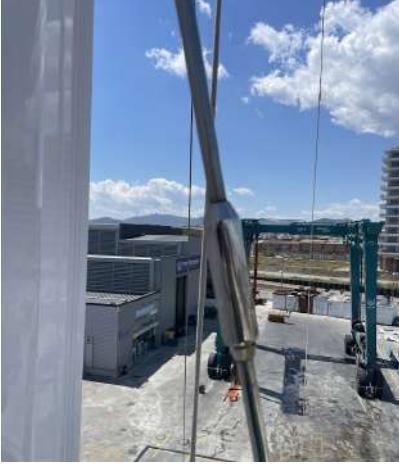
Mast union crack

Mast union detail

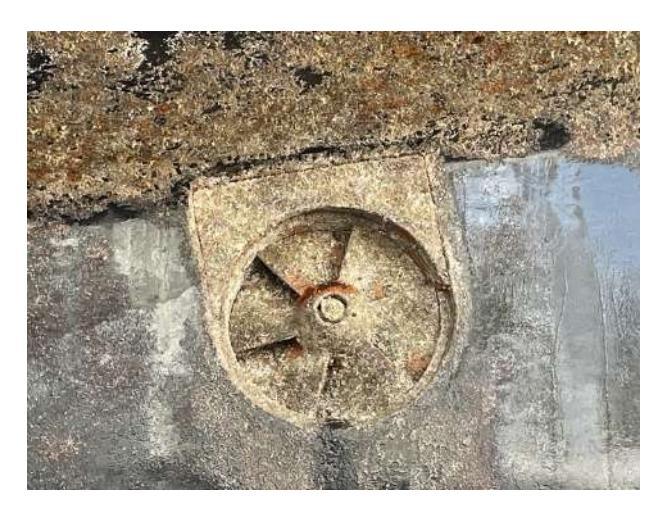
Aft thruster - no grills

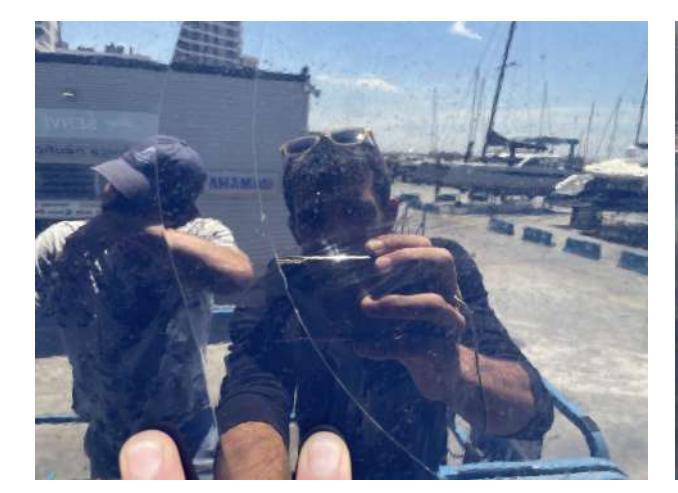
FWD STB Damage I

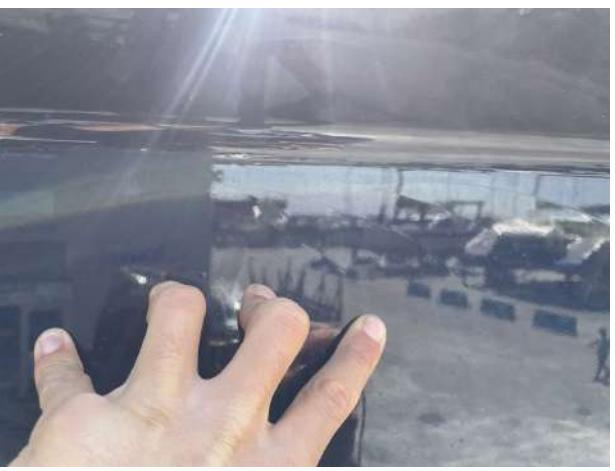
FWD STB Damage II

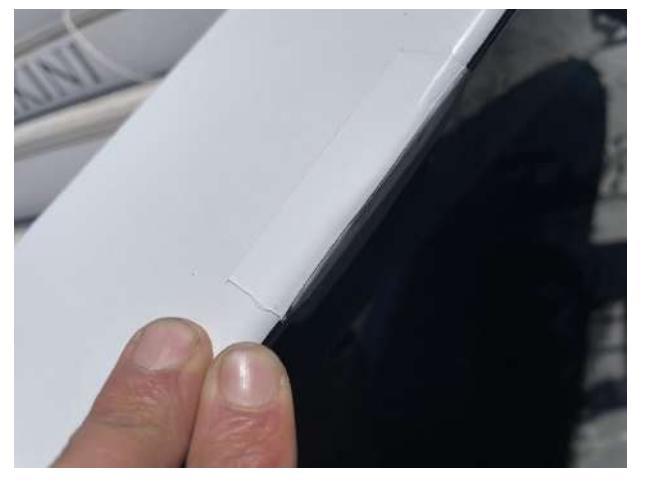
AFT STB repairs

ATF PS repair

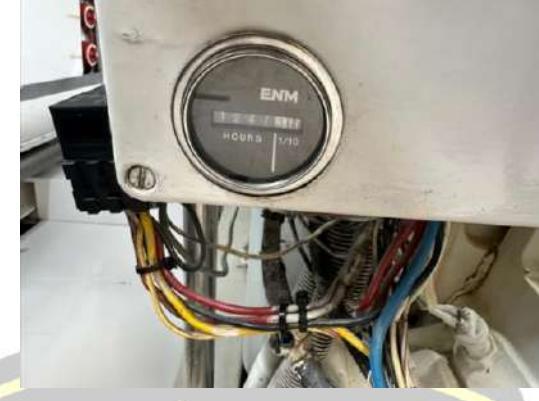
Running hours: 12473 + On this counter there are a marking indicating this is not correct and extra hours to be added. The real hours I do not know 100%.

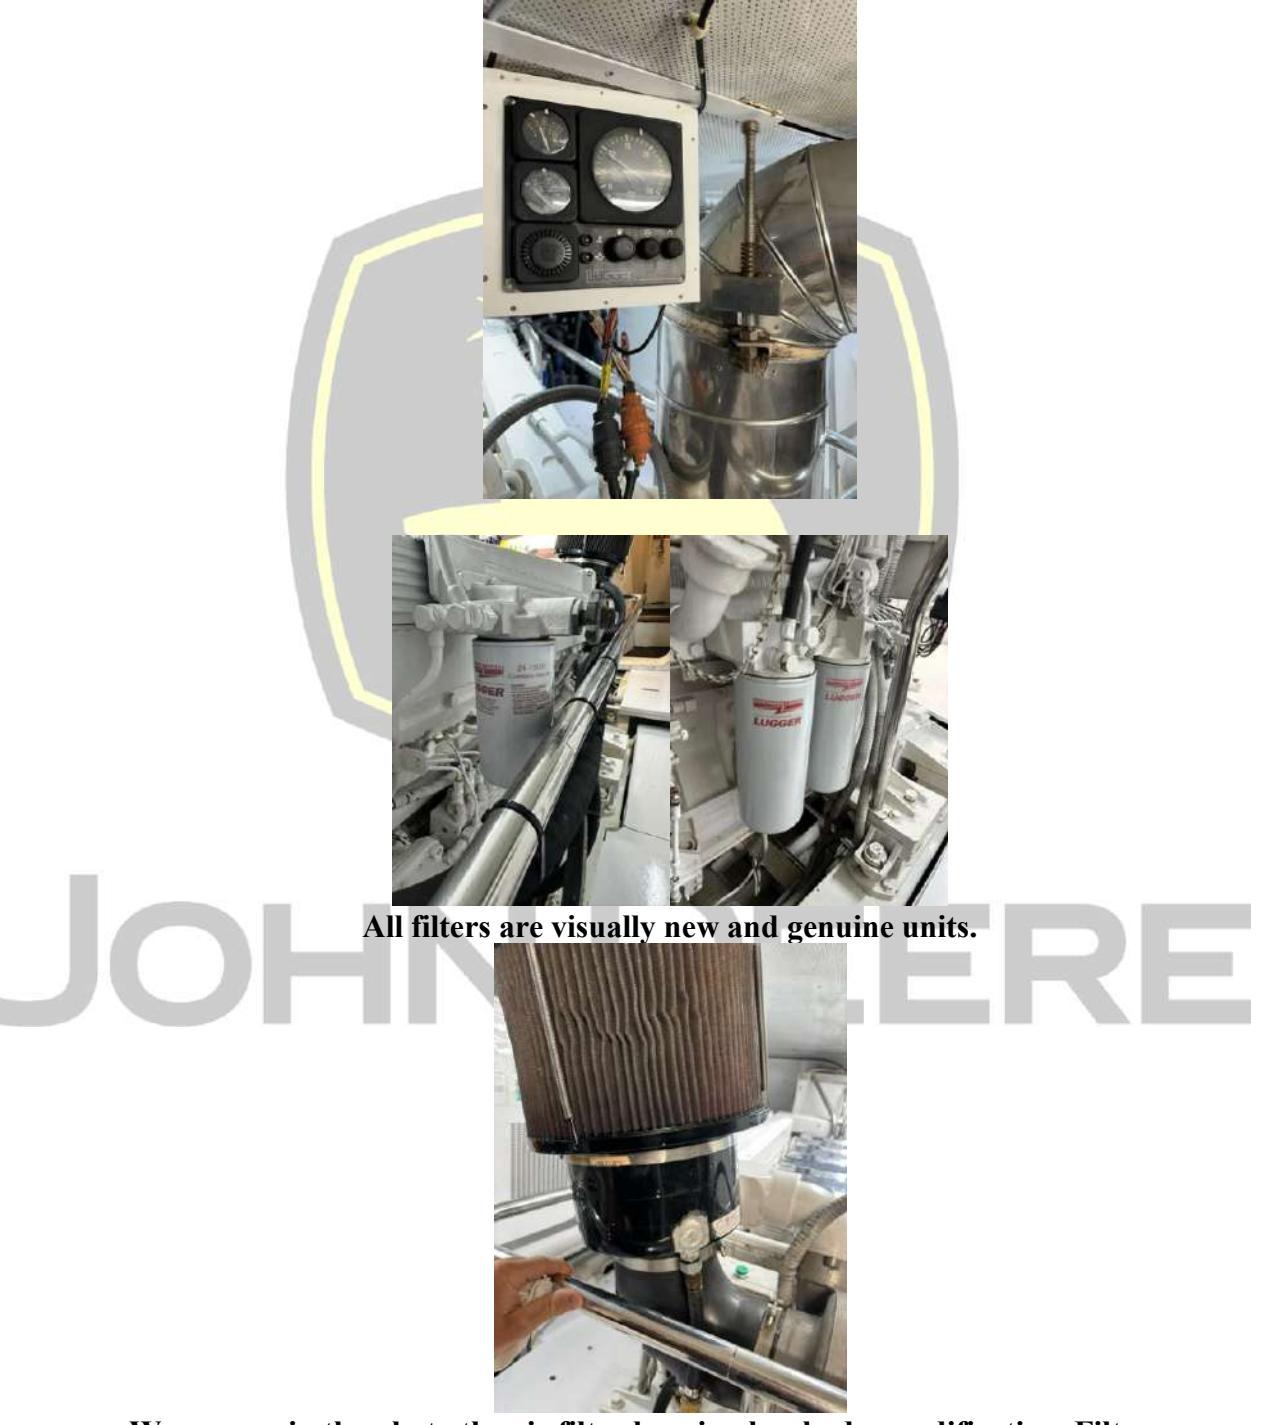
We can see in the photo the air filter housing has had a modification. Filter was working but recommend cleaning or replacement.

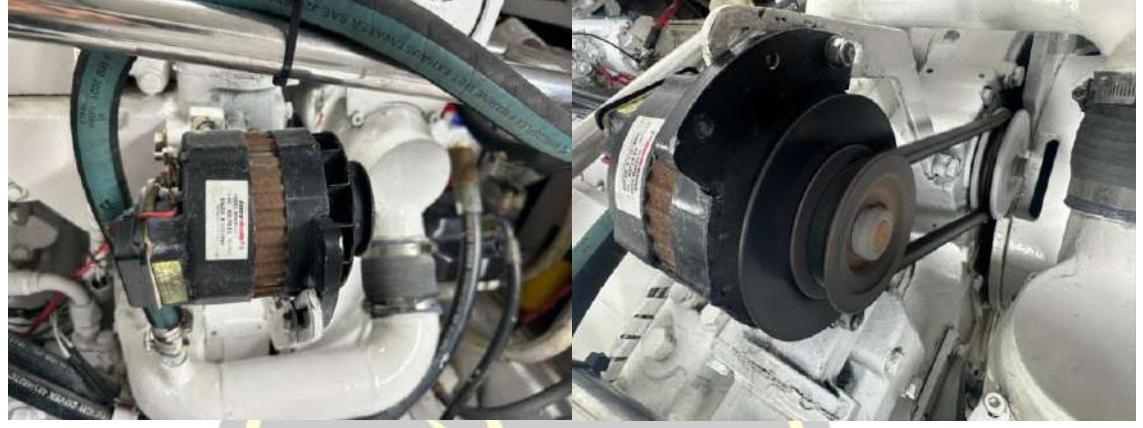
Engine alternator functioning and operating correct output from gauge I can see. When running we can hear the bearing noise. I would recommend this unit be serviced or replaced. But is operating and working currently.

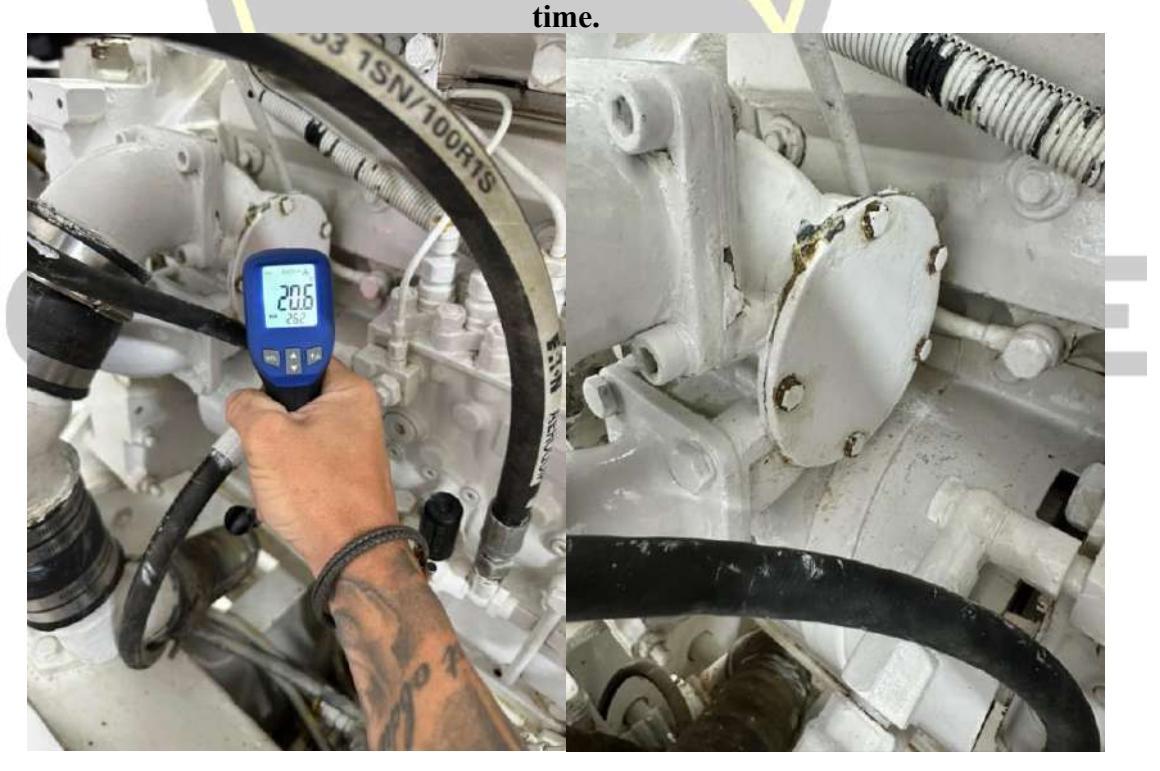
Engine sea water pump No leaks present and running correct temperature. Salt debris and flacking to the rear impeller plate. No heat signs on the plate. Visually checking the sea water pump from the tell tail signs I recommend the sea water pump be removed and serviced. The rear gasket normal perish on the rear plates due to salt water and normally indicates the impeller has not been replaced for some

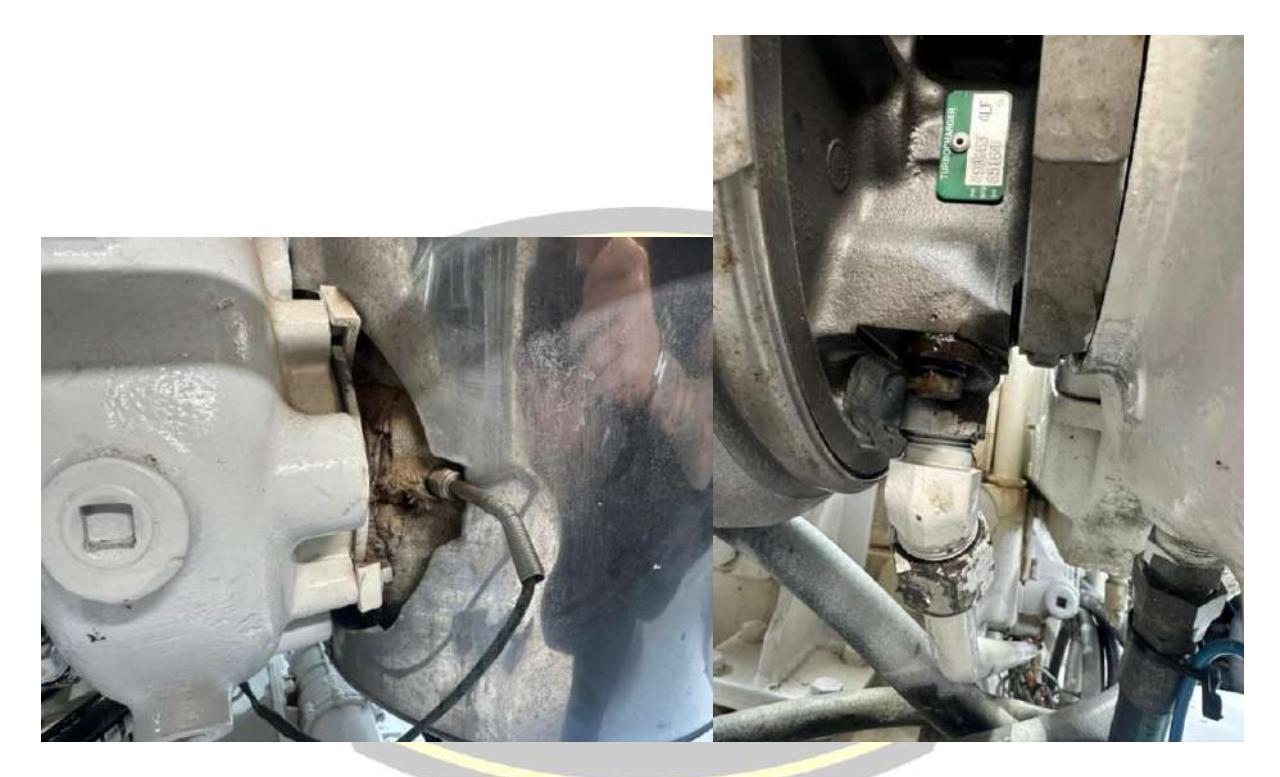
Engine turbo. No signs of smoke or overheating Internally. There is a small oil leak on the turbo oil return. I would say the turbo looks in good condition and the Cartridge for the turbo is new but not a genuine unit. Operation of the turbo was correct and boosting pressures correct.

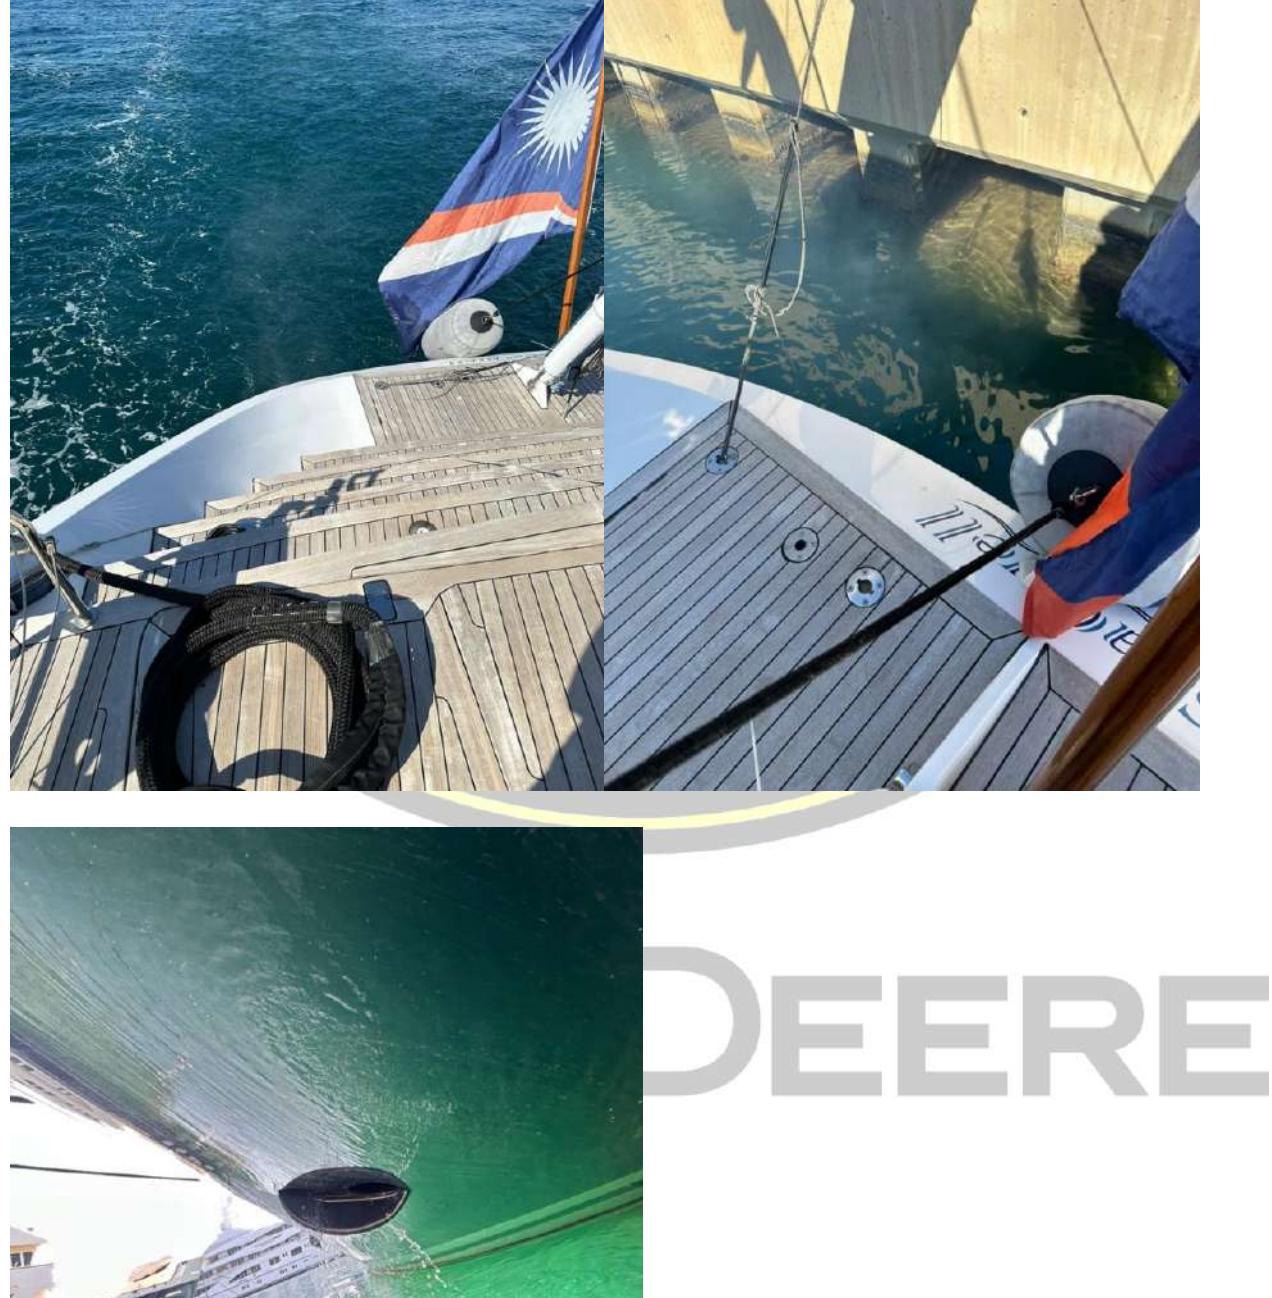
External exhaust visual black smoke worse when cold but also visual on the trip. This would need more investigation. Can be a number of factors starting with turbo outlets being clean to fuel injection system being checked.

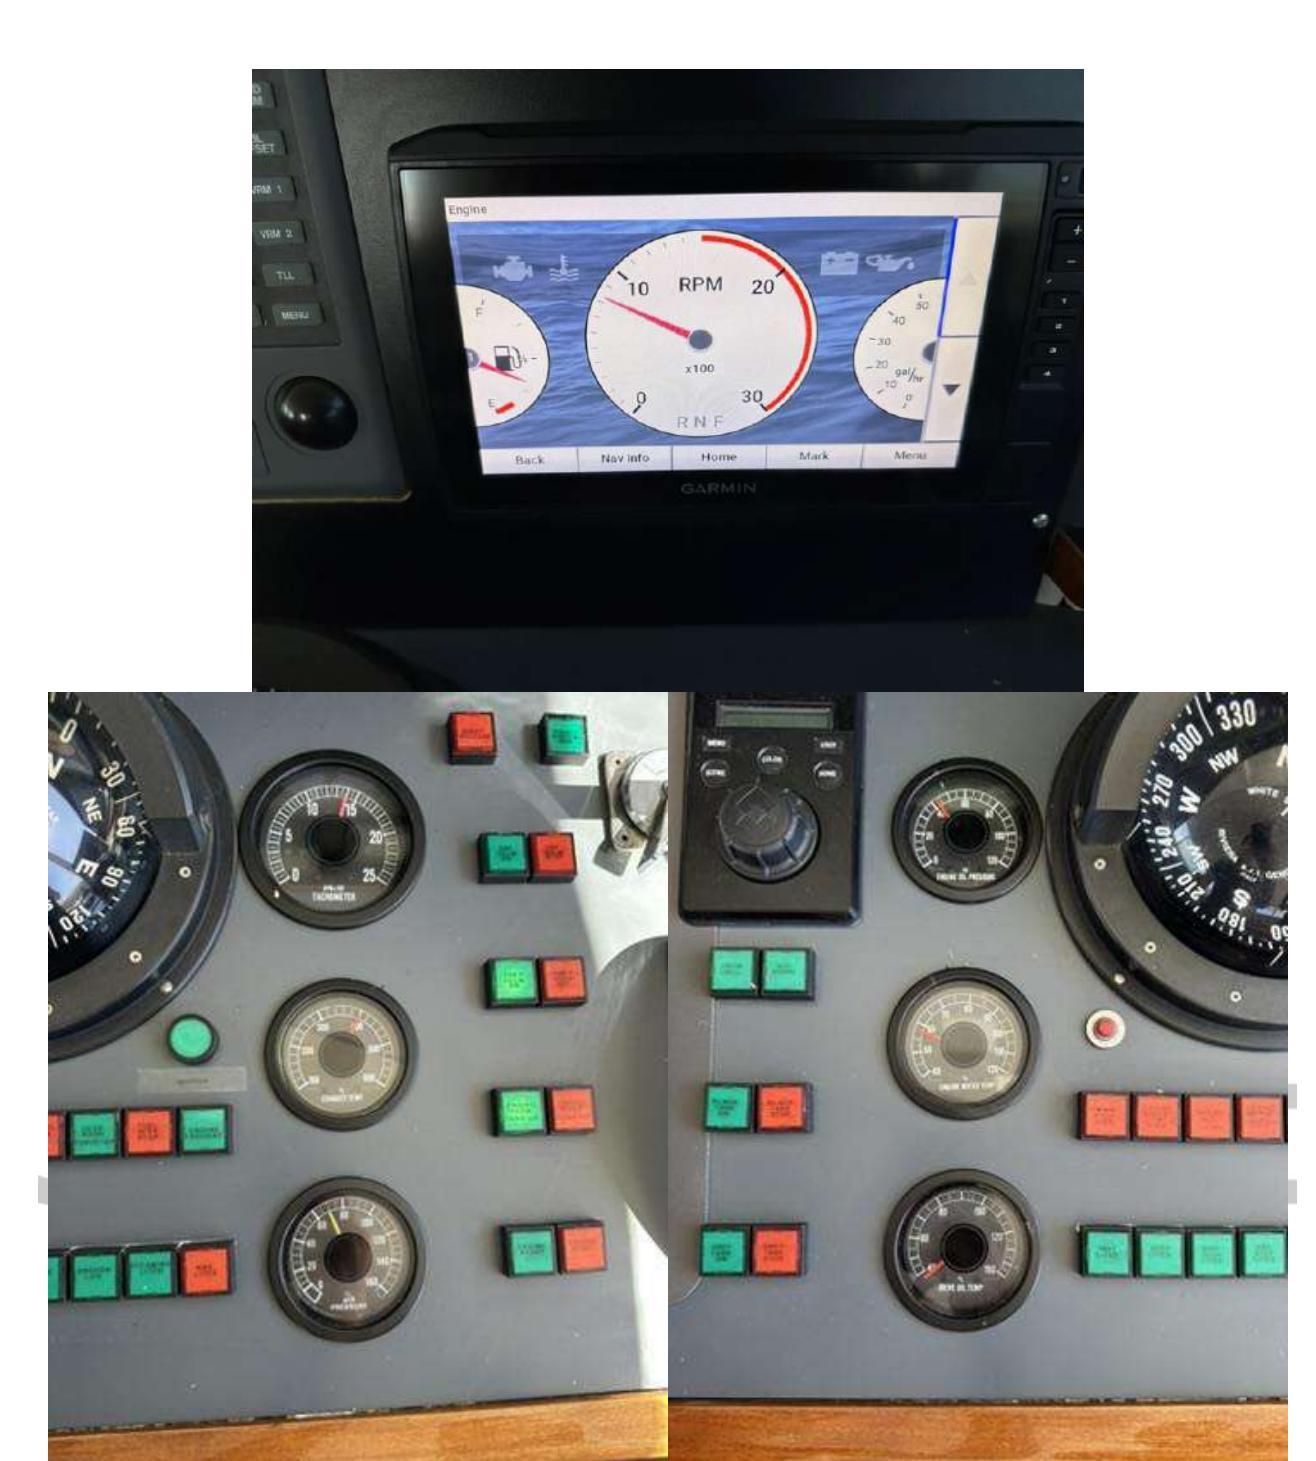
The gauge in the right bottom photo was not functional would need investigation.

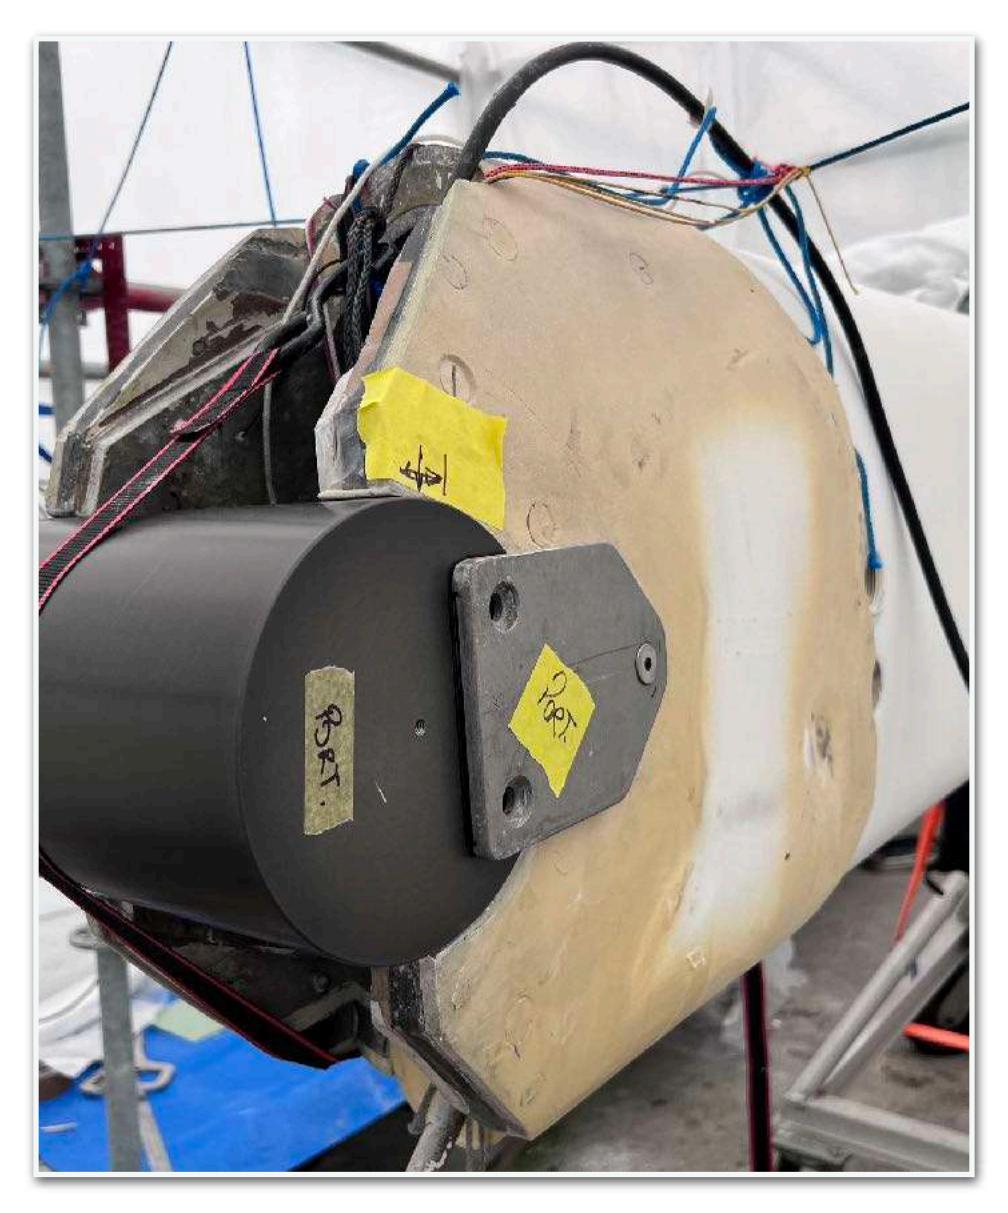
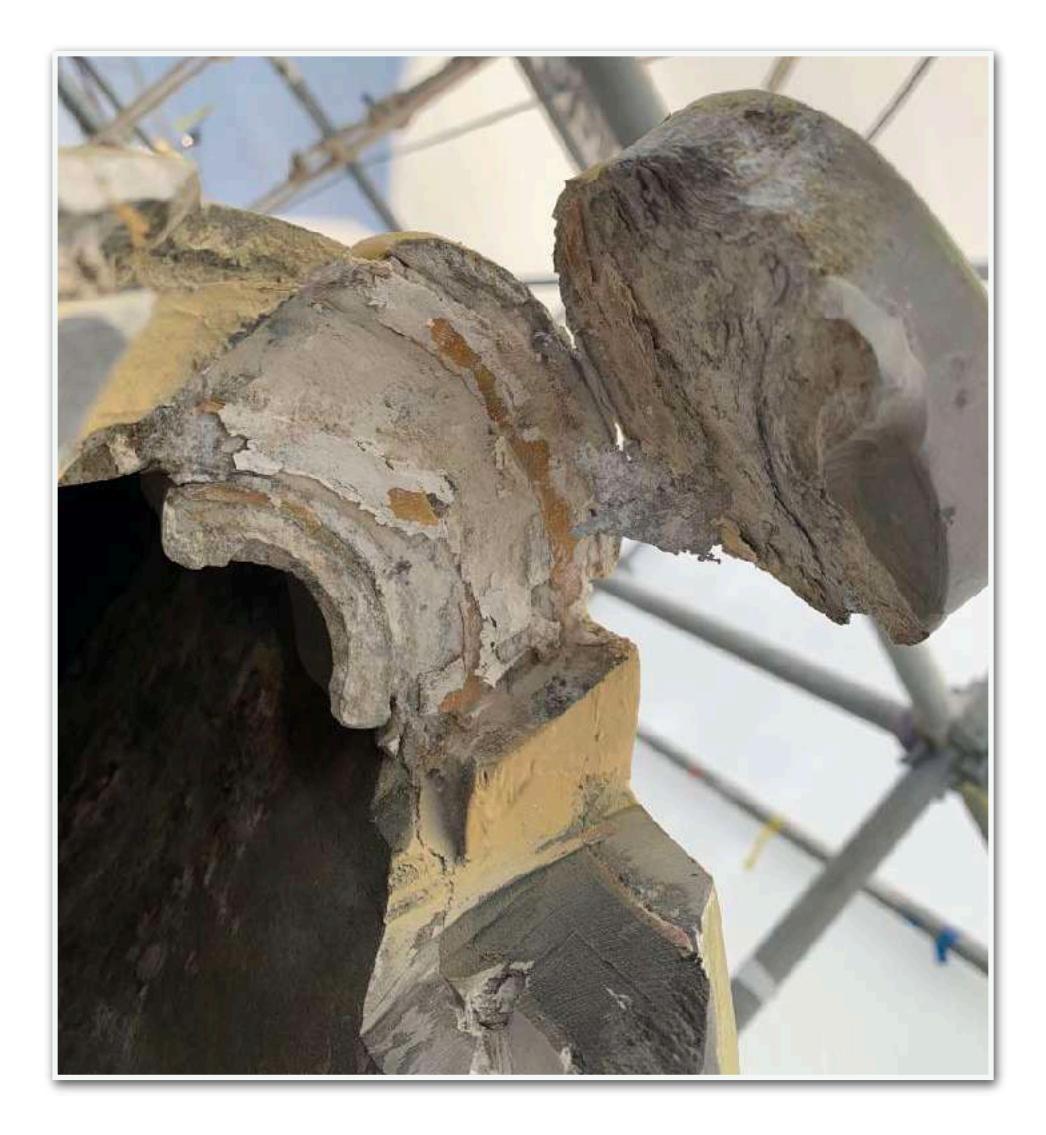
The composite mast tube needed some work done in a couple of areas. The mast step was seeing a huge amount of corrosion with the aluminum rocker bar. As a result the painters got over zealous in removing the corrosion of the aluminum side wall doubler plates and removed some carbon under the the mast foot, in the process loosing the datum for rocker bar. Fortunately the location plates for the rocker bar provided the necessary information to re bed the rocker bar interface. A new rocker bar had to be manufactured due to extremely heavy pitting found on the old one. The new bedding in process was done with an epoxy fibre mix, by John Holstrum a top composites technician and good friend of Shane the skipper.

The forward mast jacking plinth also had to be replaced due to heavy corrosion and cracking.

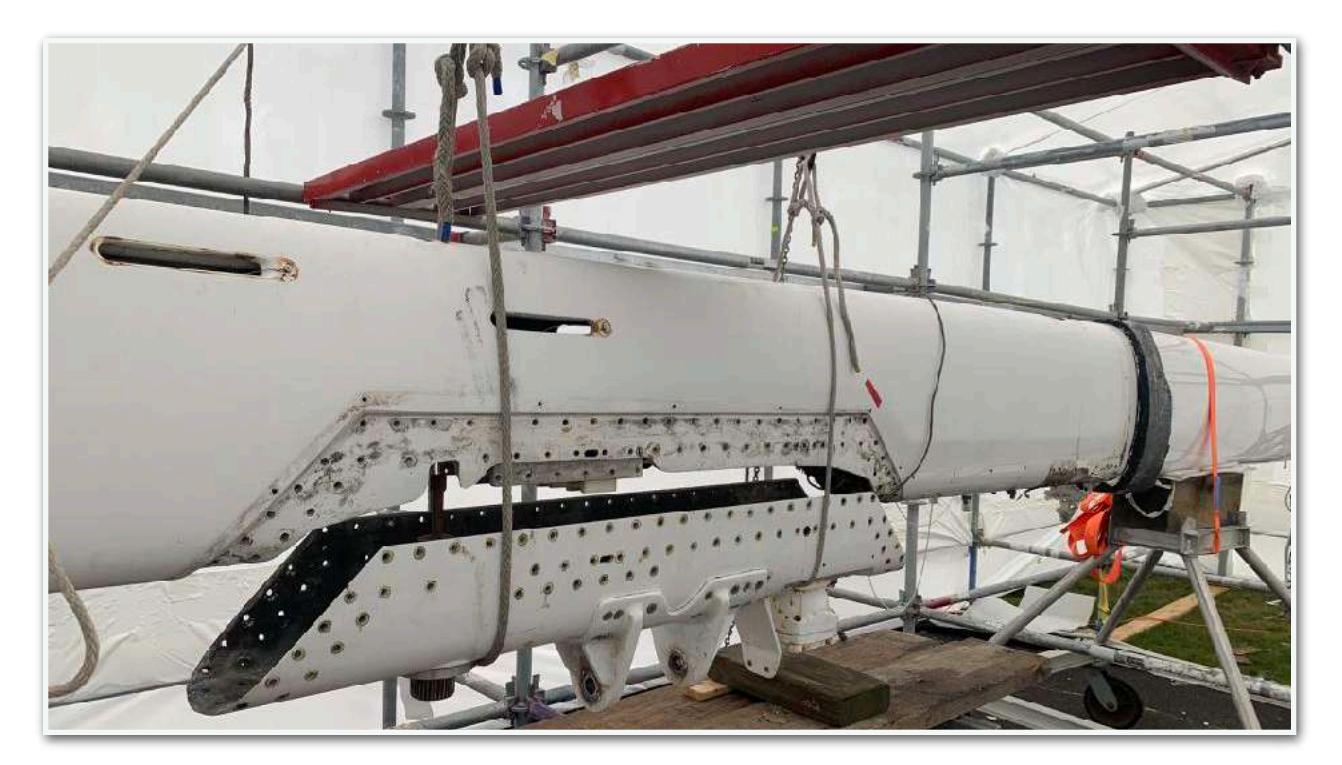
13 put of the 28 fastenings for the Gooseneck bracket were bent, many were too short and almost all nylock nuts were found ineffective.

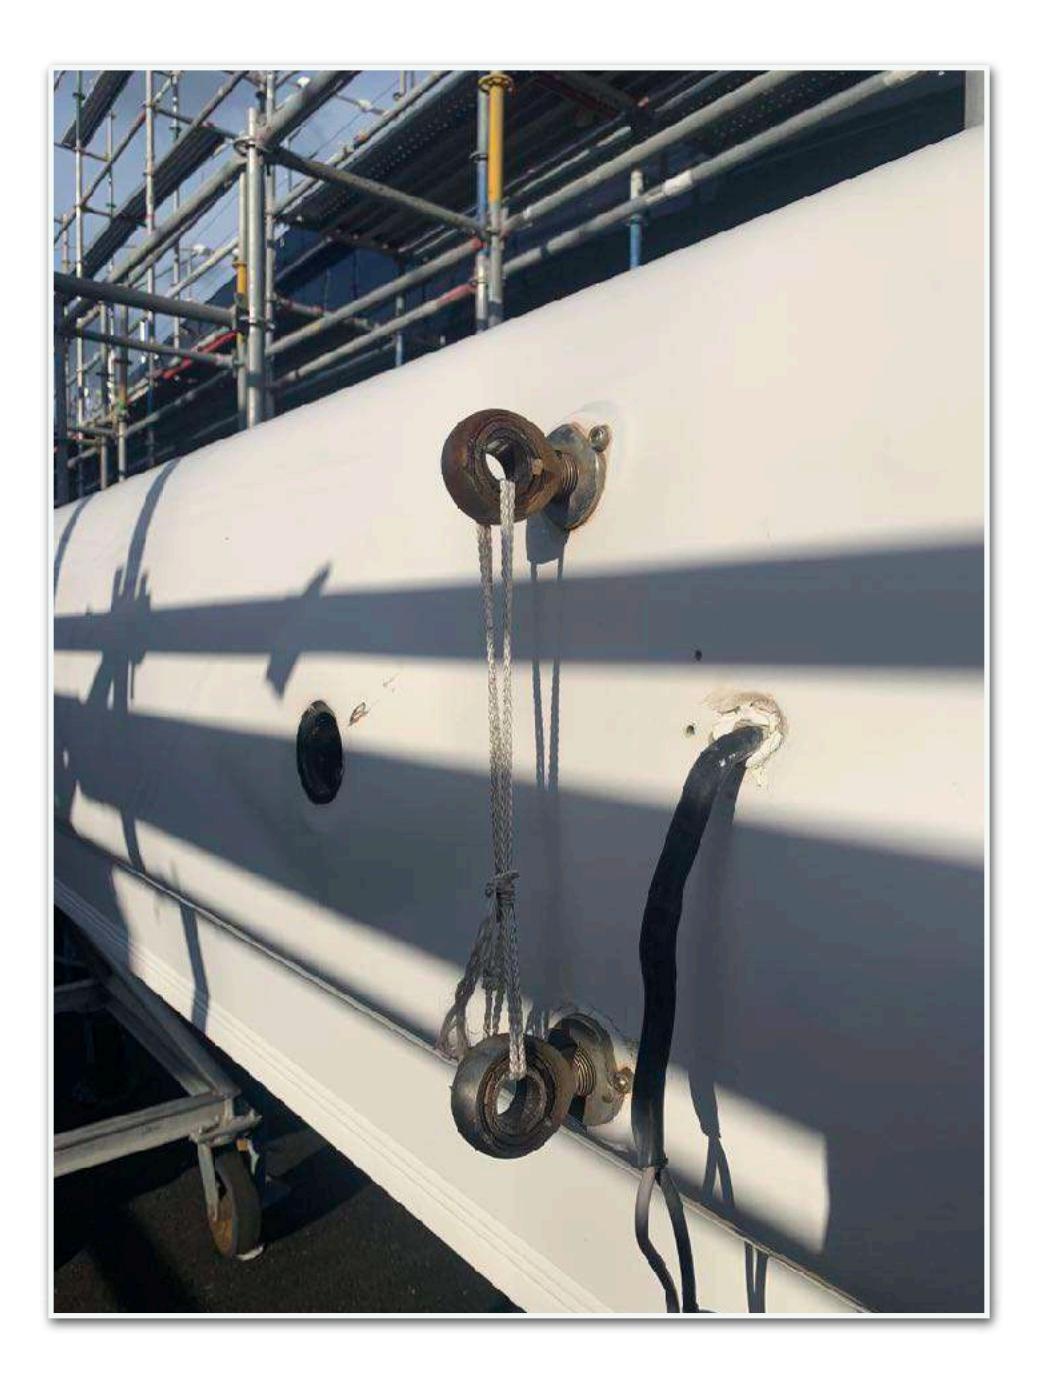
SEAQUELL Rod end spreader root findings

Based on the inspection results of the spreader root rod ends these were estimated to be very old, see the following spread sheet outlining their condition found . A total of 12 units were replaced.

Ball Condition Corrosion **Ball Rotation** Other Replacement Status comments S1 Pt Crack starting, OK Nice Original piece Replace Aft good Fwd Crack & pitting OK Nice Original piece Replace S1 St - - -- - -- - -Cannot remove - - -Aft Fwd Pitting Just OK Hard Original piece S2 Pt Good OK Nice Keep Aft Fwd Just OK OK Just OK Rust & pitting S2 St OK A lot of pitting Nice Aft Fwd Tiny pitting Just OK Loose Replace S3 Pt Tiny pitting OK Nice Original piece Keep Aft Fwd Just OK Tight Very rusted Original piece Replace S3 St Cracked Just OK OK Aft Nice Fwd Good OK Keep S4 Pt Isolated pitting OK Nice Original piece Keep Aft Fwd Isolated pitting Just OK OK Original piece S4 St Good Just OK Nice Original piece Aft Original piece Fwd Very bad pitting Very bad Replace S5 Pt OK Nice Isolated pitting Original piece Keep Aft Fwd Small pitting OK Nice Original piece Keep S5 St OK Small pitting Tight-ish Original piece Keep Aft Fwd Small pitting OK Nice Original piece Keep

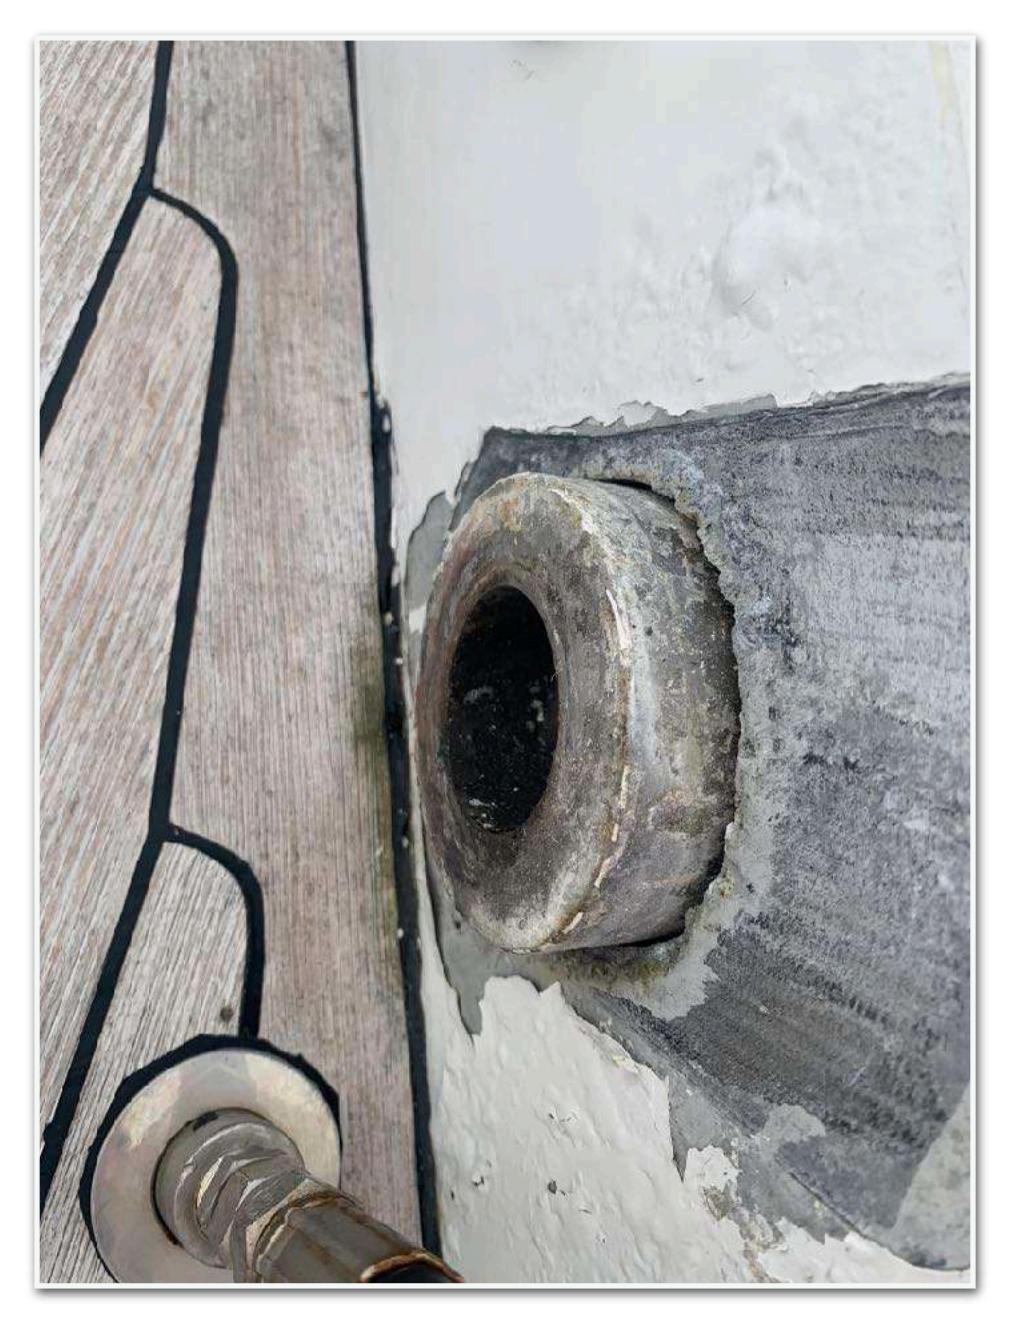
HS chain plate bush was replaced due to excessive wear with the chainplate interface. The hole was dressed and a larger OD bush was installed.

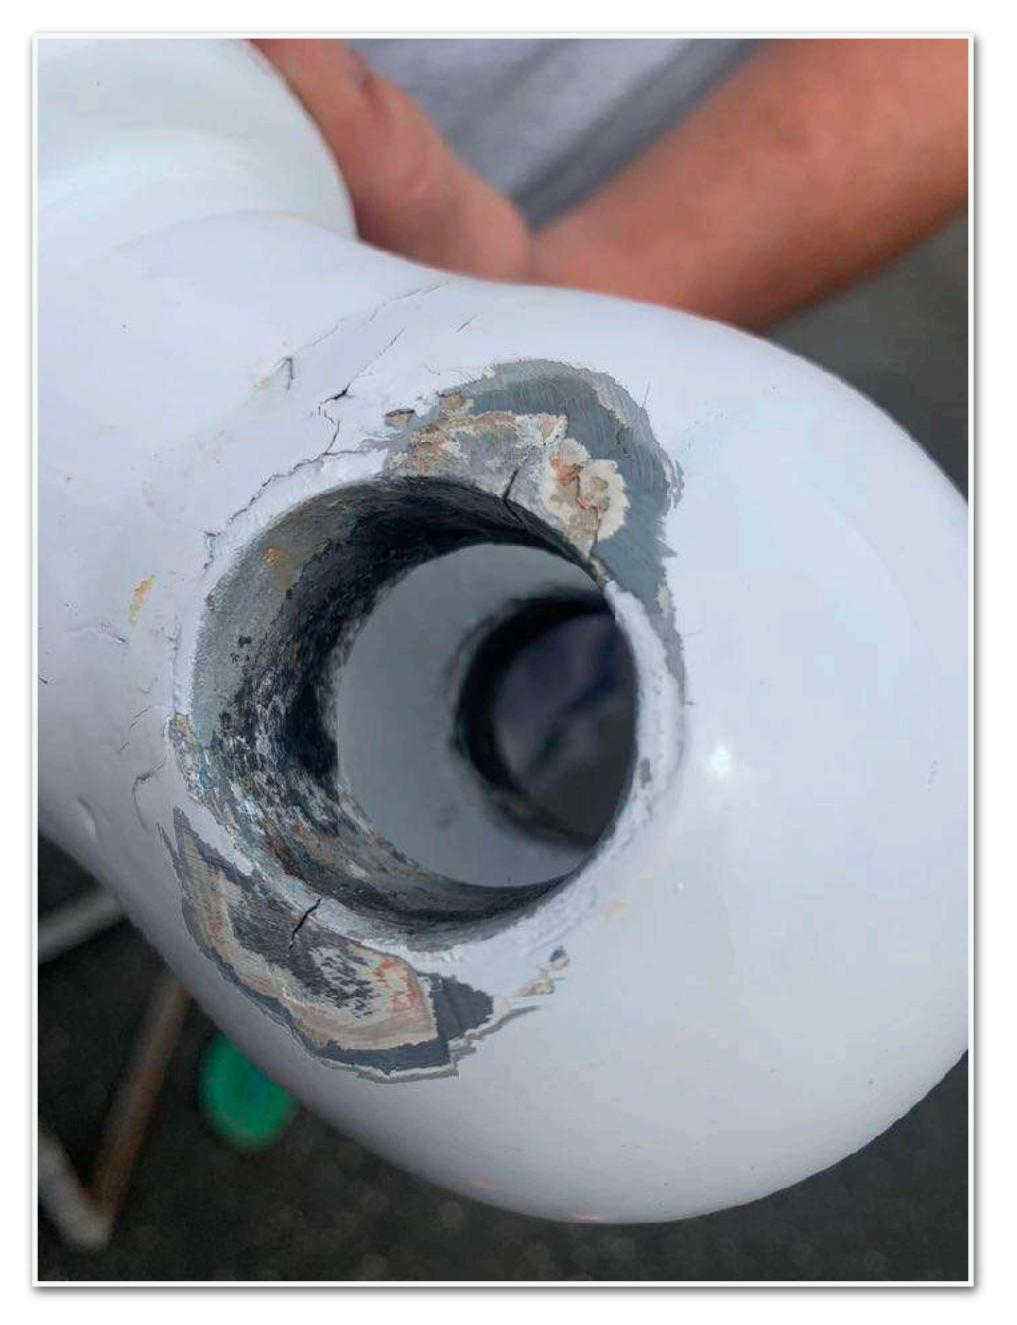
The Vang cylinder had a crack in one end of its eye profile. This was repaired / serviced by the company in New Hampshire.

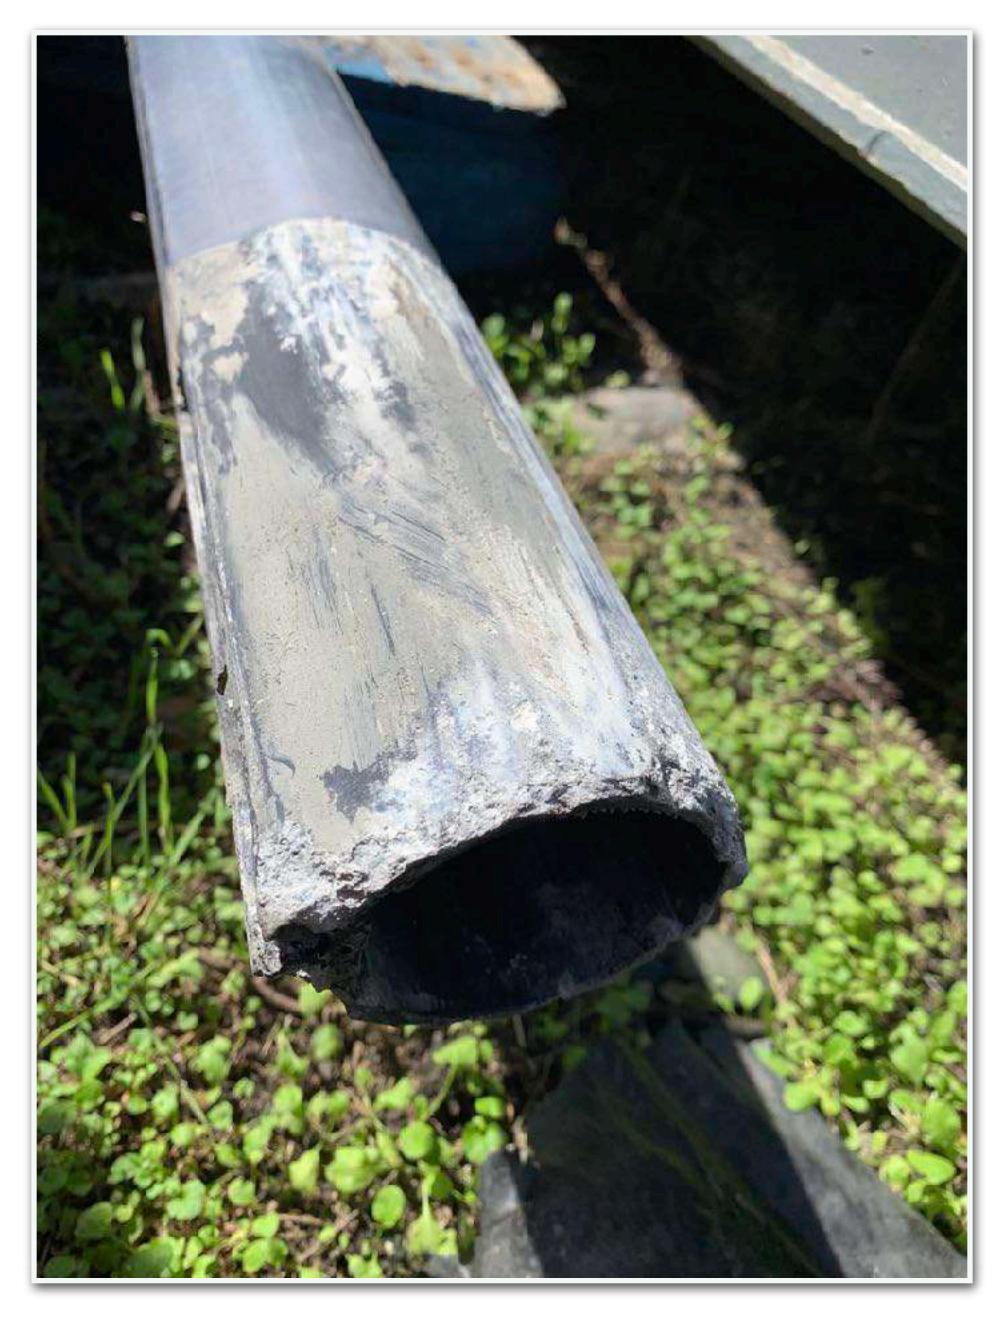
Lower feeder foil interfaces were almost completely corroded away, and all foil joins were extremely worn producing excessive play in the bolt rope alignments and accelerated wear on the head sail luff tapes.
