REPORT OF MARINE SURVEY

CONDITION & VALUATION

2017 OCEAN ALEXANDER 70 EVOLUTION

M/V “LIVE MAS”

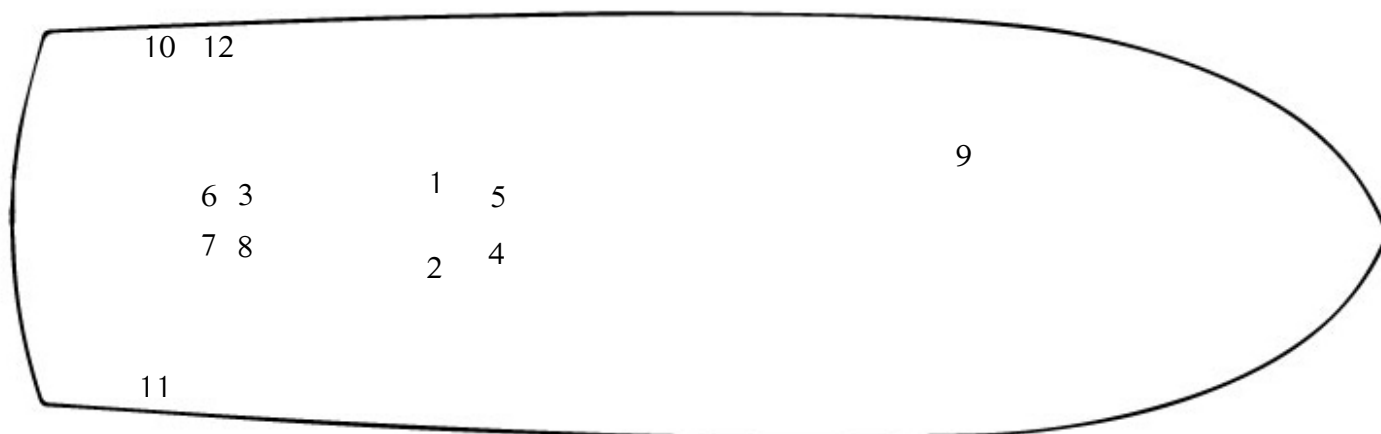
THRU-HULL DIAGRAM

THRU-HULL DESCRIPTION	CONDITION
1	PORT Engine Seawater Intake	FUNCTIONAL / AVERAGE Condition / Exercise to Ensure Reliability
2	STBD Engine Seawater Intake	FUNCTIONAL / AVERAGE Condition / Exercise to Ensure Reliability
3	PORT GenSet Engine Seawater Intake	FUNCTIONAL / AVERAGE Condition / Exercise to Ensure Reliability
4	STBD GenSet Engine Seawater Intake	FUNCTIONAL / AVERAGE Condition / Exercise to Ensure Reliability
5	HVAC Pump #1 Seawater Intake	FUNCTIONAL / AVERAGE Condition / Exercise to Ensure Reliability
6	HVAC Pump #2 Seawater Intake	FUNCTIONAL / AVERAGE Condition / Exercise to Ensure Reliability
7	Water Maker Pump Seawater Intake	FUNCTIONAL / AVERAGE Condition / Exercise to Ensure Reliability
8	Stabilizer Cooling Pump Seawater Intake	FUNCTIONAL / AVERAGE Condition / Exercise to Ensure Reliability
9	Fwd Black Water Pump Overboard Discharge	FUNCTIONAL / AVERAGE Condition / Exercise to Ensure Reliability

10	PORT GenSet Wet Exhaust Overboard Discharge	BELOW AVERAGE / Valve Stiff & Difficult to Operate
11	STBD GenSet Wet Exhaust Overboard Discharge	BELOW AVERAGE / Valve Stiff & Difficult to Operate
12	Aft Black Water Pump Overboard Discharge	BELOW AVERAGE / Valve Stiff & Difficult to Operate

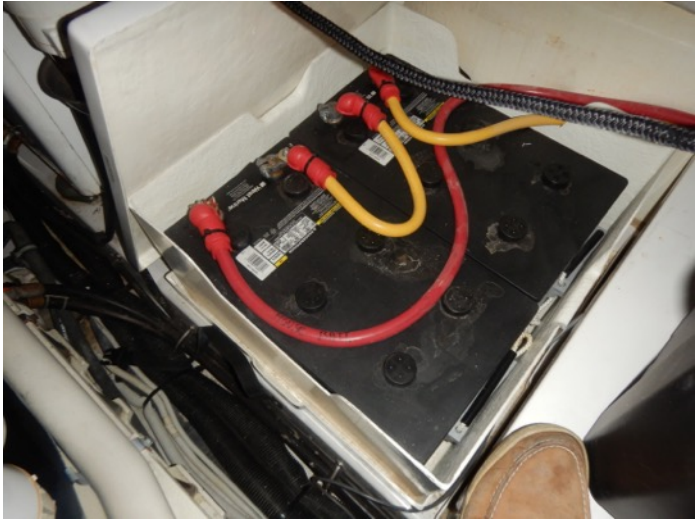
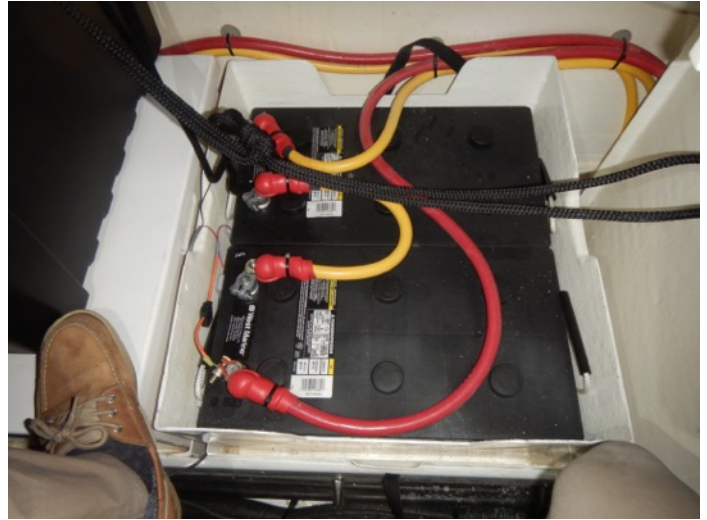
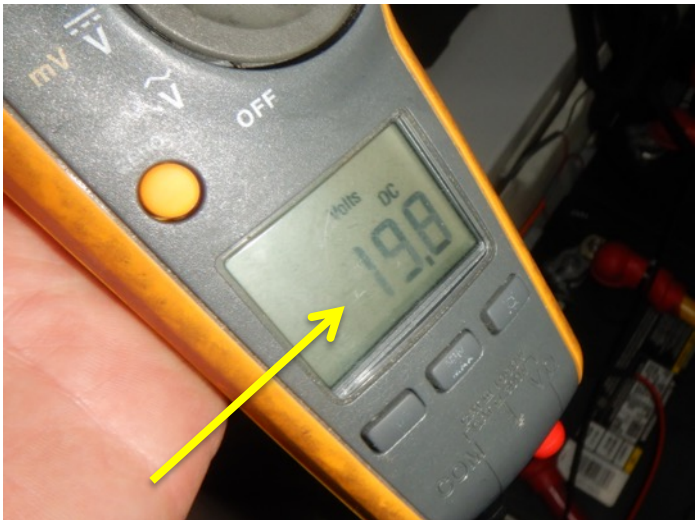
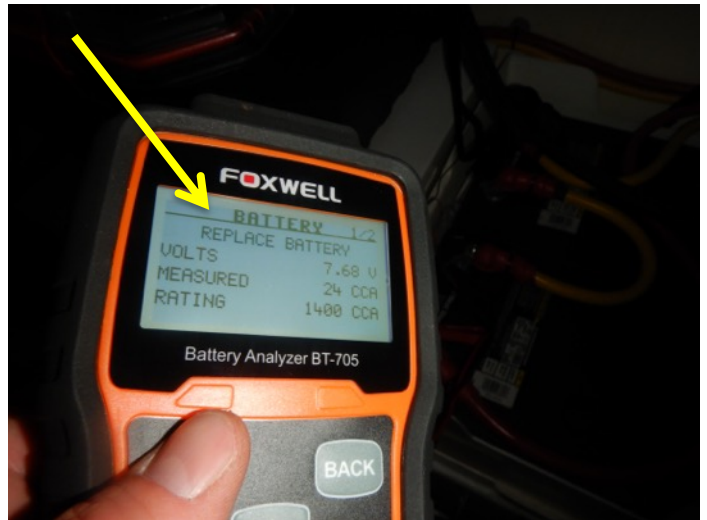
2. HOUSE Batteries

The 24VDC HOUSE batteries performed in POOR condition & appeared to be at the end of their useful service lives. Battery voltage quickly dropped below 24VDC when the battery charger appliance was powered OFF & the batteries tested poorly when evaluated using a battery conductance testing tool. Recommend the HOUSE batteries be replaced with the intent to improve operating performance.

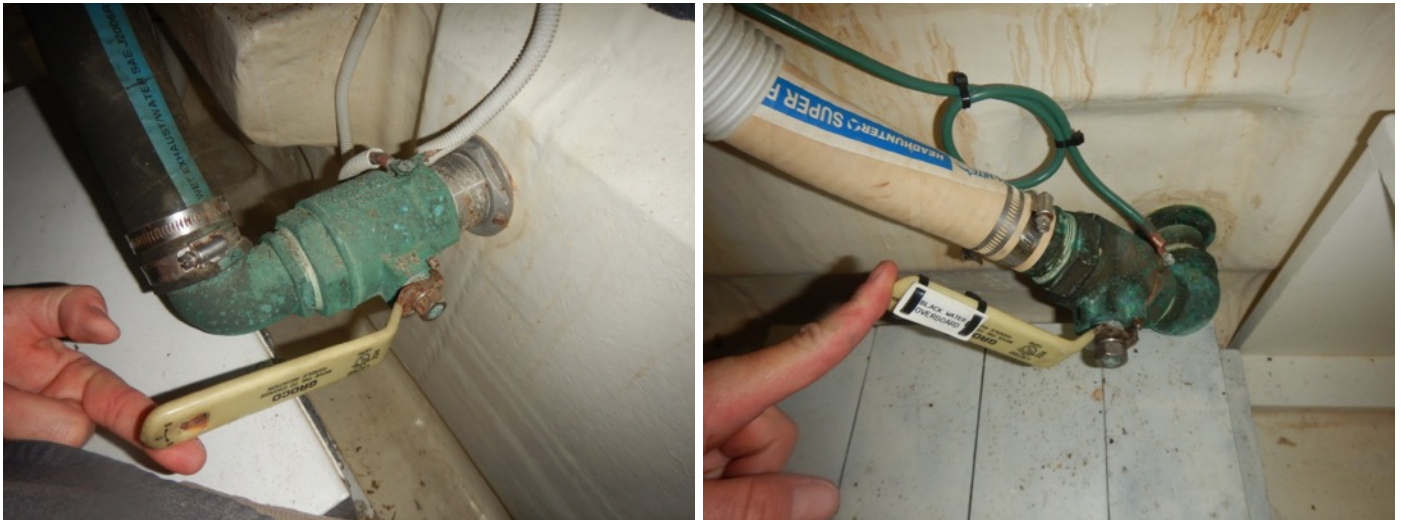
3. Below-the-Waterline Seacock Valve Maintenance

The PORT GENSET WET EXHAUST OVERBOARD, STBD GENSET WET EXHAUST OVERBOARD, and AFT BLACK WATER PUMP OVERBOARD below-the-waterline seacock valves were stiff & difficult to operate. The valves described were stuck in the OPEN position when testing was attempted during the inspection. Recommend defective seacock valves be adjusted, exercised, or replaced with the intent to improve operating performance & to ensure that all seacock valves are fully operational.

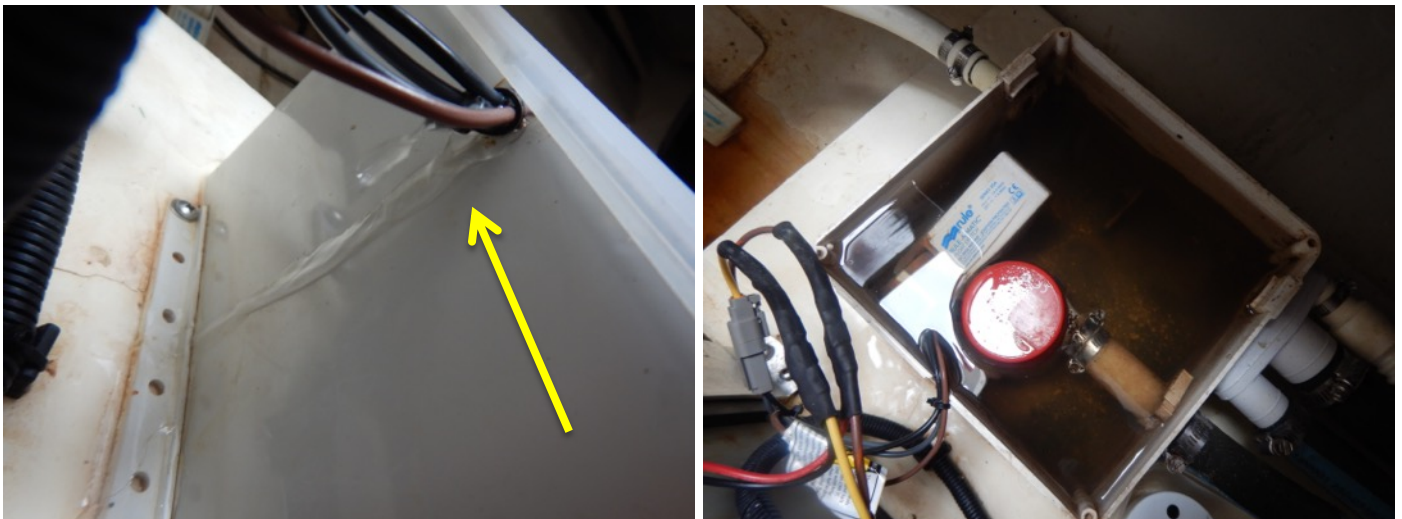
4. CREW Gray Water Sump Pump

The GRAY WATER SUMP PUMP installed in the CREW BILGE was INOPERABLE. The 24VDC electric pump did not power on during testing procedures. Further investigation is needed to determine an explanation for the deficiency described. Recommend defective gray water sump pump components be repaired or replaced with the intent to improve operating performance.

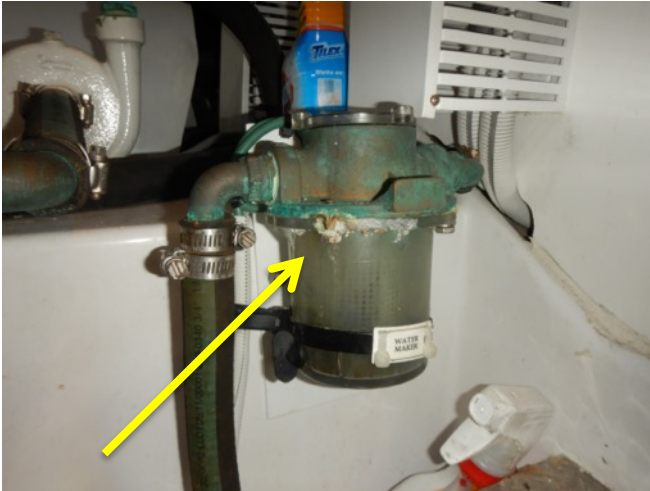
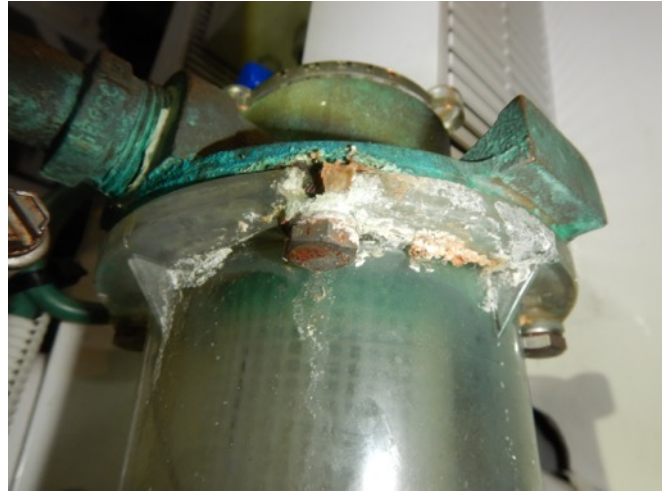
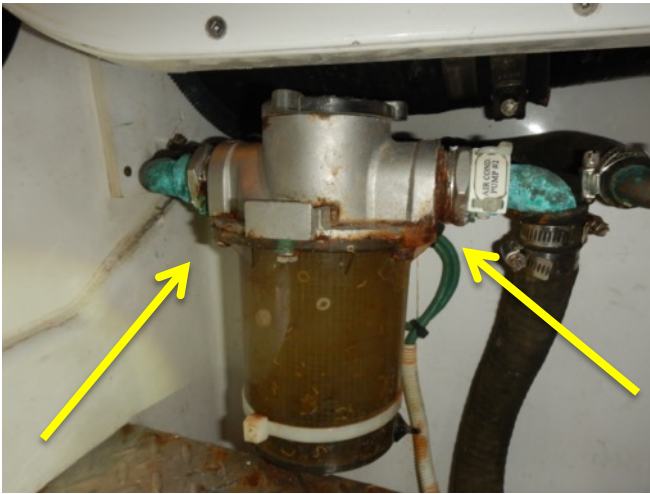
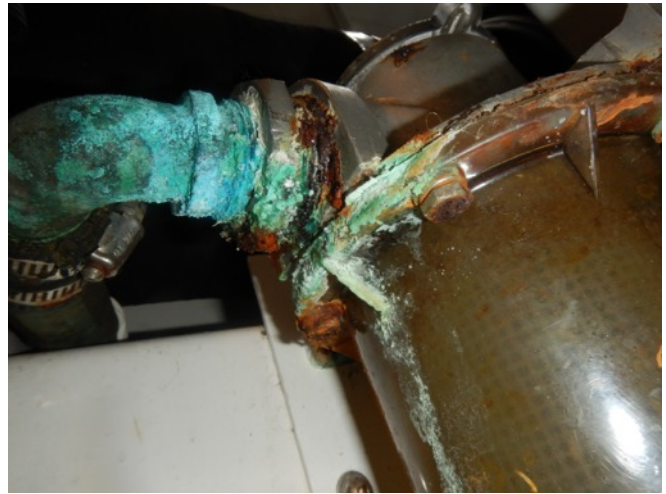
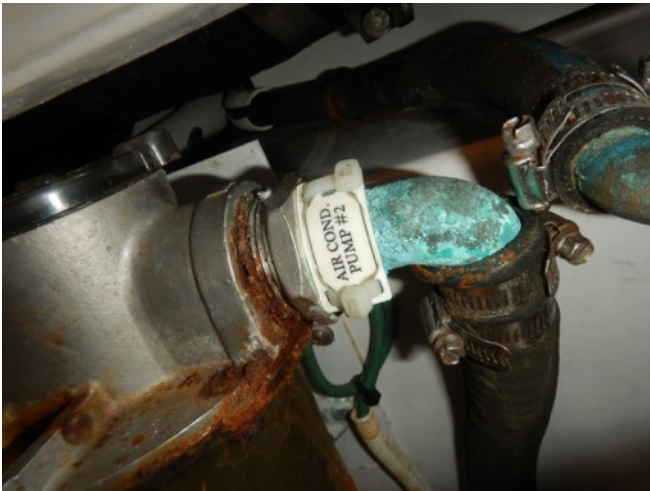
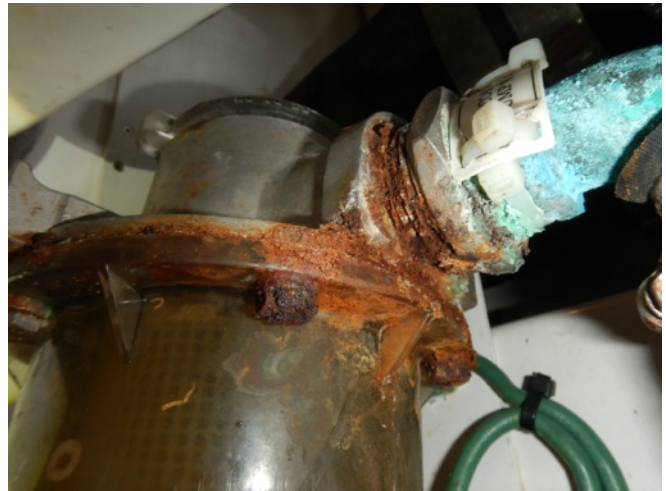
5. Sea Strainer Maintenance

The WATER MAKER & HVAC PUMP #2 sea strainers appeared in BELOW AVERAGE condition. There was evidence of water leaks, corrosion damage, and physical damage to the sea strainer sight bowls observed at the sea strainer assemblies installed in the center portion of the engine room bilge compartment. Recommend defective sea strainer components be repaired or replaced as an act of preventative maintenance & with the intent to eliminate water leaks.

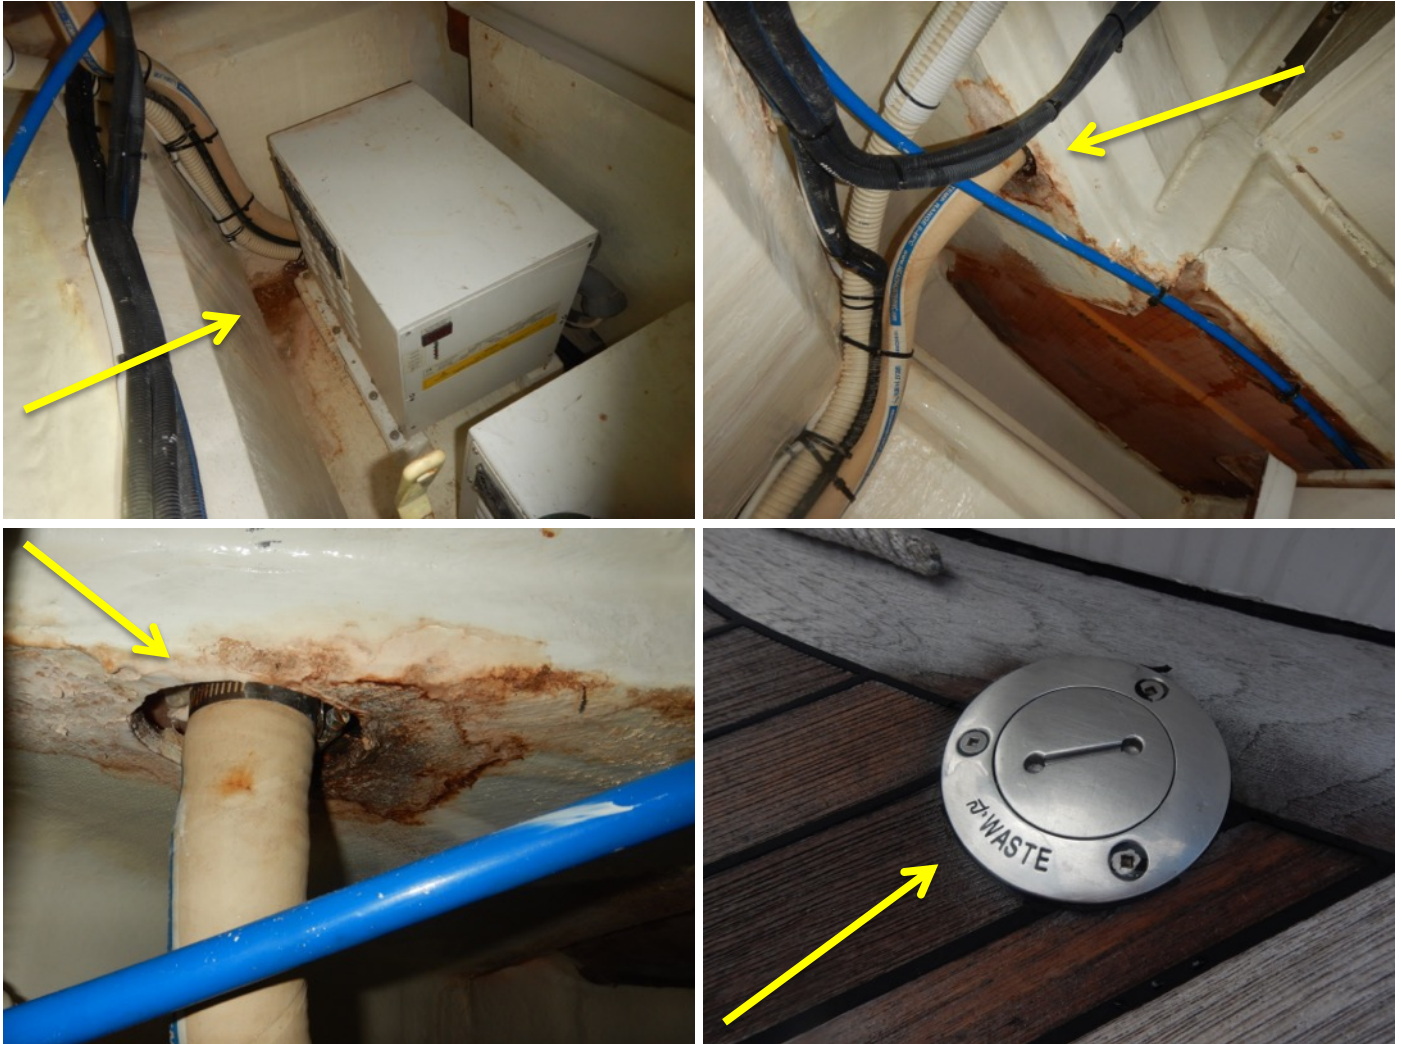
6. AFT STBD ENGINE ROOM Water Leak

There was evidence of a water leak identified in the aft STBD corner of the engine room bilge compartment. The leak appeared to originate at the swim platform mounted deck fitting used for the dock-side pump-out feature of the black water holding tank installed in the CREW bilge compartment. Recommend appropriate repair be performed with the intent to eliminate water leaks. The swim platform mounted deck fitting may need to be disassembled & reinstalled using new marine adhesive sealant. Clean & dry bilge compartment surfaces, place absorbent pads in strategic locations, monitor on a regular basis for recurring deficiency, and perform appropriate maintenance service in a timely manner if active fluid leaks are discovered.

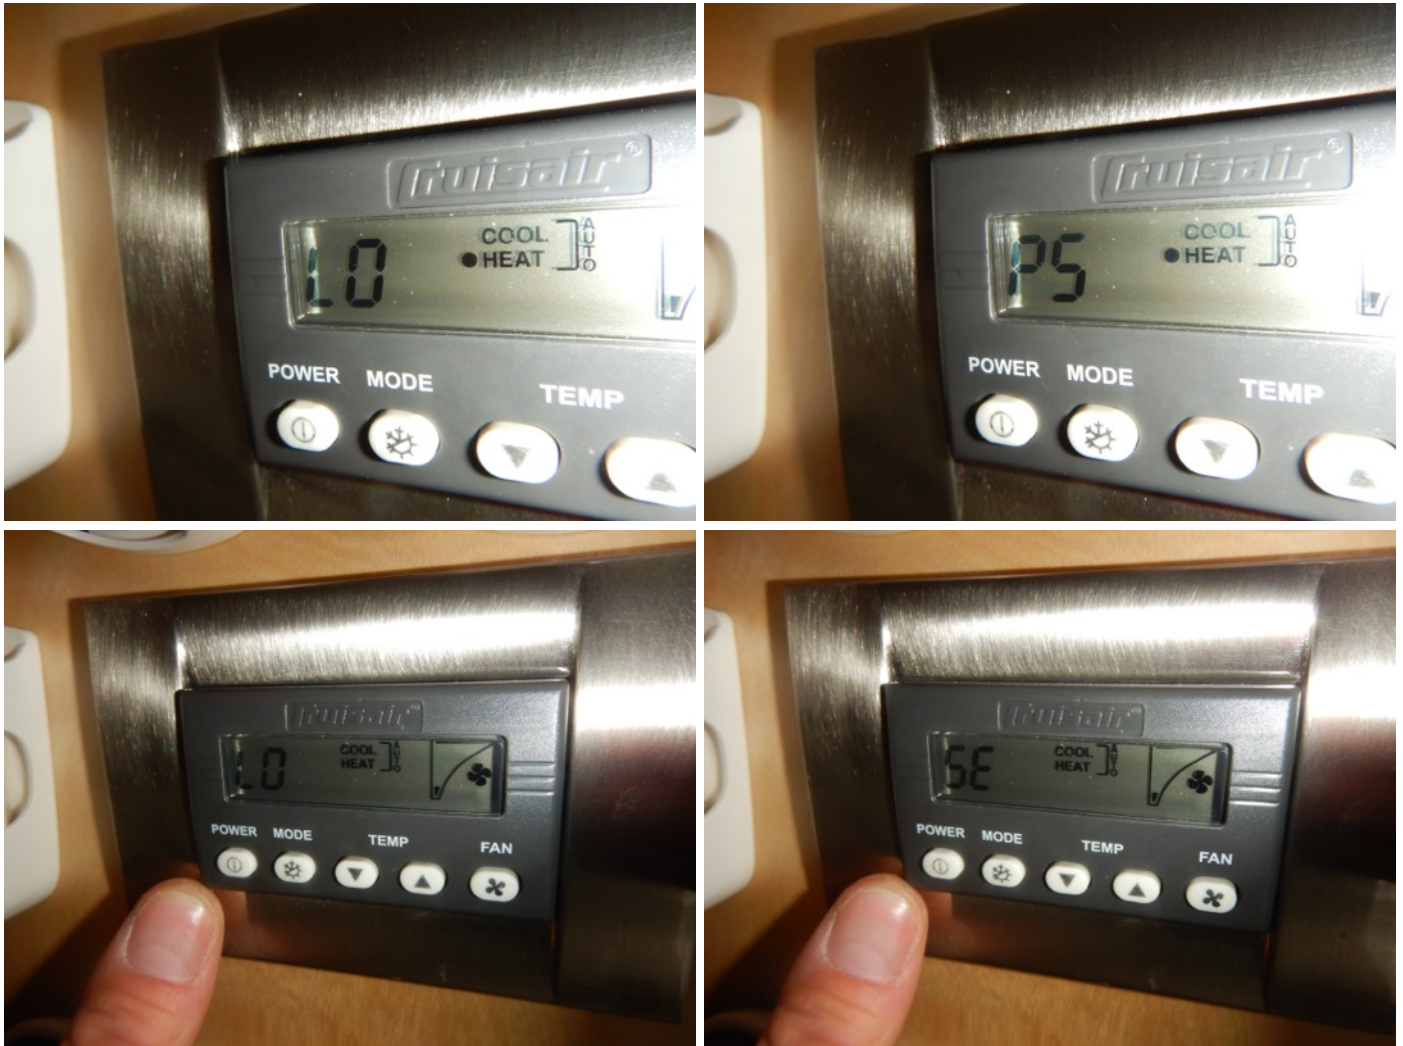
7. HVAC Heating & Air Conditioning Maintenance

The vessel was equipped with a SEVEN ZONE HVAC system. Five of the HVAC zones performed in ABOVE AVERAGE condition, but the AFT SALON ZONE & the CREW ZONE performed in BELOW AVERAGE condition. ERROR CODES reading LO PS & LO SE flashed on the thermostat control screens during testing procedures. Further investigation is needed to determine an explanation for the deficiency described. Recommend defective HVAC system components be repaired or replaced with the intent to improve operating performance. Consult a qualified technician or reputable service facility to discuss troubleshooting & service options.

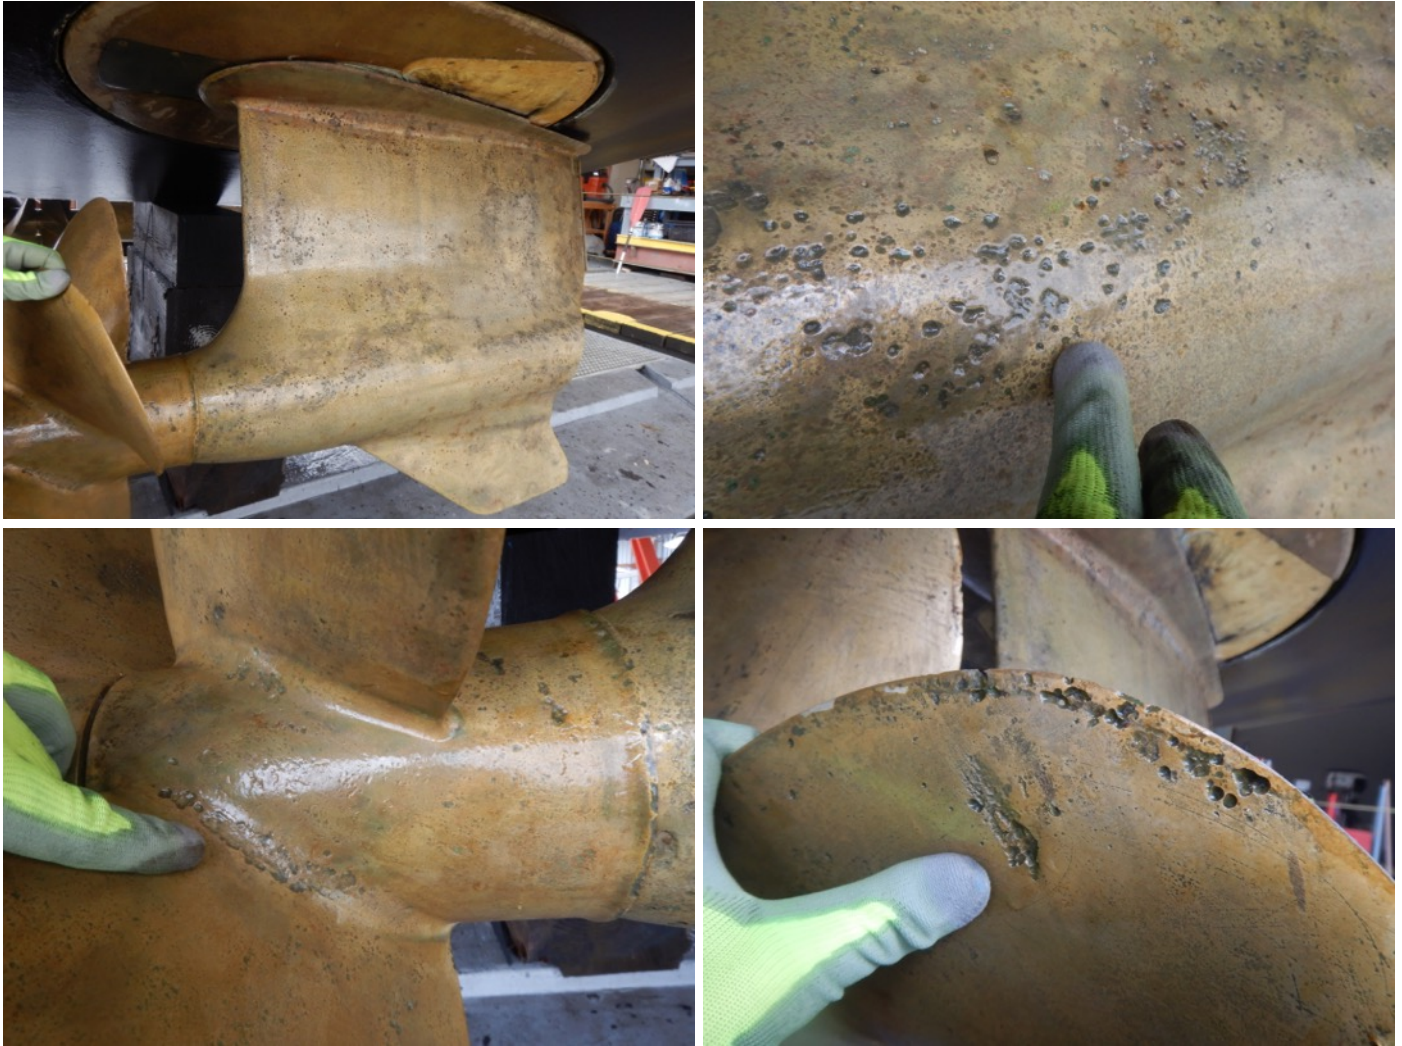
8. Pod Drive & Propeller Corrosion Damage

There was evidence of corrosion damage identified at bronze components of the PORT IPS POD DRIVE when observed during the out-of-water portion of the inspection. The propellers & pod drives have been coated with PROPSPEED, which will help to mitigate the corrosion defects. Recommend monitor the condition of the pod drives & propellers on a regular basis & perform appropriate repair or component replacement if condition worsens. Consult a qualified technician or reputable service facility to discuss troubleshooting & service options.

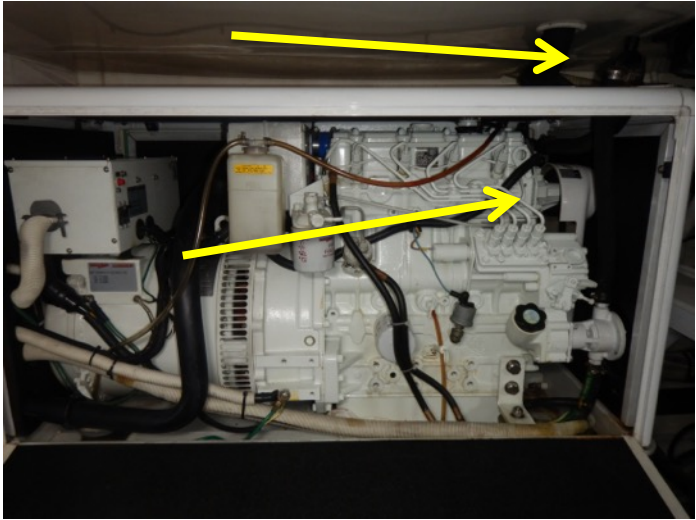
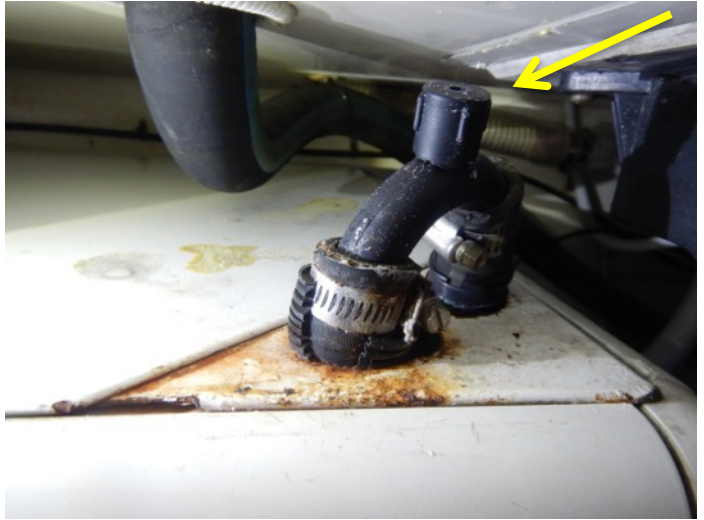
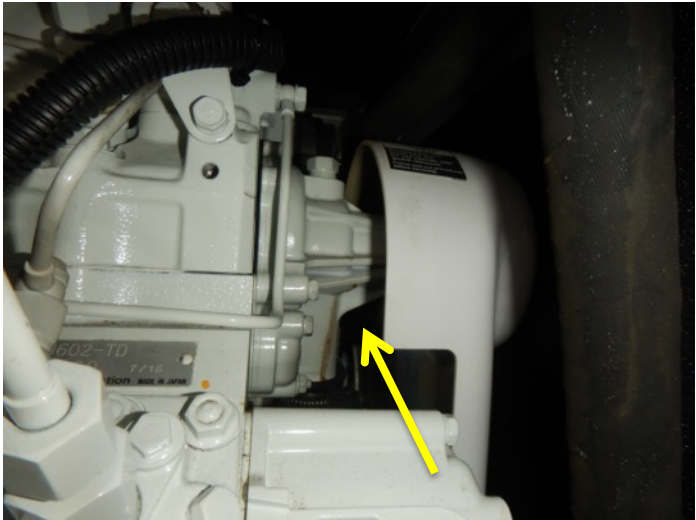
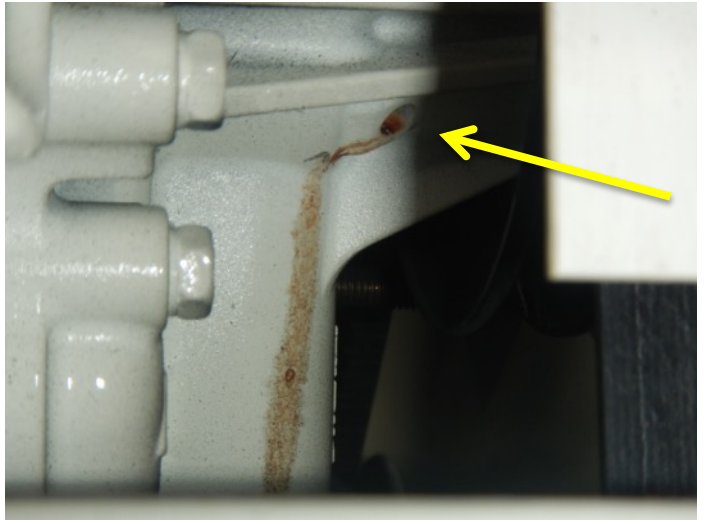
9. STBD GenSet Cooling System Fluid Leaks

There was evidence of fluid leaks identified at the STBD GENSET. The leaks appeared to originate at the ANTI-SIPHON VENT component of the generator engine's cooling system & at the weep-hole portion of the COOLANT CIRCULATION PUMP. Recommend defective GenSet cooling system components be repaired or replaced with the intent to eliminate fluid leaks & improve operating performance.

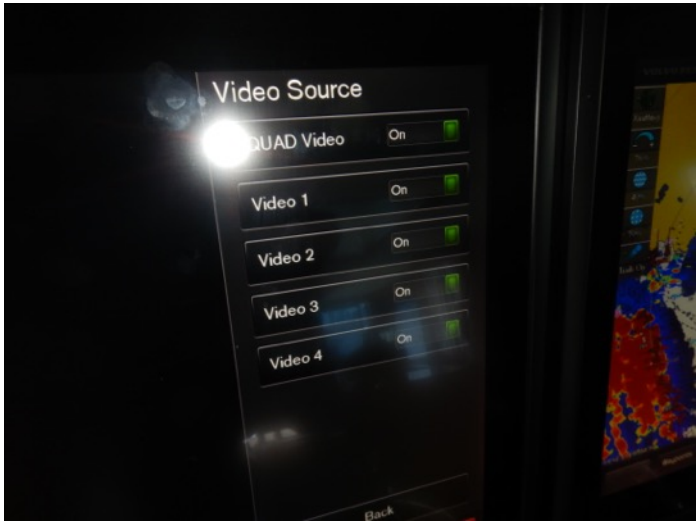
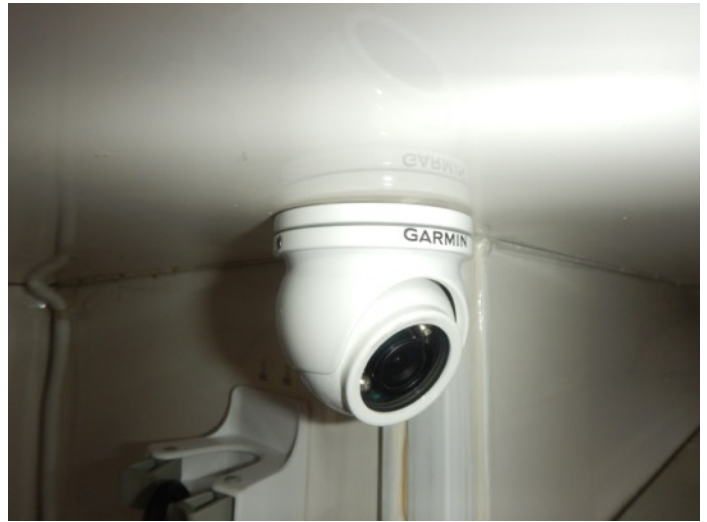
10. GARMIN Video Cameras

The VIDEO CAMERA systems were INOPERABLE. The GARMIN electronics installed at the pilothouse & flybridge control stations would not connect to GARMIN video camera devices installed on interior & exterior portions of the vessel. Further investigation is needed to determine an explanation for the deficiency described. Recommend defective video camera components be adjusted, repaired, or replaced with the intent to improve operating performance.

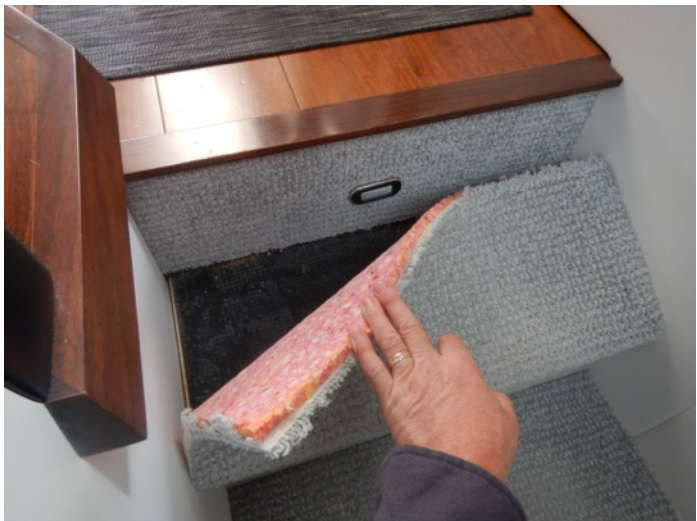
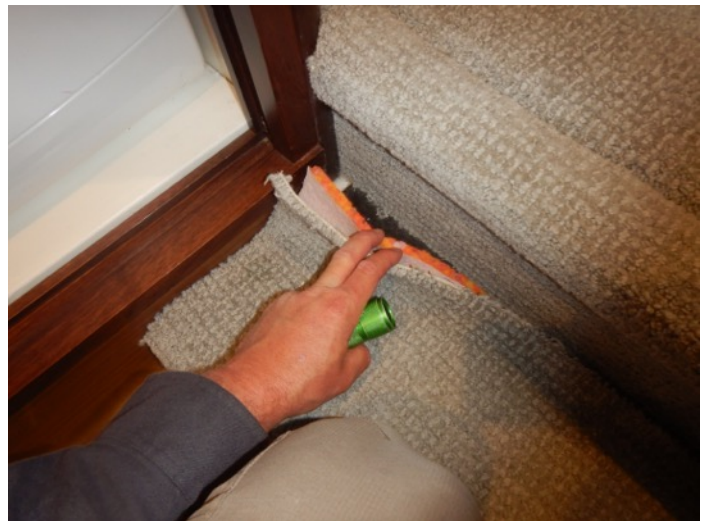
11. Companionway Carpet

Tacked carpet was found loose in two locations along the companionway stairs. Recommend appropriate carpet installation be performed with the intent to improve cosmetic appearance.

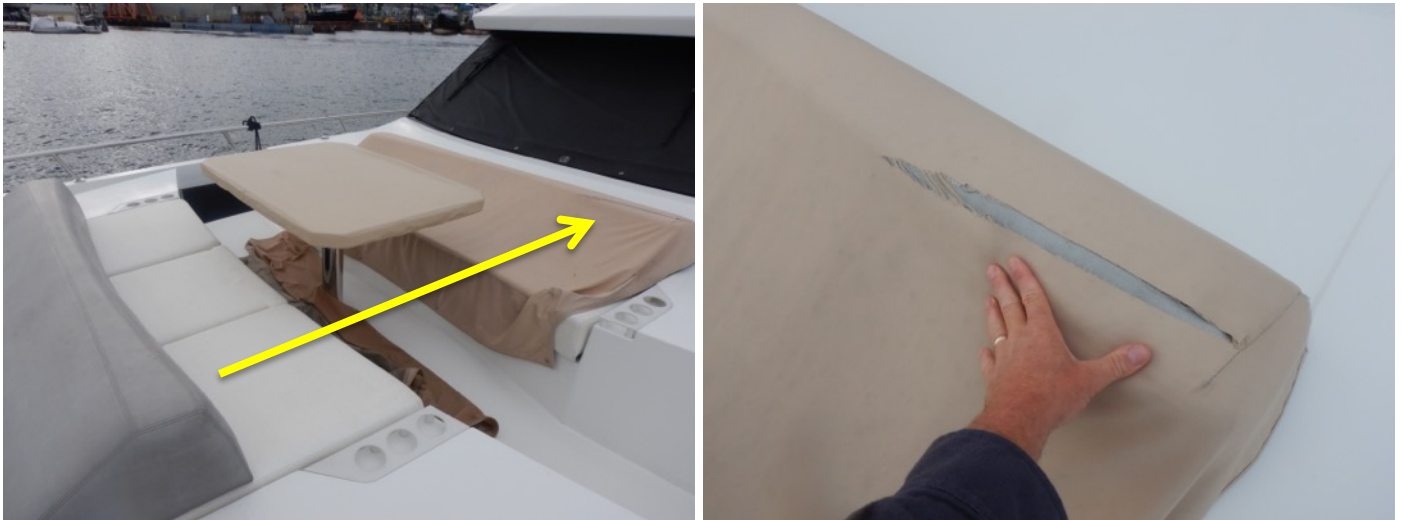
12. Foredeck Canvas

There was a tear found in a canvas cover installed on the foredeck. Recommend defective canvas components be repaired or replaced with the intent to improve operating performance & cosmetic appearance.

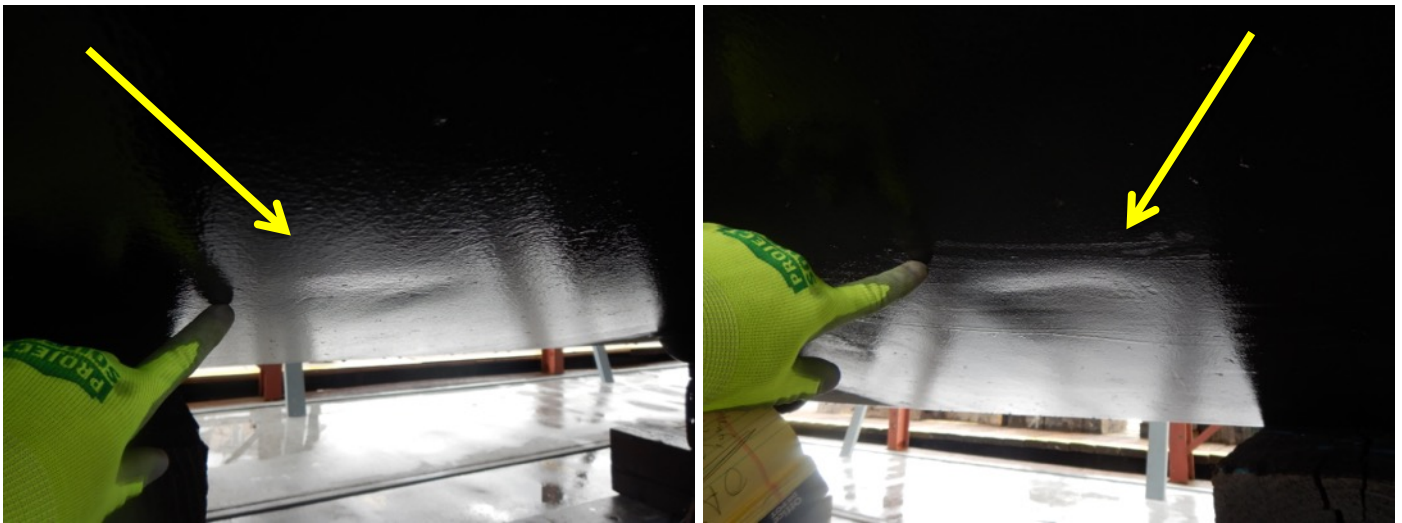
13. Hull Bottom Indent

There were two mild indents observed in mirrored locations on the PORT & STBD sides of the fiberglass hull bottom. There was no evidence of structure defects when evaluated using non-destructive testing techniques & repair service did not appear necessary. Recommend monitor the condition of the fiberglass hull structure each time the vessel is hauled out of the water & perform appropriate repair if fiberglass defects are discovered.
