Nance and Underwood Rigging and Sails RIGGING INSPECTION

December 22nd, 2023

Farr 585 - Principal Interest

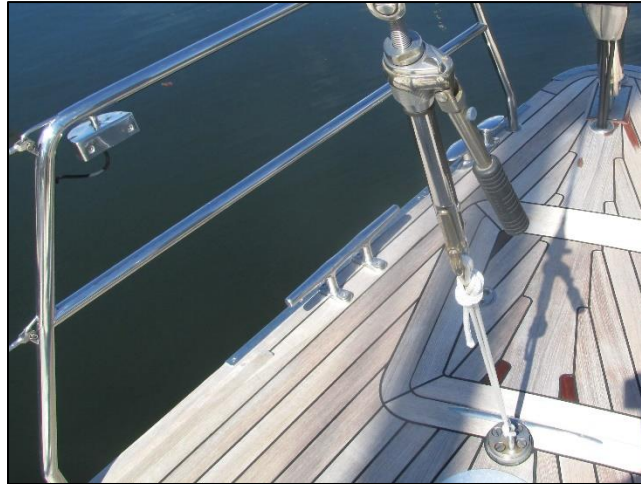
1. Due to the age of the standing rigging and as per manufacturers recommendation, the mast should be unstepped and all hardware thoroughly inspected. Attached is a copy of Hall Spar rigging service guidelines. The following was noted when inspecting the standing rigging: -
 - a. The inner forestay was found to be secured to the deck with a tied piece of line.

1. As per Hall Spars guidelines, the mast should be unstopped and all hardware inspected.
2. The inner forestay should be secured to the deck with a proper wire strop.
3. The extra piece of extrusion should be cut off.
4. The lightning dissipater should be removed and the rust cleaned up.
5. New sheaves should be fabricated and installed in the jib sheave box.

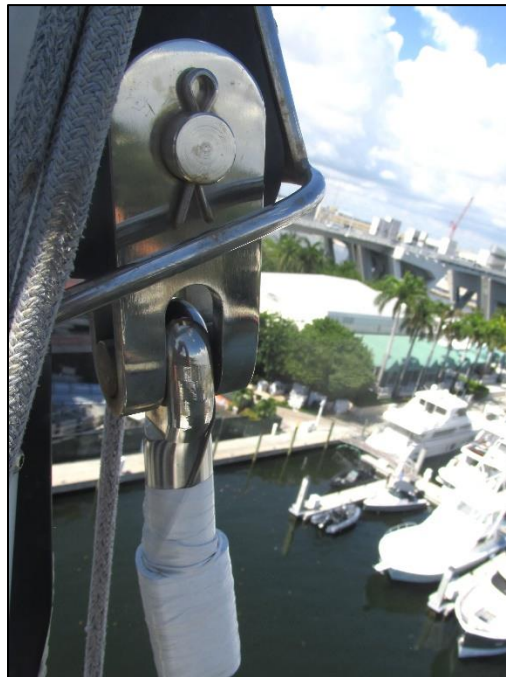
- b. There is an extra piece of extrusion above the furling system on the rod.

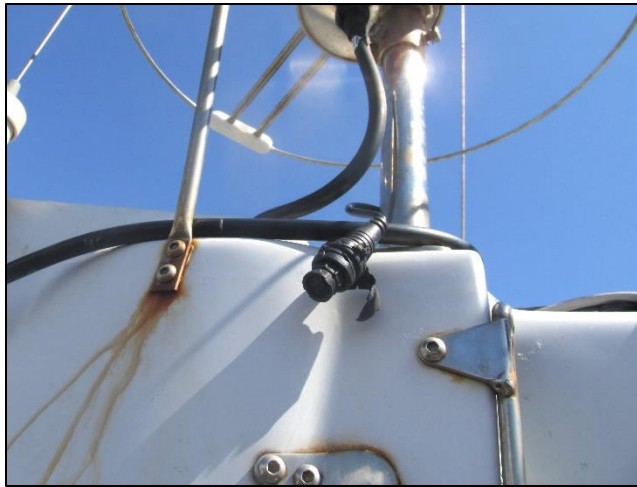
2. The mast was ascended and found to be intact and in good condition.
3. There is rust at the masthead from the lightning dissipater.
