REPORT OF MARINE SURVEY

INSURANCE CONDITION & VALUE

"MINKIE - B"

1997 Lyman-Morse Custom Flybridge 46'

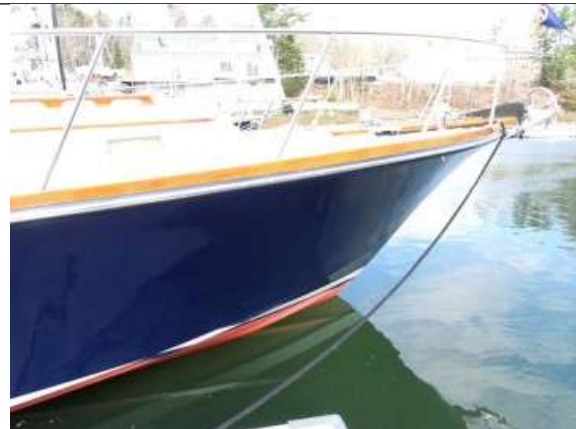
Moisture/Delamination: The majority of comparative moisture meter readings on the topsides were consistently low with the following exceptions with isolated moderate to high comparative moisture meter readings: below the four engine room vents along the topsides below the rail (two per side), and one isolated area on the port quarter. There was an isolated area with tones of delamination at the bottom aft corner of the after most engine room vent on the starboard side. The elevated comparative moisture meter readings found were isolated in nature and appear to be associated with the fasteners and drains for the engine room vents. Since the areas with elevated moisture meter readings were found the owner has had the yard reseal fasteners for the engine room vent boxes which were believed to have been a source of moisture intrusion. No further repairs are considered necessary at this time. (Photos taken on January 9, 2026)

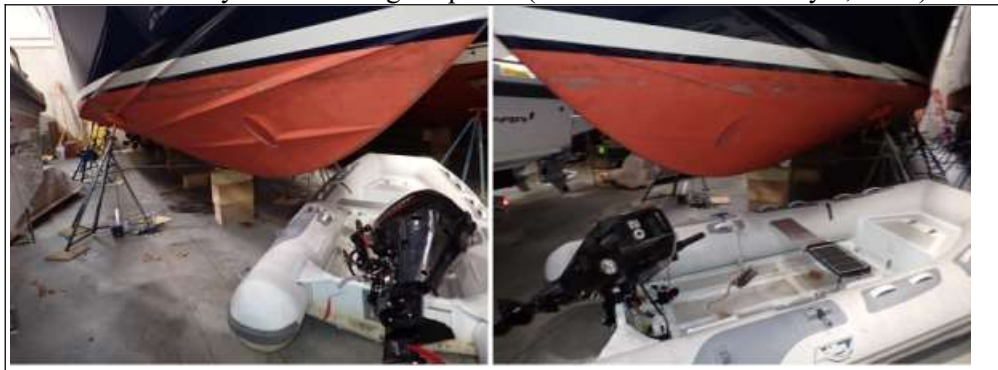
Construction material: The hull bottom was constructed of molded solid laminate FRP with integral strakes for stability while turning at speed. (Photos taken on January 9, 2026)

Moisture/Delamination: The majority of the comparative moisture meter readings on the hull bottom were low with moderate to high readings around the port propeller shaft strut base. There

was one small area with tones of delamination on the port side run at the end of one of the strakes. **PRIORITY THREE RECOMMENDATION:** It is advised to monitor the area with the noted delamination in the future and to make repairs if it begins to grow in size. If the port side propeller strut has not been rebbed in the last few seasons it is advised to do so a preventative maintenance in the near future due to the elevated comparative moisture meter readings around it's base. (Photos taken January 9, 2026)

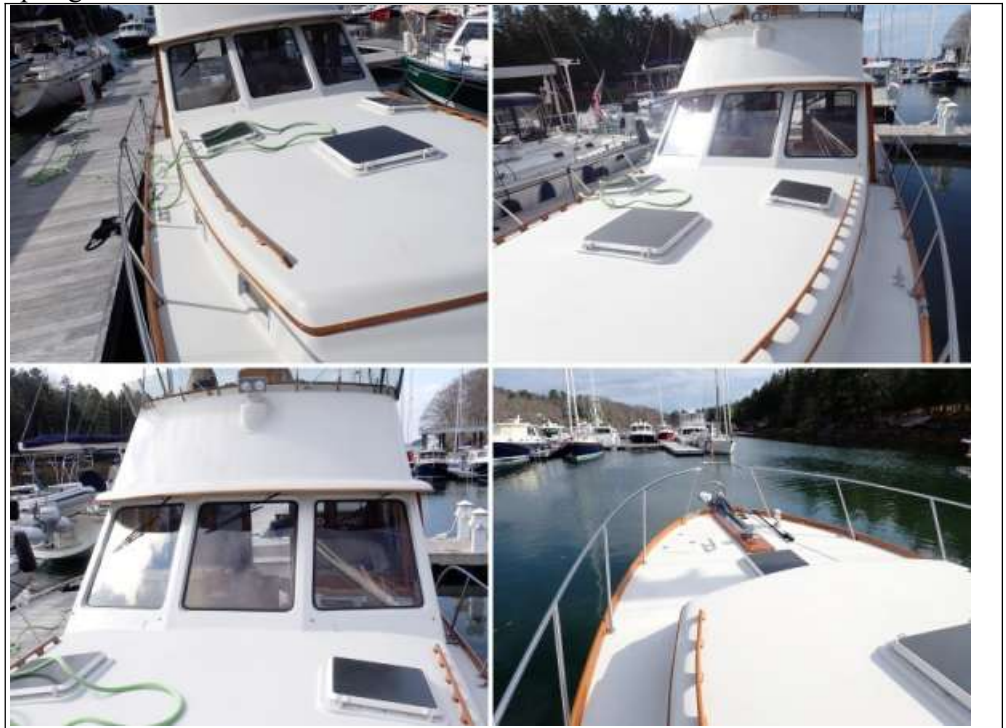
The majority of the decks and cabin trunk top had consistently low comparative moisture meter readings. There was an area with high comparative moisture meter readings on the starboard side deck between the toe rail and the cabin trunk. This area had deck fittings for the starboard water tank fill and waste tank pump out. The area with the high readings on the starboard side deck is approximated within the red outline in the following photo.

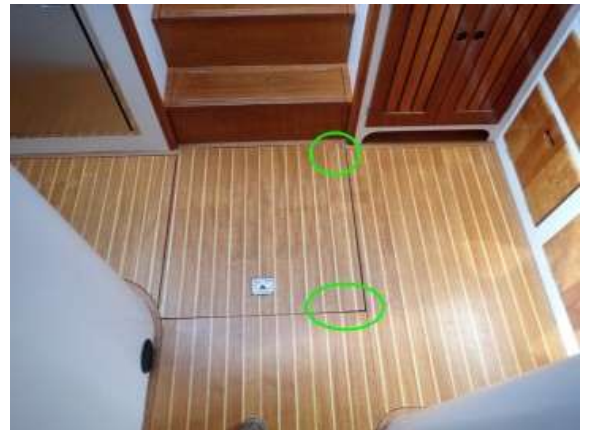
A teak and holly satin varnished sole. The sole was in very good condition with only little cosmetic wear. There was no softness or water damage sighted. The panel at the landing of the companionway steps was slightly warped. The salon and galley sole were repaired and refinished in 2022.

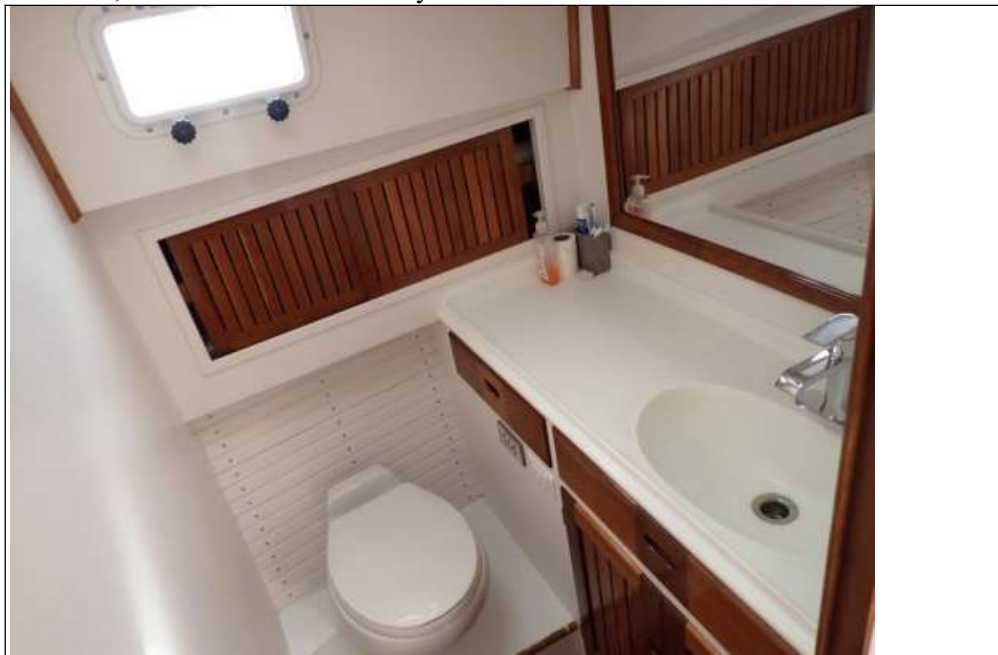
The head was located on the starboard side of the forward accommodations between the galley and master stateroom. The head had white bulkheads, varnished teak trim, and a solid surface vanity.

A Vacuflush marine toilet. No signs of leaks or damage sighted.

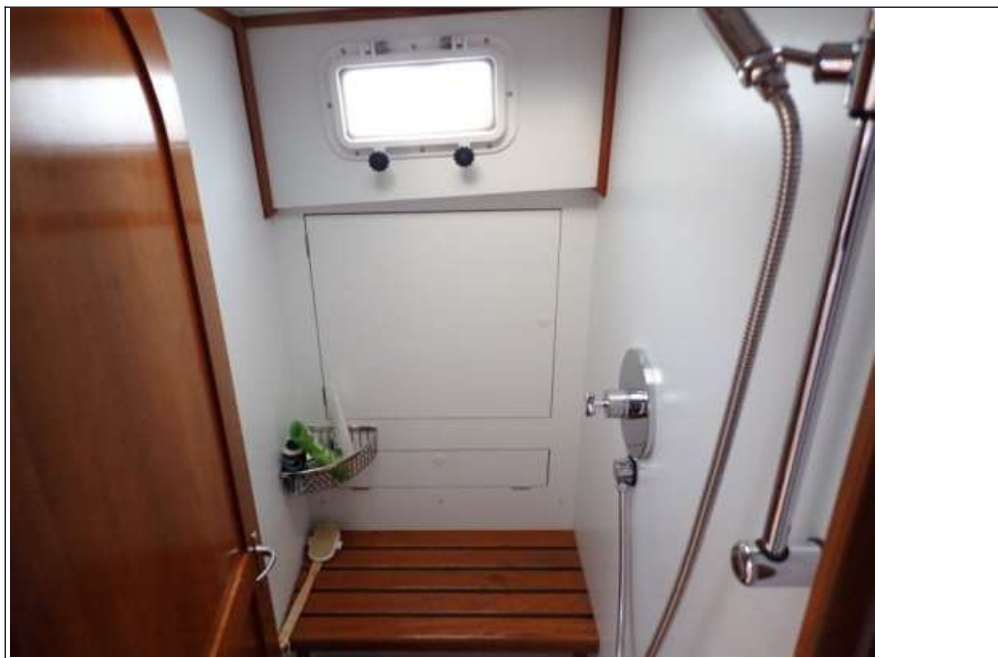
A shower stall was located on the port side of the forward passageway opposite the head.

Other notes: The vessel's head and shower were in very good condition and the trim well maintained. No damage or signs of leaks were noted from the plumbing.

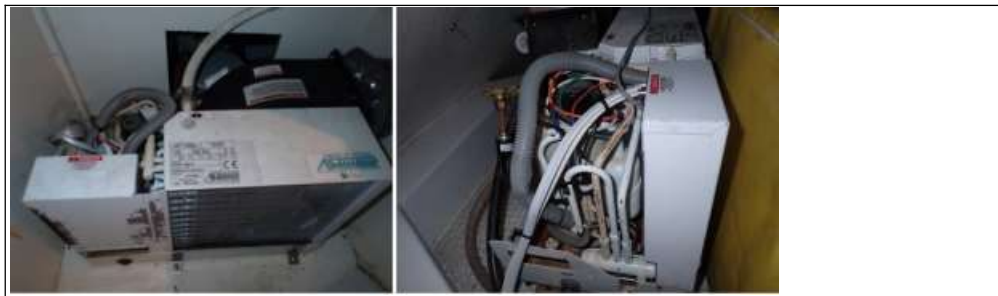
Locations / BTU Capacity: One model: VCP12K A/C unit was located below the master stateroom berth servicing the forward accommodations with a rating of 12,000 BTUs, serial number: D0-M81661.

A second model: VCP16KHV A/C unit was located below the forward cowling of the flybridge servicing the salon with a rating of 16,000 BTUs, serial number: D0-M81543.

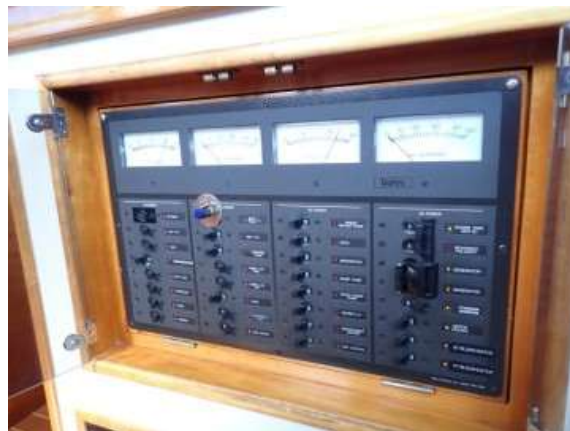
Distribution panel: A Bass Products DC distribution panel was located near the helm with an acrylic door to protect it. The switches were appropriately labeled per ABYC E-11.5.1.3.4.

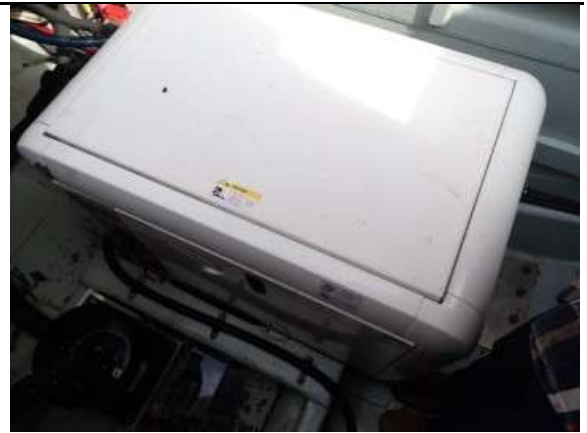
Manufacturer/Location: Kohler, model: 9E0ZD located in the lazarette. The generator was reportedly replaced in 2016. The generator was installed within an sound dampening case.

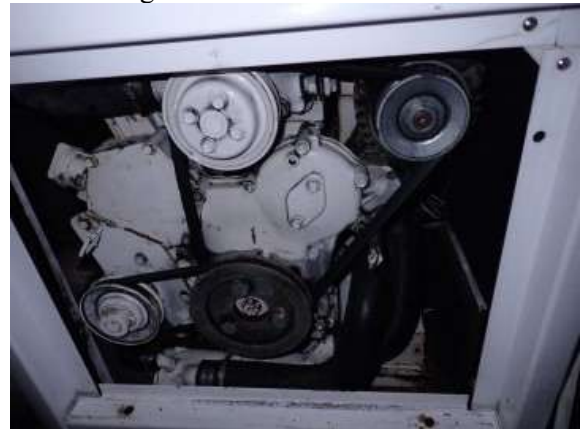
Belts and pulleys: In serviceable condition.

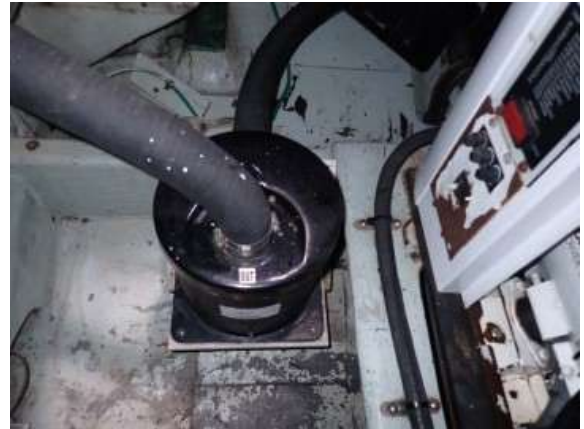
Engine mounts and beds: Secure and in serviceable condition.
Engine ground cable: Securely attached and in good condition.
Exhaust piping: Wire reinforced rubber marine wet exhaust hoses securely double clamped per ABYC P-1.7.
Muffler: A fiberglass water lift type muffler, securely mounted, and in good condition.

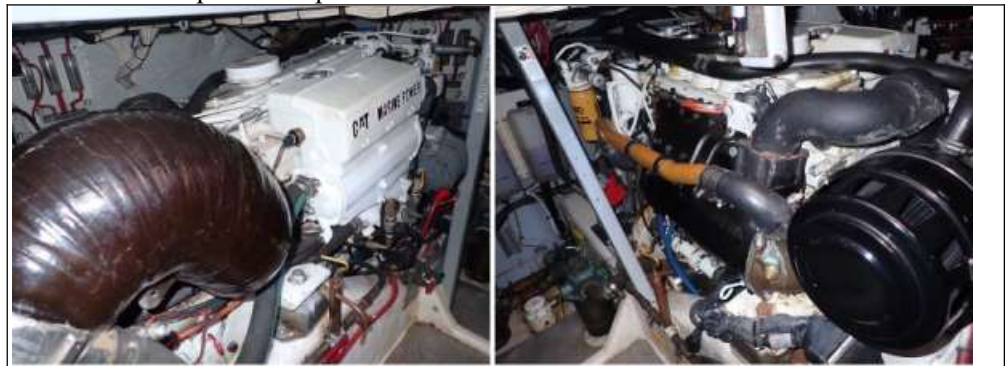
Engine specifications Twin Caterpillar C7 turbocharged and aftercooled 6 cylinder inline marine diesel engine. Each engine was rated at a maximum output of 420 HP at 2,800 RPM for a total maximum power output of 840 HP.

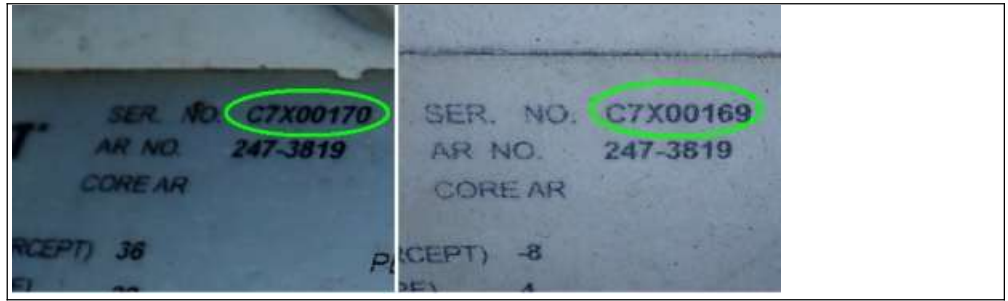
Port: C7X00170 Starboard: C7X00169

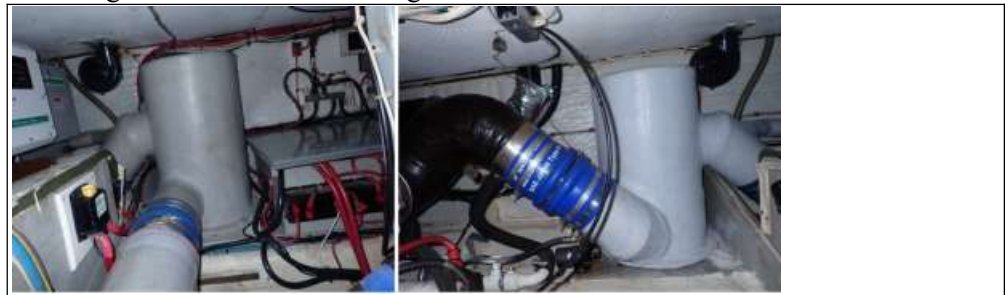
Water drop FRP mufflers were installed on either side of the engine room aft and were in good condition with no signs of leaks noted.

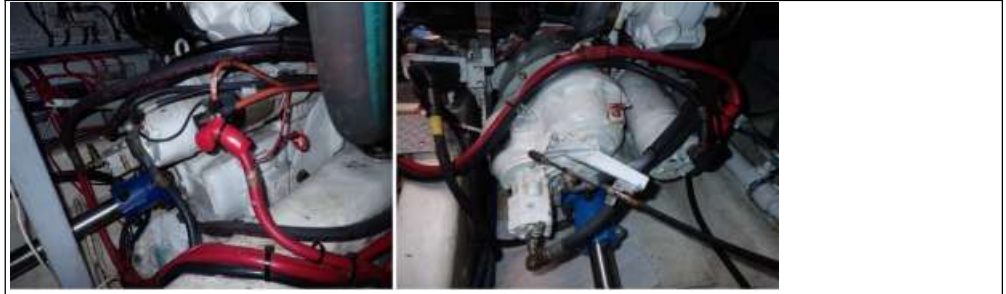
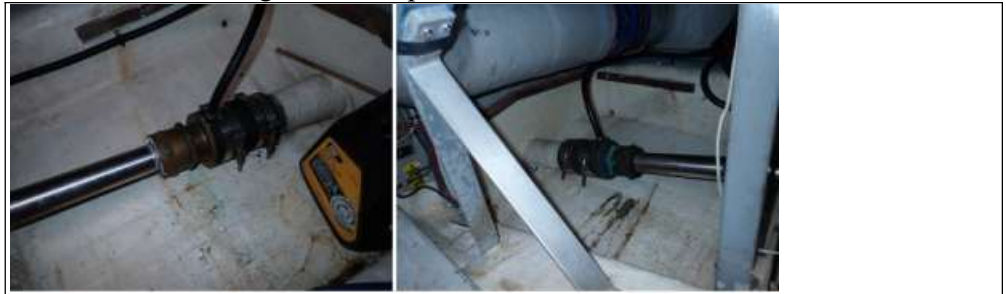
Serial no(s): Starboard: 5D-G668 Port: 7E-1110
Gear ratio: 1.98:1
Fluid level and condition: Clean and full.
Propeller shaft(s): 2" stainless steel alloy propeller shafts with newer cast steel transmission couplers.
Stuffing box(es): Water cooled conventional bronze stuffing boxes with wire reinforced rubber boots. The stuffing boxes were in good condition with no damage sighted. The starboard side stuffing box was repacked in 2024 and the starboard side in 2025.

Condition summary: No oil leaks or exterior damage was sighted on the transmissions. The shafts, couplers, and stuffing boxes were in serviceable condition on visual inspection.

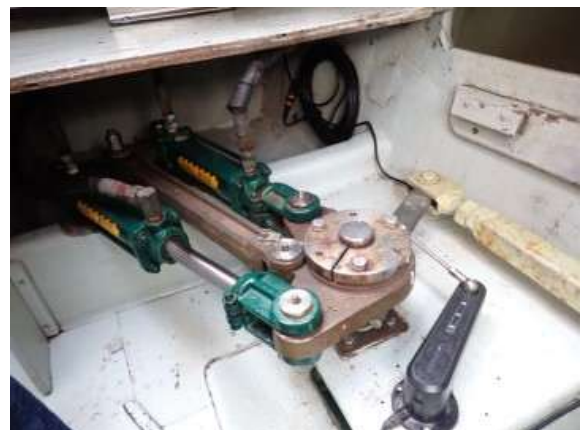
Type: Powered hydraulic steering with a hydraulic pump driven off the starboard main engine.
Mounting(s): The Hydro-Slave dual ram quadrant was securely mounted and connected to the starboard rudder stock. No leaks or damage sighted.

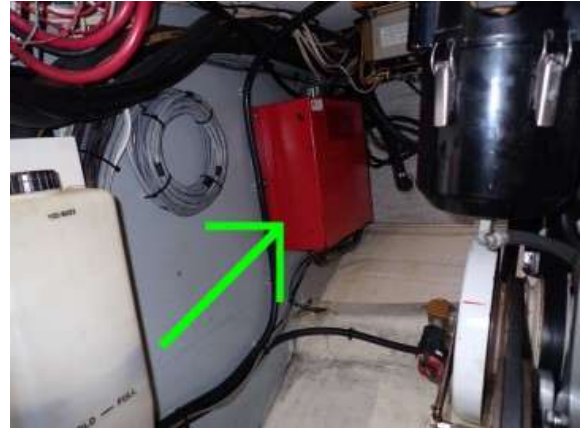
Steering tie bar: A steel tie bar was securely fitted linking the port and starboard rudder stocks.
Lines and fittings: Flexible hydraulic hoses in serviceable condition with no leaks noted.
Pressure/reservoir tank: Located on the starboard side of forward bulkhead in the engine room. No leaks or damage sighted.

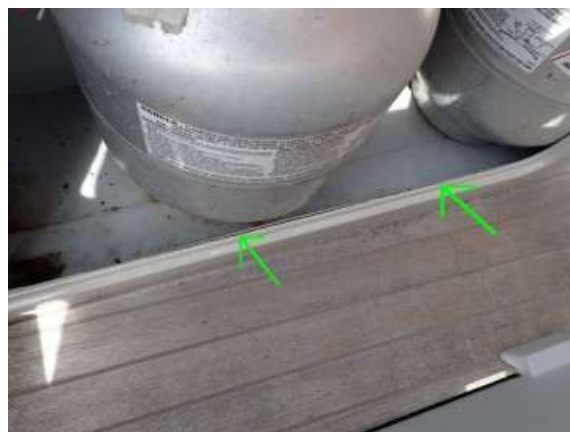
No & location of tanks:	Two tanks located below the port side rail of the cockpit in a designated locker per ABYC A-1.8.7.
Secured:	The tanks were secured.
Tank type & OPD:	Aluminum tanks with OPDs installed. The tanks were in good condition with a visual inspection.
Regulator(s):	An appropriate LPG regulator was installed.
Pressure gauge(s):	Pressure gauge is installed and holds pressure when main gas valve is turned off indicating no leaks in the system. NOTE: <i>Always retest for leaks when removing or refilling LPG tank.</i>
Shut off valve(s):	LPG shut off valve at the tank top. In addition an LPG electrical solenoid shut off valve switch was available near the galley and tested functional.
Supply lines:	Flex LPG type hose. Good condition where could be sighted.
Locker(s) vented:	The locker was properly vented at its base per ABYC A-1.8.4.
Inspection/cleaning access:	Easily accessible.
Other notes:	The bottom edge of the frame for the access hatch to the locker was cracking. PRIORITY THREE RECOMMENDATION: Repair the crack to prevent it from deteriorating further.

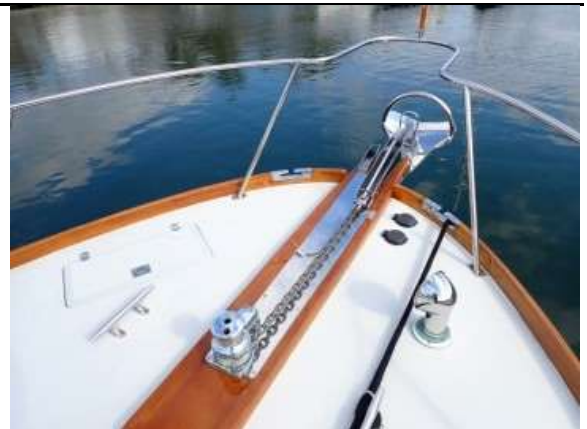
A polished stainless steel 55lb Rocna anchor was located at the roller on the bow. The anchor was securely attached to a reported 200 ft of galvanized steel anchor chain. The chain and anchor were in good condition. (The entire length of the chain was not inspected.)

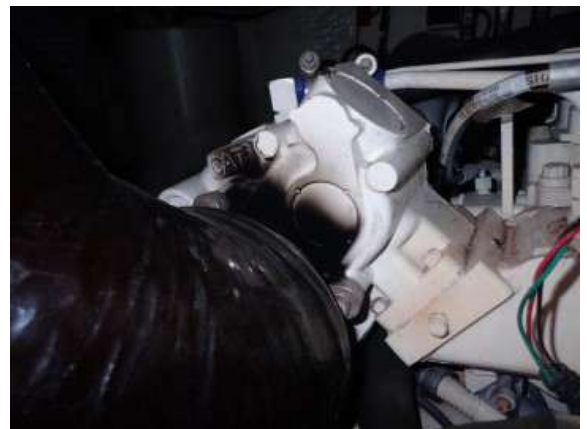
Other notes: There was some soot around the mixing elbow connection to the port engine's turbo. **PRIORITY TWO RECOMMENDATION:** Wipe clean and monitor for leaks. Repair is an exhaust leak is verified.
