Maine Design Company, LLC
Capt. Tom Lokocz Adams, SAMS® AMS®
Marine Design, Engineering and Surveys Since 1999

Condition & Value Survey

April 8, 2019

Jean Marie

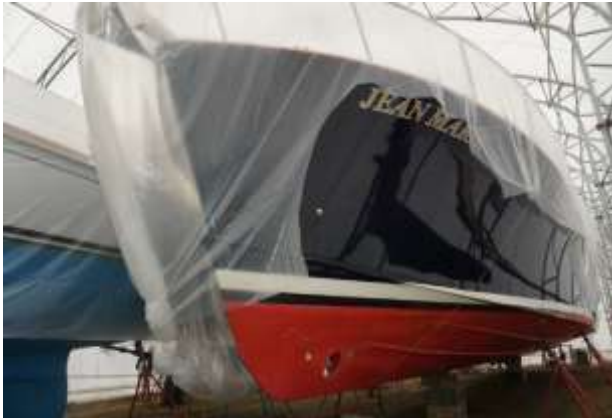
Figure 10.1 View of port bow

The subject of this survey is a Vicem Classic 58 built in 2004 by Vicem Yachts of Turkey [Figure 10.1].

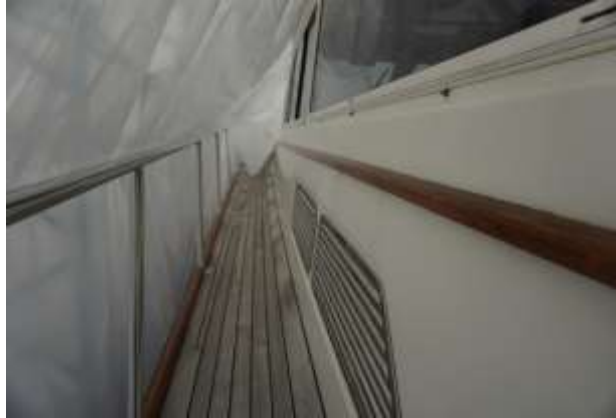
Figure 10.8 Side deck

The interior is well appointed with attractive woods, well executed joiner work and high-quality finishes [Figure 10.9 & Figure 10.11]. The galley is nicely laid out with ample storage for galley items and provisions [Figure 10.12]. The decks are wide between the deck houses and the toe rail giving plenty of room for footing [Figure 10.8]. Secure handrails and robust outboard railings give a feeling of security while moving on deck.

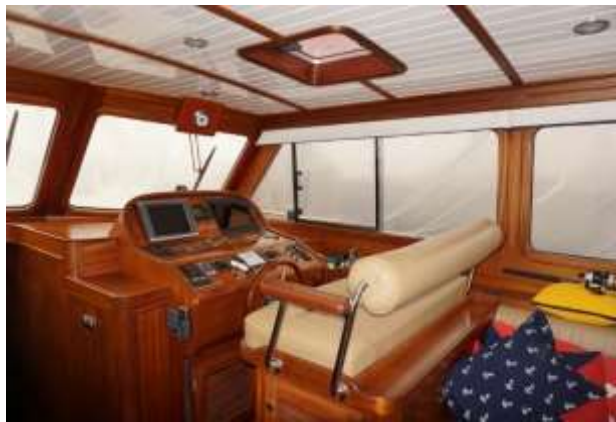
Figure 10.10 Helm

Type of Steering: Wheel, hydraulic
Stations: One [Figure 10.10]
Visibility: Good
Rudder(s): Serviceable condition; recently serviced
Rudder Hardware: Serviceable condition; recently serviced
Auxiliary Steering: NA

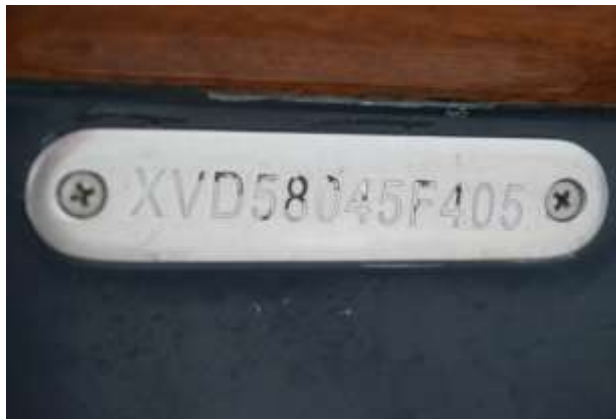
Figure 10.34 HIN

Hull Number (HIN): XVD58045F405 [Figure 10.34]
