# VESSEL PRE-PURCHASE SURVEY REPORT

M/Y "BRANDI WINE" Hargrave 114'

Fort Lauderdale, FL, USA – October 6th, 2026

This is to certify that I personally attended the model year 2009, 114-foot fiberglass hull, motor yacht built by Kha Shing Enterprises Co. (HIN – HCY14125G809).

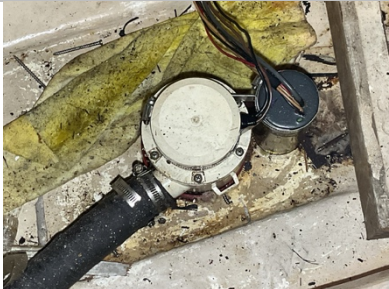
| 4 | The aft engine room bilge pump was not secured to its base, and the second metal mounting clamp was broken. | Repair or replace the broken clamp and properly secure the pump to its base to prevent failure in service. | |

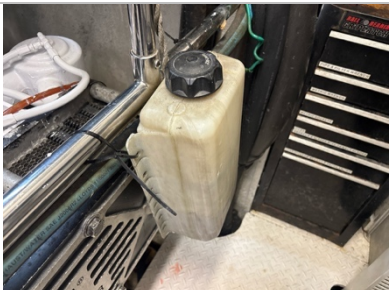
| 8 | The starboard engine coolant overflow tank was not properly mounted. | Securely mount the tank. | |

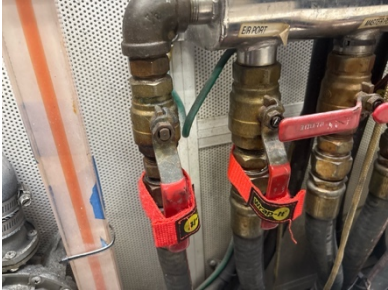
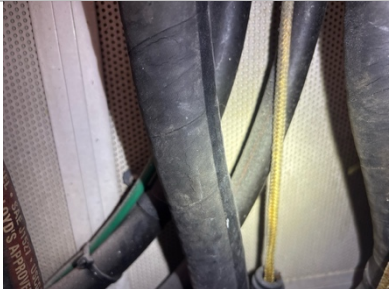
| 9 | Both port engine fuel hoses were deteriorated and cracked. | <p>Replace without delay with marine-rated fuel hose meeting ABYC requirements to prevent fuel leakage into the engine room.</p> | |

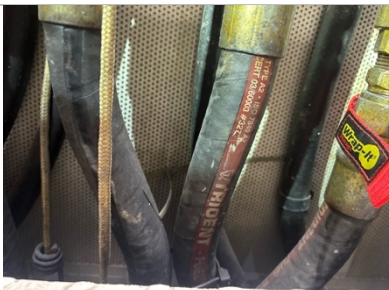
| 11 | The generator fuel hoses were cracked and deteriorated. | <p>Replace without delay with marine-rated fuel hose meeting ABYC requirements to prevent fuel leakage into the engine room.</p> | |

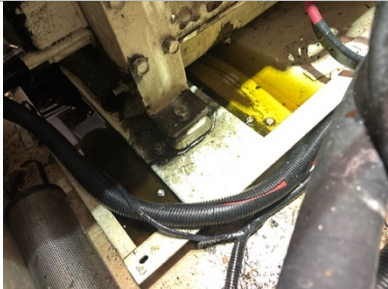
| 13 | Excessive oil was observed at the base of the night generator. | Clean the oil, identify the source of the leak, and repair as needed. | |

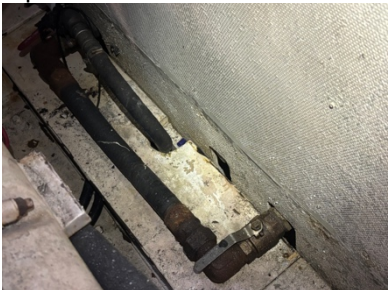
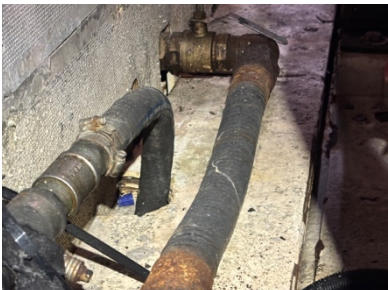
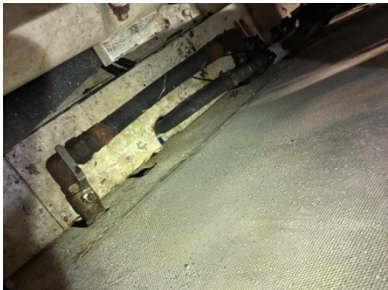
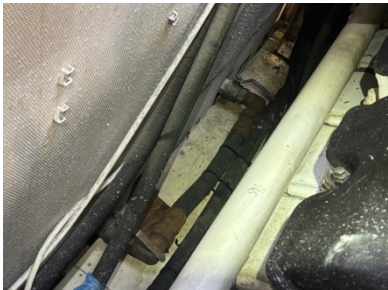
| 14 | The 90-degree crossover valve fittings for the port and starboard outboard fuel tanks in the engine room were excessively corroded, and the associated fuel hoses were cracked and degraded. | Replace the 90-degree fittings and fuel hoses, and service or replace the valves as needed. | |

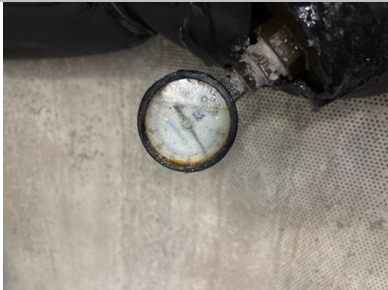
| 15 | A manifold pressure gauge on the A/C chilled water loop was approximately seven-eighths filled with fluid. | Replace the gauge. | |

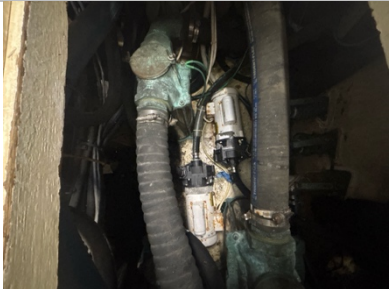
| 17 | Neither the port nor the starboard main engine sea strainer was mounted. | Securely mount the strainers to prevent excessive stress on the connected hoses, which could lead to hose failure and flooding. | |

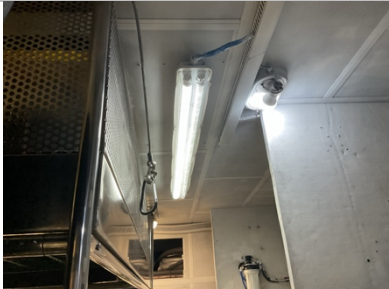
| 24 | The starboard engine room lighting was not in a safe condition. | Replace the flickering lamp and install a cover over the exposed bulb. | |

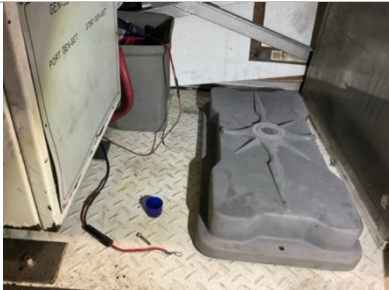
| 26 | The starboard generator battery box cover was not properly secured, and a loose, unlabeled cable was observed. | Secure the battery box cover to prevent battery movement, and secure and insulate the loose cable. Remove the cable and associated connections if no longer in use. | |

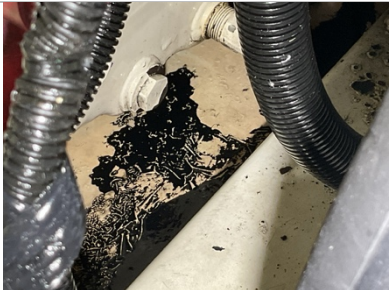
| 27 | Accumulated oil was observed on the lower frame of the port generator. | Perform a full inspection, identify the source of the leak, and repair or replace components as needed. | |

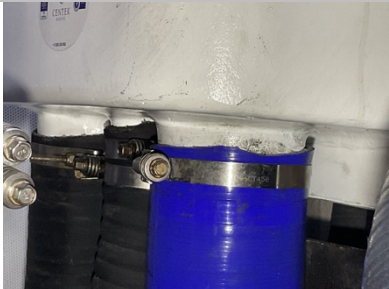
| 28 | Double clamps were missing at the water/mixing box connections on the port generator exhaust lines. | Install double clamps as needed. | |

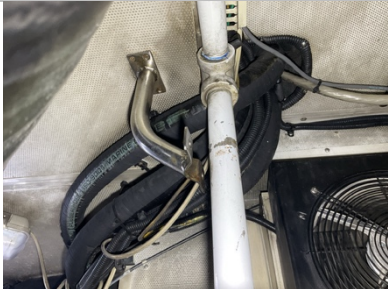
| 29 | A fire suppression system pipe was not supported by its bracket; at the time of inspection, the bracket was approximately 2 inches away from the pipe. | Fabricate or adjust a bracket to secure the pipe in its correct position so the system performs as designed in an emergency. | |

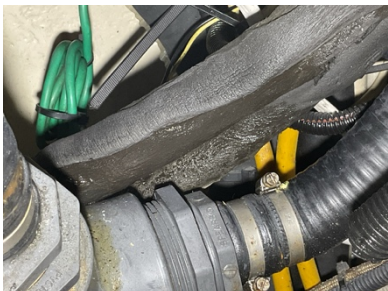
| 31 | The chiller line hose in the port aft engine room, behind the generator, showed deterioration, with wet areas dripping into the bilge. | Remove the deteriorated insulation and install proper insulation around the chiller hose. | |

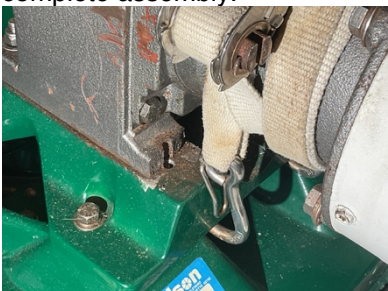
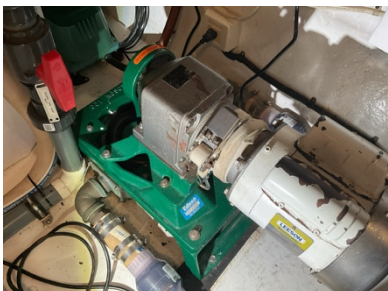
| 32 | The black water pump bracket was broken. | Source replacement parts if available; otherwise, replace the complete assembly. | |

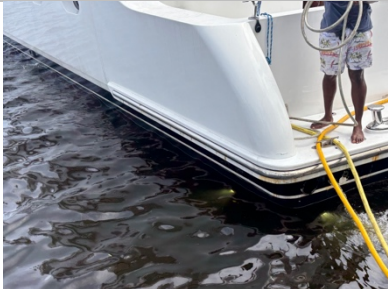
| 37 | The port forward, starboard forward, and farthest starboard outboard lights on the transom were inoperable. | Investigate further and replace the power supply and/or lamps as necessary to restore function. | |

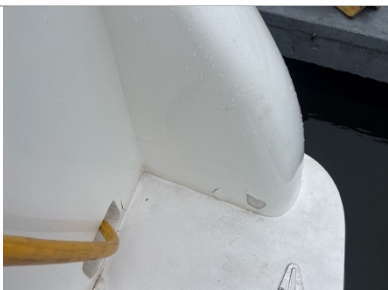
| 40 | Chipped and flaking paint was observed on the transom. | Prep and refinish the affected area. | |

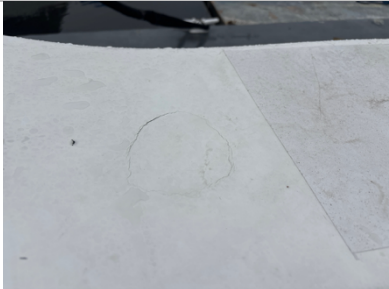
| 41 | Topcoat and gelcoat damage was observed on the starboard aft topsides near the transom. | Repair the damaged areas and refinish. | |

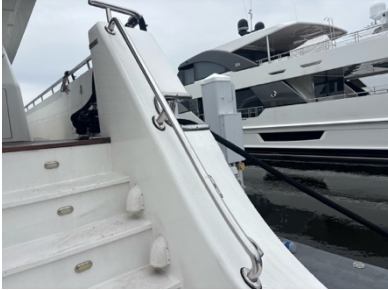
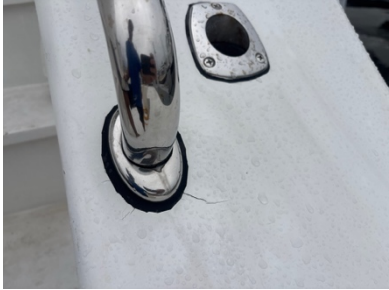
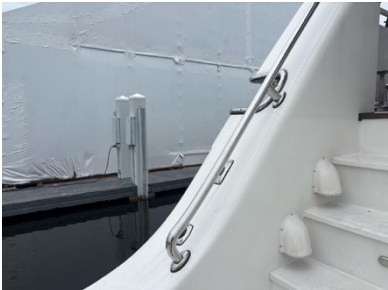
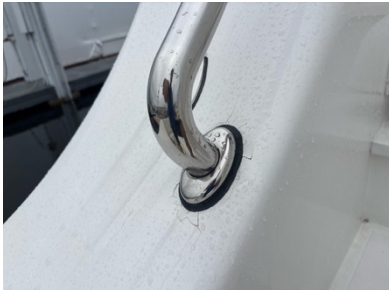
| 42 | Gelcoat damage was observed on the lower supports of the port and starboard handrails for the transom steps. | Repair the damaged gelcoat and refinish. | |

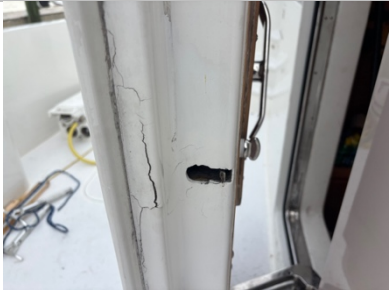
| 44 | Topcoat damage was observed on the starboard side of the weathertight hatch between the transom and the engine room. | Prep and recoat with an appropriate coating system. | |

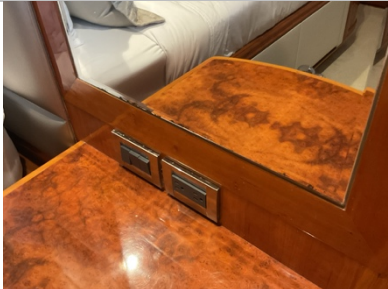
| 51 | The mirror on the outboard side of the bed showed desilvering. | Replace the mirror if desired. | |

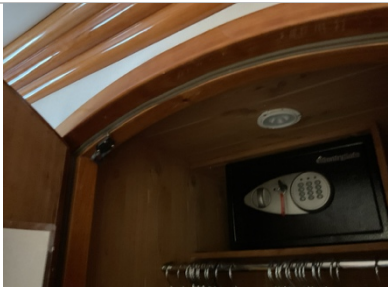
| 52 | The cabinet light was inoperable. | Inspect the switch and lamp and replace components as needed. | |

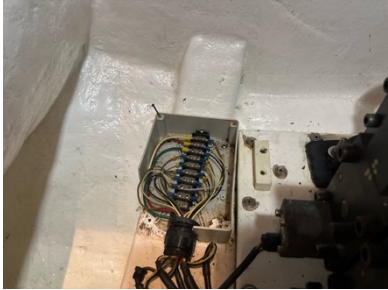
| 53 | The junction box for the hydraulic actuators in the bilge below the forward crew quarters was broken, with the cover missing. | Replace the junction box cover. | |

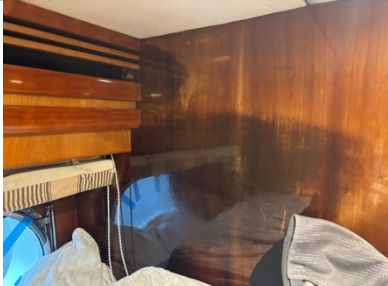
| 54 | Water damaged wall coverings were observed in the aft crew quarters. | Check for water leaks and repair the wall coverings to match the surrounding areas. | |
