**PATTON MARINE INC.**  
**SURVEYORS And CONSULTANTS**  
P.O. Box 331884  
Miami, FL 33233-1884, USA

**May 30, 2026**  
**File No.: 13984-26**  
**Page 1 of 36**

**RE: "ELYSIAN", 2004,  
130' Westport Motor Yacht**

**RECOMMENDATIONS**

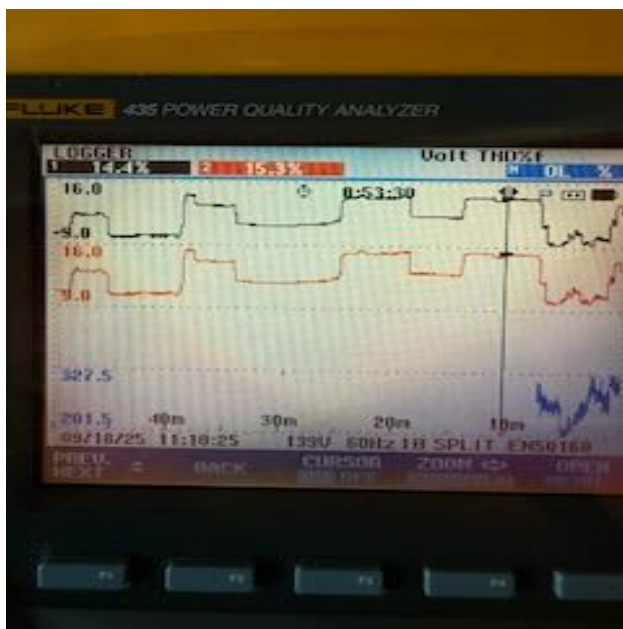
In addition, voltage wave form is heavily corrupted and is flat topping, this condition will not allow any electrical components utilizing capacitors to fully re-charge which could cause damage / failure of sensitive equipment.

A separated power quality report has been provided.
