REPORT OF MARINE SURVEY
Pre-purchase condition & value survey
of the vessel

"FREE RANGE CHICKEN"
2006 Custom Perry 59

Survey file no: H1222817.CVS.Stewart
Date of survey: October 12, 2022
Date of written report: October 13, 2022
Type of survey: Pre-purchase condition & value survey
Survey conducted by: Robert A. Noyce
Requested by: This survey was performed at the request of the purchaser Michael Stewart who was present at the time of the survey.
Purpose of survey: Assess the overall condition and value of vessel for pre-purchase decision making.
Vessel surveyed at: Bert Jabin's Yacht Yard
Survey conducted with vessel: The vessel was surveyed both while afloat & hauled out of the water.
Sea trial: A sea trial was performed as part of this survey. The results are included in the Sea Trial section.
Engine survey: The engine survey was conducted by Jeff Leitch of Bay Shore Marine.
Sailboat rigging: The mast, boom, standing and running rigging were inspected from deck level only.

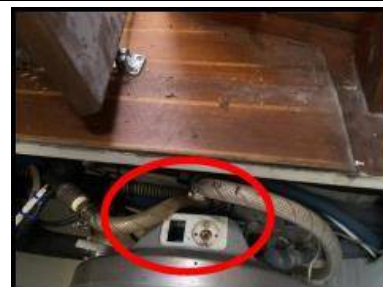
Manufacturer/Capacity: ISOtemp, thought to be 40 liters. Some repair or service is needed **(RR)**.

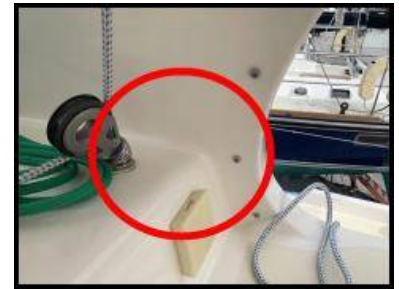
Cockpit surface: Fiberglass deck with Painted-in non-skid surface.
Moisture content: Moisture meter readings were all relatively dry.
Delamination: No obvious signs of delamination were noted.
Cockpit hatches: Well secured.
Scuppers/deck drains: Yes open transom and drains overboard.
Cockpit Equipment: Twin pedestals, teak table. There is a hard dodger with the mainsheet traveler attached. **NOTE: Minor fractures at the side supports at the bases (R).**

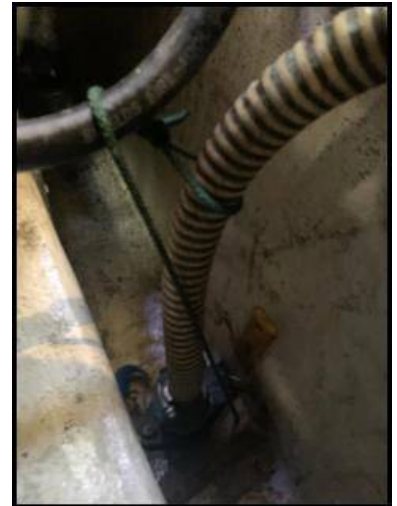
All thru-hull fittings are adequately sealed and bonded to hull. Inspect all hoses and replace with certified underwater hose if required **(RR)**.

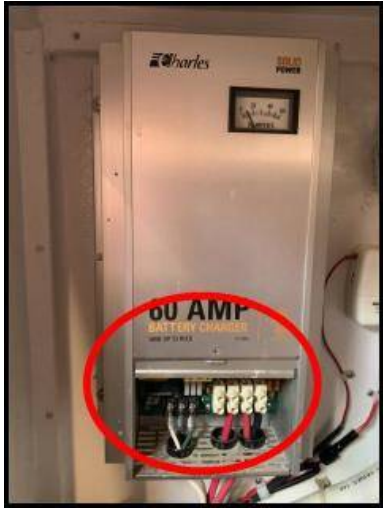
Number of units: Charles 5000 SP Series 12v 60a for 12V Bank-replace panel (**RR**). Charles 5000 SP Series 24v 30a Auxiliary Charger for 24V Bank

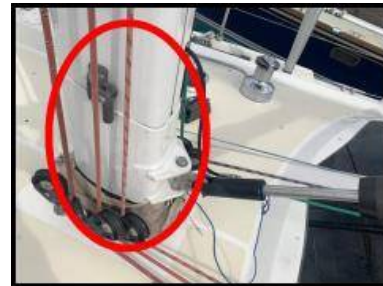
Secure where visible. **NOTE: A doubler has been added to the mast at the partners. It reinforces the vang bracket well.**

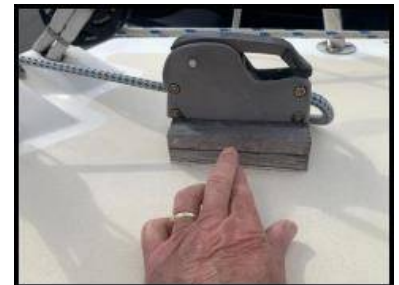
Roller furling gear Harken genoa and staysail furling gear.
Spinnaker pole: Stored on deck and secured.
Boom Vang: Navtec hydraulic vang.
Traveler System: Appears serviceable.
Jib Tracks: Well secured.
Deck Blocks: Secure.
Hydraulic systems: Navtec
Comments: Note that the shims for the aft sheet clutches are made of wood. **It is prudent to replace the worn wood with Starboard or FRP.**

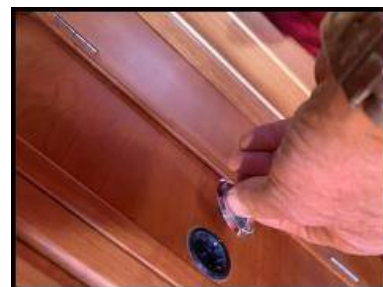
Style: Traditional.
Navigation station: Table with storage under top.
Headliner: Vinyl panels.
Sole: Teak & holly cabin sole installed.
Fabric & cushions: Good condition.
Light fixtures: 24 volt cabin lights throughout the vessel.
Cabin fans: DC Hella fans.
Water intrusion signs: No significant evidence sighted.
Condition: Interior is in good condition for its age. **Some cabinet latches require repair.**

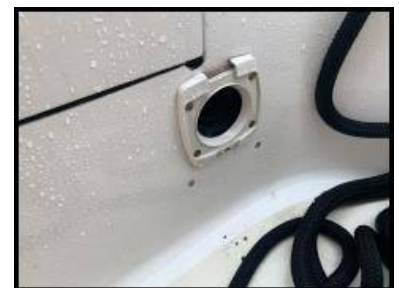
DC BILGE PUMPS: There are four automatic bilge pumps, **I was no able to prove all pumps in the automatic function.**
COCKPIT MANUAL PUMPS: Whale manual bilge pump. **The cover plate is missing, pump appeared to be serviceable.**
