# **Certificate of Marine Survey THERIAULT MARINE CONSULTING, LLC**

## SURVEY NUMBER: 23TS2621

VESSEL NAME:	SUNFLOWER
TYPE OF VESSEL:	FRP; AUXILIARY SLOOP [Beneteau Oceanis 523 Clipper]
HULL IDENTIFICATION NUMBER:	BEYE3009B505
VESSEL HAILING PORT:	HARPSWELL, ME
FLAG:	United States of America
DATE SURVEYED:	07 March 2023
LOCATION SURVEYED:	Safe Harbor Great Island Harpswell, Maine
CLIENT/ADDRESS:	Mr. Mark Lenci 18 Woronoco Drive Natick, MA 01760
TELEPHONE:	617.525.8050
EMAIL:	marklenci@gmail.com
VESSEL BUILDER:	BENETEAU YACHTS
BUILDER LOCATION:	Marion, SC & Chantiers, France
YEAR VESSEL BUILT:	2005
LENGTH OVERALL:	53'01"
BEAM:	16'00"
DRAFT:	7'06″

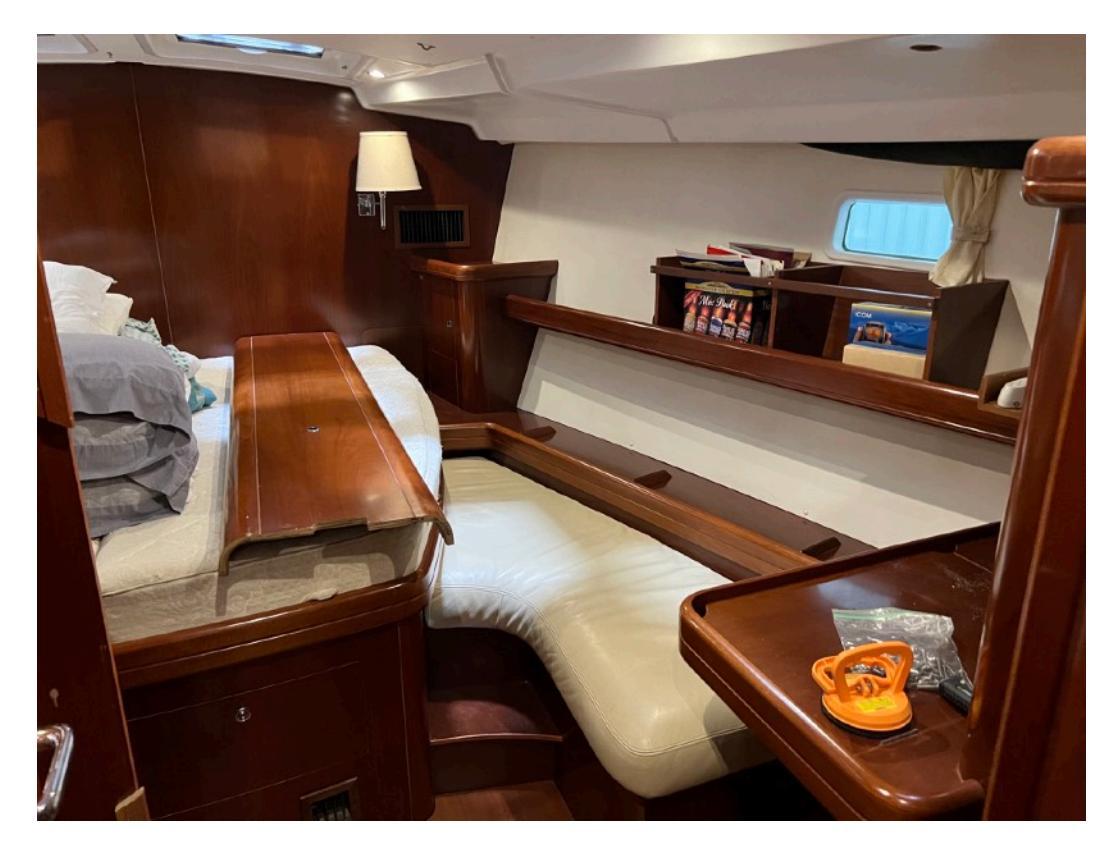
INTERIOR FORWARD CABIN

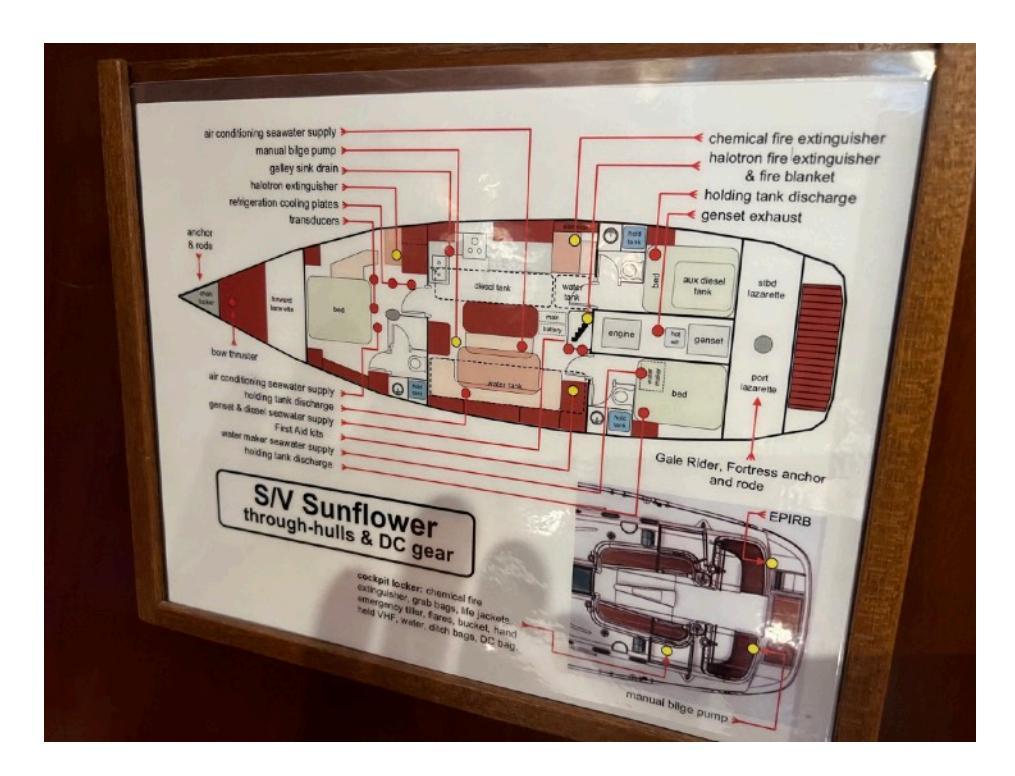
<u>Noted:</u> Sea Valves are diagramed and posted at navigation station.

SHIP'S DIAGRAM OF THROUGH HULL FITTINGS & DC GEAR

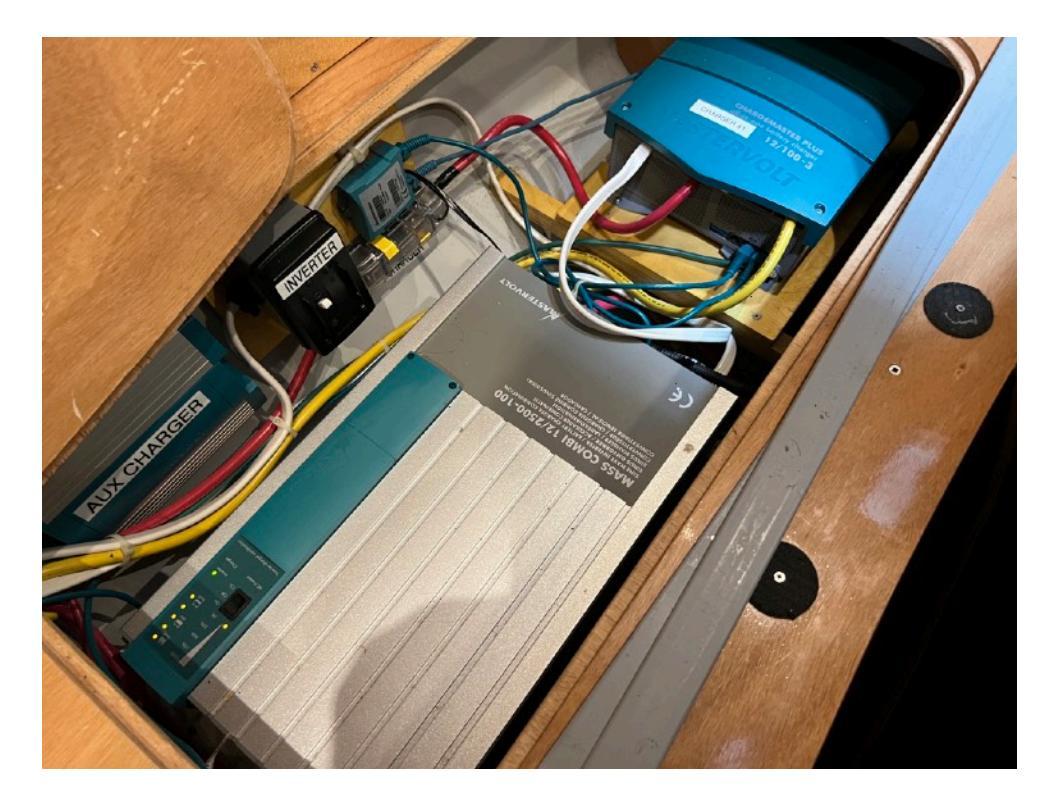
The vessel's primary electrical system is twelve (12) volt DC and is supplied by two (2) Mastervolt DC Lithium 5,000 Watt 14 volt DC batteries and a Master Volt 130 amp continuous belt driven engine alternator. The batteries are secured in liquid as recommended by ABYC and NFPA. The wiring system, where available for examination, is generally is recent and in very good condition with labeled circuit breaker switch panels and safety disconnect switches. The electrical system is used for auxiliary engine starting, navigation lights, interior lights, pumping, electronics, etc. The electrical system, where available for examination, appeared adequately grounded. Switches and electrical controls are marked to indicate their usage, and the panelboard is placed in a permanently mounted enclosure.

CHARGING SYSTEM FOR LITHIUM BATTERIES
