**PATTON MARINE SURVEYORS  
AND CONSULTANTS, INC.**

**June 12, 2026**  
**File No.: 13993-26**  
**Page 1 of 29**

**RE: "ESCAPE of LONDON", 1997,  
36.46 Meter TRIDENT Motor Yacht**

**RECOMMENDATIONS**

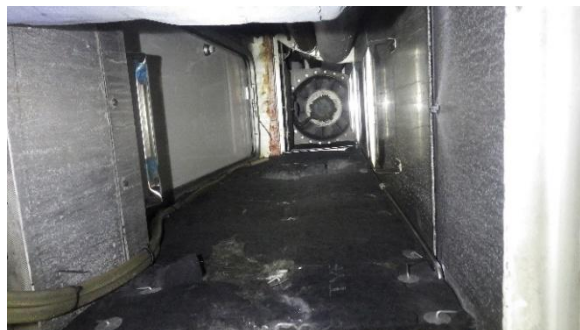
**MAIN ENGINE ROOM EXHAUST FANS INSTALLED WITHOUT PROTECTIVE GUARD/SCREENS**

7. The lazarette fan is showing signs of corrosion. Chemical etch, prime and paint.
8. The engine room duct work port and starboard up the stack needs attention. Sound insulation is deteriorating, oxidation is evident, protective screens not mounted over rotating fan assemblies and plenums are heavily soiled.
