**2005 73' Park Isle Marine, Sooke, BC Canada Snowbird**

## **"True Love"**

# Report of Marine Survey

**Date Of Survey:** July 31, 2024 & August 1, 2024

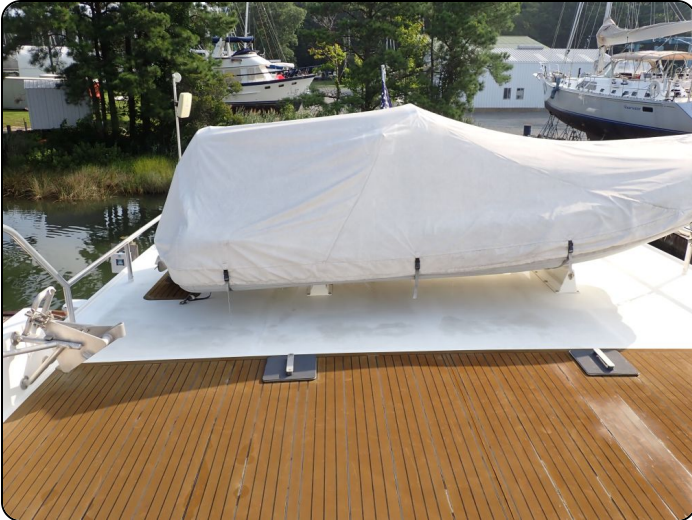
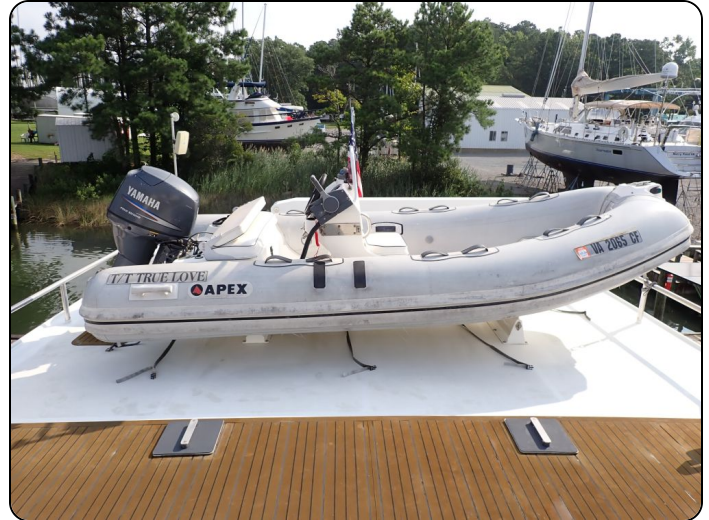
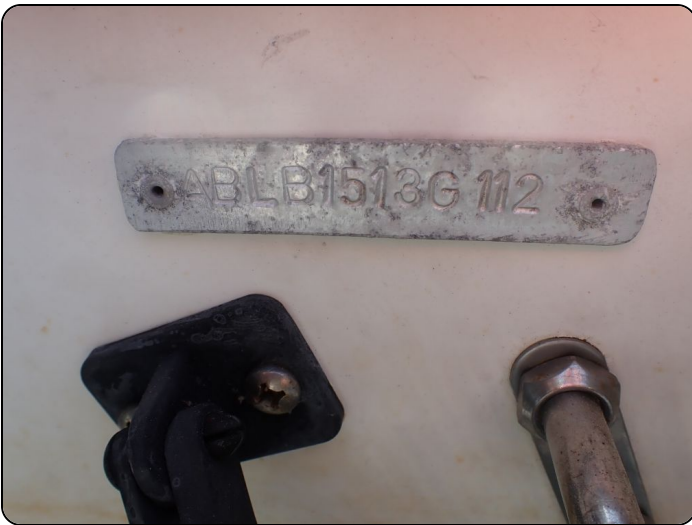
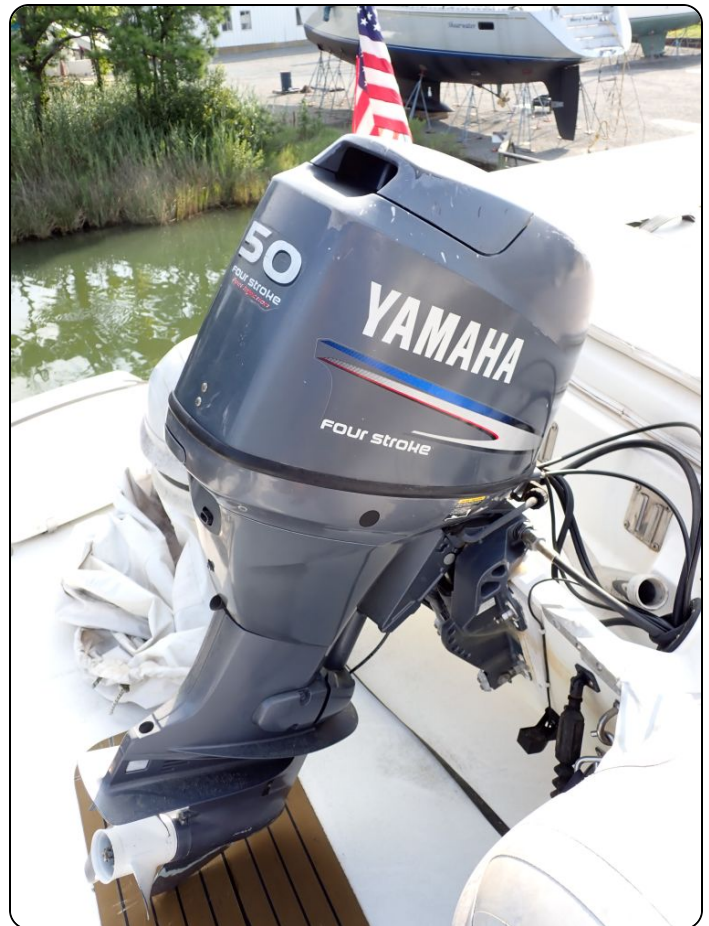
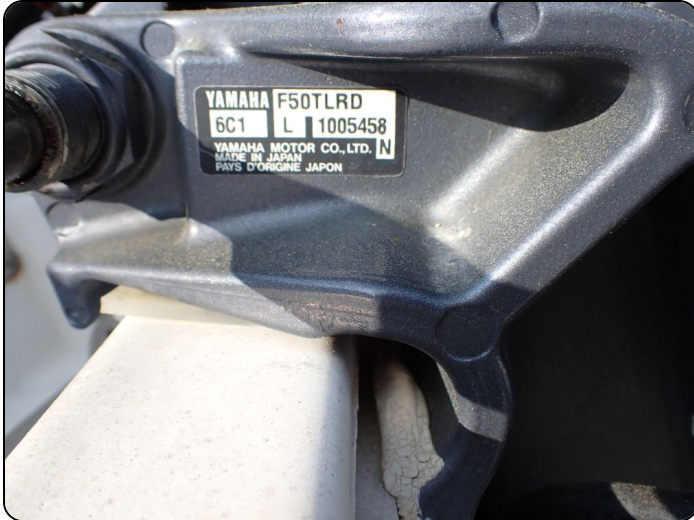
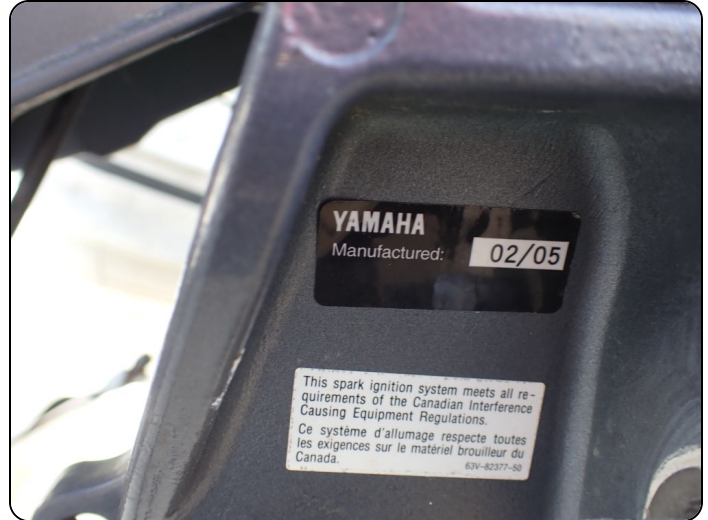
### TENDER/WATERCRAFT

2012 APEX 15' RHIB, HIN# ABLB1513G112 cradled at the aft boat deck, in worn but serviceable condition.
